ARBORICULTURAL INSPECTION REPORT

REDWOOD FOREST: VISITOR FACILITIES IMPROVEMENTS

VERSION 3 (UPDATED 14/3/2024)

Prepared by Stephen Fitzgerald
for:
Parks Victoria

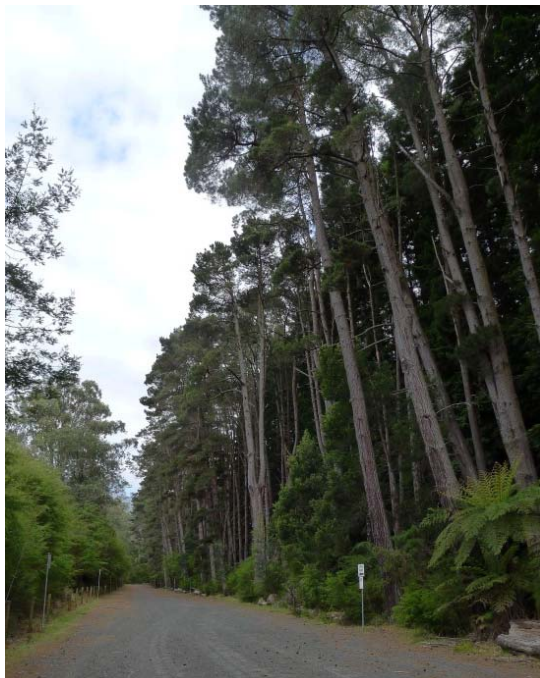
Photo 1 Bishop Pines on north side of car park

A few of the Bishop Pines were noticed to have suffered branch, root or stem failures, some appearing to be recent. Trees #63, 235 and 238 at the east end of

the planting have been recommended for removal due to defects noticed and declining structural conditions. Some trees including many not included in the inspection display poor stem taper (ratio of stem diameter to tree height). Tree #97 is an extreme example of a tree with poor taper (see Appendix 1, Photo 99). A recent stem failure of tree #238 was probably due to a combination of a bifurcation defect and poor stem taper (see Appendix 1, Photo 211). Poor stem taper usually only becomes a problem for trees in groups when they become exposed often after surrounding trees fail or are removed or, when the tree grows higher than surrounding trees allowing its canopy to be exposed to winds.

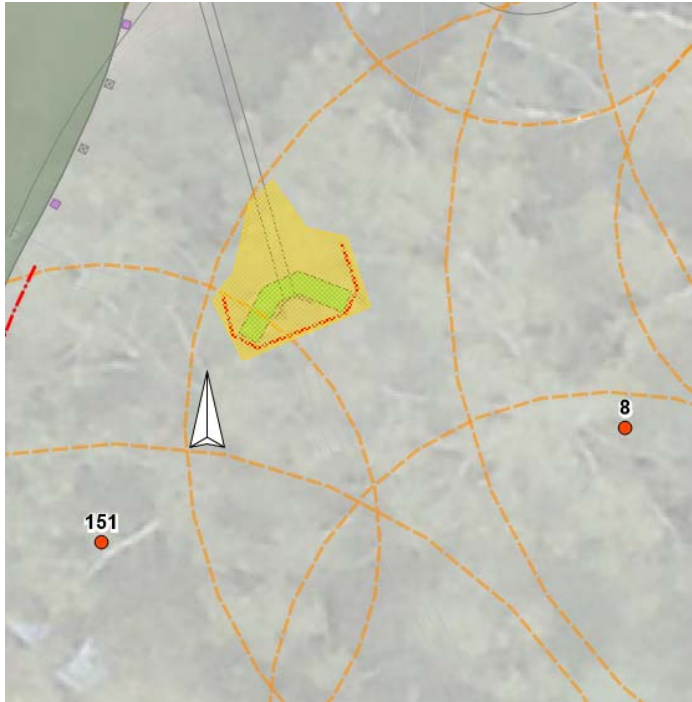
Figure 1 TPZ encroachments from proposed culvert pipe trench to trees #8 and 151 (shaded areas).

Tree #8 and 151 TPZs will be encroached approximately 3% and 1% respectively with the encroachment well outside of their SRZs. The encroachments are minor and unlikely to impact the trees.

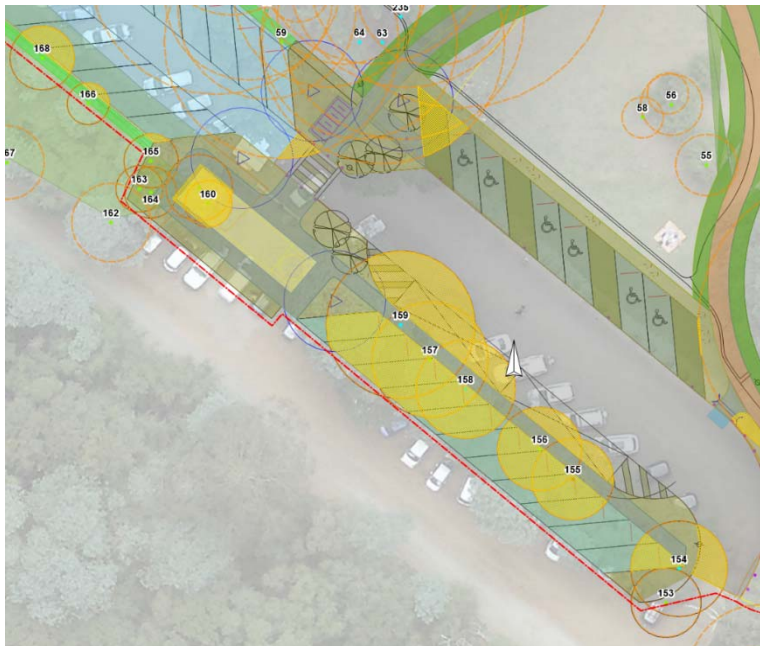
Figure 2 TPZ encroachments from new compacted gravel and asphalt car park, toilet block and extension of car park into vegetated area to south to trees #154, 155, 156, 157, 158, 159, 160, 161, 165, 166 and 168 (shaded areas).

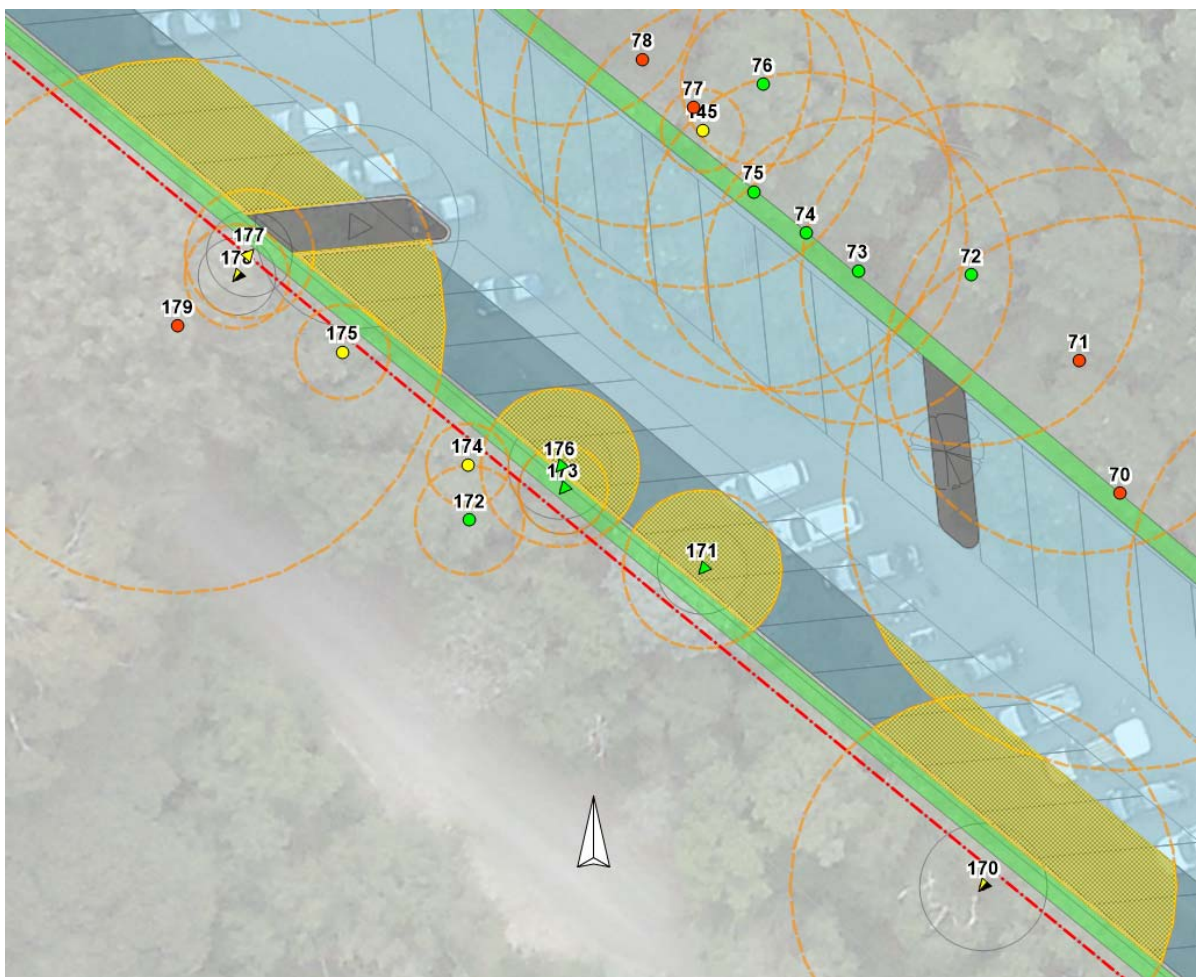
Figure 3 TPZ encroachments from extension of car park into the vegetated area to south to trees #170, 171, 173, 176, 177 and 179 (small encroachment to tree #70 (out of view) on north side of car park also shown near tree #170) (shaded areas). All apart from tree #179 are to be removed.

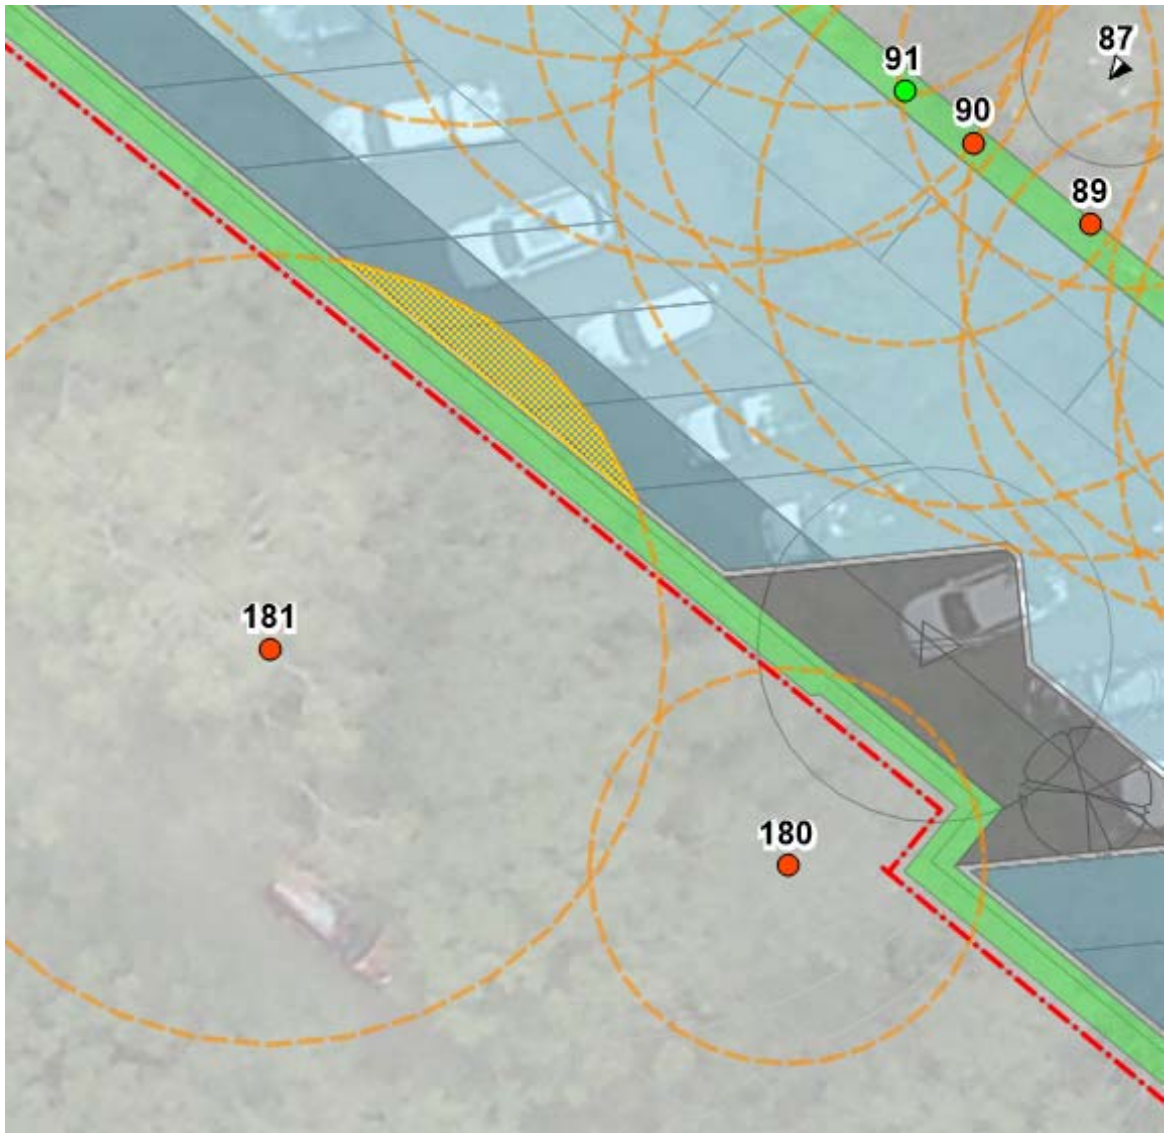
Figure 4 TPZ encroachments from extension of car park into the vegetated area to south to tree #181 (shaded areas).

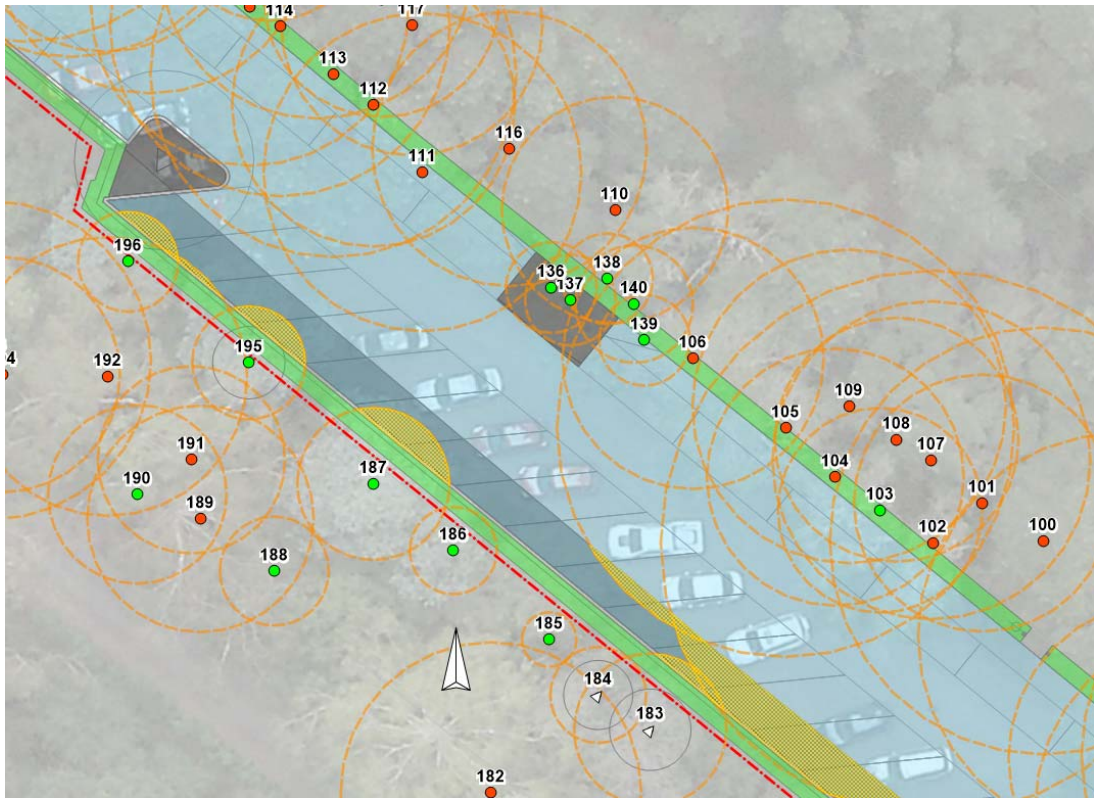
Figure 5 TPZ encroachments from extension of car park into the vegetated area to the south to trees #183, 187, 195 and 196 on south side and trees #102 and 105 on north side of car park (shaded areas). All, apart from trees #183 and 184 are to be retained.

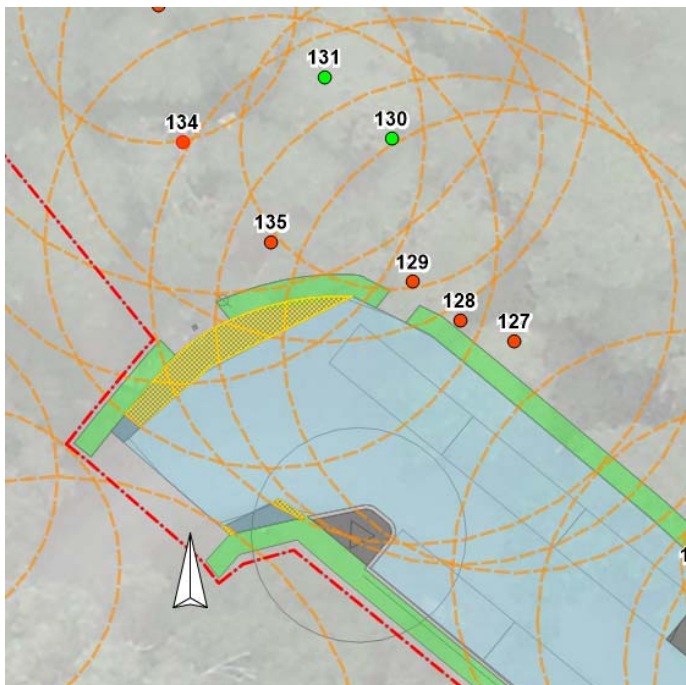
Figure 6 TPZ encroachments from extension of car park into vegetated area to northwest to trees #134 and 135.

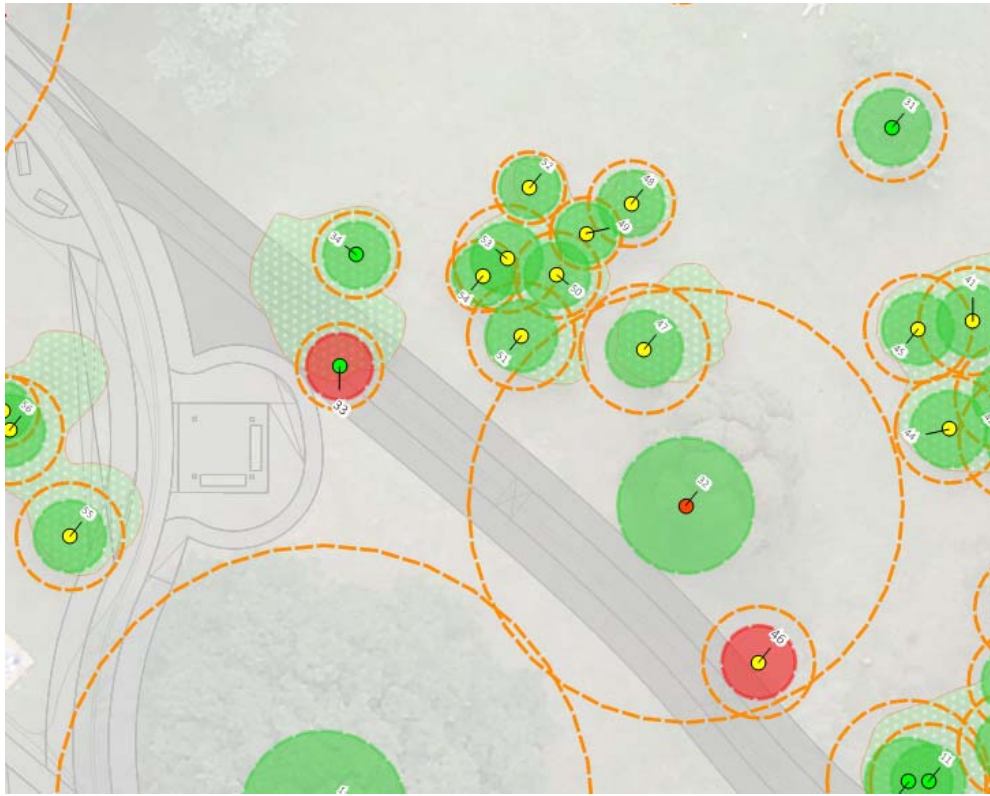
Figure 7 Trees #33 and 46 are within the proposed trail alignment and need to be removed.

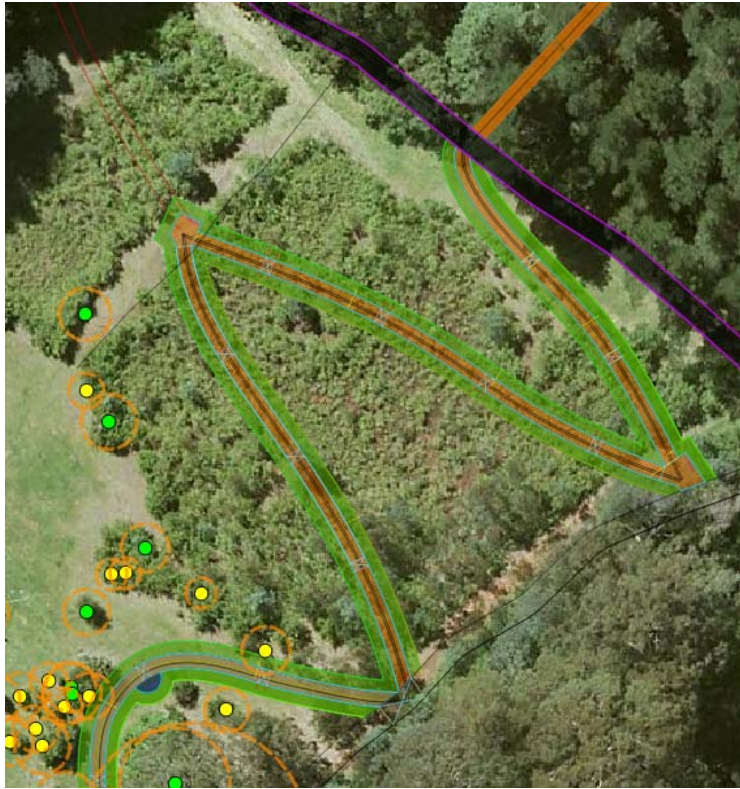
It can be seen in Figures 8 and 9 that regrowth of wattles and eucalypts has proliferated significantly between 2014 and 2023.

Figure 8 Proposed trail path through existing Burgan, eucalypt and wattle regrowth (2014)

Clearing will be required to create the path. Lost vegetation in these densely vegetated patches would need to be assessed as a Habitat Hectare Assessment by a qualified ecologist.

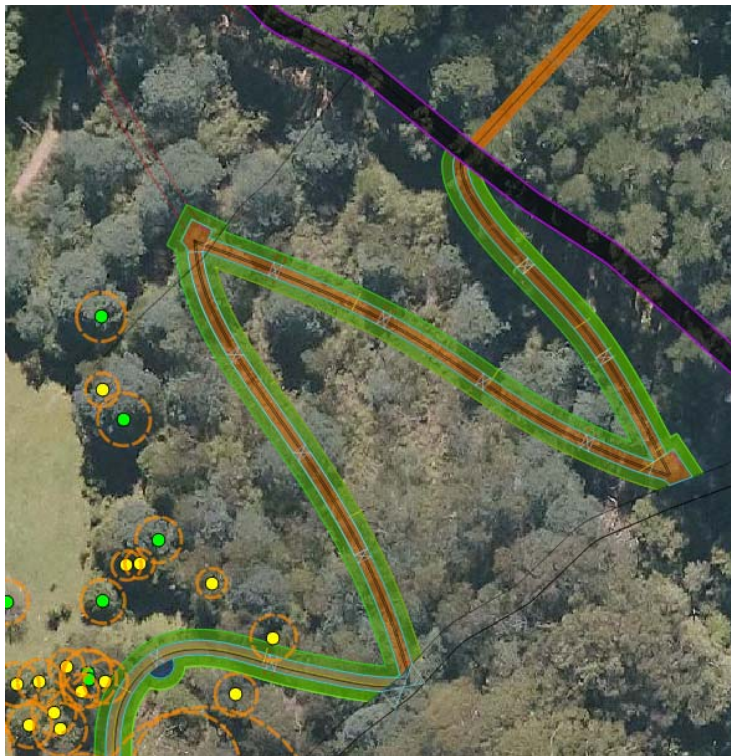
Figure 9 Proposed trail path through existing Burgan, eucalypt and wattle regrowth (2023)

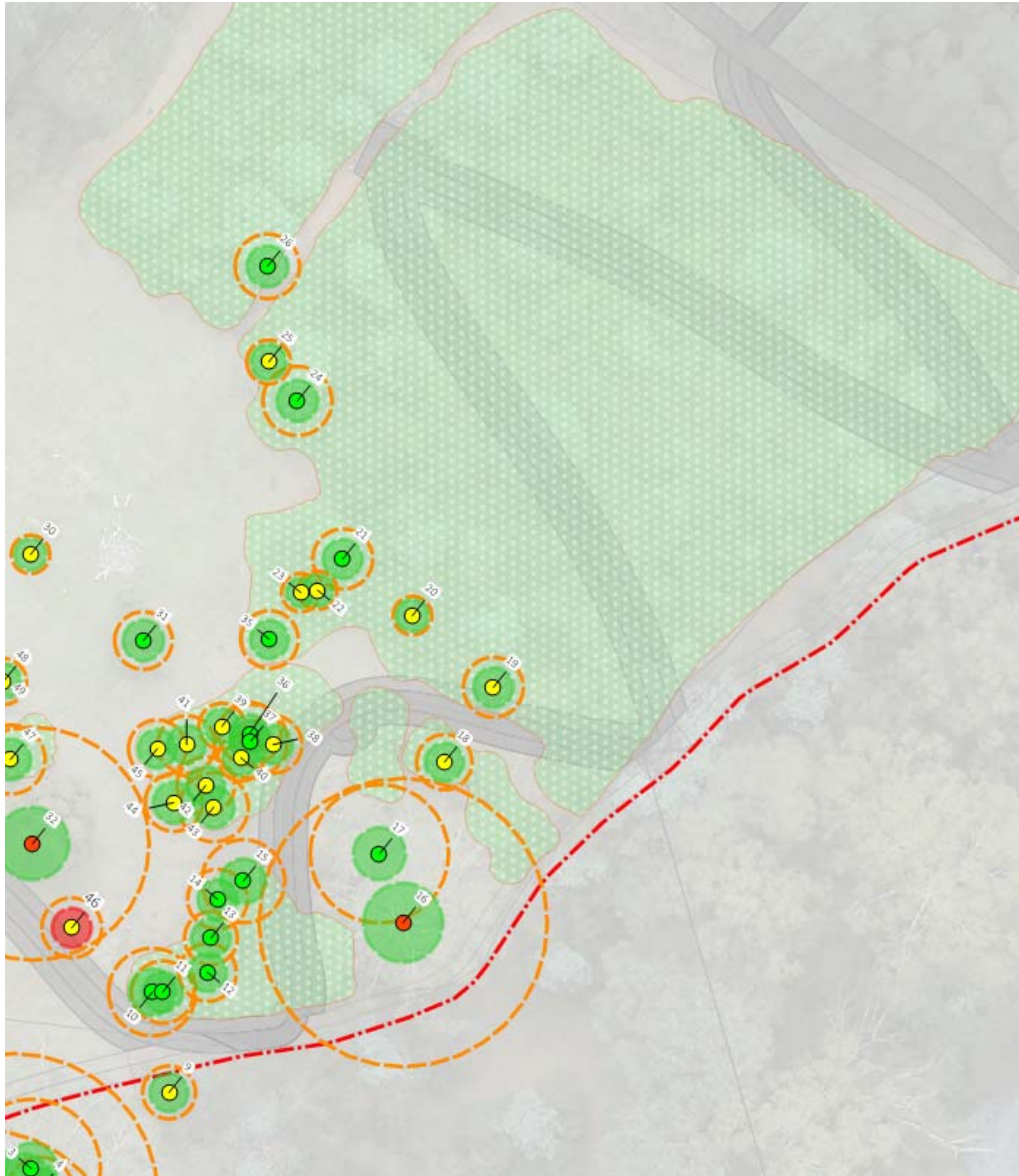
Figure 10 Proposed trail within an area of dense Burgan, Silver Wattles and young eucalypts

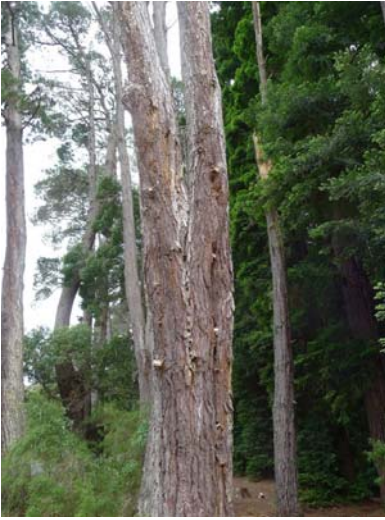
Photo 64 from south-east: Tree 63
bifurcation defect of main stem

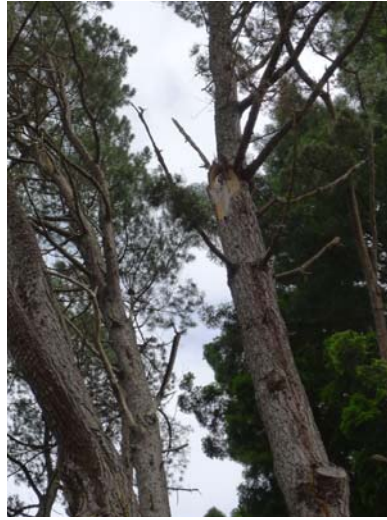
Photo 65 from south-east: Tree 63
recent bifurcation failure

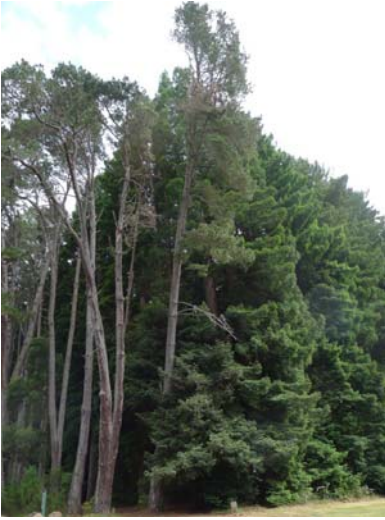
Photo 208 from south-east: Tree 235 right (tallest tree)

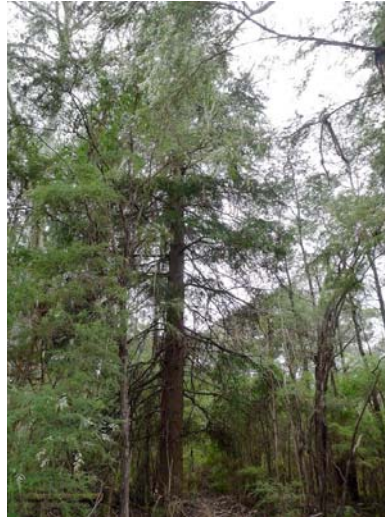
Photo 209 from south-east: Tree 236 centre background (leaning to right)

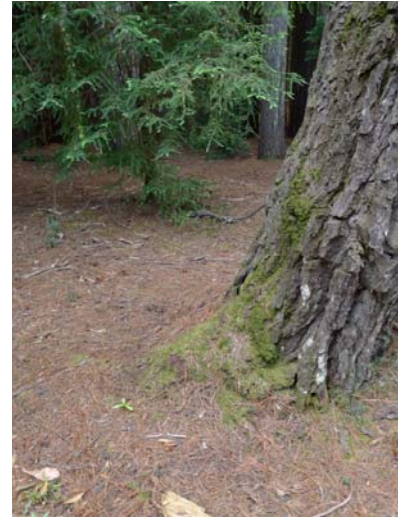
Photo 210: Tree 237 base of tree showing root heave

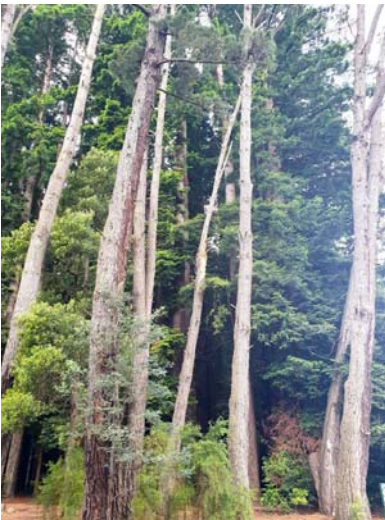
Photo 211: Tree 238 centre background

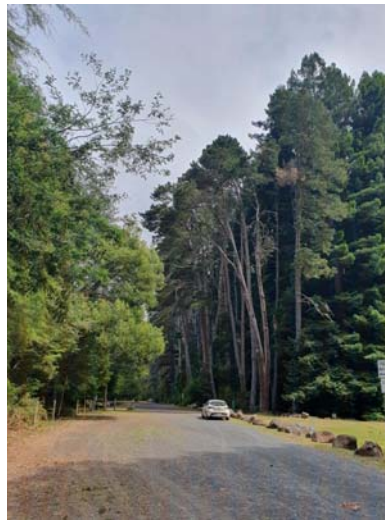
Trees #239 to 243 are Redwoods that are at the edge of the larger Redwood plantation. The very high retention value reflects that of the whole plantation and is based on the heritage value of the trees. A statement of significance for these and other trees at the site can be found in VHR H2439 Victorian Heritage Register record.

Photo 212 from south-east: Tree 243 taller trees on right are #239 to 243
