Werribee Hangar Relocation Project

25th February 2019

**Re : Werribee Hangar Relocation Project
Geelong Road
Werribee**

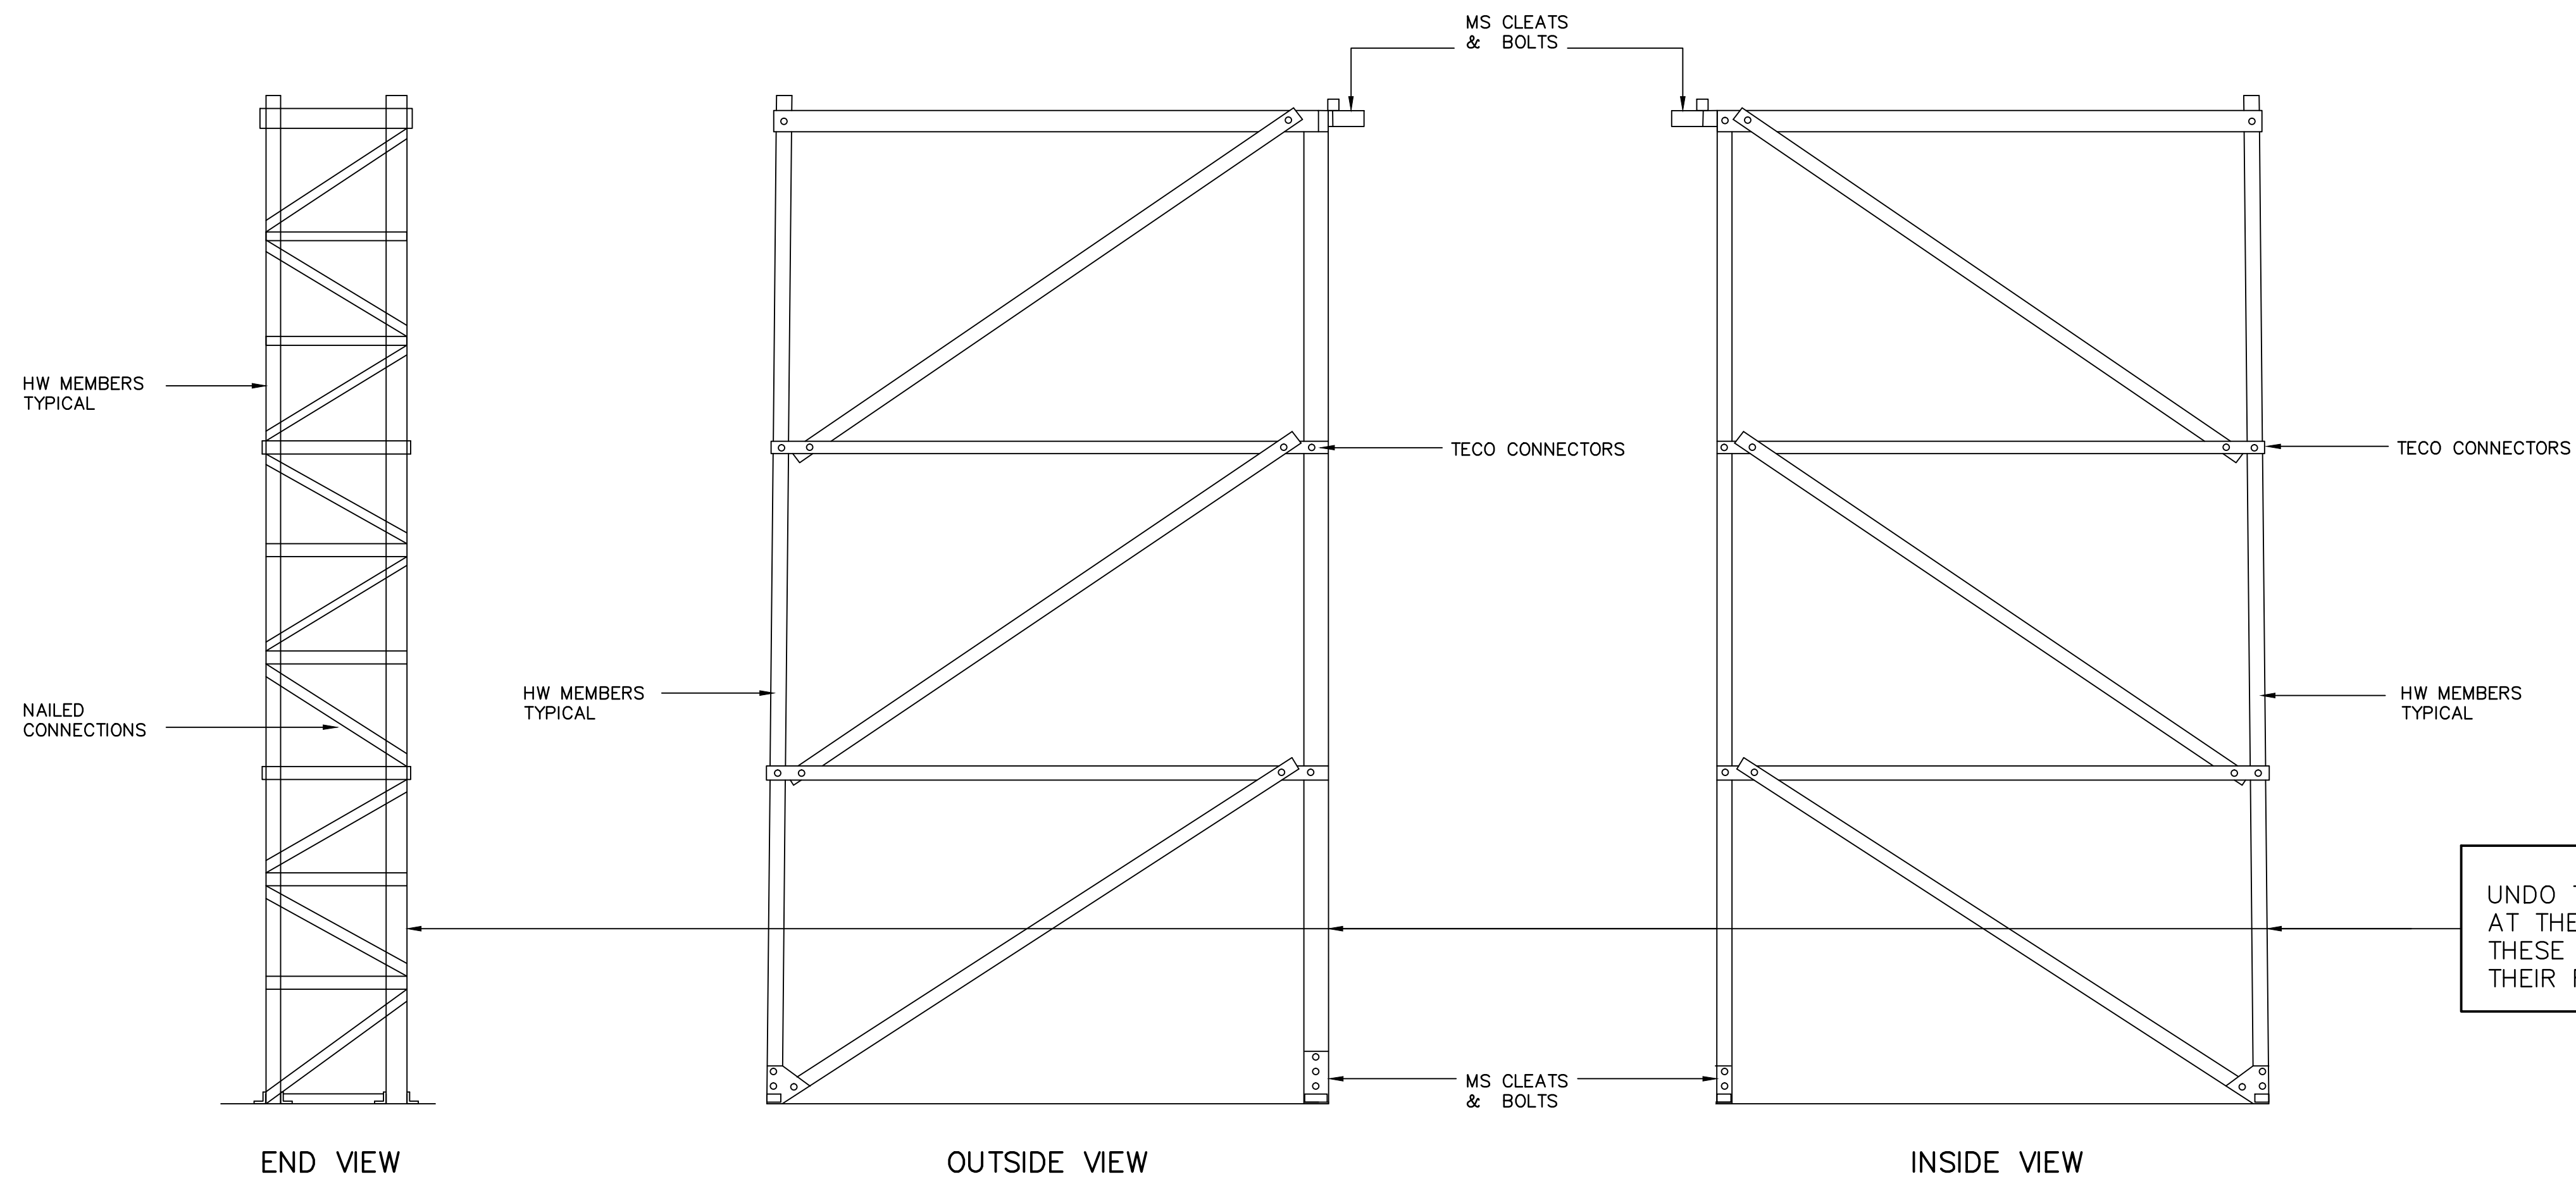
DOOR DOCK ELEVATIONS

Our ground level inspection of the interior of Hangar 2 revealed that apart from some dry rot in the internal Door Dock framework, the timber appears to be in good condition, noting that the roof structure was not able to be adequately inspected from the ground level, and not all of the sub-roof structure was visible. Note that in 2015 we did not carry out a high-level inspection of the Hangar 2 roof structure. Our inspection of the external flying struts revealed that whilst the flying struts along the western side of the Hangar have been remediated and capped with metal flashing, the flying struts along the eastern side suffer from dry rot and need to be replaced.

UNDO THE BOLTED CONNECTIONS AT THE TOPS AND THE BASES OF THESE FRAMES TO ALLOW FOR THEIR RELOCATION.

REPLACE THE EXISTING FLYING STRUTS WITH F27 SEASONED DURABLE HW TO COMPLY WITH THE BCA, AND NOTE THAT THE NEW FLYING STRUTS MAY BE LARGER THAN THE EXISTING. CLEAN AND PAINT THE EXISTING BOLTS AND WASHERS FOR RE-USE AND CAP OVER THE NEW TIMBERS. NOTE THAT THE NEW FLYING STRUTS MAY BE LARGER TO SUIT THE CURRENT WIND DESIGN LOADINGS.

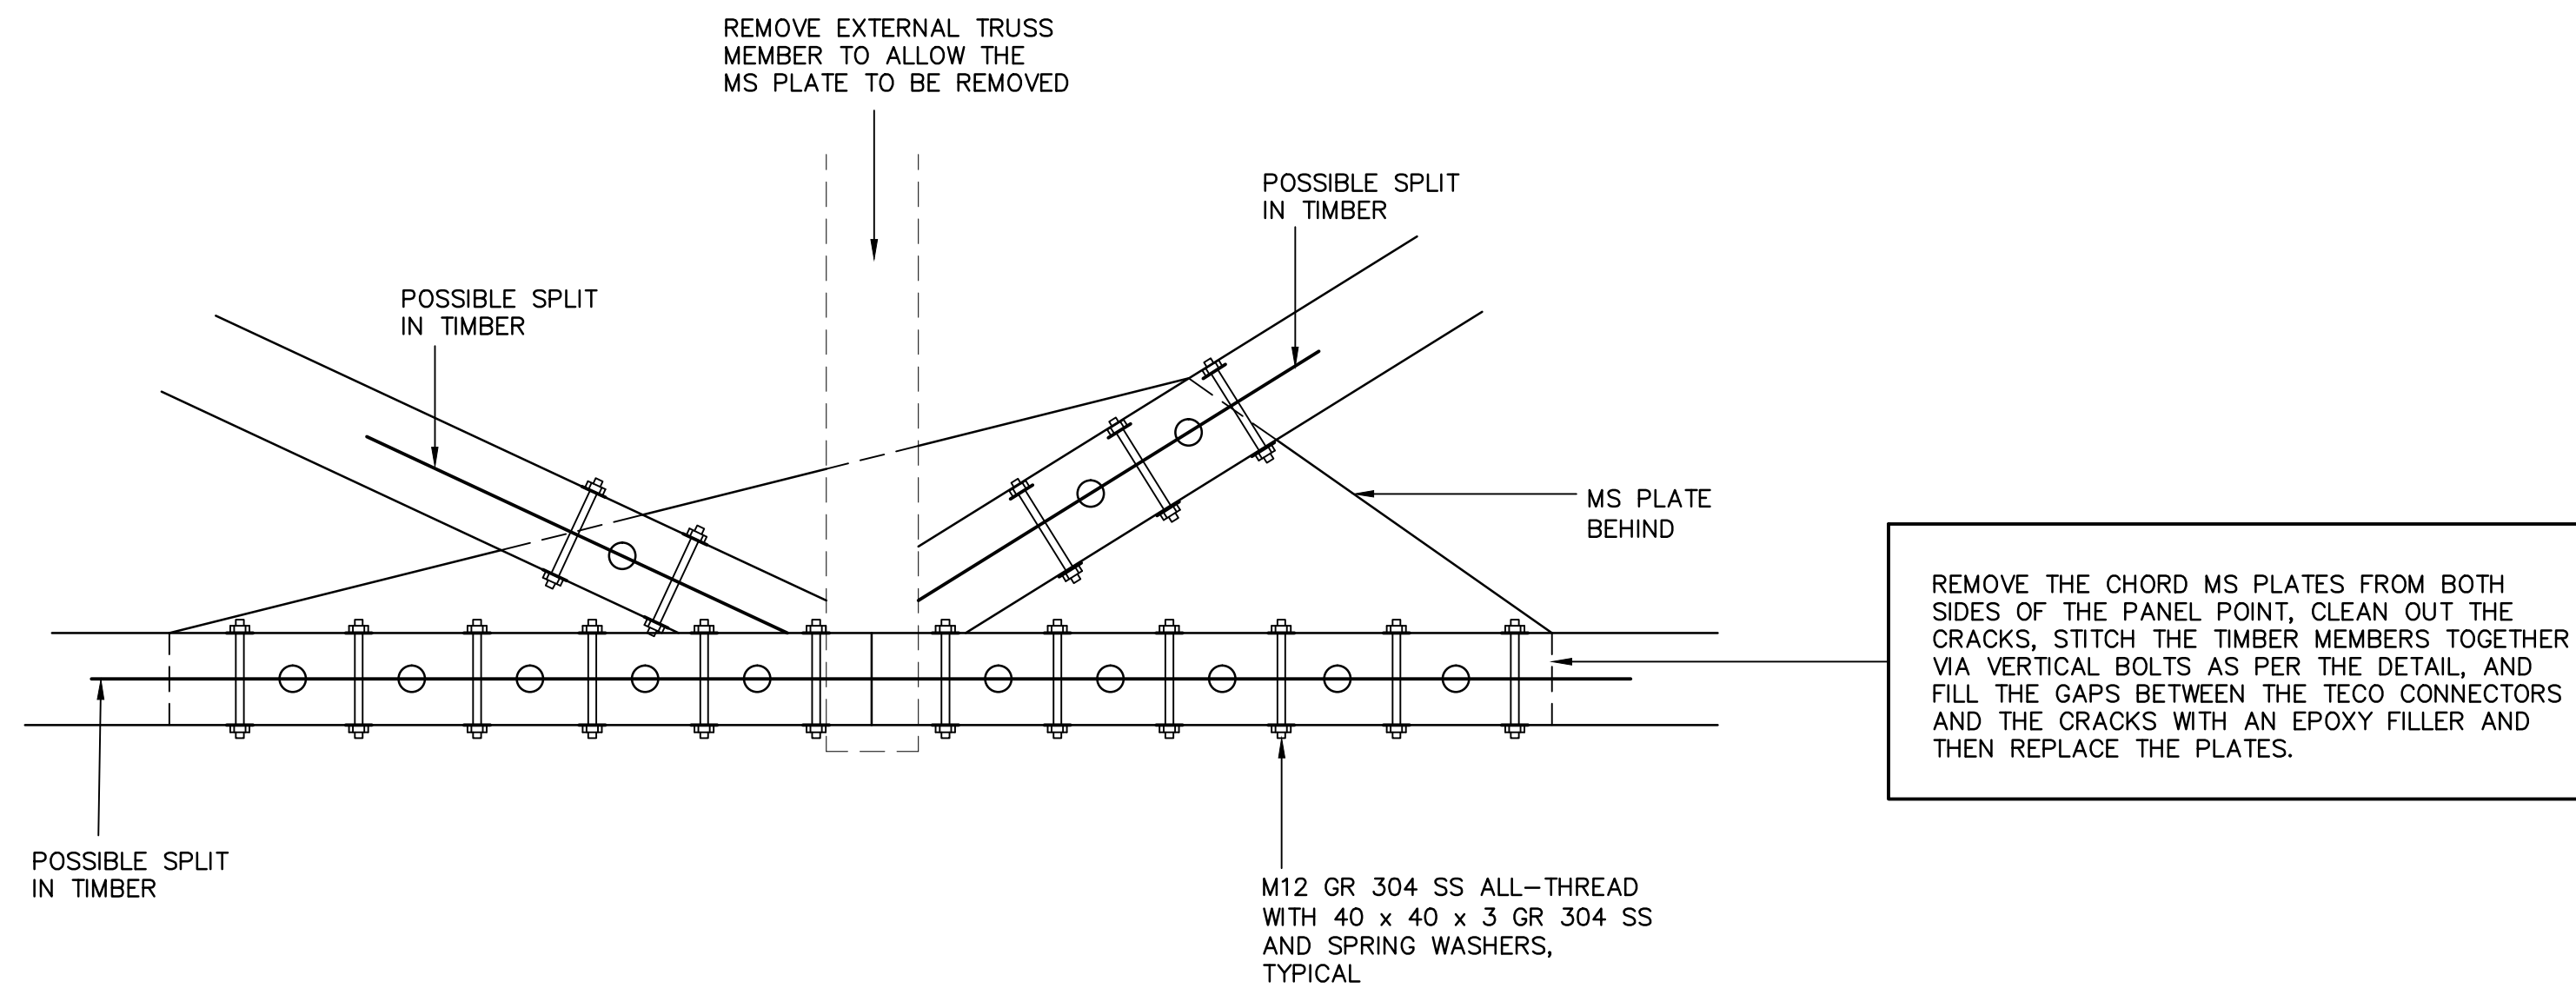
TYPICAL PRIMARY TRUSS JOINT REMEDIATION DETAIL

Notwithstanding that our 2015 brief was to inspect two typical primary roof trusses, our cursory inspection of other parts of the structure revealed a number of broken bottom chords, dry rot in the roofing members where the roofing was missing or had otherwise failed, dry rot in the base of one timber post, and some dry rot in the internal Door Dock framework. Our inspection of the flying struts that are located along the eastern and western external walls of the Hangar revealed extensive dry rot. In general and as per Hyder's findings, the majority of the defects that we observed from our high level inspection were in the roof structure and were generally confined to splitting of the timber members at the joints.

- 1 LABEL THE MEMBERS WITH ENGRAVED NAME PLATES PRIOR TO THEIR DIS-ASSEMBLY TO ENSURE THAT THEY ARE RE-ERECTED IN THE CORRECT LOCATIONS.
- 2 REMEDIATE THE PRIMARY TRUSS JOINTS IN ACCORDANCE WITH THE 'TYPICAL PRIMARY TRUSS JOINT REMEDIATION DETAIL' ON S7. NOTE THAT WHERE THE TRUSS MEMBERS ARE ROTTED, CRUSHED OR OTHERWISE DEEMED SUB-STANDARD BY THE STRUCTURAL ENGINEER THEY SHALL BE REPLACED WITH F27 SEASONED DURABLE RECYCLED HW THE SAME DIMENSIONS AS THE MEMBER THAT IS TO BE REPLACED. PRIOR TO THE RE-ASSEMBLY OF THE JOINTS THE TECO SHEAR-PLATE AND SPLIT-RING CONNECTORS AND THE BOLTS AND WASHERS SHALL BE GRIT BLASTED AND PAINTED.
