10 April 2024

Arboricultural Impact Assessment Report regarding sixty-six (66) trees located within the vicinity of the proposed multideck carpark development at Thomas Embling Hospital and Melbourne Polytechnic, 201 Yarra Bend Road, Fairfield

Andrew Clark
Consulting Arborist
Dip. Hort. (Arb.), AQF Level 5

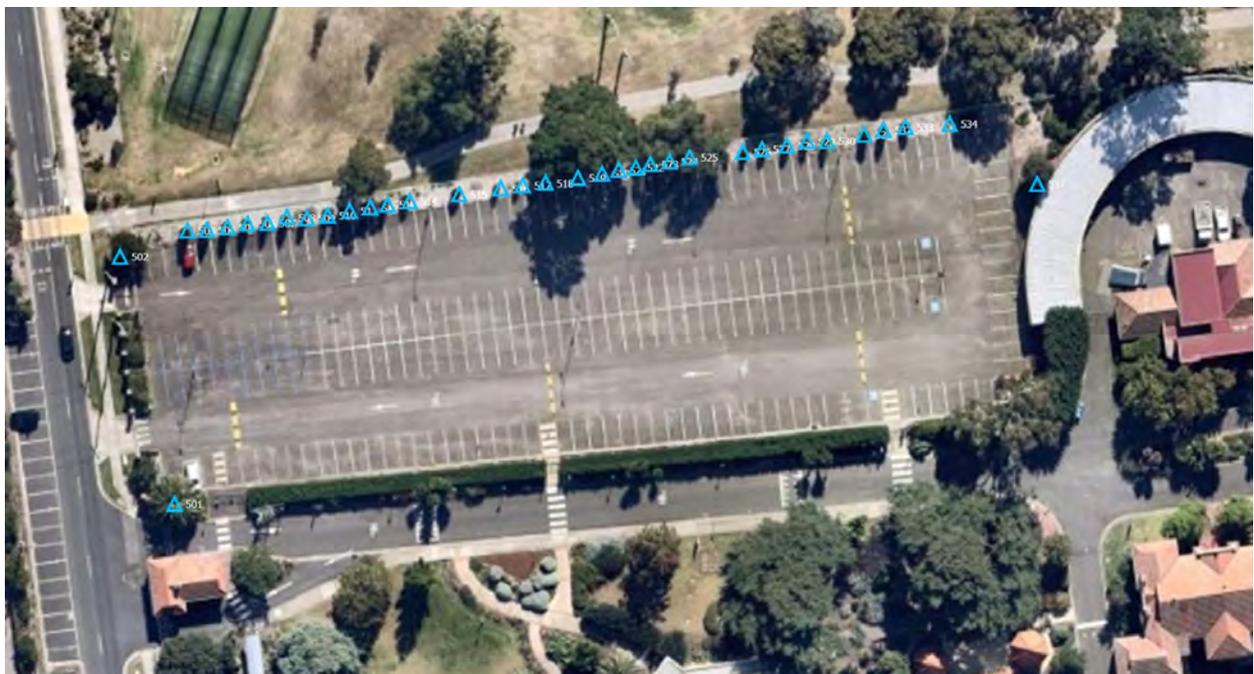
7.1.2 One (1) *Ligustrum lucidum* (Chinese Privet) tree should be removed irrespective of development (Category U) due to its small stature and recognised weed status within the Yarra Council LGA.

Figure 6. Site map showing the Category U retention value tree recommended for removal. ArborSite, April 2024).

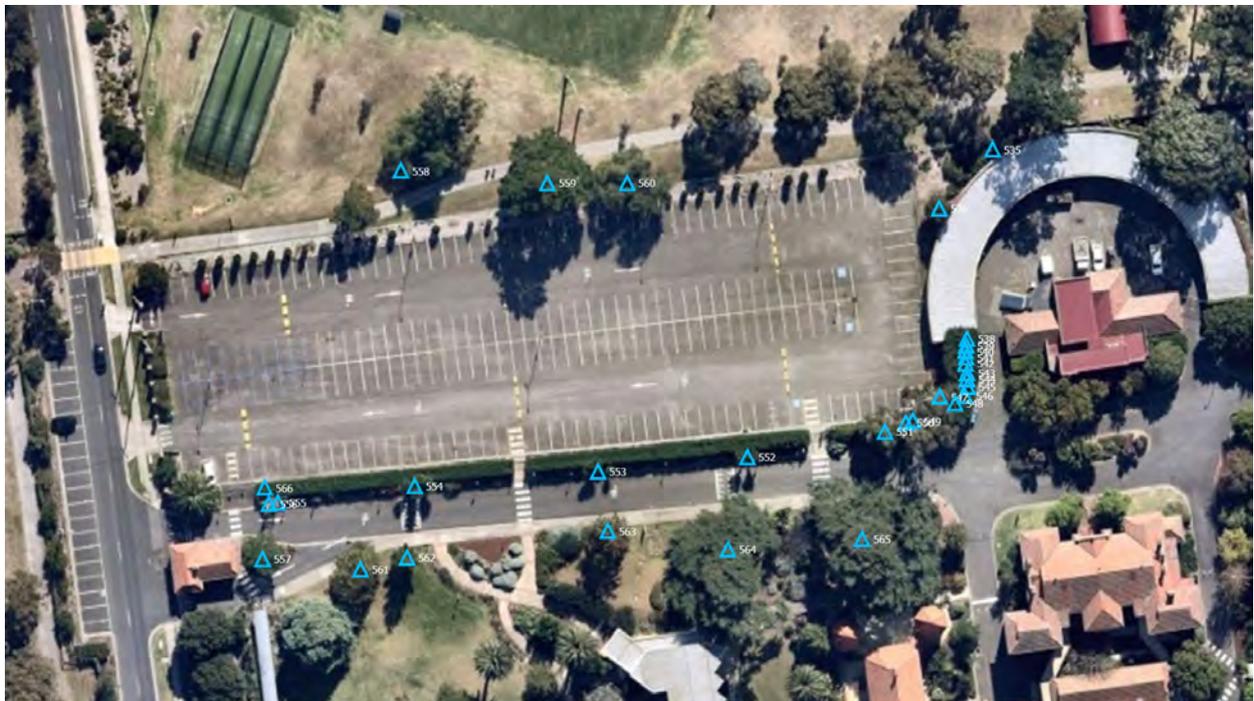
7.2.1 Thirty-one (31) trees were recommended for retention and require generic protection measures during construction to ensure they remain viable following the completion of works.

Figure 7. Site map showing tree requiring generic protection measures. ArborSite, April 2024.

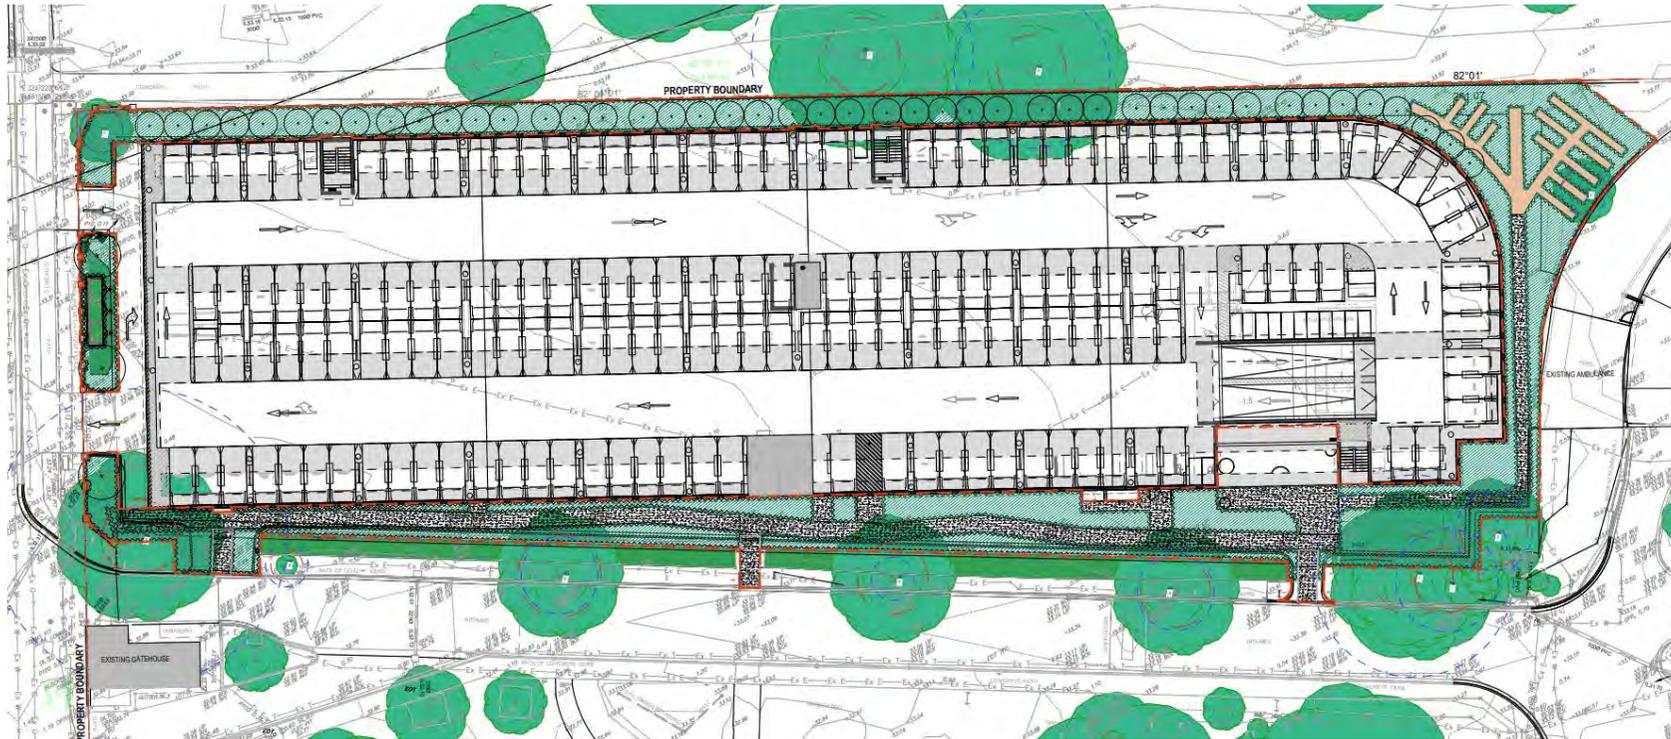
Figure 11. Site map showing retained trees with suggested Tree Protection Fence locations (Shown in red). (Guymer Bailey Landscape November 2023).

- Install Tree Protection Fencing excluding the proposed landscaped areas from the general building site.
- Restrict activities within the TPZ as detailed within section 7.4 of this Report.
- Use trunk and ground protection if the protection fencing requires removal.
- Install Tree protection signage.
