**ATTACHMENT D:
PILE CAP EXPOSURES,
REPORT**

20144725-003-L-Rev0

28 CLARENDON STREET, SOUTHBANK – PILE CAP EXPOSURES

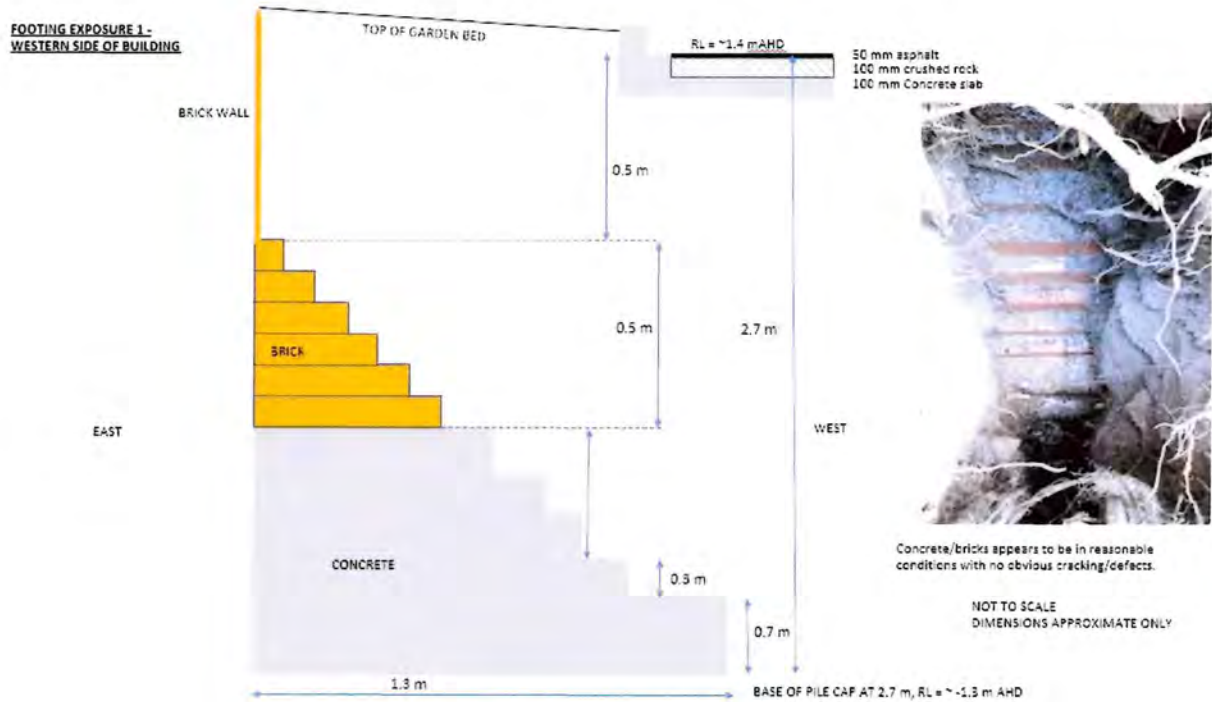
Figure 2: Footing Exposure 1 Sketch and Photo

- Footing Exposure 1 (western side of building): Base of pile cap 2.7 m below ground level (approximate RL = -1.3 m AHD) – refer to Figure 2
 - Concrete exposed in pile cap appears to be in reasonable condition with no obvious cracking/defects

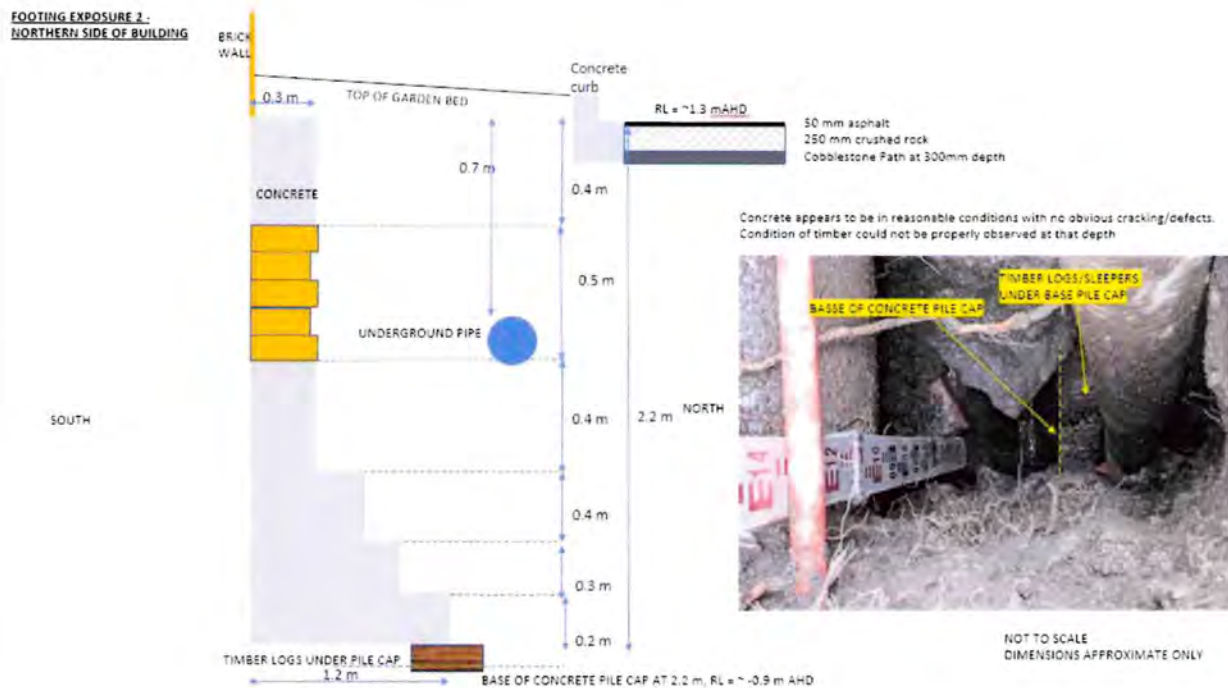
Figure 3: Footing Exposure 2 Sketch and Photo

- Footing Exposure 2 (northern side of building): Base of pile cap 2.2 m below ground level (approximate RL = -0.9 m AHD) – refer to Figure 3
 - Concrete exposed in pile cap appears to be in reasonable condition with no obvious cracking/defects

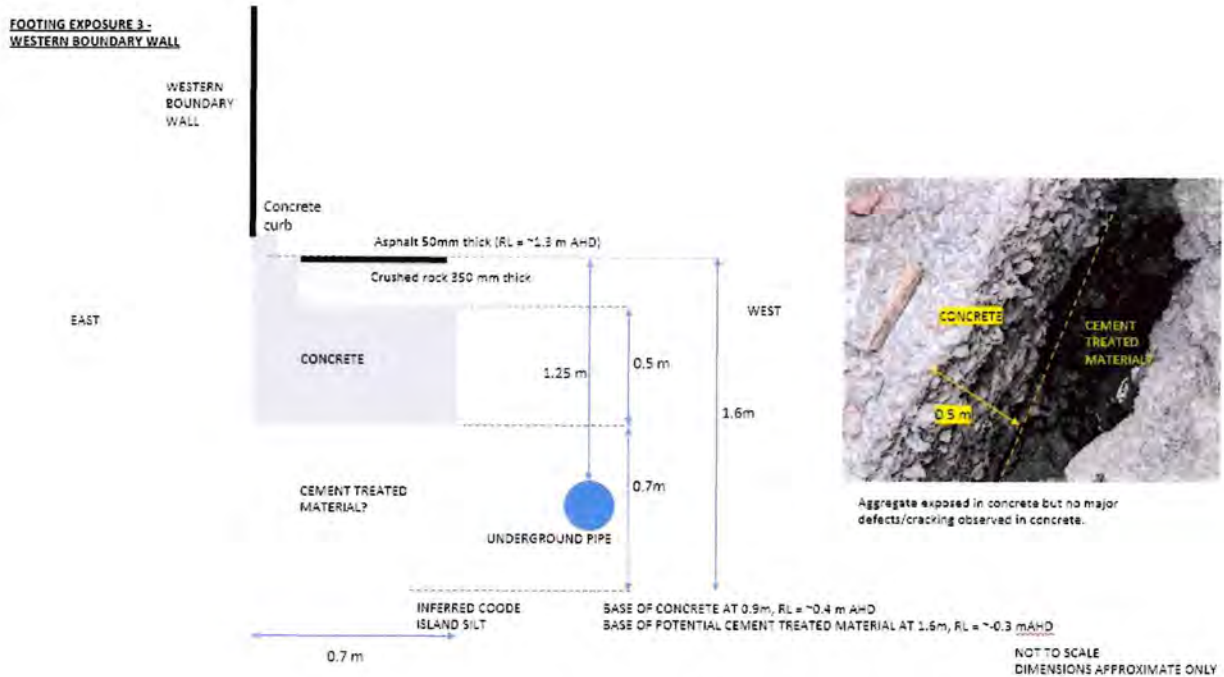
Figure 4: Footing Exposure 3 Sketch and Photo

- Footing Exposure 3, western perimeter wall (refer Figure 4):

- Base of inferred concrete strip footing at 0.9 m below ground level (approximate RL = 0.4 m AHD)
- Inferred cement treated gravel/sand beneath the inferred concrete strip footing from 0.9 -1.6 m.

- Aggregate exposed in concrete side of strip footing exposed but no major defects/cracking observed in concrete.
- Footing Exposure 4 (from the basement of building):

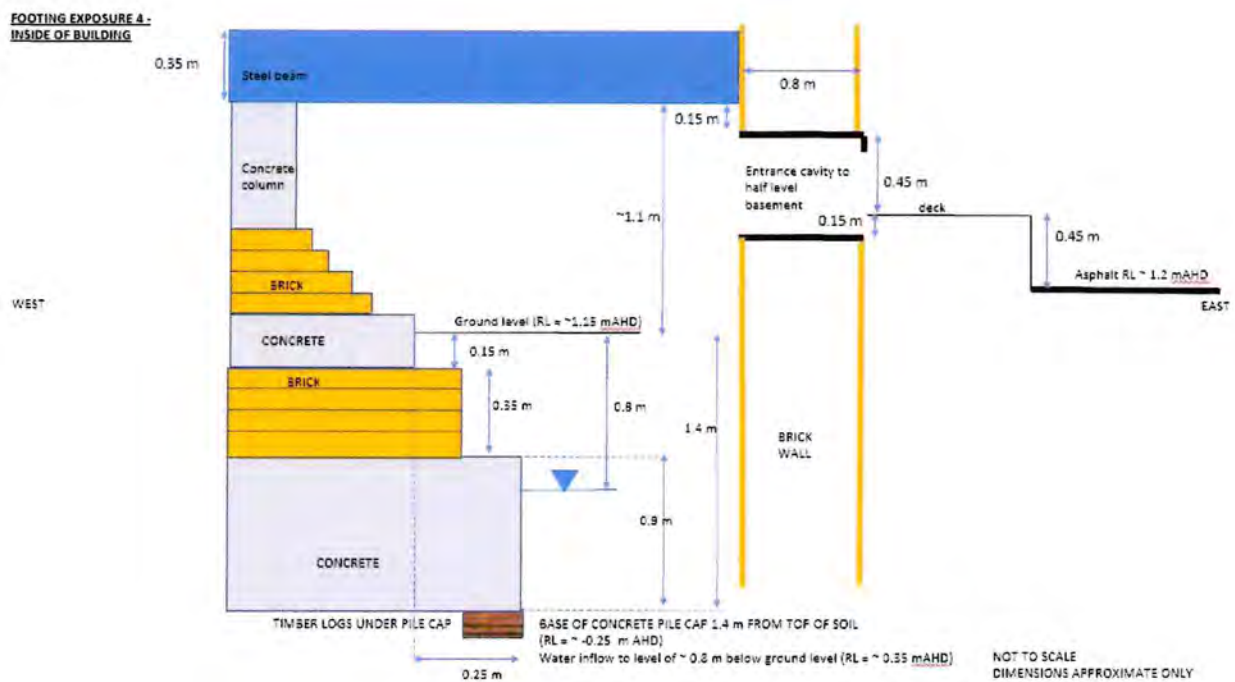
Figure 5: Footing Exposure 4 Sketch

- Base of pile cap 1.4 m below ground level (approximate RL = -0.25 m AHD)
 - Groundwater inflow to a depth of 0.8 m below ground level (approximate elevation RL = 0.35 m AHD)

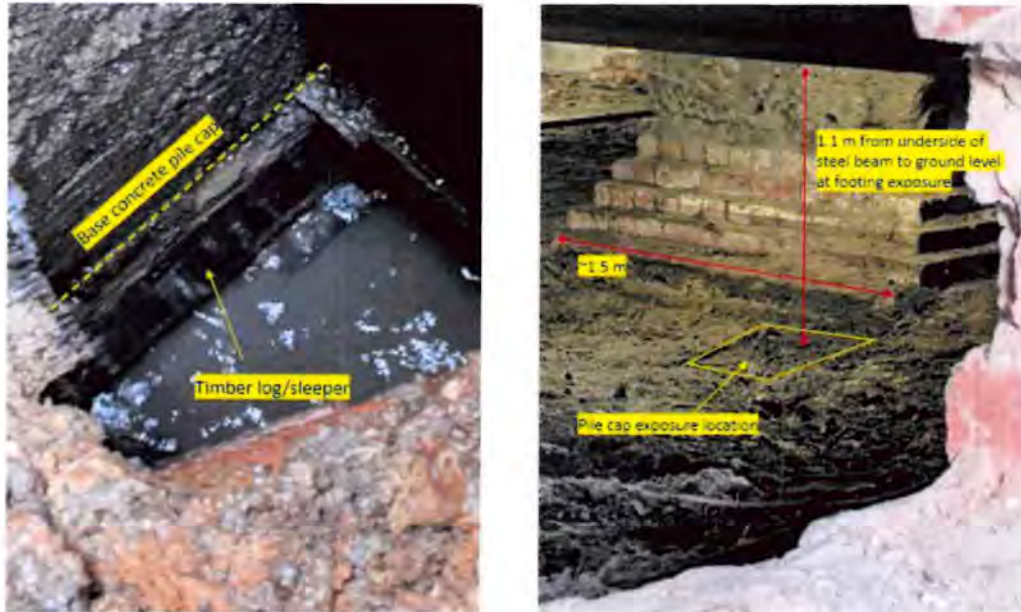
Figure 6: Footing Exposure 4 Photos

- Concrete exposed in pile cap appears to be in reasonable condition with no obvious cracking/defects
- Groundwater levels were previously measured in three standpipes installed as part of the geotechnical investigation for the proposed development. Groundwater levels were measured to range between about RL 0.2 m AHD to RL 0.3 m AHD.

Concrete in pile cap appears to be in good conditions with no obvious cracking/defects.
Difficult to assess condition of timber but looks to be relatively well preserved
