# Professional Diving Services

## Princes Pier Pile Forest Survey

### January 2024

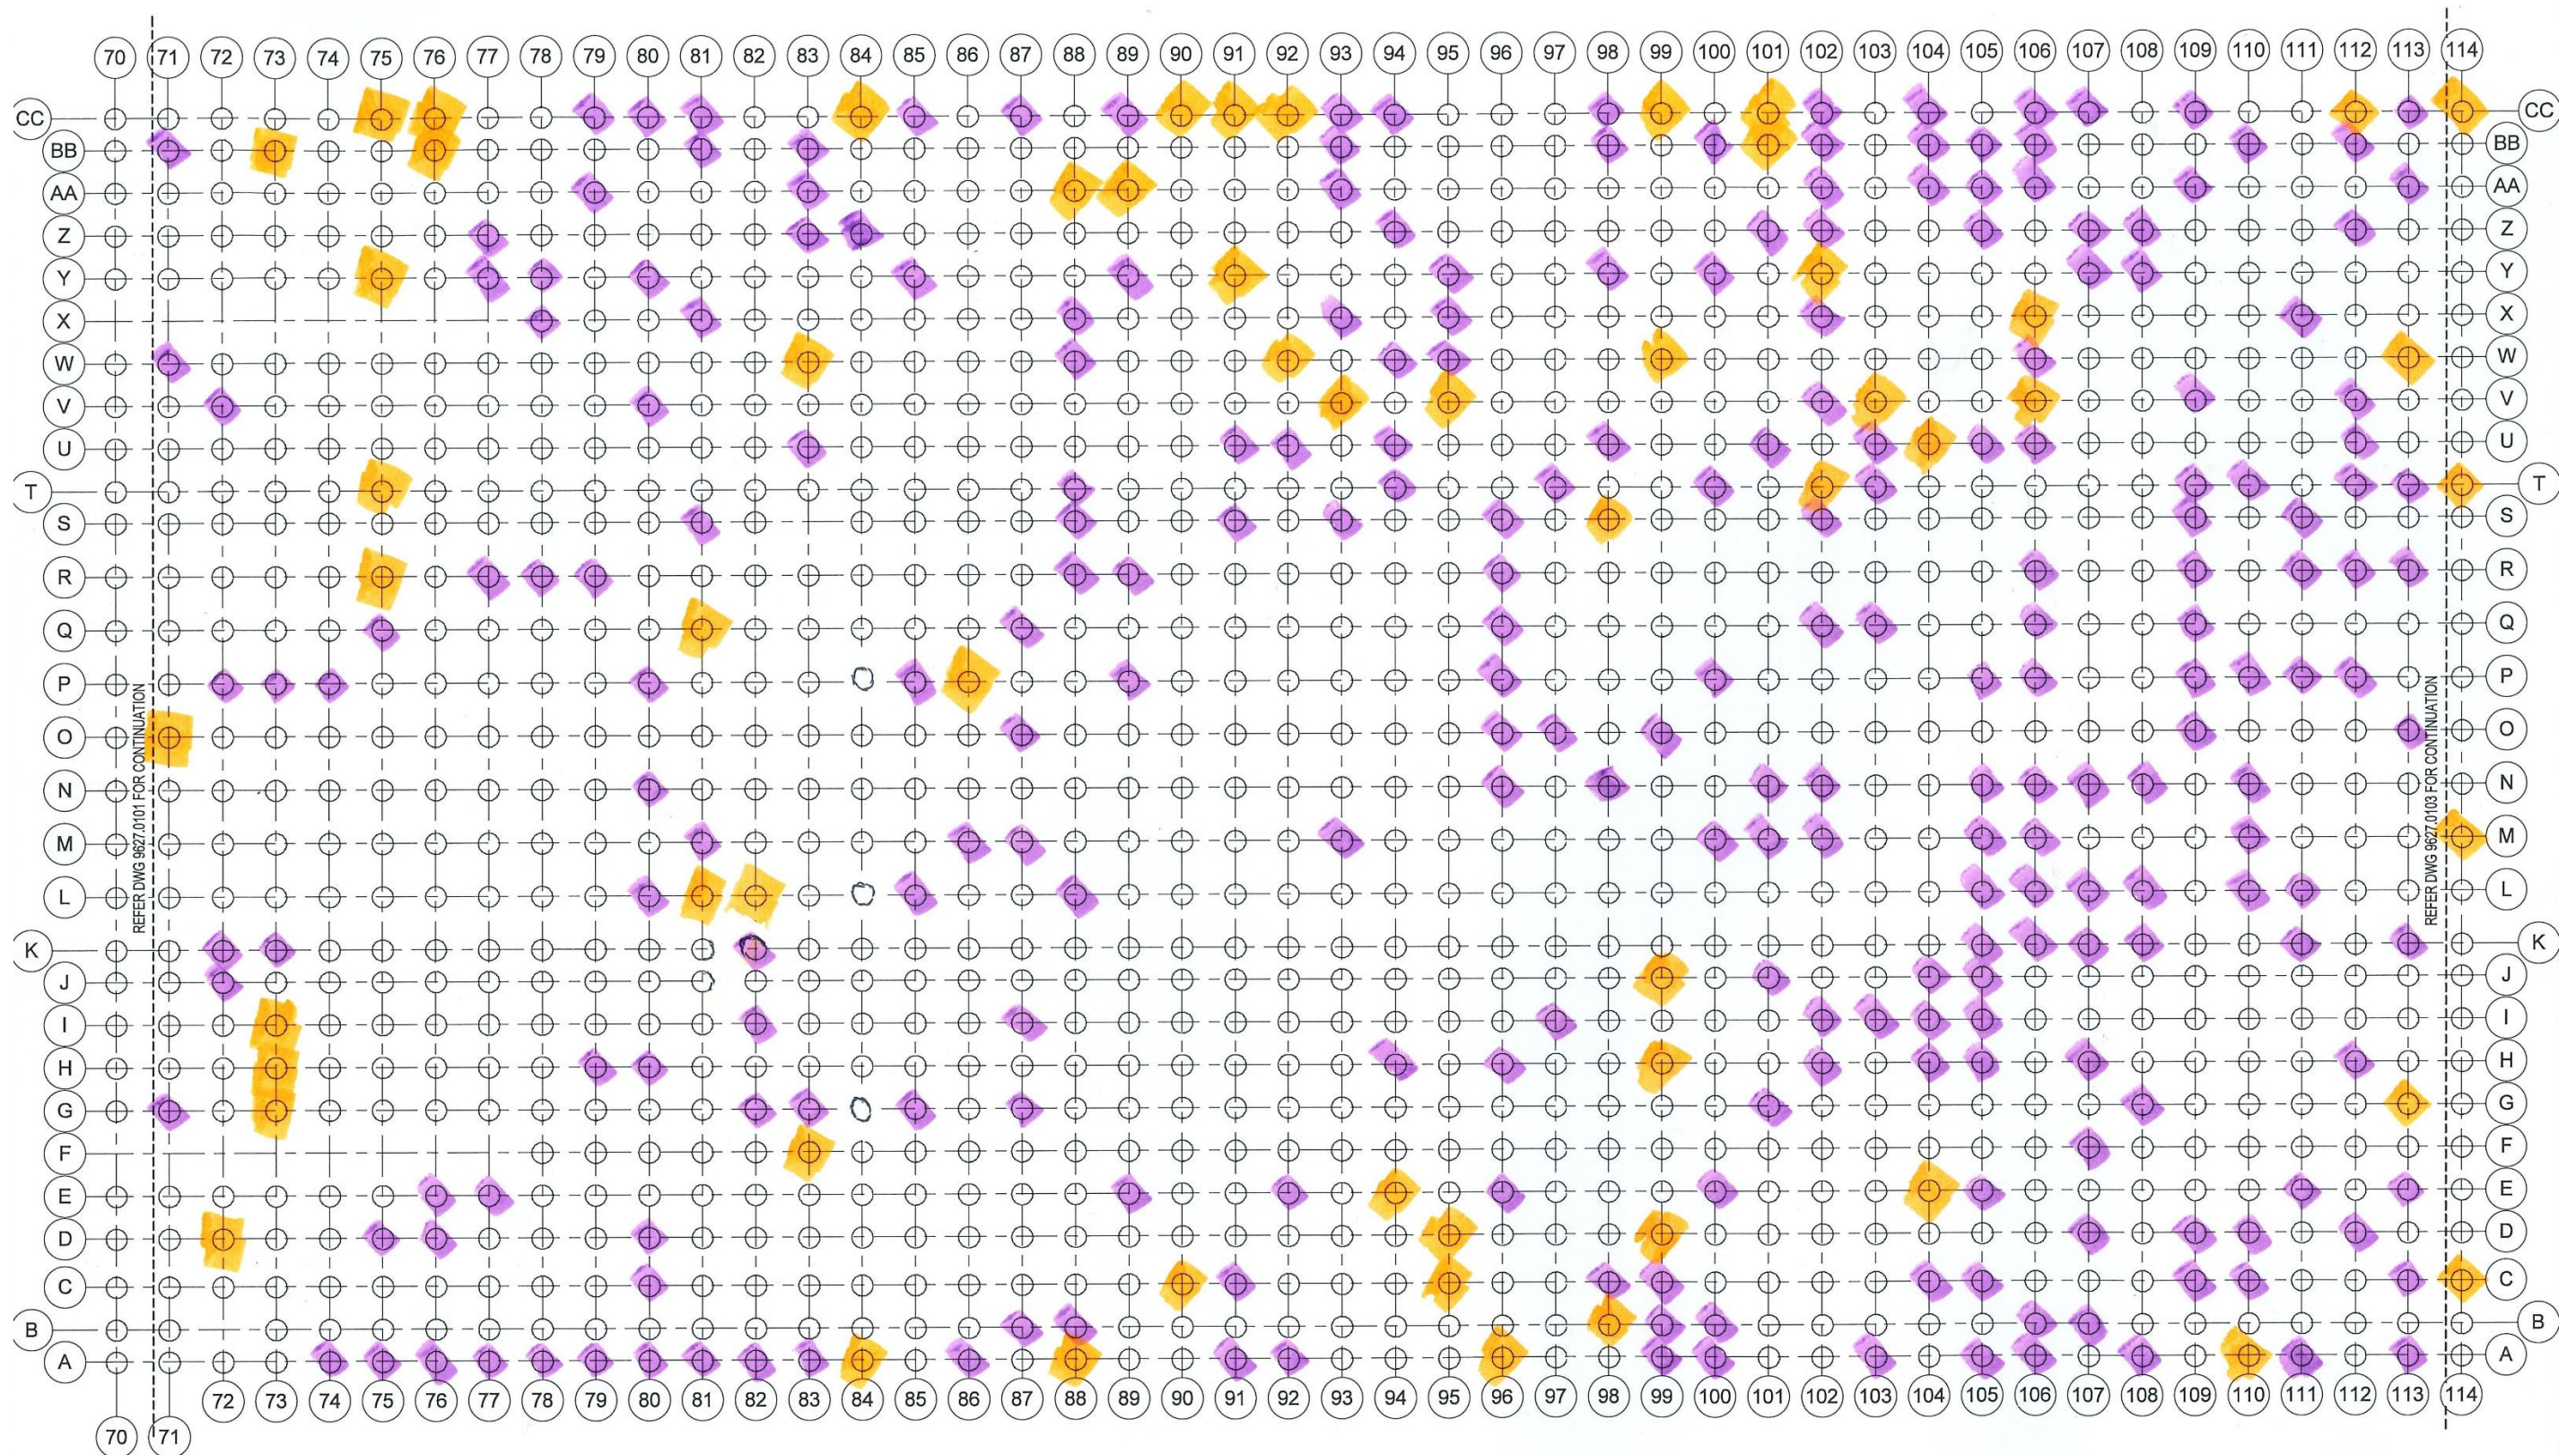
**Figure 1.** Pile 'Forest' plan with swim through ratings highlighted. (Key: Purple are broken/missing; Orange are failing).

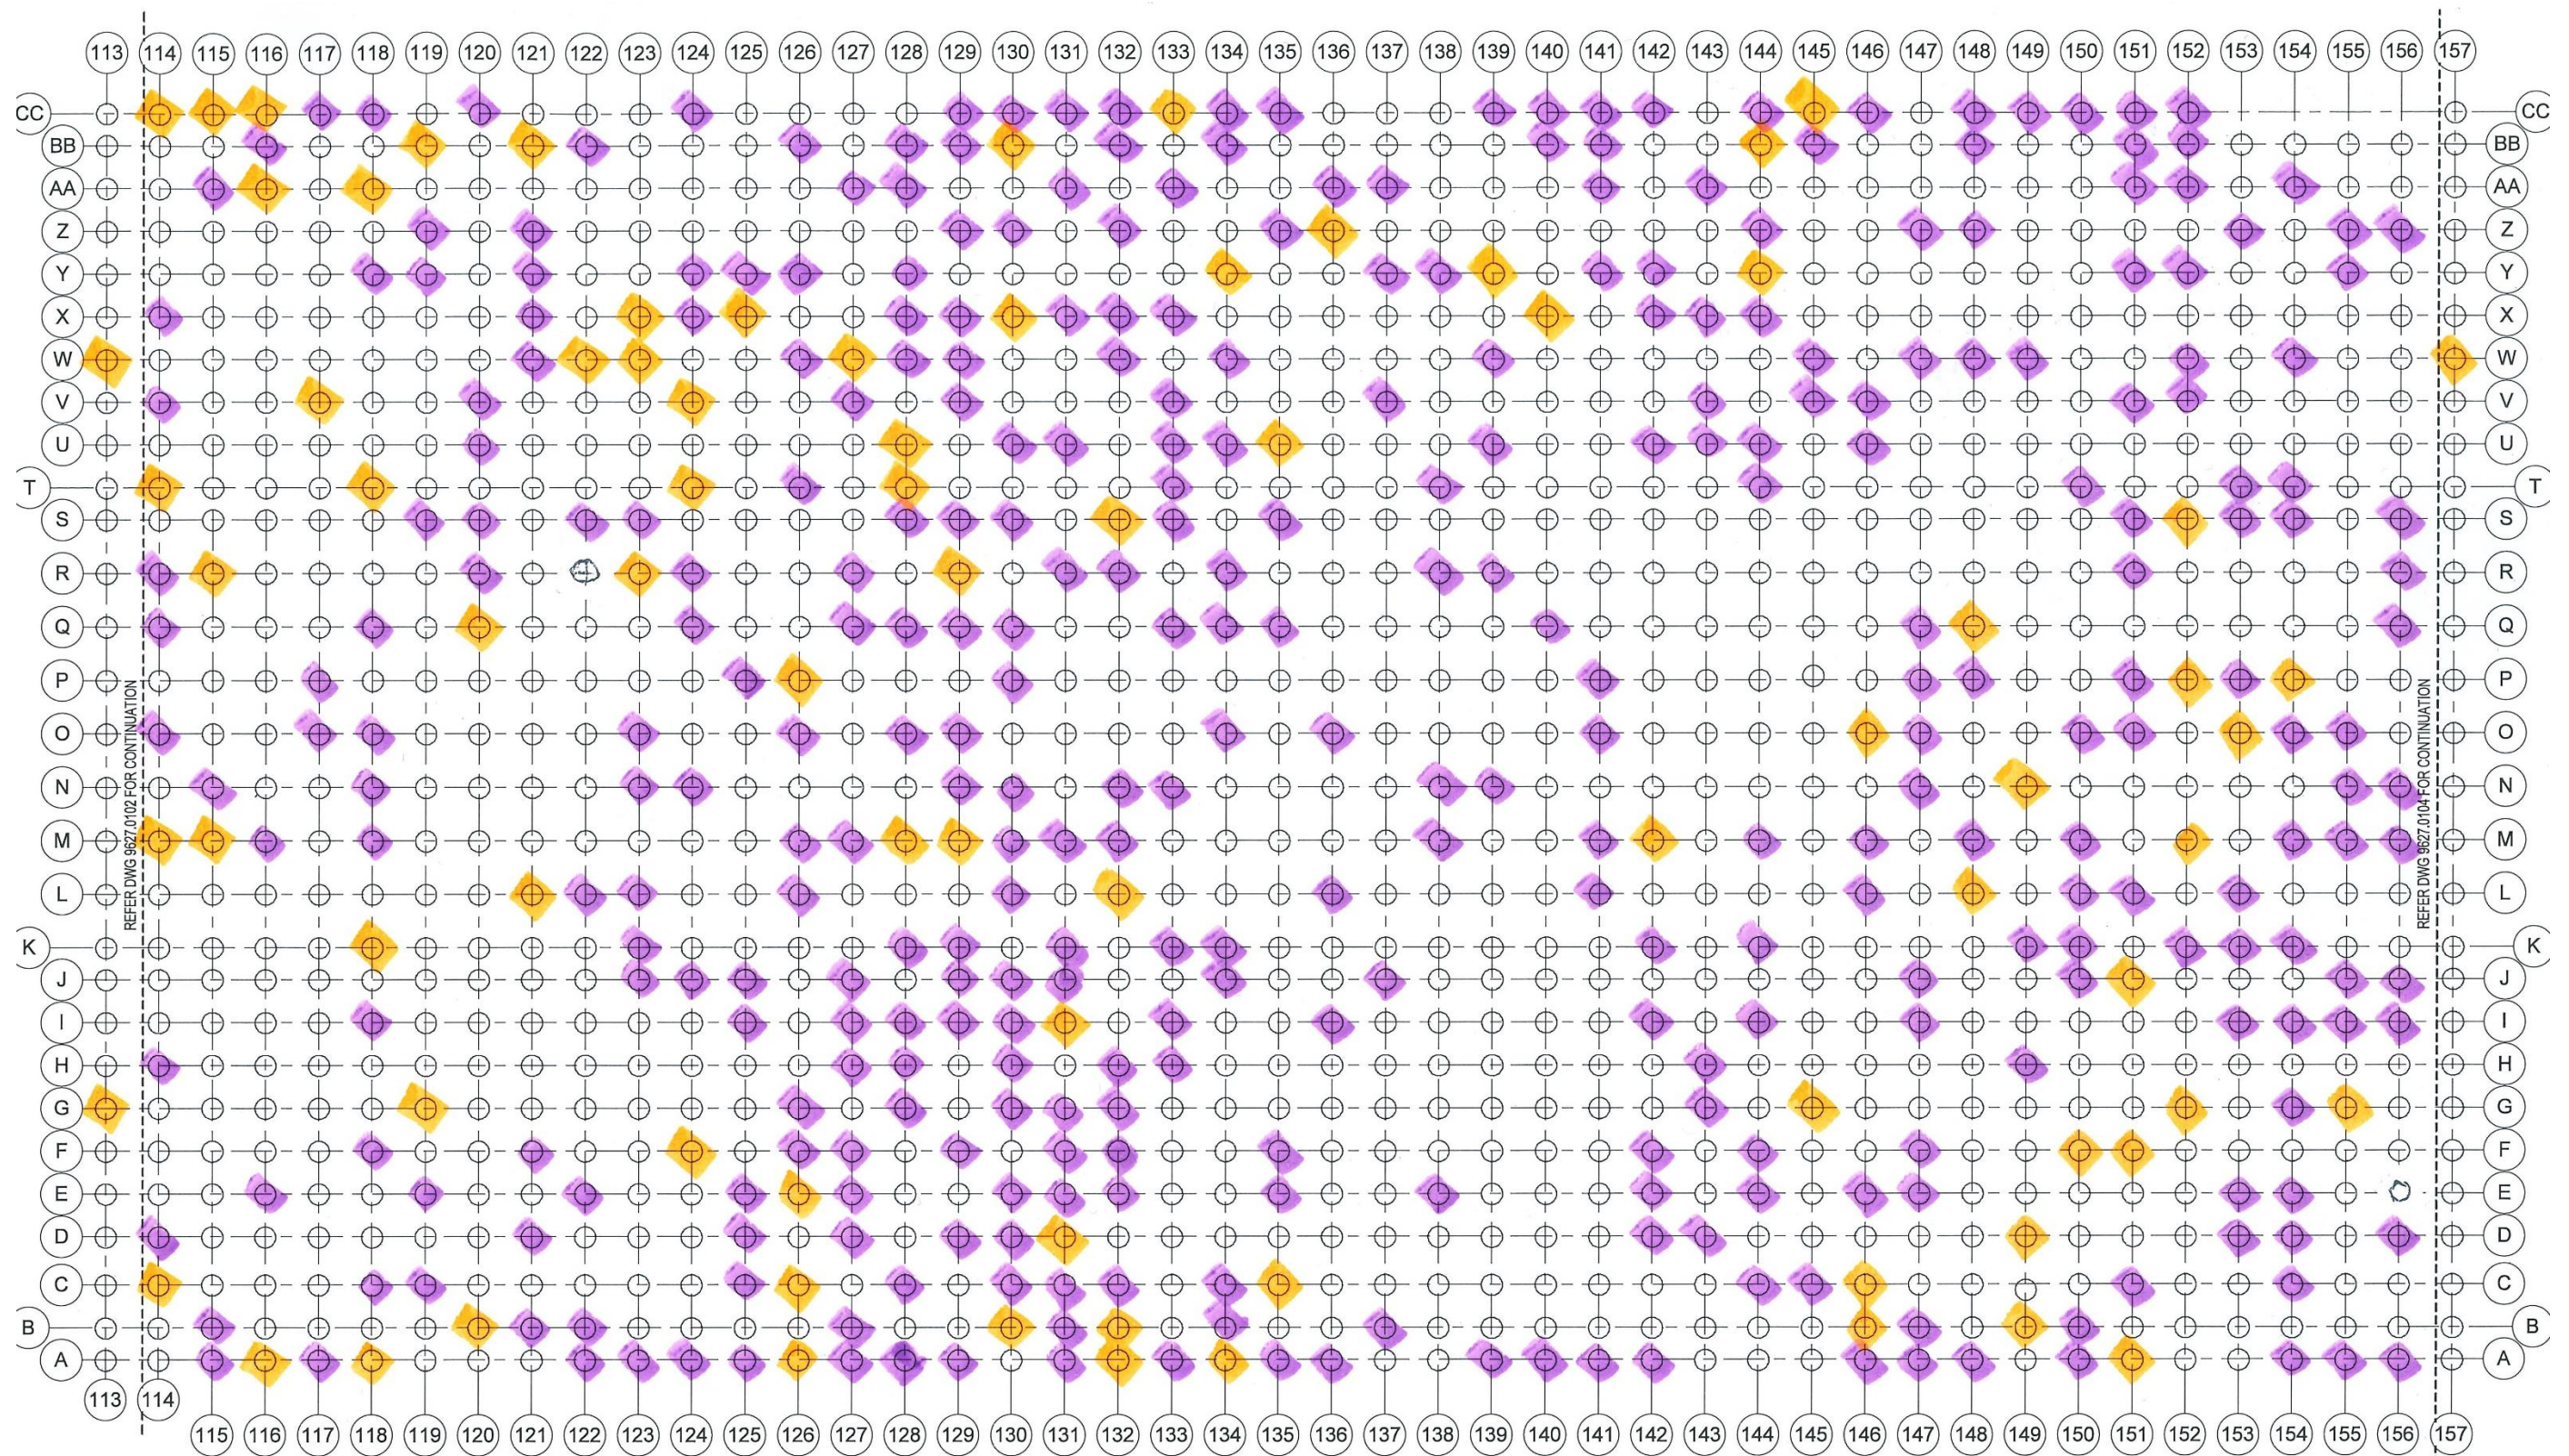
**Figure 2.** Pile ‘Forest’ plan with swim through ratings highlighted. (Key: Purple are broken/missing; Orange are failing).

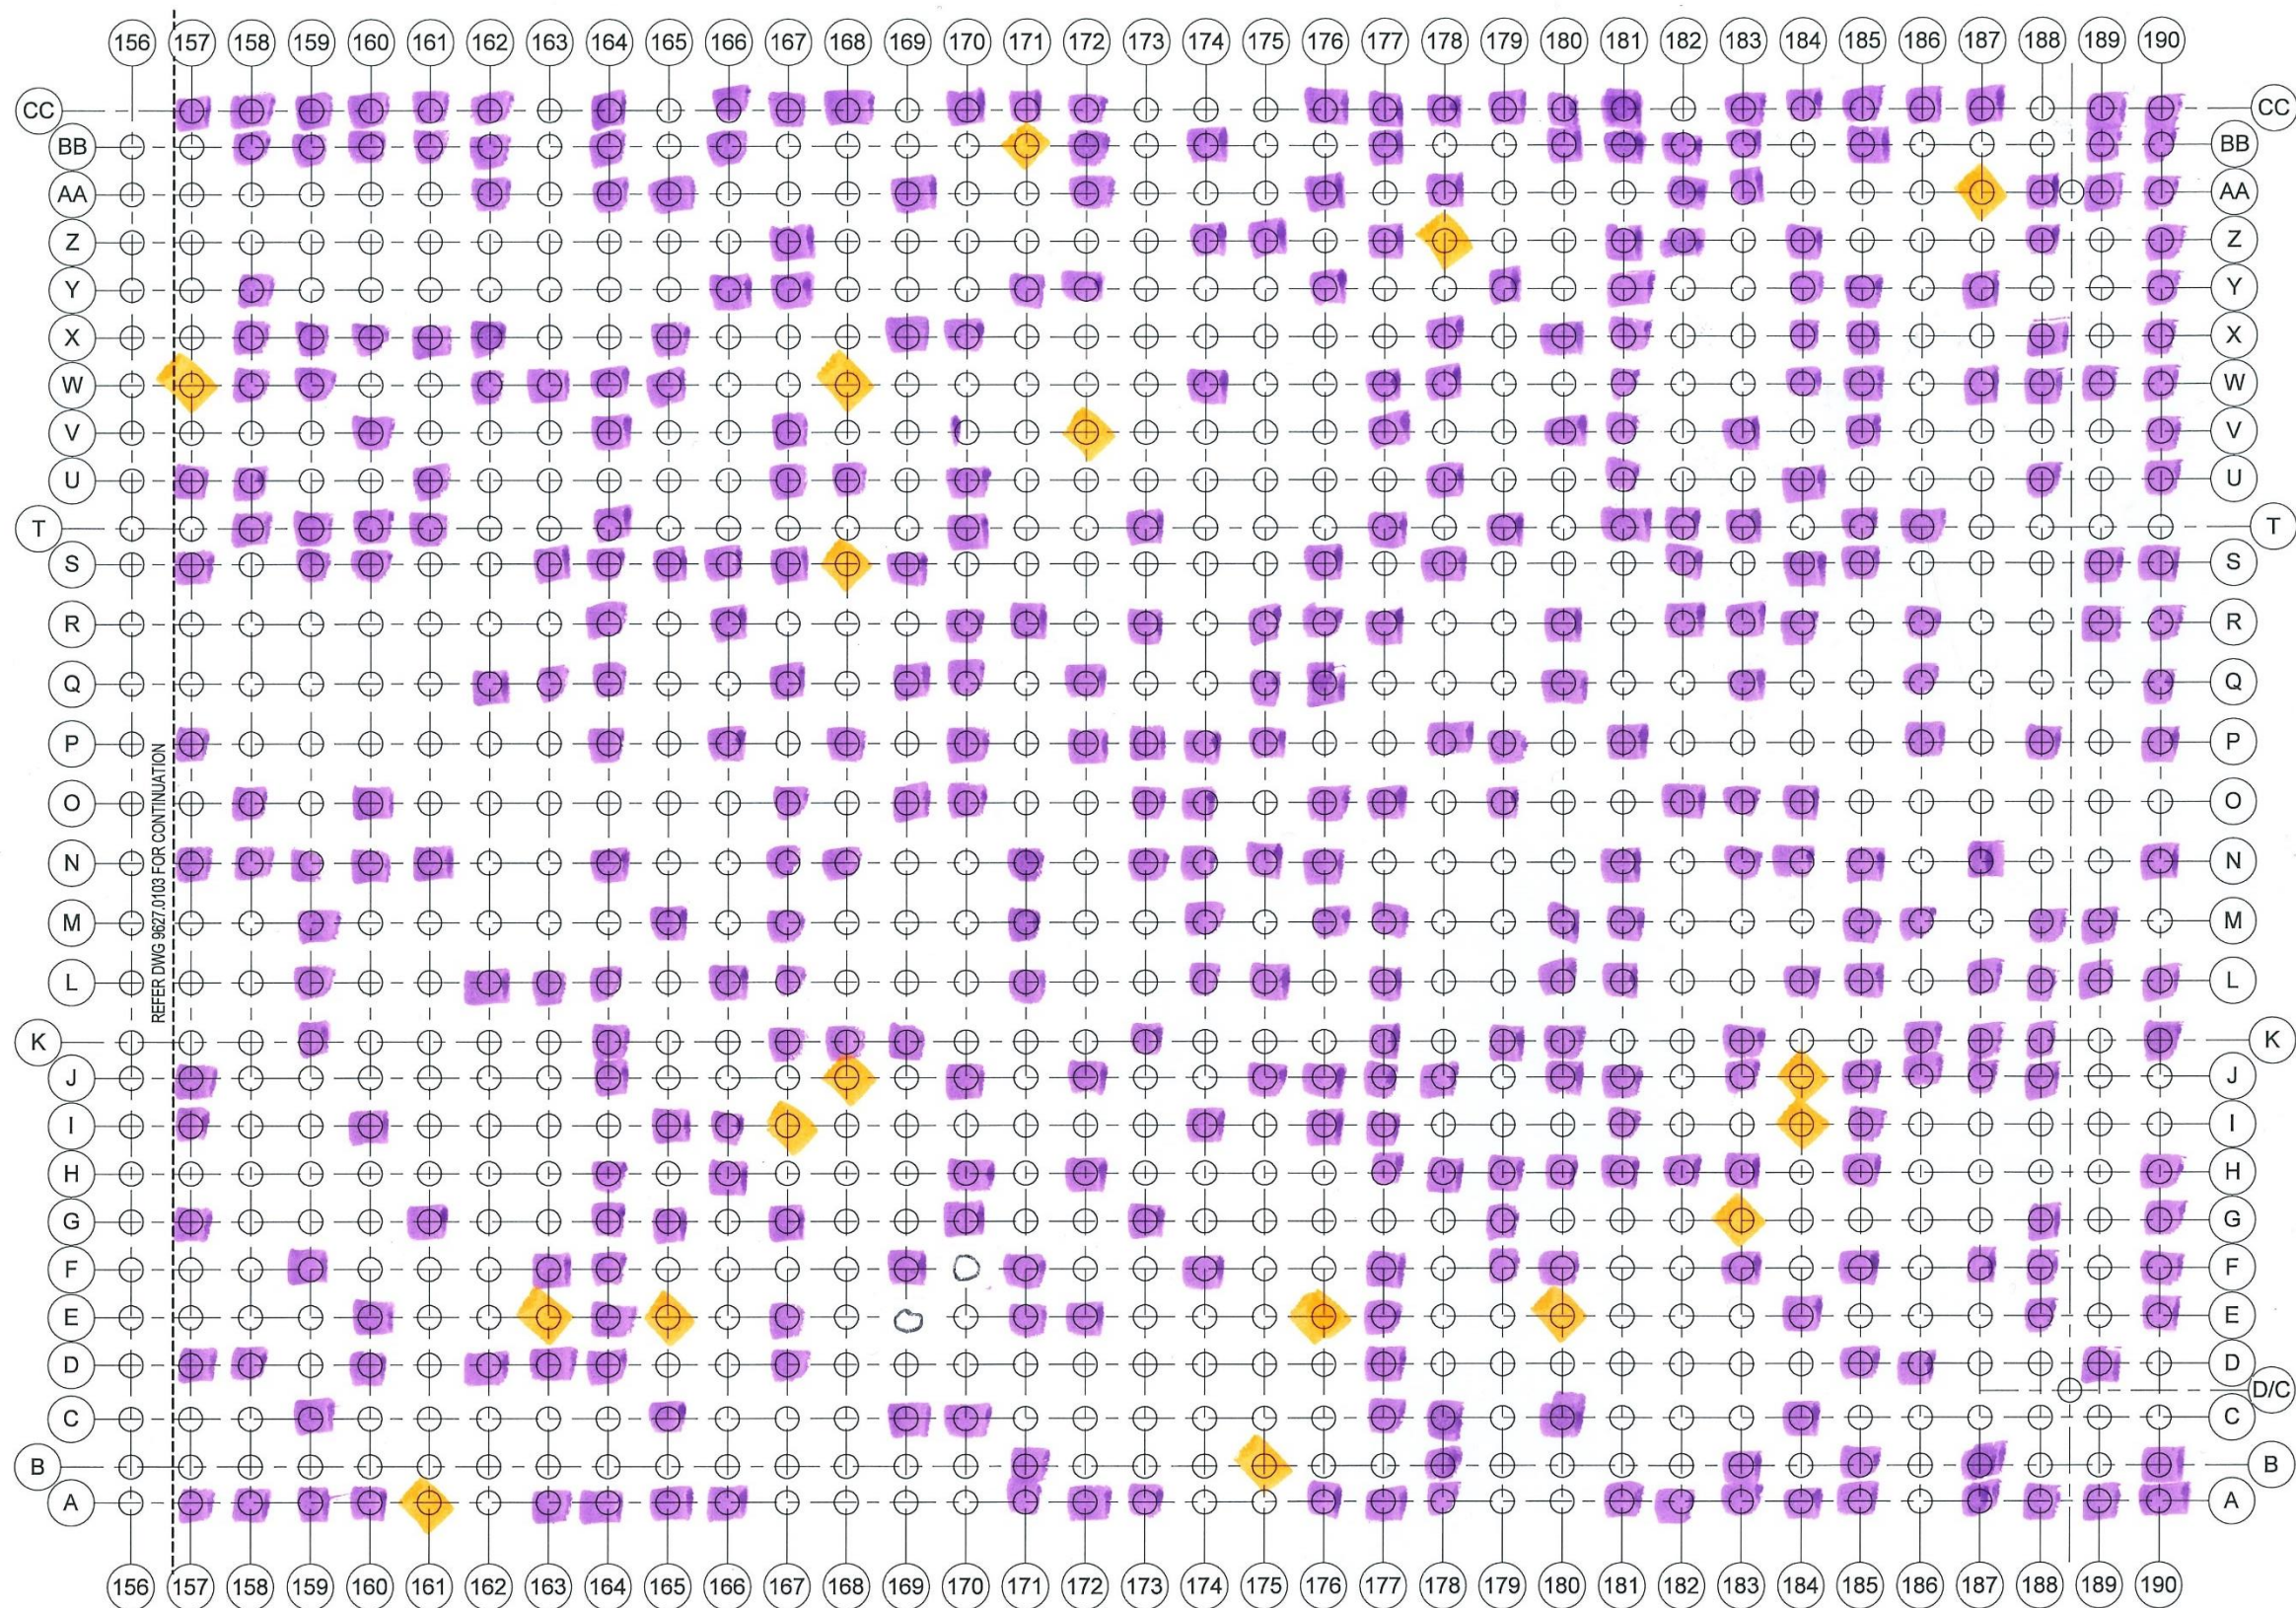
**Figure 3.** Pile 'Forest' plan with swim through ratings highlighted. (Key: Purple are broken/missing; Orange are failing).

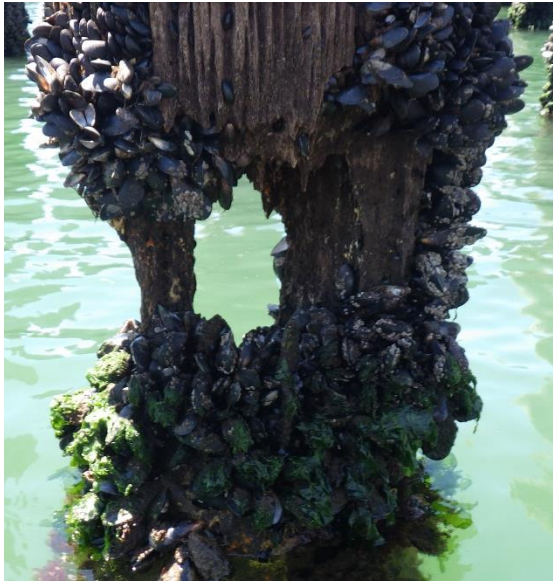
**Figure 4.** Failing pile – hollowing (104-E)

1. Removal of failing piles
  - Programmed work (within the next 2 years)
    - i. 154 piles identified
  - Programmed work (yearly from 2025)
    - i. 31 piles (estimated)
2. Programmed risk-based pile survey (every 1-2 years)
  - 3,462 piles total

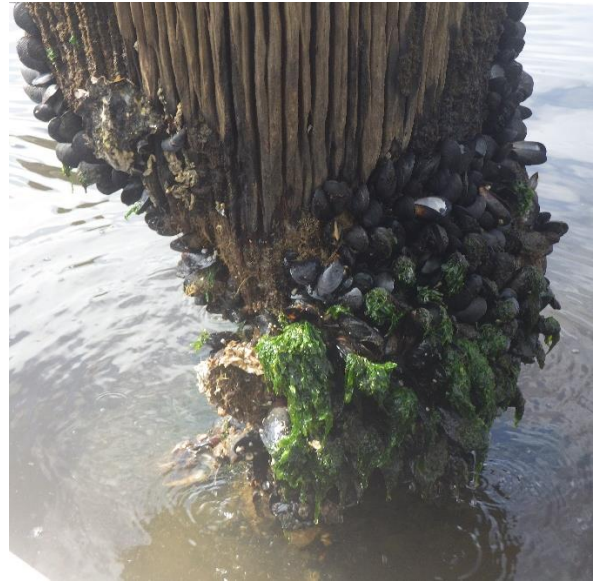
**Figure 5.** Failing pile – necking (148-L)

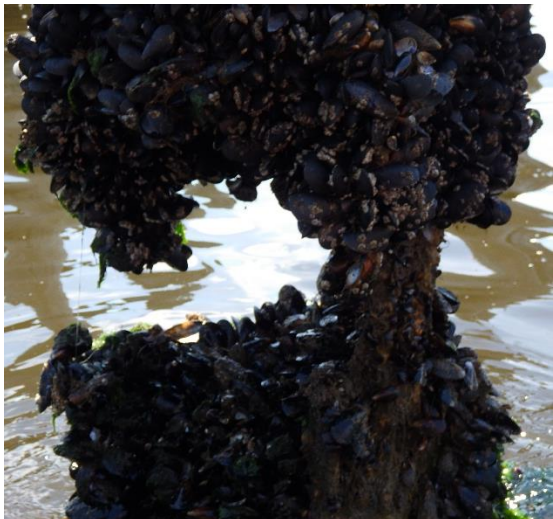
**Figure 6.** Failing pile – hollowing (165-E)

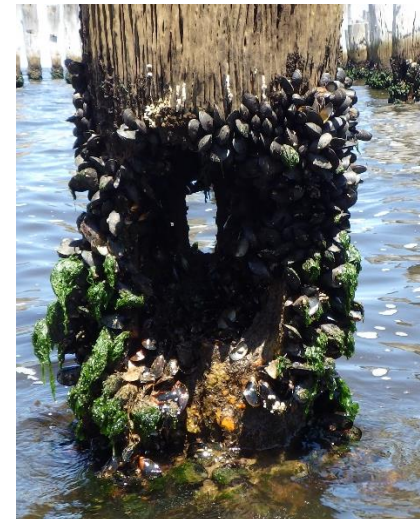
**Figure 7.** Failing pile – hollowing (168-W)
