# Tree Audit and Risk Assessment Report

Ormond College  
49 College Cres, Parkville

Report prepared by  
Matthew P James  
*MUrbanHort* (studying)  
*GradCertArb*  
*Dip.Arb*

Submitted  
27/02/2025

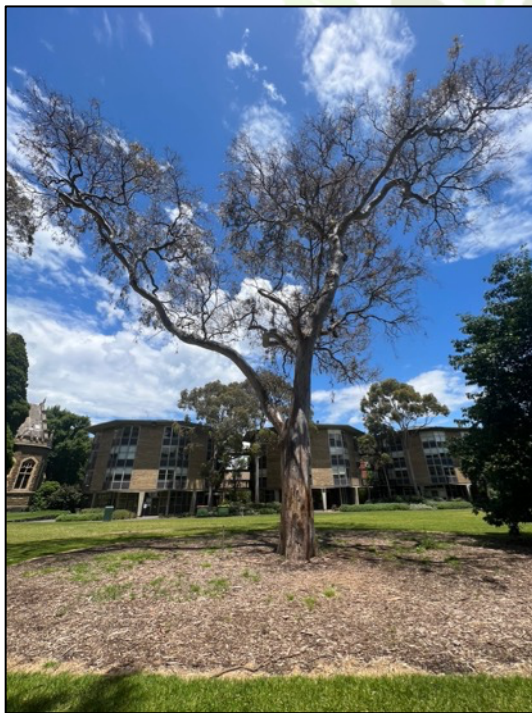
The large River Red Gum (Tree 134) has declined over the past three years due to an extensive sap sucking pest (Psyllid) attack (Figure 2). Soil treatments containing silicate, which have been found to be an effective non-pesticide control for sap suck pests (de Queiroz et al., 2016), have been carried out over the past three years. The health of the tree has improved since the treatments (Figure 3); however, the tree will require annual treatments to improve the vigor and vitality of the tree.

Figure 2. Tree 134 was in decline, with a thin canopy, dieback, and extensive Psyllid attack (photo taken 22/12/2022)

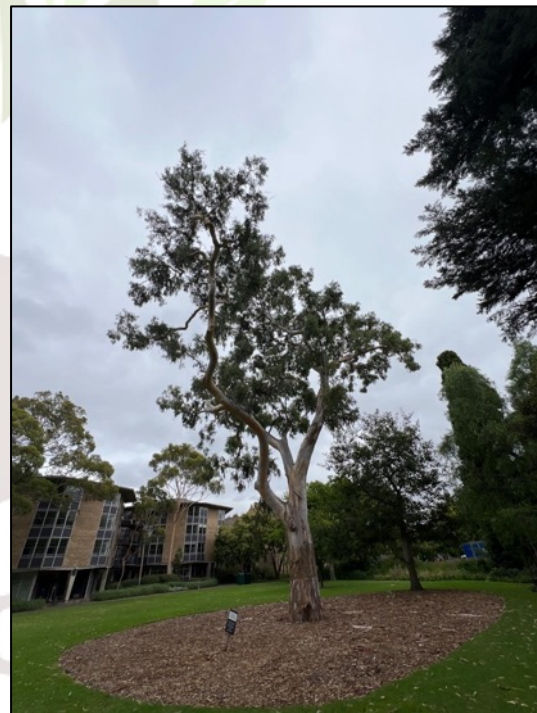
Figure 3. The health of Tree 134 has improved since soil treatments have been carried out. (photo taken 18/2/2025)

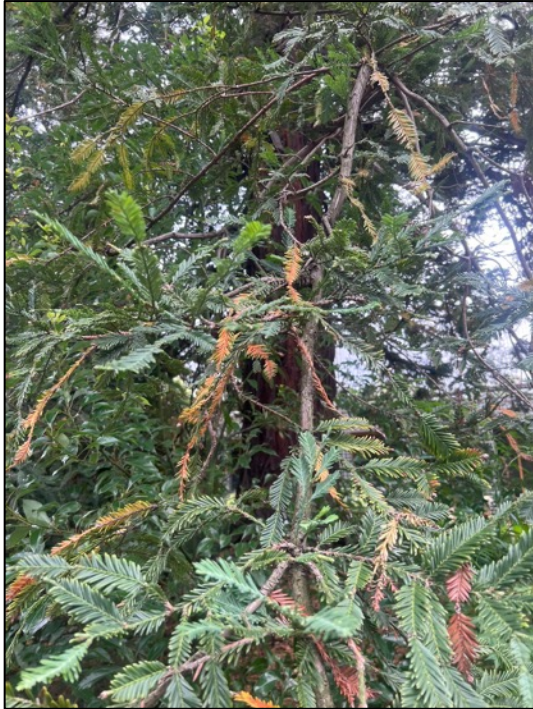
The three large Coast Redwoods (trees 92, 93, 97) are showing signs of stress, with discolouration (chlorosis) of the needles in the lower canopies (Figure 4 and Figure 5). This suggests there may be a chemical imbalance in the soil (Costello et al., 2003). Soil leaf samples should be collected from each tree and sent for analysis to determine the cause. A tree health program can then be formulated and implemented to ensure the health of these significant trees improves.

Figure 4. Tree 92 is showing signs of trees with needle chlorosis on the lower canopy.

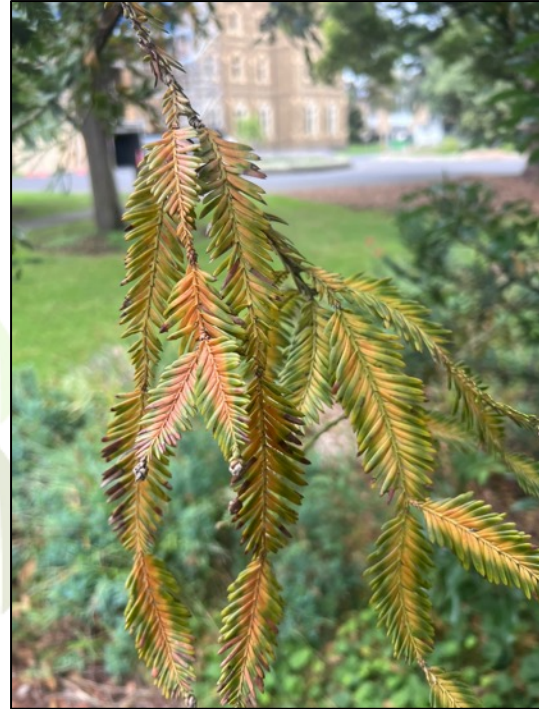
Figure 5. Needle chlorosis on Tree 97.

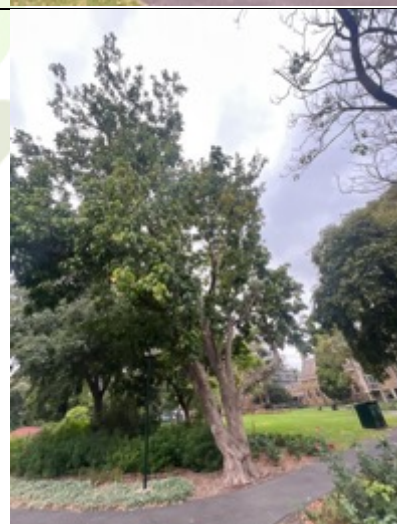
**Tree Id:** 116

**Observations:** Decay. Hollows. Included codominant stems. Previously lopped. Previous failures. Cable brace installed.

**RoH:** 1/500,000
