SCH-01 EXISTING WINDOWS SCHEDULE OF WORKS**AIRLIE MANSION 425 ST KILDA RD, MELBOURNE 3004**

Revision: DD1

Date: 15/11/2023

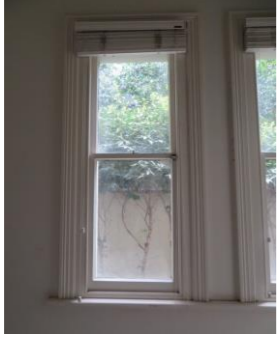
EXISTING WINDOWS										
ITEM / CODE	INTERIOR	EXTERIOR	TYPE	LOCATION	NOM SIZE (WIDTH x HEIGHT)	REFURBISHMENT WORKS	NEW WINDOW COVERINGS	NEW GLAZING	NEW BRUSH SEALS	OTHER COMMENTS
XWG-03

Double Hung Sash Window	Ground Floor, Room G01	700x2040	<ul style="list-style-type: none"> Refer to general notes on repair/refurbishment works Repair external sash horn (Repair Code C1) 	Yes, replace existing blinds with new acoustic curtains to meet acoustic requirements	Yes (Repair Code C2)	Yes	
XWG-04

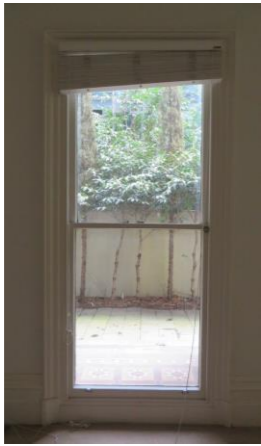
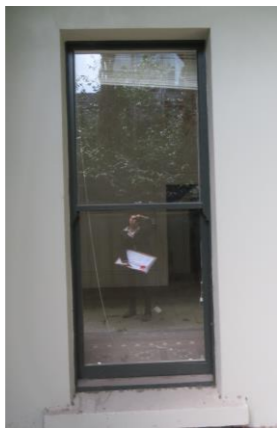
Double Hung Sash Window	Ground Floor, Room G02	1070x2760	<ul style="list-style-type: none"> Refer to general notes on repair/refurbishment works Repair right skirting block separating from architrave (Repair Code C7) 	Yes, replace existing blinds with new acoustic curtains to meet acoustic requirements	Yes (Repair Code C2)	Yes

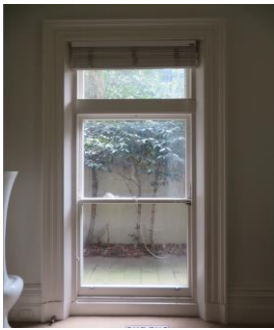
EXISTING WINDOWS										
ITEM / CODE	INTERIOR	EXTERIOR	TYPE	LOCATION	NOM SIZE (WIDTH x HEIGHT)	REFURBISHMENT WORKS	NEW WINDOW COVERINGS	NEW GLAZING	NEW BRUSH SEALS	OTHER COMMENTS
XWG-07

Double Hung Sash Window with fixed top light	Ground Floor, Room G03	1250x2940	<ul style="list-style-type: none"> Refer to general notes on repair/refurbishment works Repair damaged internal timber frame of window top and bottom (Repair Code C1) Allow to cut out section of bottom rail to bottom sash where rotten or damaged and splice in new section of timber (Repair Code C1) 	Yes, replace existing blinds with new acoustic curtains to meet acoustic requirements	Yes (Repair Code C2)	Yes	
XWG-08

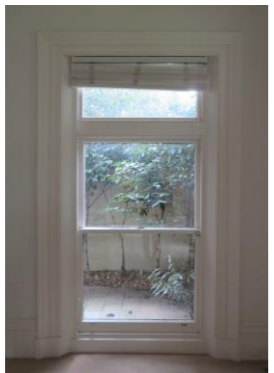
Double Hung Sash Window with fixed top light	Ground Floor, Room G03	1250x2940	<ul style="list-style-type: none"> Refer to general notes on repair/refurbishment works Repair chipped top of internal timber frame (Repair Code C1) 	Yes, replace existing blinds with new acoustic curtains to meet acoustic requirements	Yes (Repair Code C2)	Yes

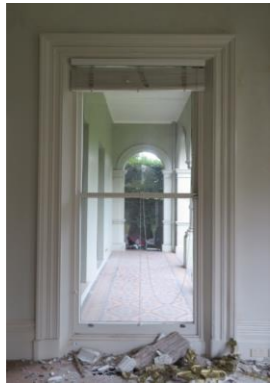
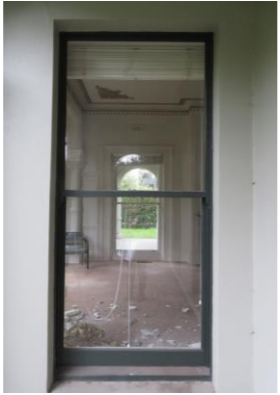
Double Hung Sash Window	Ground Floor, Room G04	1250x2930	<ul style="list-style-type: none"> Refer to general notes on repair/refurbishment works Allow to cut out and replace rotten or damaged window frame/architrave and splice in new section of timber (Repair Code C1) 	Yes, replace existing blinds with new acoustic curtains to meet acoustic requirements	Yes (Repair Code C2)	Yes

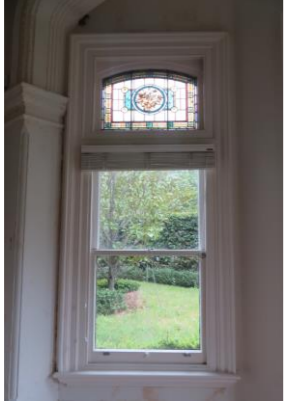
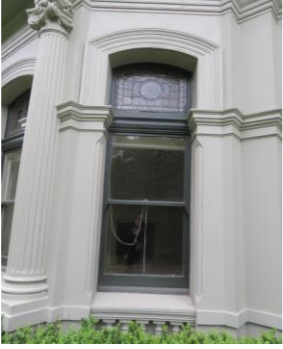
EXISTING WINDOWS										
ITEM / CODE	INTERIOR	EXTERIOR	TYPE	LOCATION	NOM SIZE (WIDTH x HEIGHT)	REFURBISHMENT WORKS	NEW WINDOW COVERINGS	NEW GLAZING	NEW BRUSH SEALS	OTHER COMMENTS
XWG-11

Double Hung Sash Window with Fixed Top Leadlight	Ground Floor, Room G04	1025x2010	<ul style="list-style-type: none"> Refer to general notes on repair/refurbishment works Allow to cut out and replace rotten/water-damaged window bottom rail and left architrave and splice in new section of timber (Repair Code C1) 	Yes, replace existing blinds with new acoustic curtains to meet acoustic requirements	Yes (Repair Code C2) Fixed Top Leadlight retained	Yes	
XWG-12

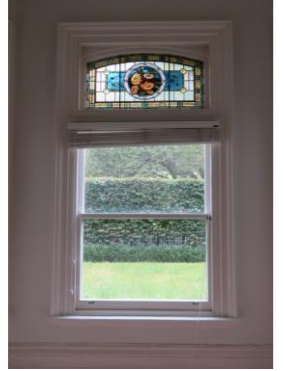
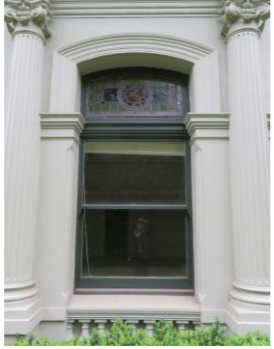
Double Hung Sash Window with Fixed Top Leadlight	Ground Floor, Room G04	1300x2010	<ul style="list-style-type: none"> Refer to general notes on repair/refurbishment works Allow to cut out and replace rotten/water-damaged window bottom rail and splice in new section of timber (Repair Code C1) Cut out and replace section of internal sill previously repaired and splice in new section of timber (Repair Code C1) Fully replace timber moulding below sill where damaged (Repair Code C1) 	Yes, replace existing blinds with new acoustic curtains to meet acoustic requirements	Yes (Repair Code C2) Fixed Top Leadlight retained	Yes

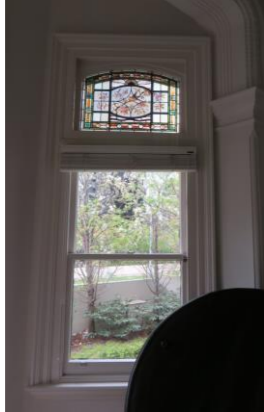
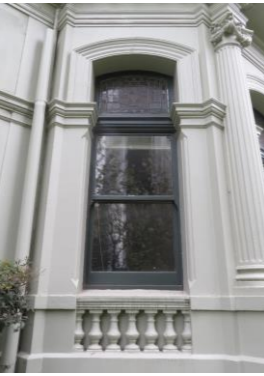
EXISTING WINDOWS										
ITEM / CODE	INTERIOR	EXTERIOR	TYPE	LOCATION	NOM SIZE (WIDTH x HEIGHT)	REFURBISHMENT WORKS	NEW WINDOW COVERINGS	NEW GLAZING	NEW BRUSH SEALS	OTHER COMMENTS
XWG-19

Double Hung Sash Window with Fixed Top Leadlight	Ground Floor, Room G07	1025x2010	<ul style="list-style-type: none"> Refer to general notes on repair/refurbishment works Allow to cut out and replace rotten/water-damaged window sill and splice in new section of timber (Repair Code C1) 	Yes, replace existing blinds with new acoustic curtains to meet acoustic requirements	Yes (Repair Code C2) Fixed Top Leadlight retained	Yes	
XWG-20	(Photo not available)	(Photo not available)	Double Hung Sash Window (non-original)	Ground Floor, Rear wing	1050x1530	<ul style="list-style-type: none"> To be demolished as part of building nominated for demolition 	-	-	-	
XWG-21	(Photo not available)	(Photo not available)	Double Hung Sash Window (non-original)	Ground Floor, Rear wing	1050x1530	<ul style="list-style-type: none"> To be demolished as part of building nominated for demolition 	-	-	-

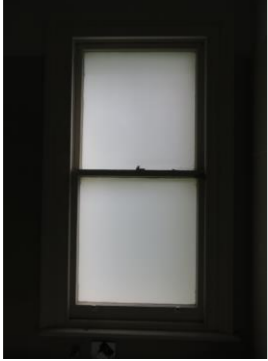
EXISTING WINDOWS										
ITEM / CODE	INTERIOR	EXTERIOR	TYPE	LOCATION	NOM SIZE (WIDTH x HEIGHT)	REFURBISHMENT WORKS	NEW WINDOW COVERINGS	NEW GLAZING	NEW BRUSH SEALS	OTHER COMMENTS
XWF-03

(Exterior photo not available)	Double Hung Sash Window with frosted glazing	First Floor, Room F02 Ensuite	860x1900	<ul style="list-style-type: none"> Refer to general notes on repair/refurbishment works Allow to replace whole of internal sill, moulding below sill, and architraves where altered previously (Repair Code C3) 	Yes, allow for new window coverings	Yes, with opaque glazing (Repair Code C2)	Yes	
XWF-04

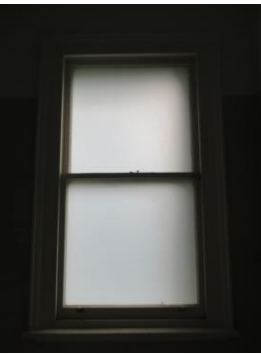
(Exterior photo not available)	Double Hung Sash Window with frosted glazing	First Floor, Room F03	1000x2040	<ul style="list-style-type: none"> Refer to general notes on repair/refurbishment works Allow to replace whole of internal sill, moulding below sill, and architraves where altered previously (Repair Code C3) 	Yes, allow for new window coverings	Yes, with opaque glazing (Repair Code C2)	Yes

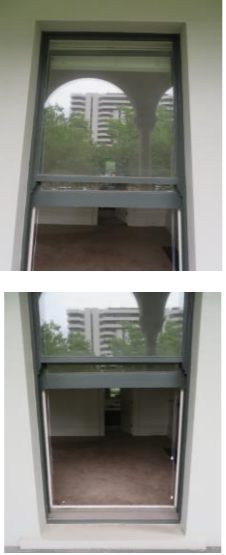
EXISTING WINDOWS										
ITEM / CODE	INTERIOR	EXTERIOR	TYPE	LOCATION	NOM SIZE (WIDTH x HEIGHT)	REFURBISHMENT WORKS	NEW WINDOW COVERINGS	NEW GLAZING	NEW BRUSH SEALS	OTHER COMMENTS
XWF-07

Double Hung Sash Window	First Floor, Room F04	1250x2990	<ul style="list-style-type: none"> Refer to general notes on repair/refurbishment works Repair splitting timber to internal left side of bottom sash (Repair Code C1) 	Yes, new acoustic curtains to meet acoustic requirements	Yes (Repair Code C2)	Yes	
XWF-08

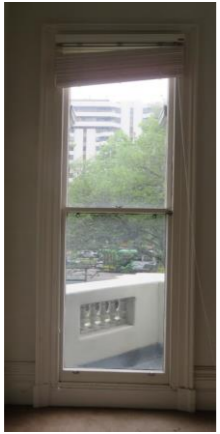
(Exterior photo not available)	Double Hung Sash Window	First Floor, Room F05	950x1920	<ul style="list-style-type: none"> Refer to general notes on repair/refurbishment works Repair damaged timber to internal right side of the bottom sash (Repair Code C1) 	Yes, new acoustic curtains to meet acoustic requirements	Yes (Repair Code C2)	Yes

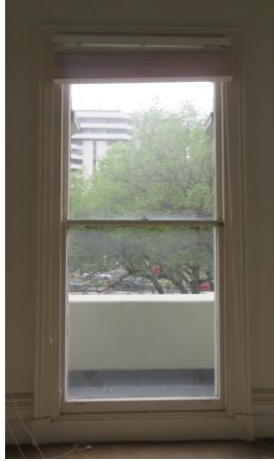
EXISTING WINDOWS										
ITEM / CODE	INTERIOR	EXTERIOR	TYPE	LOCATION	NOM SIZE (WIDTH x HEIGHT)	REFURBISHMENT WORKS	NEW WINDOW COVERINGS	NEW GLAZING	NEW BRUSH SEALS	OTHER COMMENTS
XWF-11

(Exterior photo not available)	Double Hung Sash Window	First Floor, Room F05	1200x1920	<ul style="list-style-type: none"> Refer to general notes on repair/refurbishment works Repair damaged timber to internal left and right sides of the bottom sash (Repair Code C1) 	Yes, new acoustic curtains to meet acoustic requirements	Yes (Repair Code C2)	Yes	
XWF-12

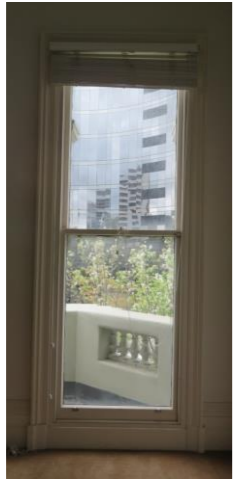
(Exterior photo not available)	Double Hung Sash Window	First Floor, Room F08	950x1920	<ul style="list-style-type: none"> Refer to general notes on repair/refurbishment works Repair damaged skirting block to internal left side (Repair Code C1) 	Yes, new acoustic curtains to meet acoustic requirements	Yes (Repair Code C2)	Yes

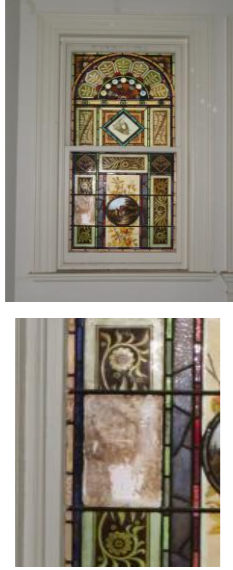
EXISTING WINDOWS										
ITEM / CODE	INTERIOR	EXTERIOR	TYPE	LOCATION	NOM SIZE (WIDTH x HEIGHT)	REFURBISHMENT WORKS	NEW WINDOW COVERINGS	NEW GLAZING	NEW BRUSH SEALS	OTHER COMMENTS
XWF-19

(Exterior photo not available)	Leadlight window	First Floor, Stair 2 Top Left	1050x2100	<ul style="list-style-type: none"> Refer to general notes on repair/refurbishment works Missing glass paint to be replaced (Repair Code LGW1) 	-	-	-	<ul style="list-style-type: none"> Specialist stained glass contractor to be consulted prior to any works to address bowing, sagging, or warping of the window.
XWF-20

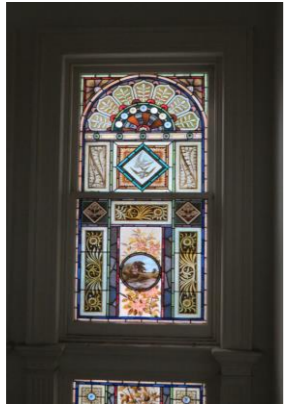
(Exterior photo not available)	Leadlight window	First Floor, Stair 2 Top Right	1050x2100	<ul style="list-style-type: none"> Refer to general notes on repair/refurbishment works Remove external acrylic pane and repair external window frame where panel was mounted (Repair Code C1) 	-	-	-	<ul style="list-style-type: none"> Specialist stained glass contractor to be consulted prior to any works to address bowing, sagging, or warping of the window.

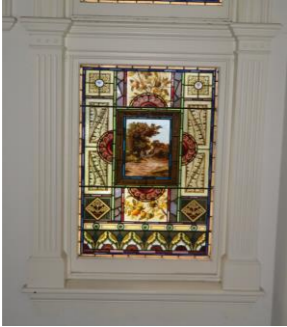
EXISTING WINDOWS										
ITEM / CODE	INTERIOR	EXTERIOR	TYPE	LOCATION	NOM SIZE (WIDTH x HEIGHT)	REFURBISHMENT WORKS	NEW WINDOW COVERINGS	NEW GLAZING	NEW BRUSH SEALS	OTHER COMMENTS
XWF-21

(Exterior photo not available)	Leadlight window	First Floor, Stair 2 Bottom Right	1050x1610	<ul style="list-style-type: none"> Refer to general notes on repair/refurbishment works 	-	-	-	<ul style="list-style-type: none"> Specialist stained glass contractor to be consulted prior to any works to address bowing, sagging, or warping of the window.
XWF-22	(Photo not available)	(Photo not available)	Fixed Glazed Window	First Floor, Room F01 Hall	1770x1570	<ul style="list-style-type: none"> To be demolished as part of works nominated for demolition 	-	-	-	
XWF-23

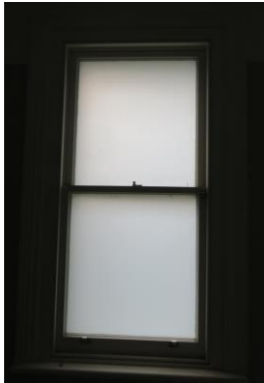
(Exterior photo not available)	Double Hung Sash Window with frosted glazing	First Floor, Room F01 Ensuite	860x1800	<ul style="list-style-type: none"> Refer to general notes on repair/refurbishment works Allow to replace whole of internal sill, moulding below sill, and architraves where altered previously (Repair Code C3) 	Yes, allow for new window coverings	Yes, with opaque glazing (Repair Code C2)	Yes
