**APPENDIX C:
ROBERT BIRD GROUP,
HERITAGE BUILDING
STRUCTURAL WORKS FOR
TEA HOUSE**

Heritage Building Structural Works for **Tea House**

Issue: F – For Authority Approval

26 May 2022

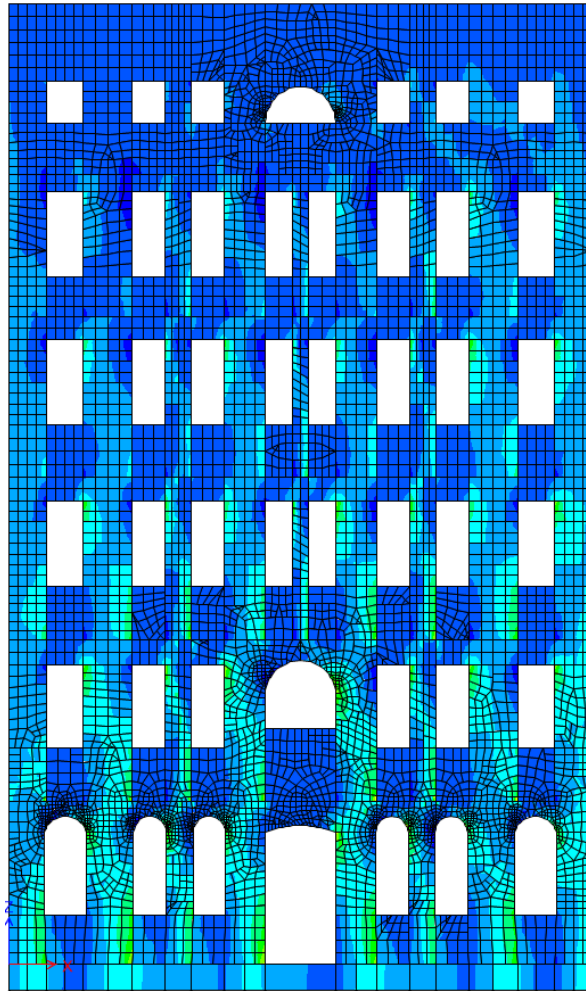
Stress Plot of Front Façade Under Seismic Loads

A finite element analysis of the Tea House façade has been completed to determine the regions where tensile stresses in the masonry exceed 0.2MPa (value to be verified via testing, as specified elsewhere in this report), at which point the masonry is deemed to have cracked and no longer contributes to the lateral resistance of the structure. These regions have either been assumed to be cracked and removed from the analysis or will require strengthening with steel plates to resist the tensile force once the masonry has cracked. The image below shows a preliminary stress plot

from the finite element analysis, where regions shaded dark blue exceed the 0.2MPa tension threshold. It can be noted that the most significant regions of high tensile load occur towards the top of the structure, where the precompression caused by the self-weight of the masonry is much lower.

To achieve compliance with AS3826, we therefore propose to strengthen piers 1, 2, 4, 5, 7 and 8 via the application of two vertical tension bars to either side of the pier up the full height of the building. A PFC running horizontally located on the underside of the joists on each level provides portal frame action in combination with these rods, and SHS frames on the lowest two levels provide the additional stiffness and strength needed to withstand the design seismic loadings. The proposed strengthenings are shown indicatively in Appendix C. Final strengthening arrangement, member sizes, plate sizes, bolt centres and transition details at steps in the masonry are subject to further detailed design at a later stage.

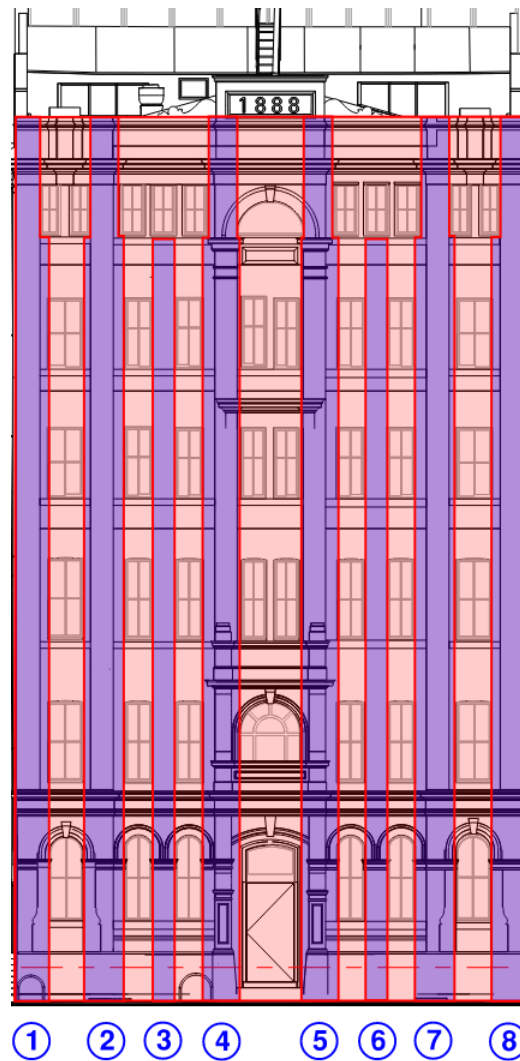
Load Bearing Masonry Piers

Upon inspection of the heritage façade, there are eight masonry piers forming the primary load path for gravitational loads. The windows, with the exception of the uppermost level, generally sit aligned between the piers so as not to interrupt the vertical load path of the façade. The piers are numbered and indicated in purple in the below image.

The piers are joined via thin (generally 2 courses thick) masonry spandrels sitting vertically between the windows. These elements form the ‘beams’ of the portal frame system, however as they are much thinner than, and thus don’t sit flush with the adjacent masonry piers, we consider that attempting to strengthen these elements would be both complex and inefficient. Our methodology for assessing the seismic load capacity of the structure has therefore focussed on strengthening the primary piers, whilst allowing the infill masonry spandrels to crack and shed load back to the strengthened piers.

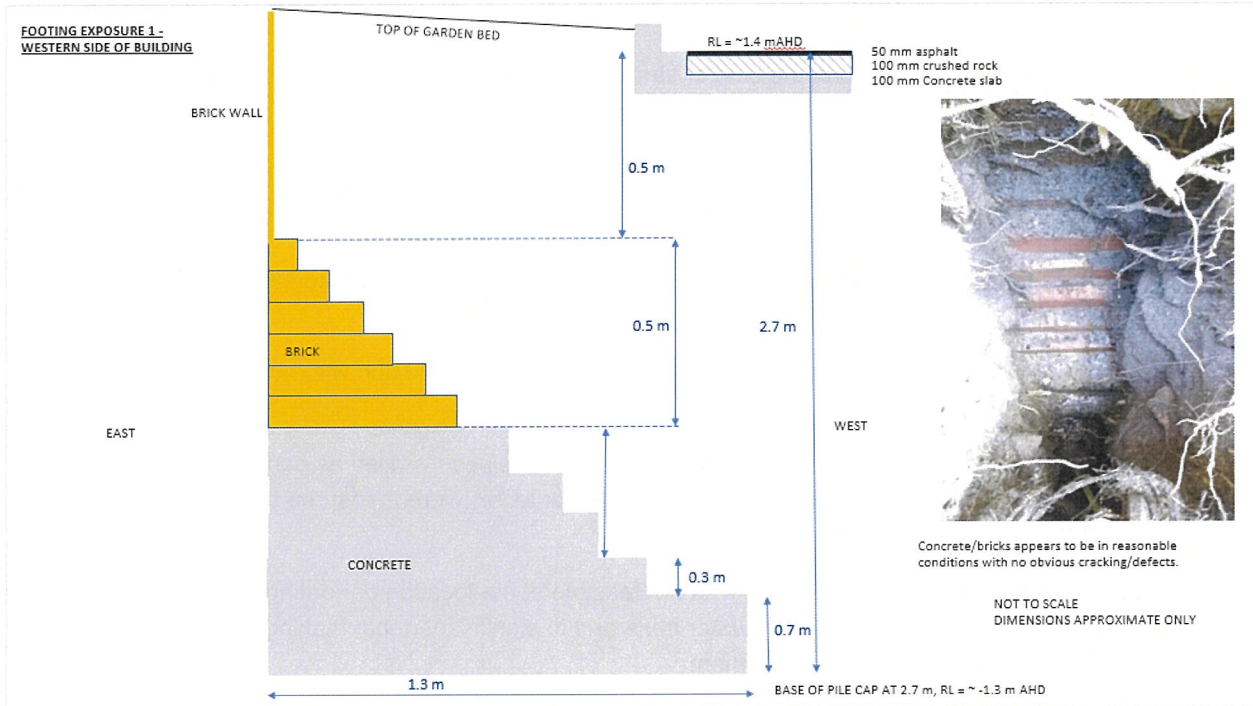
Figure 2: Footing Exposure 1 Sketch and Photo

- Footing Exposure 1 (western side of building): Base of pile cap 2.7 m below ground level (approximate RL = -1.3 m AHD) – refer to Figure 2
 - Concrete exposed in pile cap appears to be in reasonable condition with no obvious cracking/defects

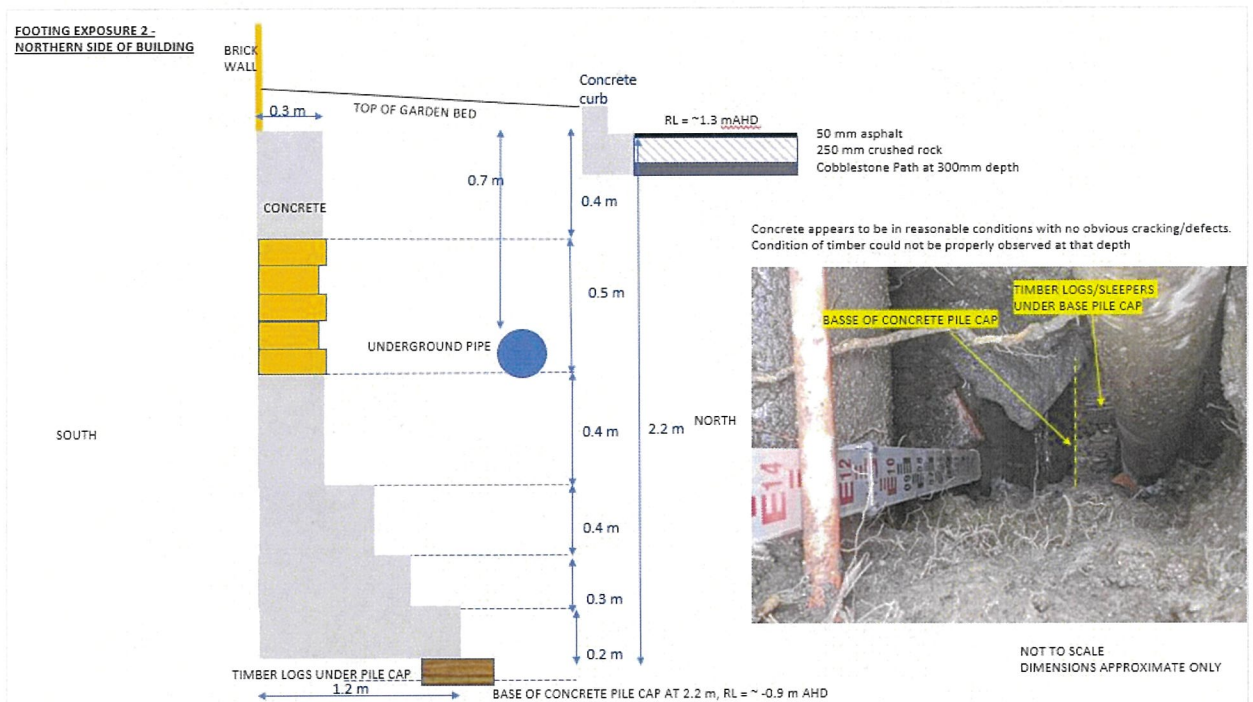
Figure 3: Footing Exposure 2 Sketch and Photo

- Footing Exposure 2 (northern side of building): Base of pile cap 2.2 m below ground level (approximate RL = -0.9 m AHD) – refer to Figure 3
 - Concrete exposed in pile cap appears to be in reasonable condition with no obvious cracking/defects

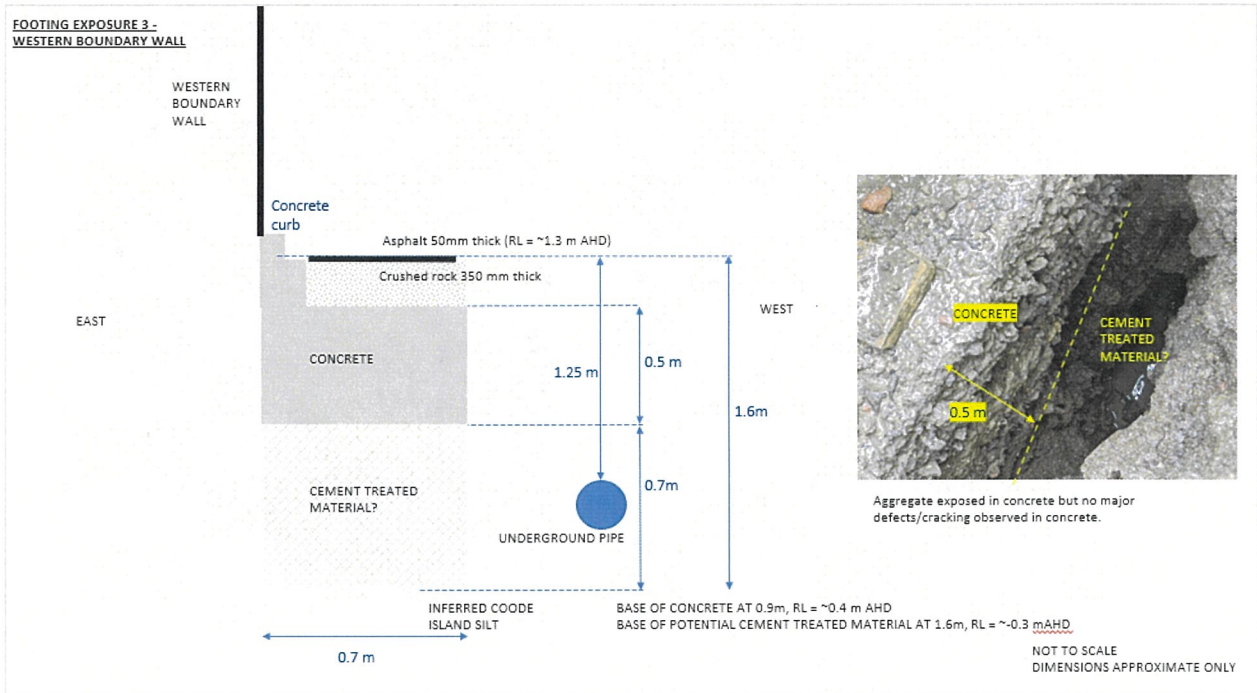
Figure 4: Footing Exposure 3 Sketch and Photo

- Aggregate exposed in concrete side of strip footing exposed but no major defects/cracking observed in concrete.
- Footing Exposure 4 (from the basement of building):

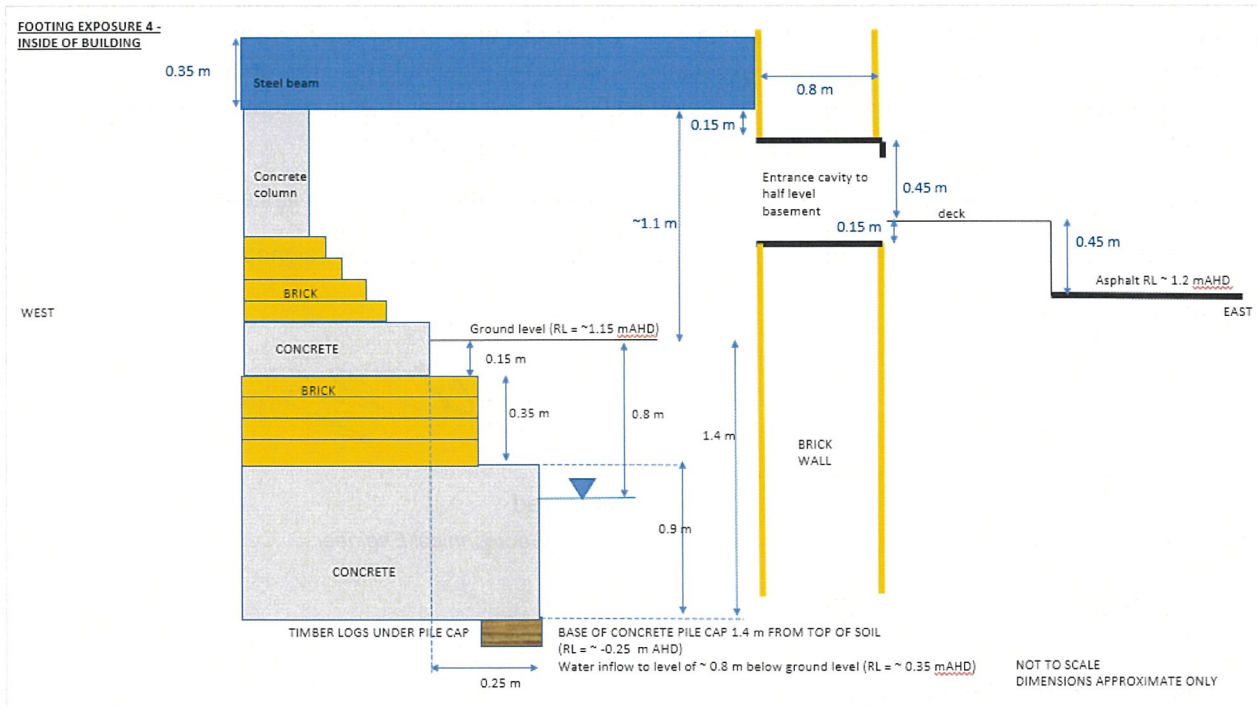
Figure 5: Footing Exposure 4 Sketch

- Concrete exposed in pile cap appears to be in reasonable condition with no obvious cracking/defects
- Groundwater levels were previously measured in three standpipes installed as part of the geotechnical investigation for the proposed development. Groundwater levels were measured to range between about RL 0.2 m AHD to RL 0.3 m AHD.

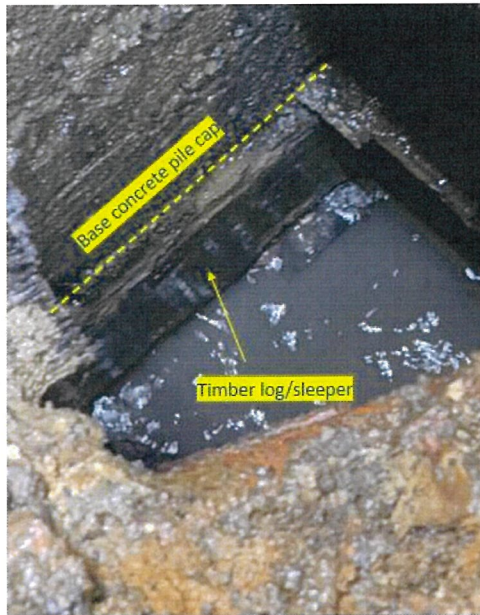
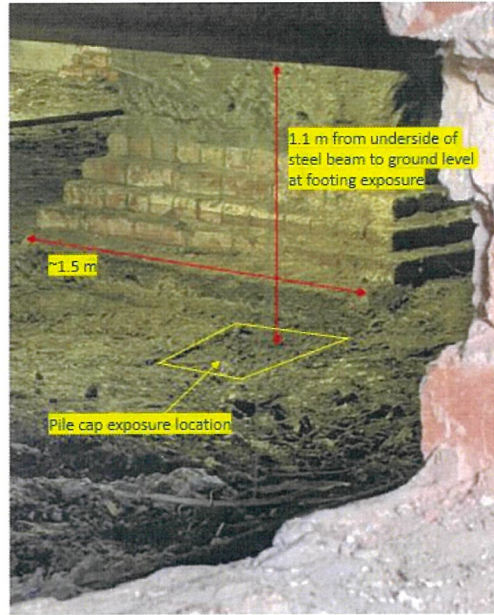
Figure 6: Footing Exposure 4 Photos

Concrete in pile cap appears to be in good conditions with no obvious cracking/defects.
Difficult to assess condition of timber but looks to be relatively well preserved
