# Barwon Aqueduct

## Structural Engineering and Risk Assessment Report

Reference: BAR-HVP-REP-001

Issue for Permit | 28 August 2025

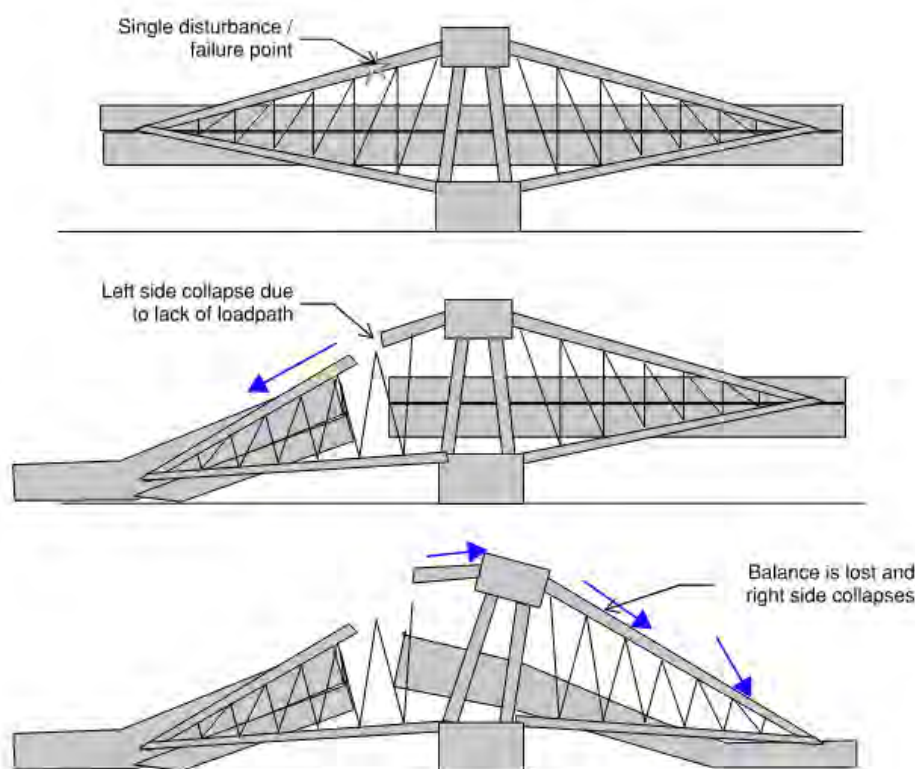
**Figure 3 Failure of Truss due to single point failure.**

1. A single member fails within a truss (Figure 3 top image) – or loading imbalance occurs
2. Load redistribution within the truss occurs, due to the failed member no longer carrying load.
3. The load redistribution causes other members in the truss to become overloaded and fail, in turn causing the entire truss span to fail. The failure deforms the tip of the truss downward (Figure 3 middle image).
4. The pier becomes unbalanced, causing a failure leading to the truss on the opposite side of the pier falling (Figure 3 bottom image).

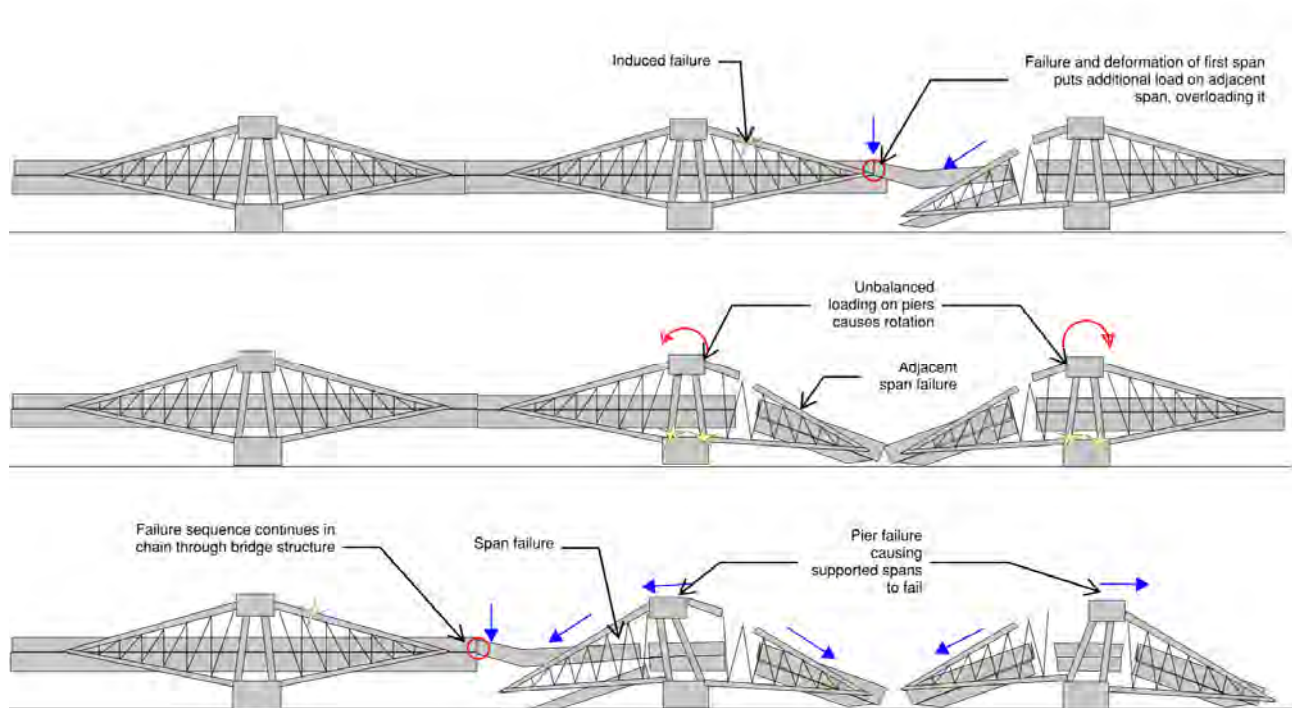
**Figure 4 Catastrophic Collapse Sequence**

This catastrophic scenario of ‘progressive collapse’ of the bridge is a possibility following a single span failure and reflects a worst-case scenario for the bridge. This is shown in Figure 4 as a continuation of the single span failure described previous:

4. The single span deformation pulls the attached walkway girder beam downward with it and places load on the adjacent truss span (Figure 4 top image)
5. The walkway girder beam movement and load overloads the adjacent span, causing failure of the span. This in turn results in loss of balance at the pier. (Figure 4 middle image)
6. The collapse repeats and propagate over multiple spans, i.e. a ‘domino effect’ (Figure 4 bottom image)

Propping under the trusses aims to arrest the catastrophic collapse scenario by preventing imbalance from a single span failure from causing deformation and loading on the adjacent span.

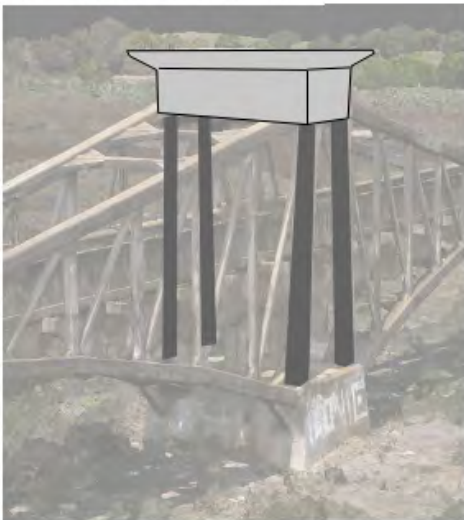
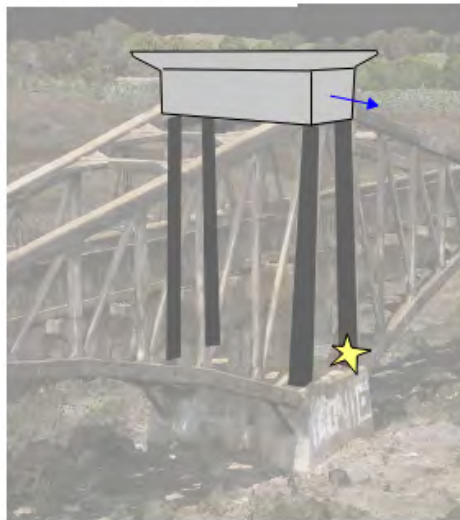
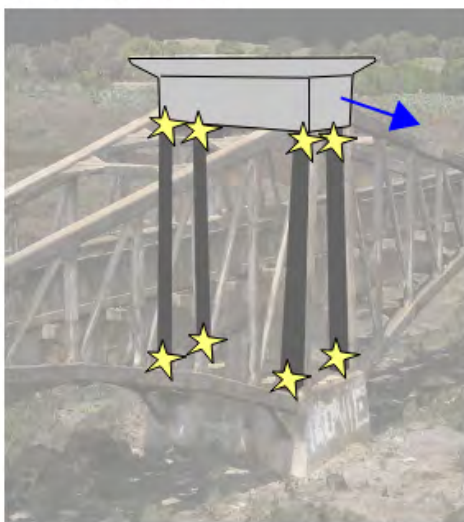
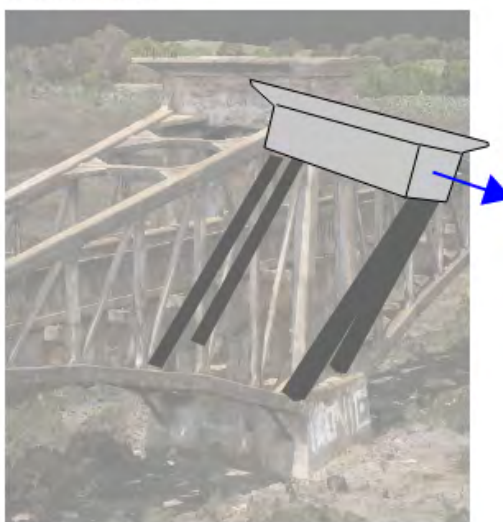
**Figure 5 Pier Sideways Failure Mode (unmitigated condition)**

- This is a complex failure mode, involving multiple individual members. Refer Figure 5 for the failure mode steps that must occur for this failure to be mobilised.
- The pier legs are in generally better external condition than other elements in the structure. They are not highly utilised in the current condition and show less signs of structural distress.
- Due to the complexity and compressive nature of the failure mode, it is expected that external visual cues, spalling and movement would be present prior to such a failure occurring.

1. At rest condition. Rigid pier legs (4x) provide support to truss and pier head

2. Single pier leg failure occurs. Minor sideways movement

3. Further sideways movement forces failure of other pier legs

4. Hinges in pier legs cause uncontrolled collapse

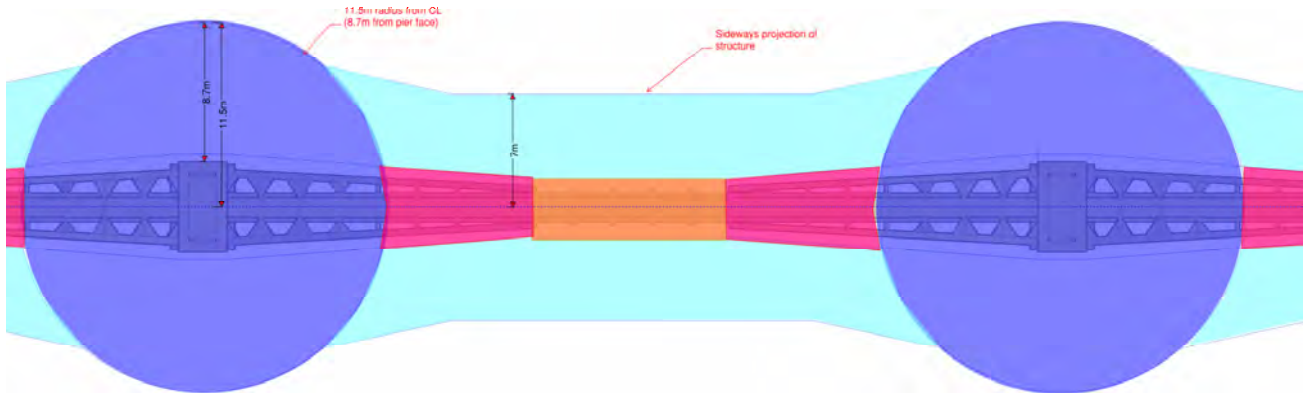
**Figure 6 Sideways Collapse - Risk Footprint**

The plan zones around the aqueduct structure that are affected by this failure type are shown in Figure 6 below. The dark blue area represents the footprint that can potentially be affected by a sideways failure of the tower (max 11.5m from the aqueduct centerline), and the light blue area represents the footprint potentially affected by a sideways failure of the truss (7m from the aqueduct centreline). The hazard within these footprints is falling debris from a structural collapse, i.e. large portions of the aqueduct structure falling sideways. The large footprint and massive nature of the potential debris makes mitigation strategies for such an event challenging – development of these are described in Section 6.

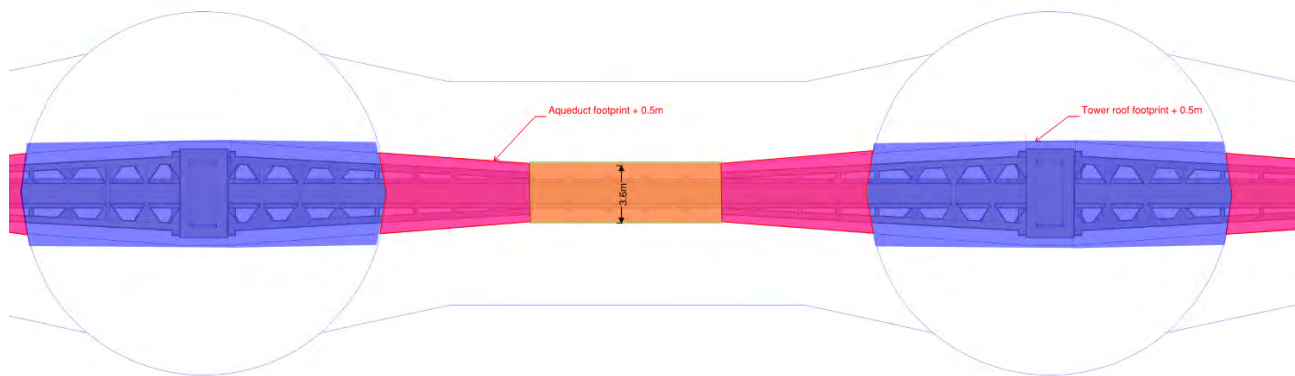
**Figure 7 Vertical Collapse – Hazard Footprint**

Figure 7 shows the risk footprint for a vertical collapse. The coloured areas represent the zone in which large scale concrete debris can be expected under the aqueduct footprint under this type of collapse.

Evidence of widespread spalling from the structure is already present, with chunks of concrete visible on the ground beneath the structure. Spalling hazards are a risk within the vertical risk zone as shown in Figure 7.

Spalling hazards are more readily mitigated during construction than the wholesale collapse hazards, due to the smaller size of concrete debris associated with a spalling failure. Typically spalling may be mitigated by providing overhead protection to any area with workers inside the defined risk zone.

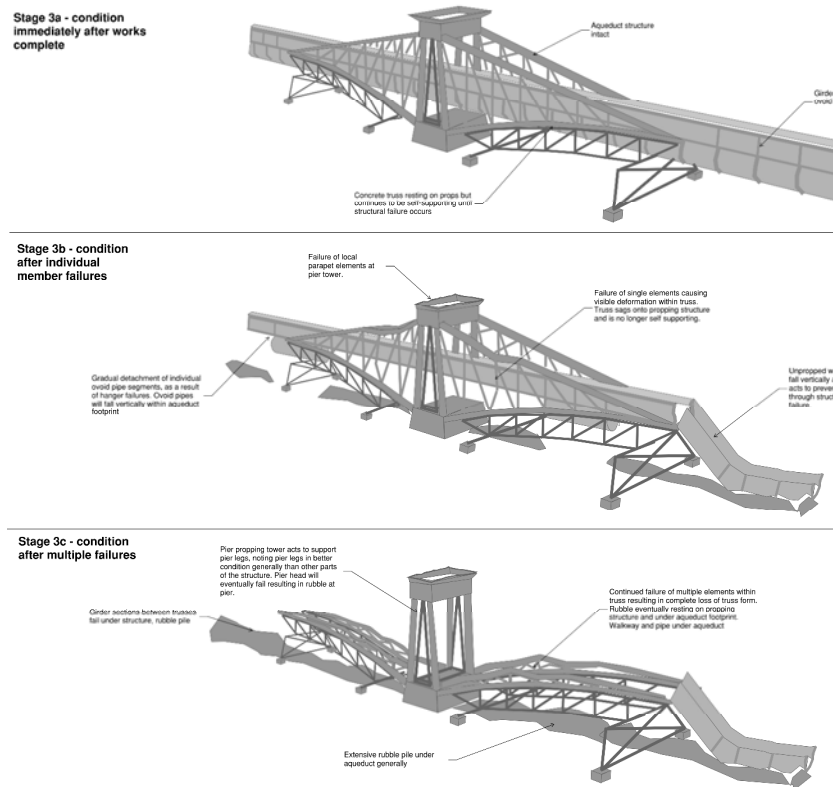
**Figure 13 Failure Sequence after Propping Installation**

After completion of any propping works, the condition of the remaining aqueduct structure will continue to decline unabated over time, at its current rate of deterioration. This will eventually lead to visible failures within the structure, as local members deflect due to inability to carry load. Figure 13 shows an indicative view of the eventual failure sequence after the installation of propping to the structure, with gradual decay leading to an eventual loss of the aqueduct’s shape and rubble forming on the props.

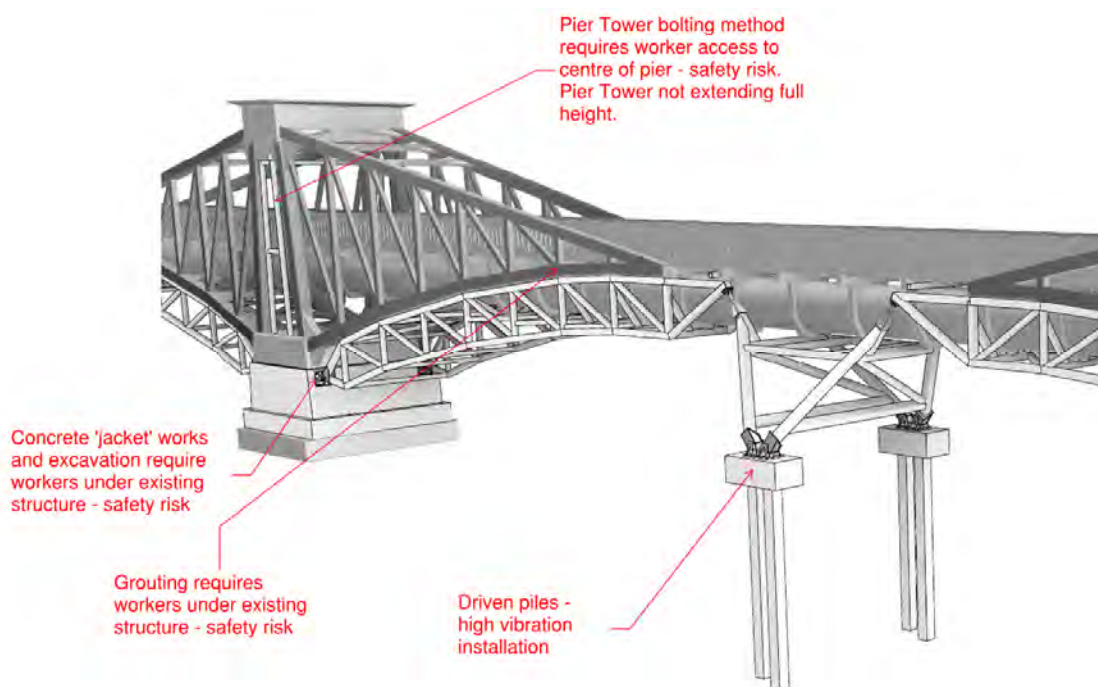
**Figure 14 WGA Propping Design showing Possible Installation Risk Items**

The HIMP Part 1 led to the creation of the risk zone footprints (refer Figure 6 and Figure 7), which drove thinking around safety during construction of the propping. A series of workshops were held in 2023 with all project parties (Barwon Water, WGA, Contractor, Arup) regarding construction safety of the propping. Following the workshops, some unmitigated construction safety issues remained with the WGA design, as summarised in Figure 14 below.

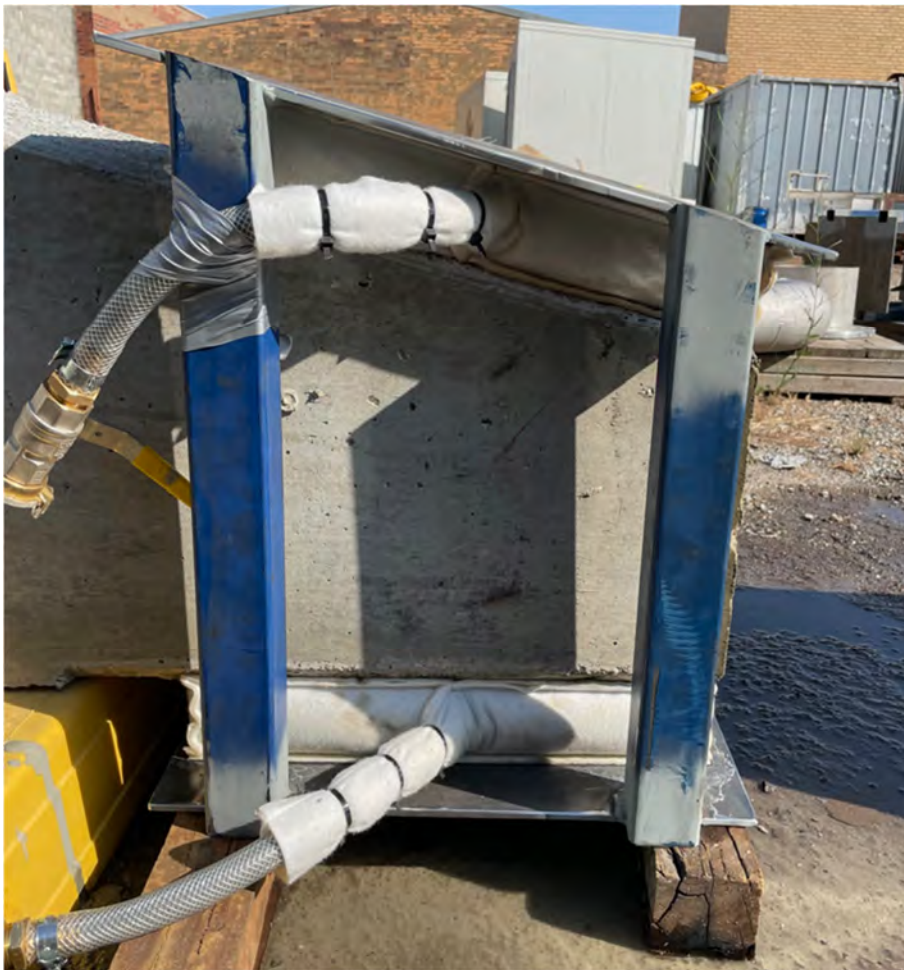
**Figure 20 Grout Bag Trial**

Physical trials were undertaken on 1:1 scale models of the prop/aqueduct geometry, suggesting technical viability of the system with pumping of grout into the bags. However considering the approach holistically, it must be acknowledged as a bespoke application with the potential for technical failure. There is little redundancy if a technical failure does occur, i.e. if the grout bag system did not work, then any rectification or alternative methods for install would face the requirement for personnel to enter the risk area.

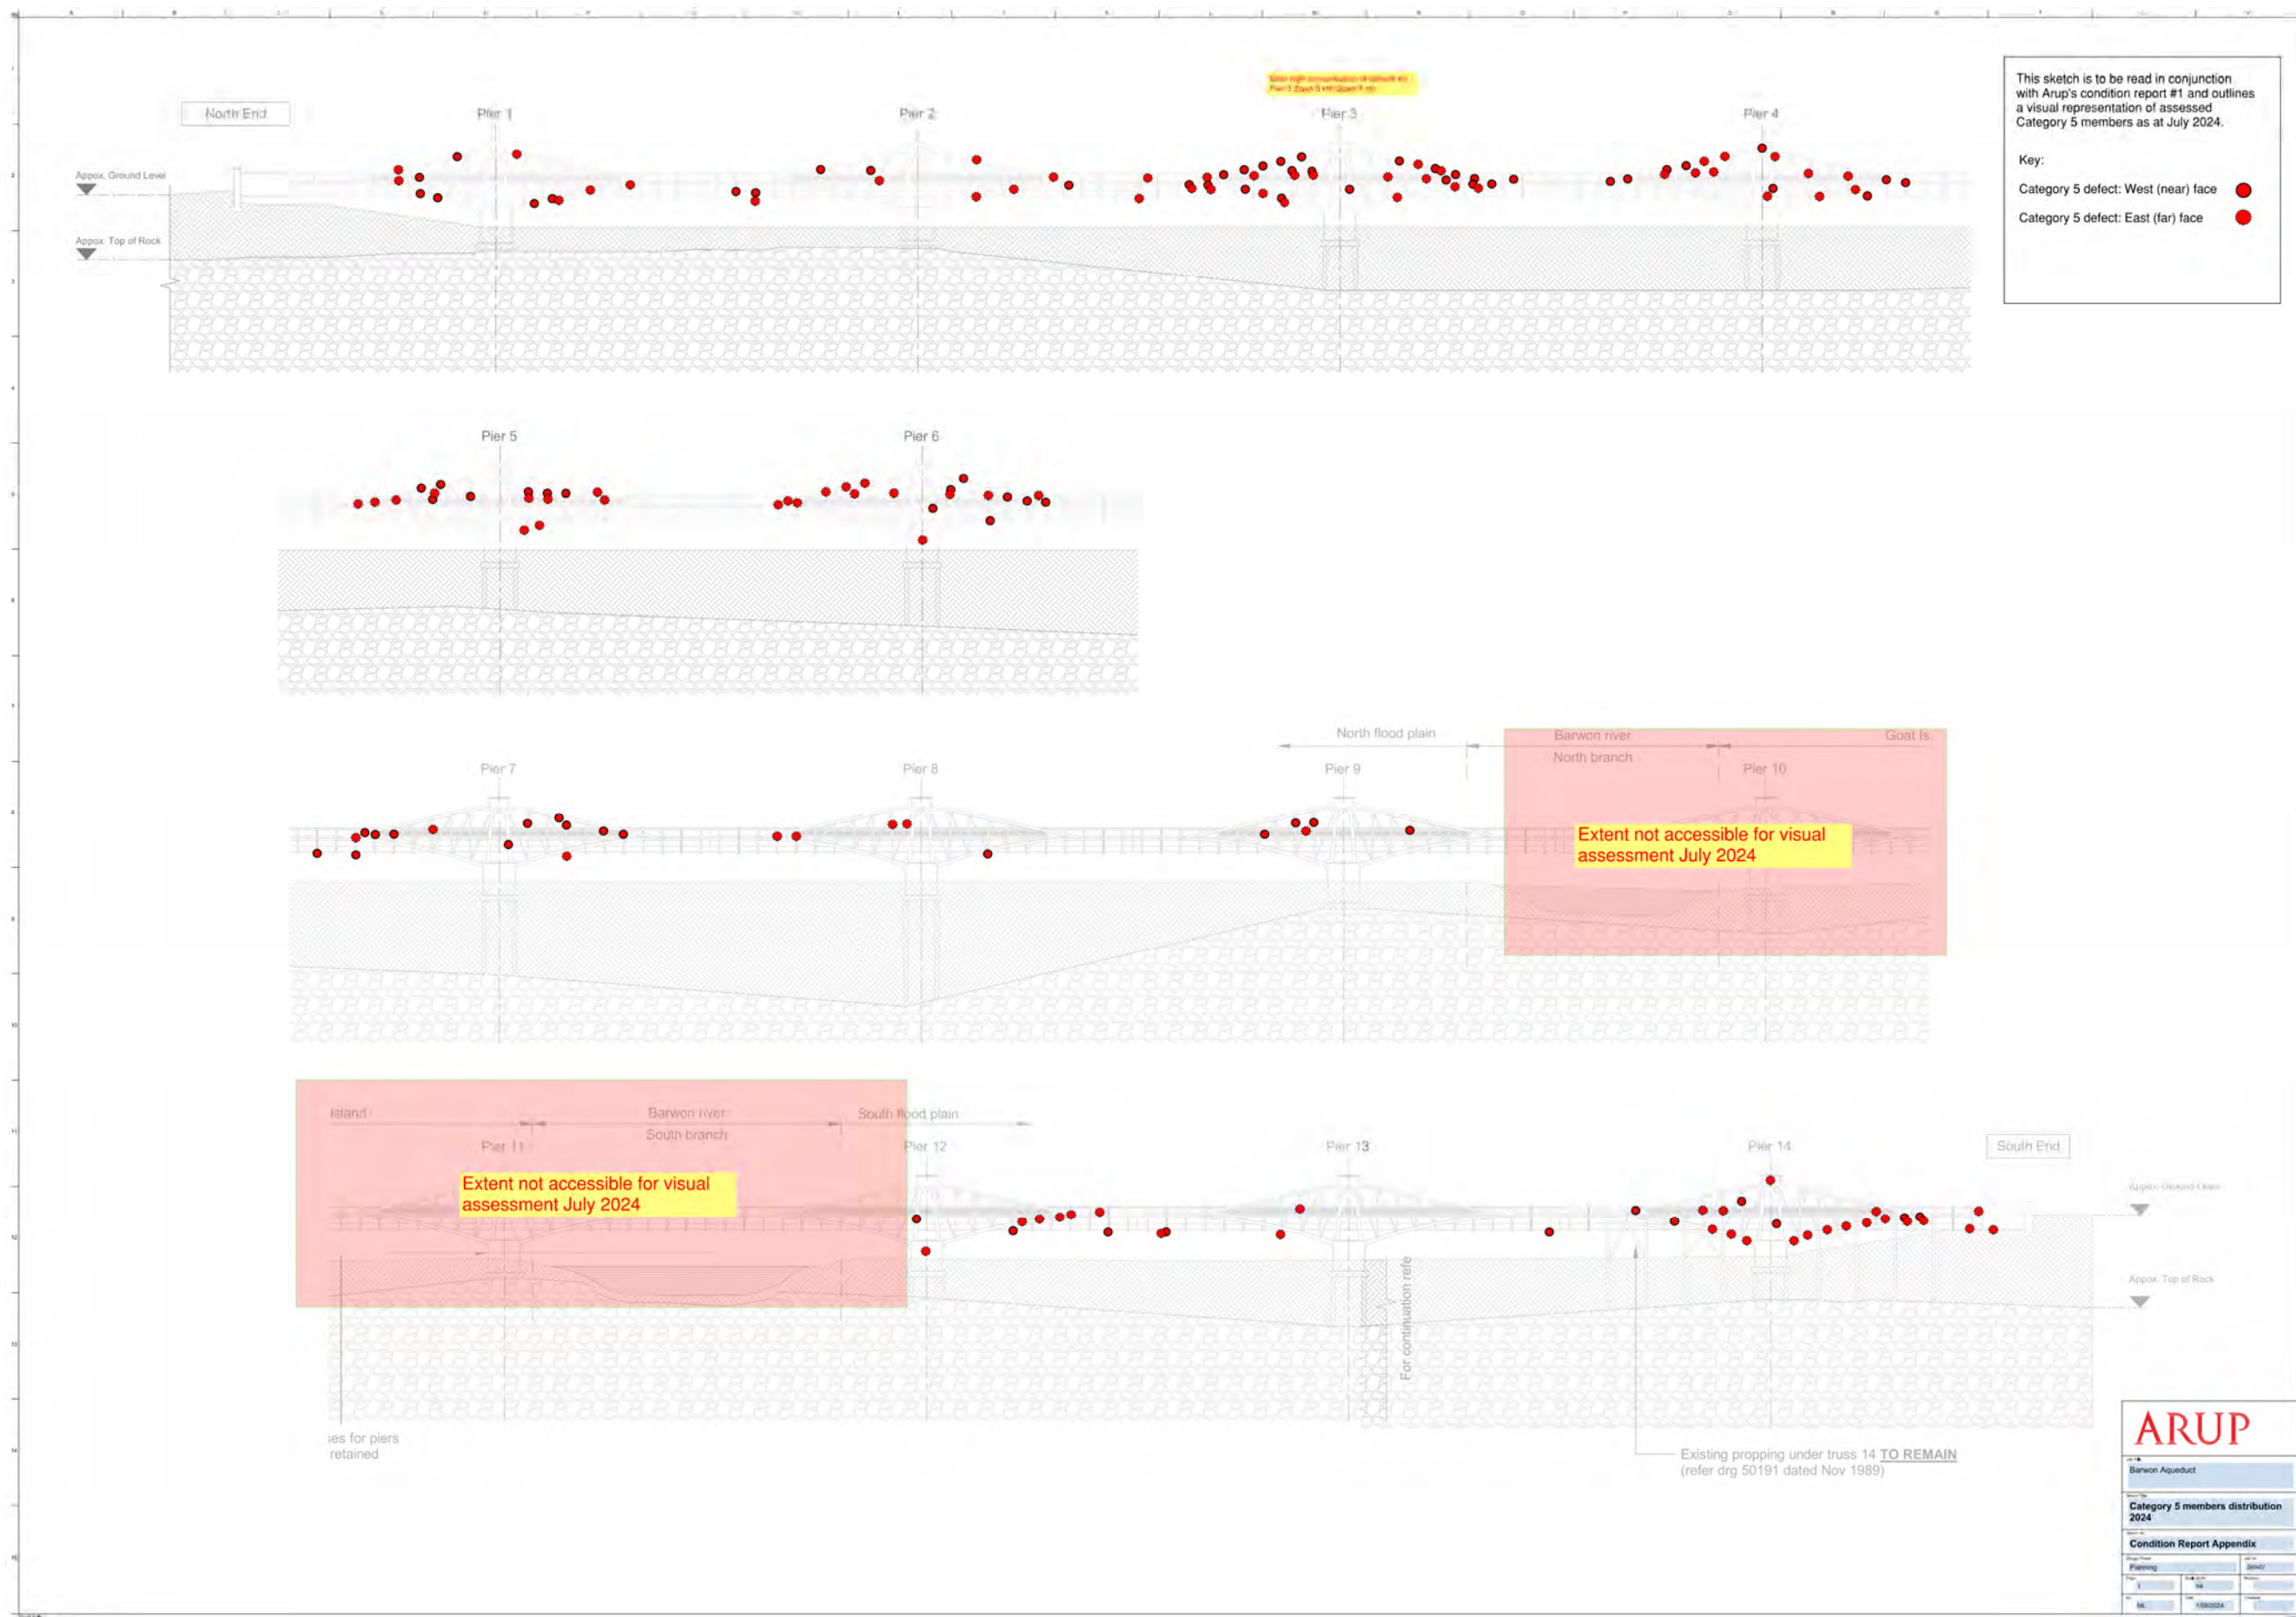
Figure 6 Summary of Category 5 members (2024)

We note that as yet, no confirmed failures or significant member deformations (Category 6) have currently been recorded in the structure. Whilst heavily degraded members are likely to have lost some of their structural capacity, the imposed load is either still being taken by the member or being redistributed to adjacent members, thus avoiding visible signs of failure.
