# Memorandum

Project	Kawarau (VHR H0489)		
Subject	Response to P41747 RFI Item No. 2	Date	15/06/2026
Location	405 Tooronga Road, Hawthorn East

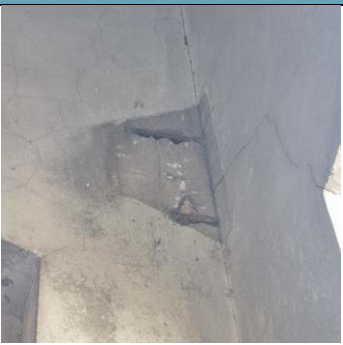
Affected Area	Observations	Photos	Proposed Conservation Actions
Walls	Small drill holes (approx. 5mm in diameter) are observed throughout. Loose and missing render at some areas, exposing red bricks underneath.

Engage a structural engineer to assess the identified areas and confirm whether there is any safety risk associated with loose render.  Remove defective, drummy, or loose render and replace with new. The defective area is to be stripped back to sound substrate. If substrate is found to be loose or

<p>crumbling, it shall be generally repaired and replaced prior to repair of render.</p> <p>New render must match the existing in the composition of render mix, colour, finish, and moulding details (where applicable).</p> <p>Surfaces to be re-rendered shall be free from dirt, paint, oil, or other loose particles.</p>
Columns	Cracks, loose, or missing render. Some cracks are >5mm and pulling away from the balustrade.

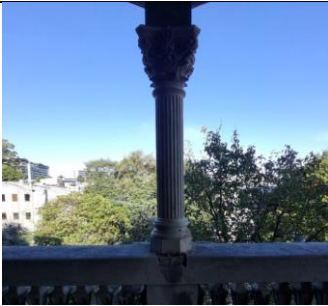
Painted metal posts	Rusting posts and peeling paint.

<p>Repair or restoration is not generally considered where damage is minor, and works should only cover what is necessary to maintain or restore functionality.</p> <p>Where necessary, clean the posts carefully and by hand to remove any rusts and peeling paint. After cleaning, prime with a zinc chromate or other appropriate metal primer and apply a full paint system in accordance with the paint manufacturer's specification.</p>

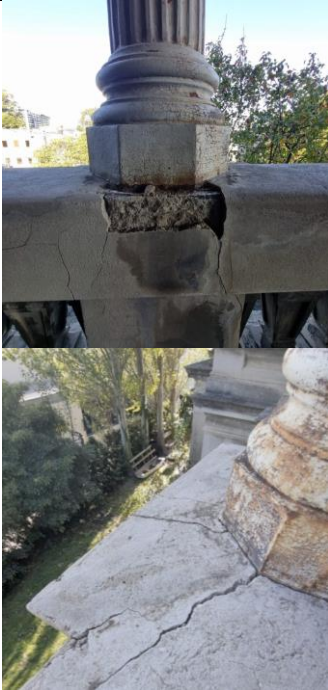
<p>Balustrade</p>	<p>Cracked concrete throughout. Specifically, star-shaped cracks radiating from the base of all cast iron columns are identified.</p>

<p>Engage a structural engineer to assess the identified areas and confirm whether there is any safety risk associated with cracking.</p> <p>Surface treatment would involve removing defective, drummy, or loose render and replace with new. The defective area is to be stripped back to sound substrate. If substrate is found to be loose or crumbling, it shall be generally repaired and replaced prior to repair of render.</p> <p>New render must match the existing in the composition of render mix, colour, finish, and moulding details (where applicable). Surfaces to be re-rendered shall be free from dirt, paint, oil, or other loose particles.</p>
<p>Gutters</p>	<p>Appears to be lead gutters and tin flashings. They are generally in good condition but are loose at certain areas.</p>

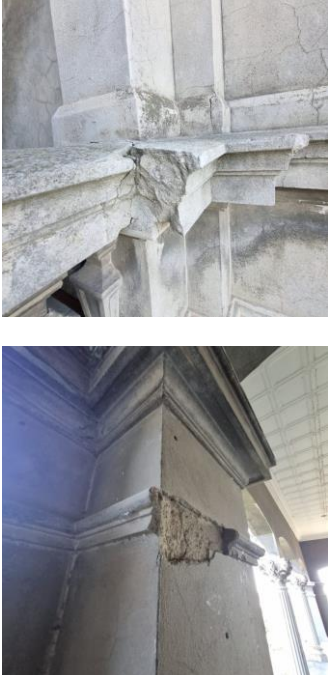
<p>Mouldings</p>	<p>Cracked render throughout. At some areas, red bricks are exposed due to missing render.</p>

<p>Remove defective, drummy, or loose render and replace with new. The defective area is to be stripped back to sound substrate. If substrate is found to be loose or crumbling, it shall be generally repaired and replaced prior to repair of render.</p> <p>Re-running of all lost moulded render should be undertaken in-situ to match profile and finish of adjacent mouldings.</p> <p>Repairs should be undertaken by an experienced tradesperson using traditional skills.</p>

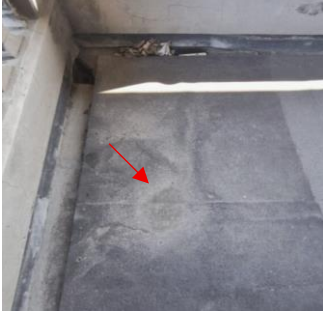
Floor	<p>The floor is covered over with non-original mats, and the floor's material and construction are unknown at this stage. However, floor may be of timber construction.</p> <p>Area at the southwestern corner has a visible indentation and is springy to touch, suggesting that there may be water damage.</p>

<p>Investigate source of water ingress and rectify as required.</p> <p>Remove mat for further inspection.</p> <p>If floor structure is confirmed to be timber, remove sections of rotten, damage, or otherwise degraded timber beyond reasonable repair and splice in new sections.</p> <p>Care is to be taken to ensure the new section matches the existing including in timber species, cut, size, grading, and profile.</p>
-------	--	---	---

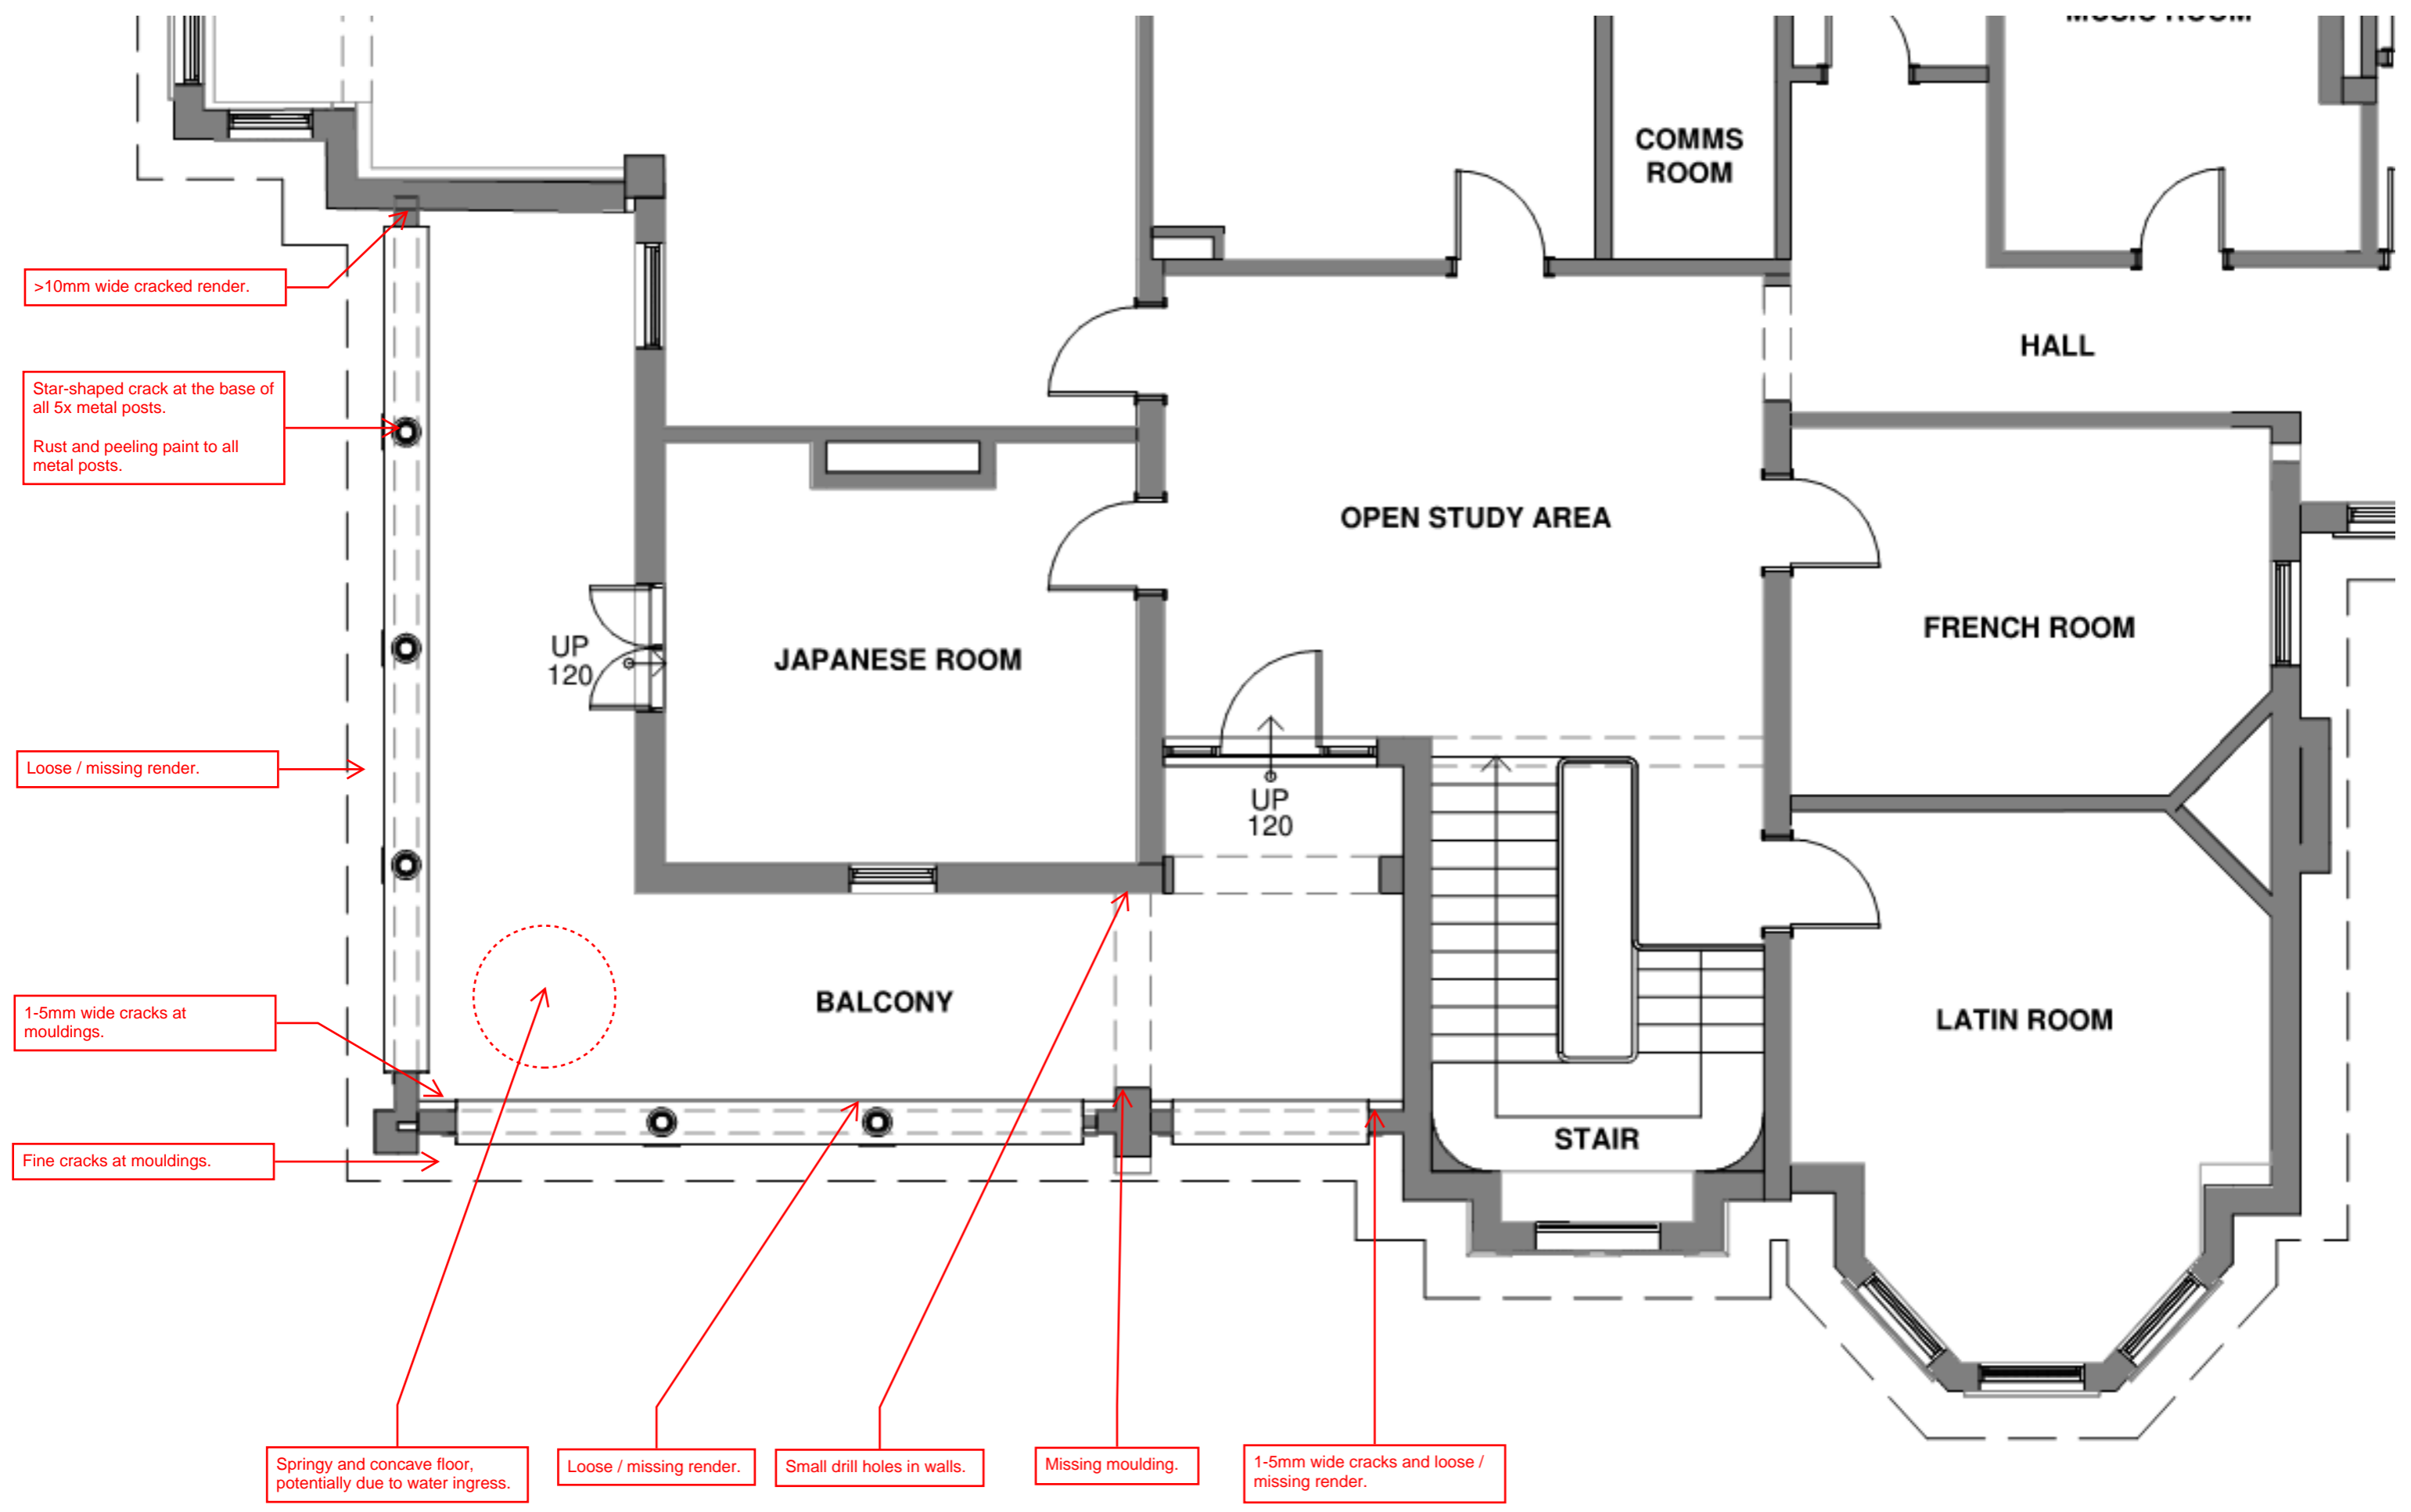
>10mm wide cracked render.

Star-shaped crack at the base of all 5x metal posts.  
Rust and peeling paint to all metal posts.

Loose / missing render.

1-5mm wide cracks at mouldings.

Fine cracks at mouldings.

Springy and concave floor, potentially due to water ingress.

Small drill holes in walls.

Missing moulding.

1-5mm wide cracks and loose / missing render.

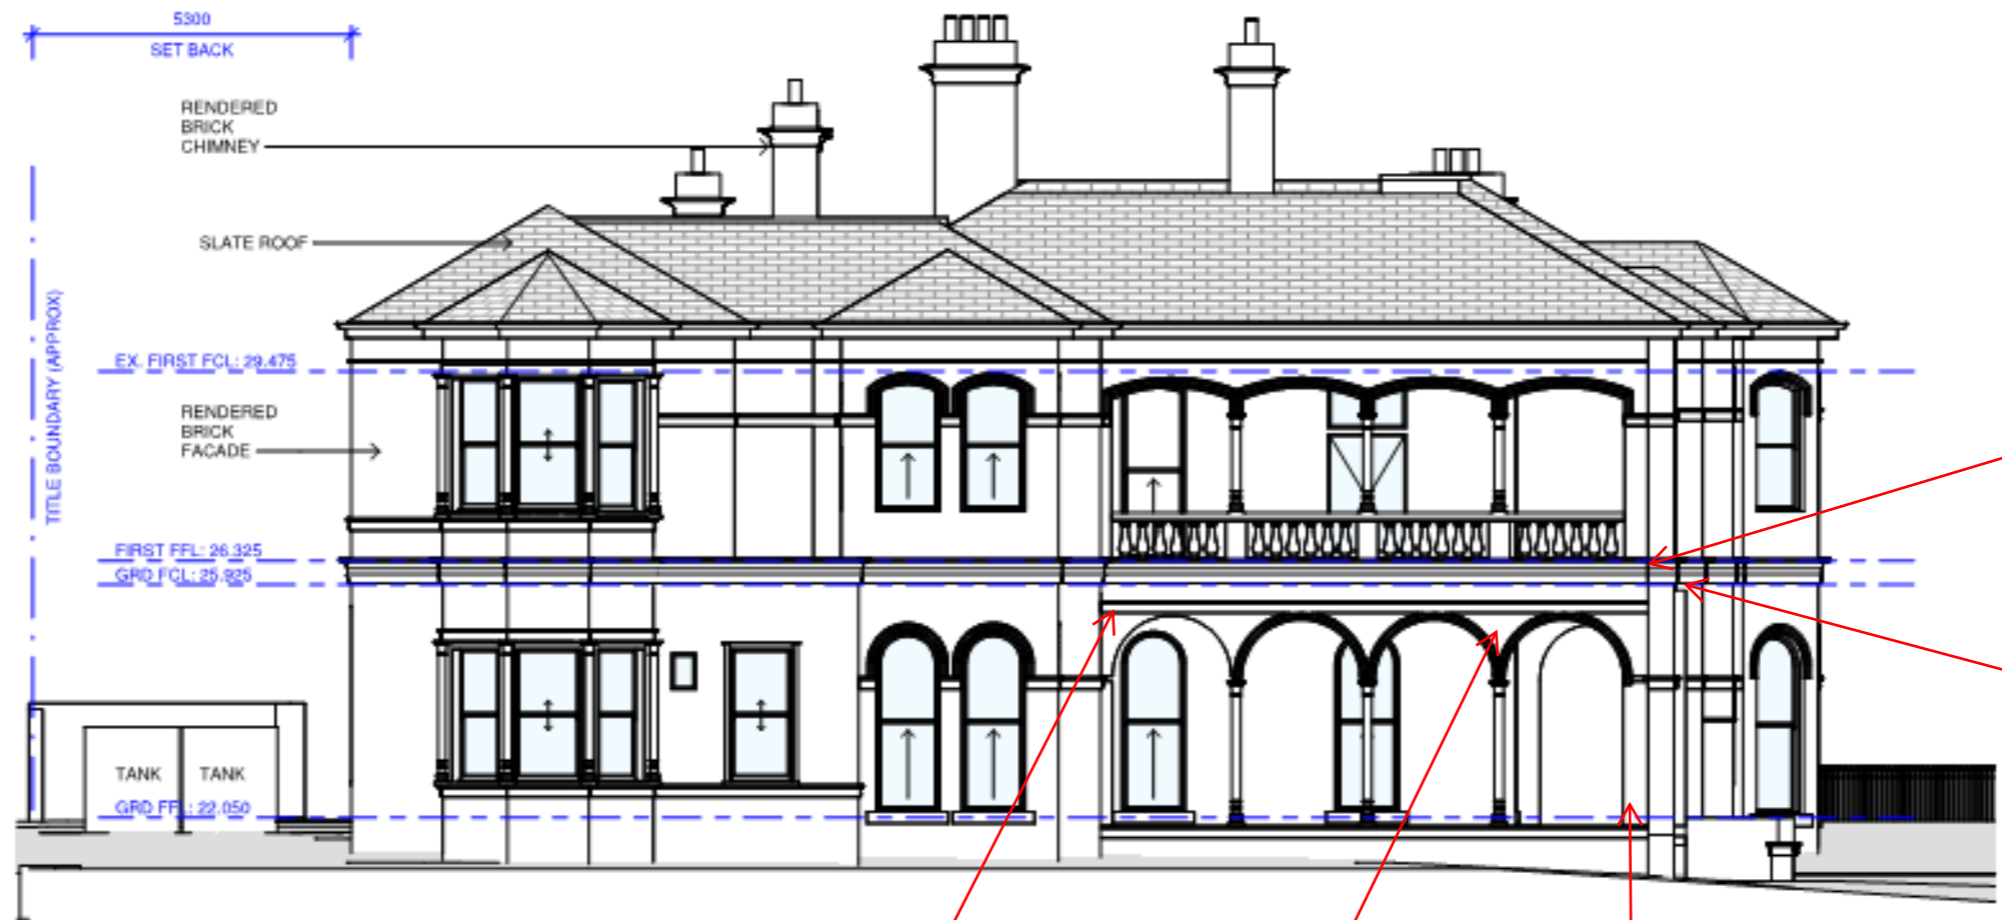
**8** EXISTING WEST ELEVATION  
SCALE 1 : 100

Missing section of moulding.

Fine cracks.

Large cracks.

>10mm large holes and some smaller drill holes.

Missing render at base corner of column, exposing steel bar.

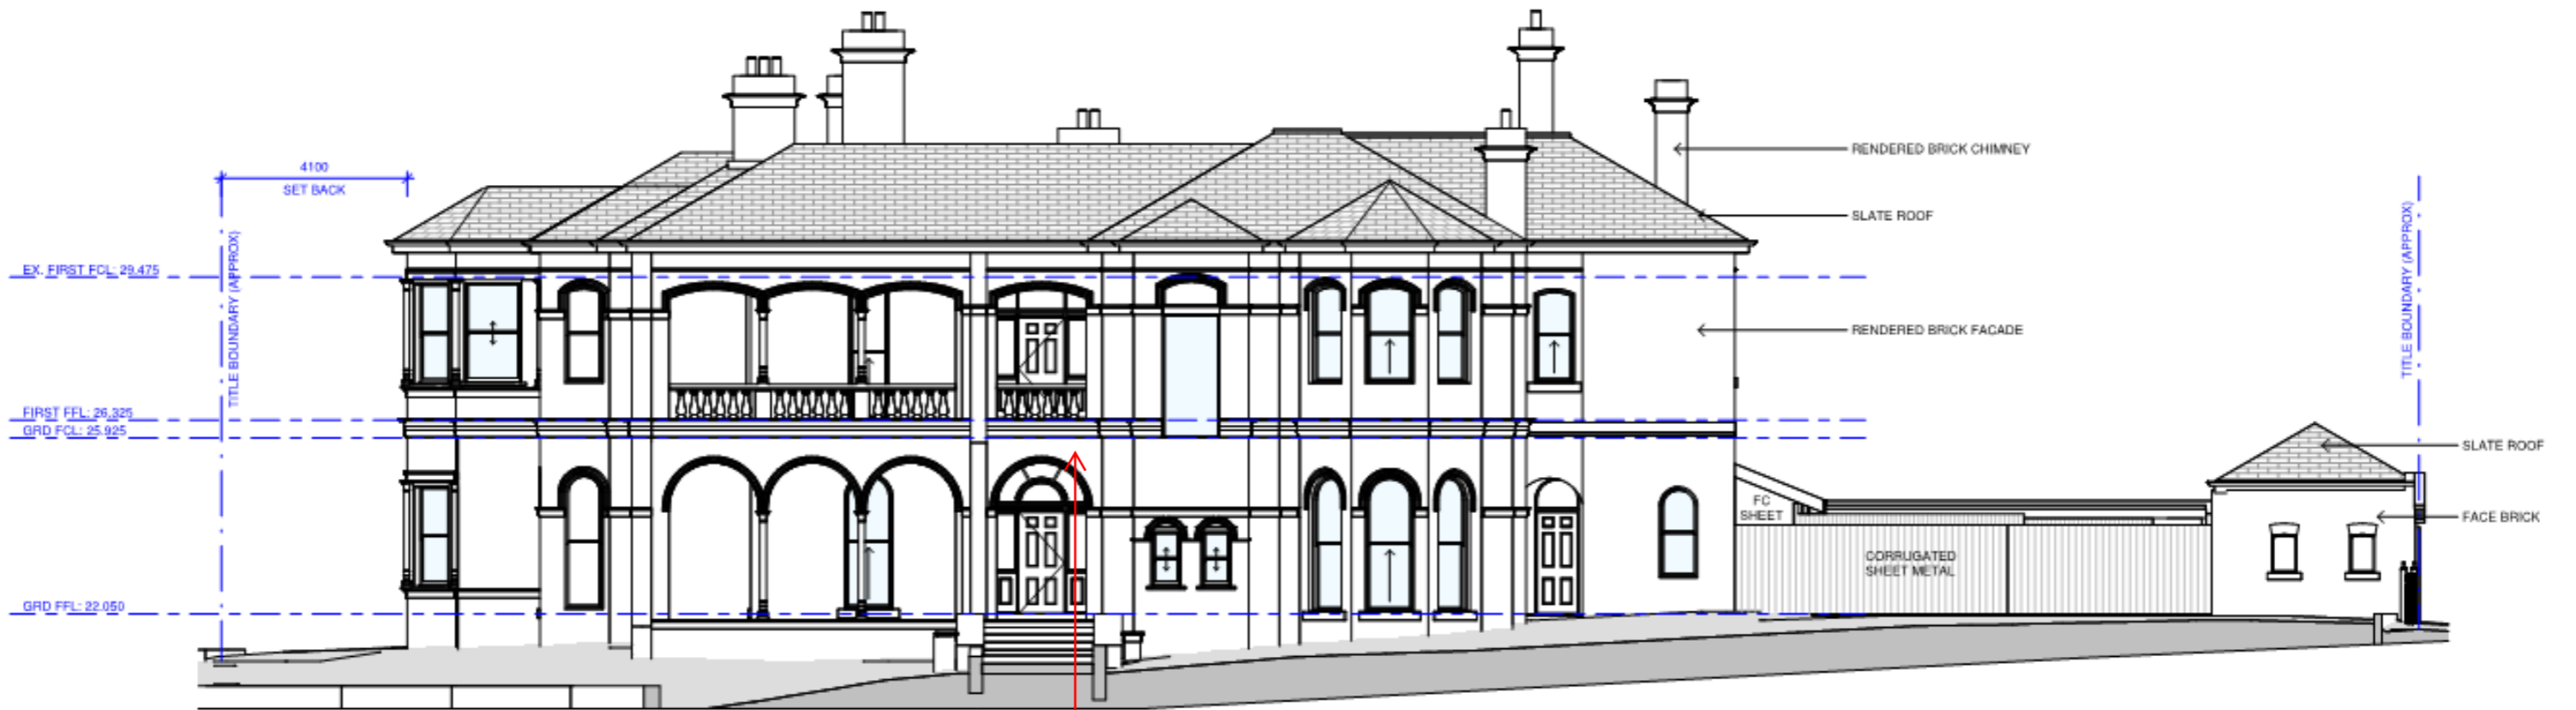
**7** EXISTING SOUTH ELEVATION  
SCALE 1 : 100

Fine crack.
