# All Saints' Anglican Church

2 Chapel Street, East St Kilda.

March 1999

## EXISTING CONDITION SURVEY

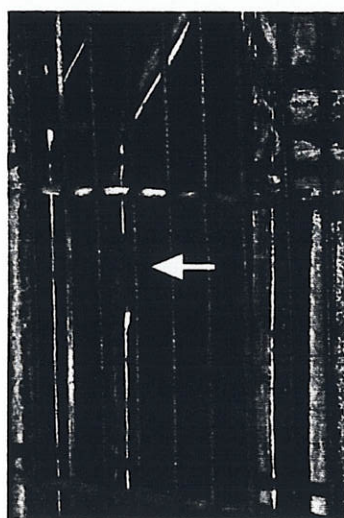
Nearly all of the windows are still housed in their original lead comes which are now approaching the end of their serviceable life. The leadlight cement has dried out and cracking and in some windows beginning to dislodge.

Leadlight cement, like all oil based putties will eventually dry out and progressively lose bonding strength. To combat this a normal 25 year cyclic maintenance program includes re-cementing of the lead comes. As this has not occurred at All Saints, the external leadlight cement is breaking down which means the the downward weight of the windows will need to be supported more and more by the fragile lead came structure alone.

Cement loss, north transept

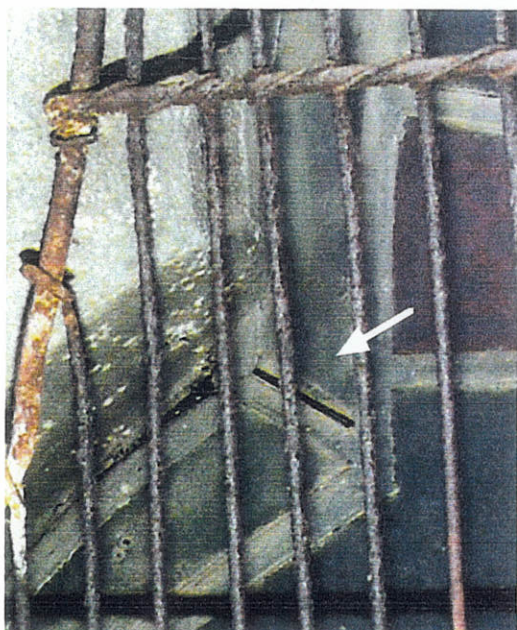
On the northern and western aspects in particular, the lead has crystallised in many windows and fine hairline cracks in the lead comes are beginning to appear. At a few localised points these cracks have opened up due to settling of the window or stone movement and raw edges of glass are now exposed.

If left unattended, over the next ten years the number and severity of these cracks will increase to a degree where windows begin leaking and daylight becomes visible at various points in individual windows.

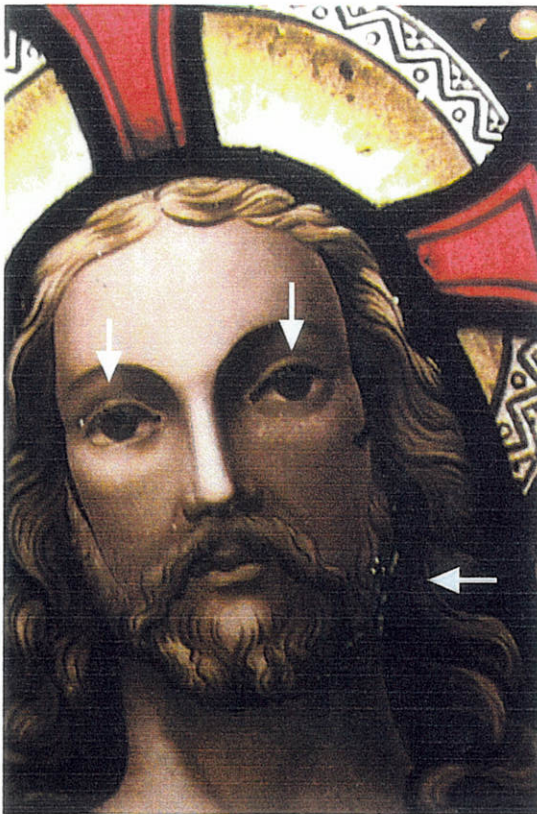
Paint loss, sanctuary

Vitreous glass paint is a compound of ferrous oxide and fluxes applied to the interior surface of the glass and fired in a kiln to bond it to the glass surface. Opaque black or brown in colour, glass paint is the traditional material of stained glass artists and provides all the detail we observe in a window: faces, drapery, decorative borders, etc. Vitreous glass paint should be permanent, as was the glass paint of the 12th and 13th centuries, but for various reasons some glass paint of the 19th century has proven to lack durability.

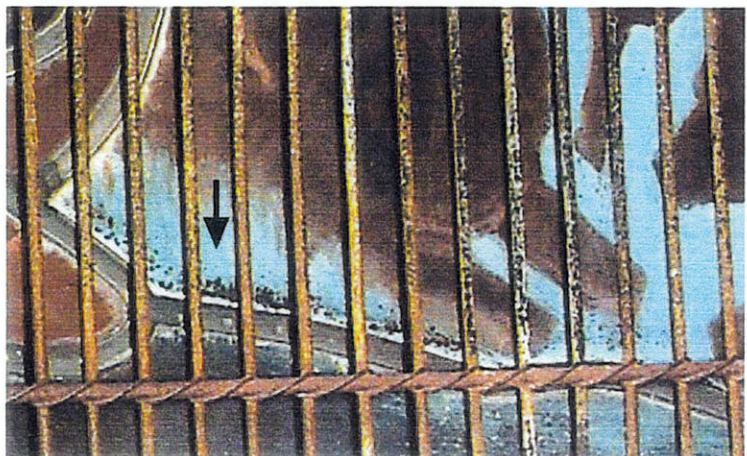
Enamelling has been used extensively on the window cycles in the north and south transepts, both of which now show evidence of enamel loss. Paint loss is apparent not only on the transept windows but also on other windows throughout the church. This instability of the enamel and glass paint will hamper normal maintenance procedures such as re-cementing and cleaning which, if performed *in situ*, would pose the risk of dislodging unstable enamel and paint.

Enamel loss, south transept external

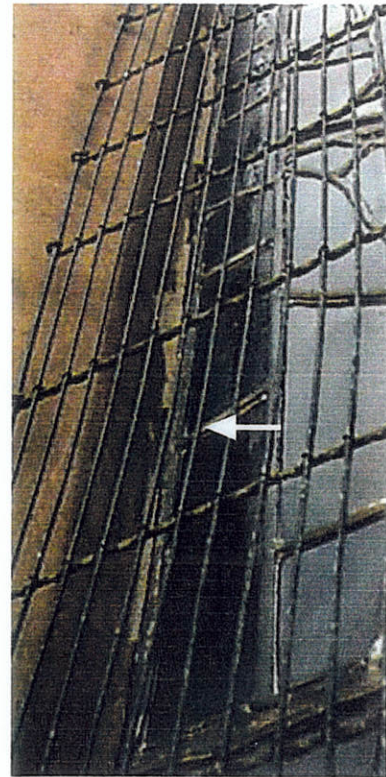
West Window: There has been considerable movement in the masonry frame of this window, particularly in the lancet containing the Jewish priests. As the masonry has spread, this lancet has split down the centre of the stained glass and daylight is now visible through the window. The border edge of the stained glass panel is exposed externally where it has pulled free from its glazing channel as the stone has moved and it is no longer secure or waterproof.

Exposed edge of stained glass panel, west window

The whole lancet requires to be excavated for repairs and because of the degraded nature of the lead will require re-leading as the lead structure will fall apart upon excavation. The remaining 3 lancets and the tracery panels could have their life extended by about 25 years through recementing but as most of the lead has crystallised, re-leading of these panels should also be considered.

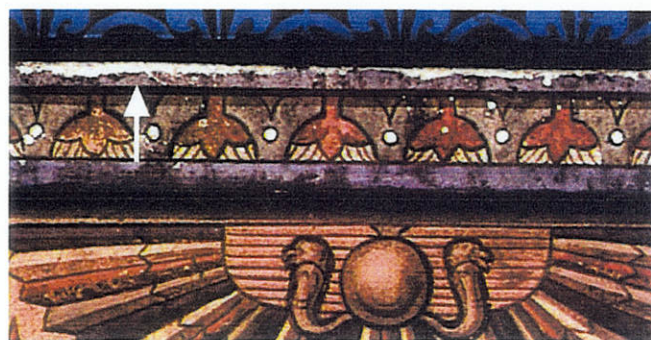
North Transept windows: The lead and leadlight cement in these windows is very decayed and with no intervention structural problems will become apparent in the next 5 to 10 years. Recementing *in situ* is not recommended for these windows due to the unstable nature of the externally applied enamel.

Enamel loss, north transept

The windows should be excavated for re-leading in the studio where the unstable enamel can be monitored with industrial magnifiers and transmitted light during repairs to keep enamel loss to a minimum.

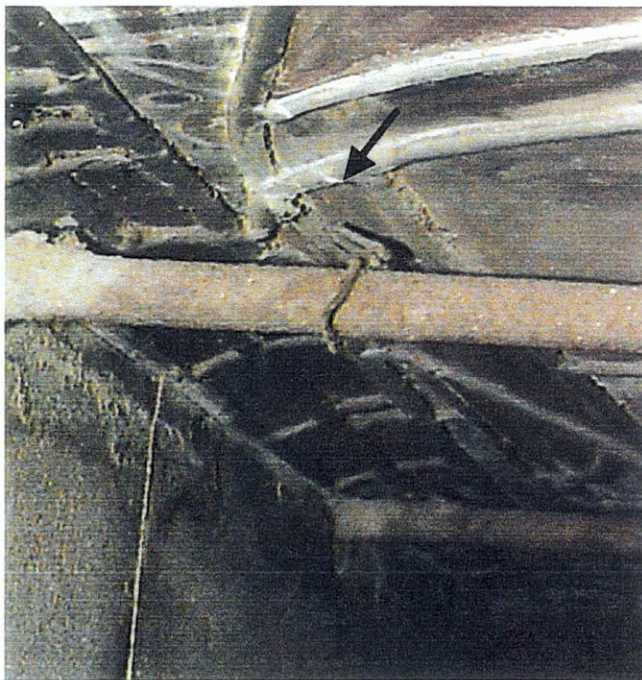
St. John window [sanctuary]: This window has severely buckled vertically down the LH border breaking tie wires from the saddle bars and exposing raw edges of glass. It has also developed a convex bulge in the upper section. The window needs to be excavated for straightening and partial re-leading.

Vertical buckling and broken tie wire, St. John window
