**conservation  
studio**

## **Condition Assessment**

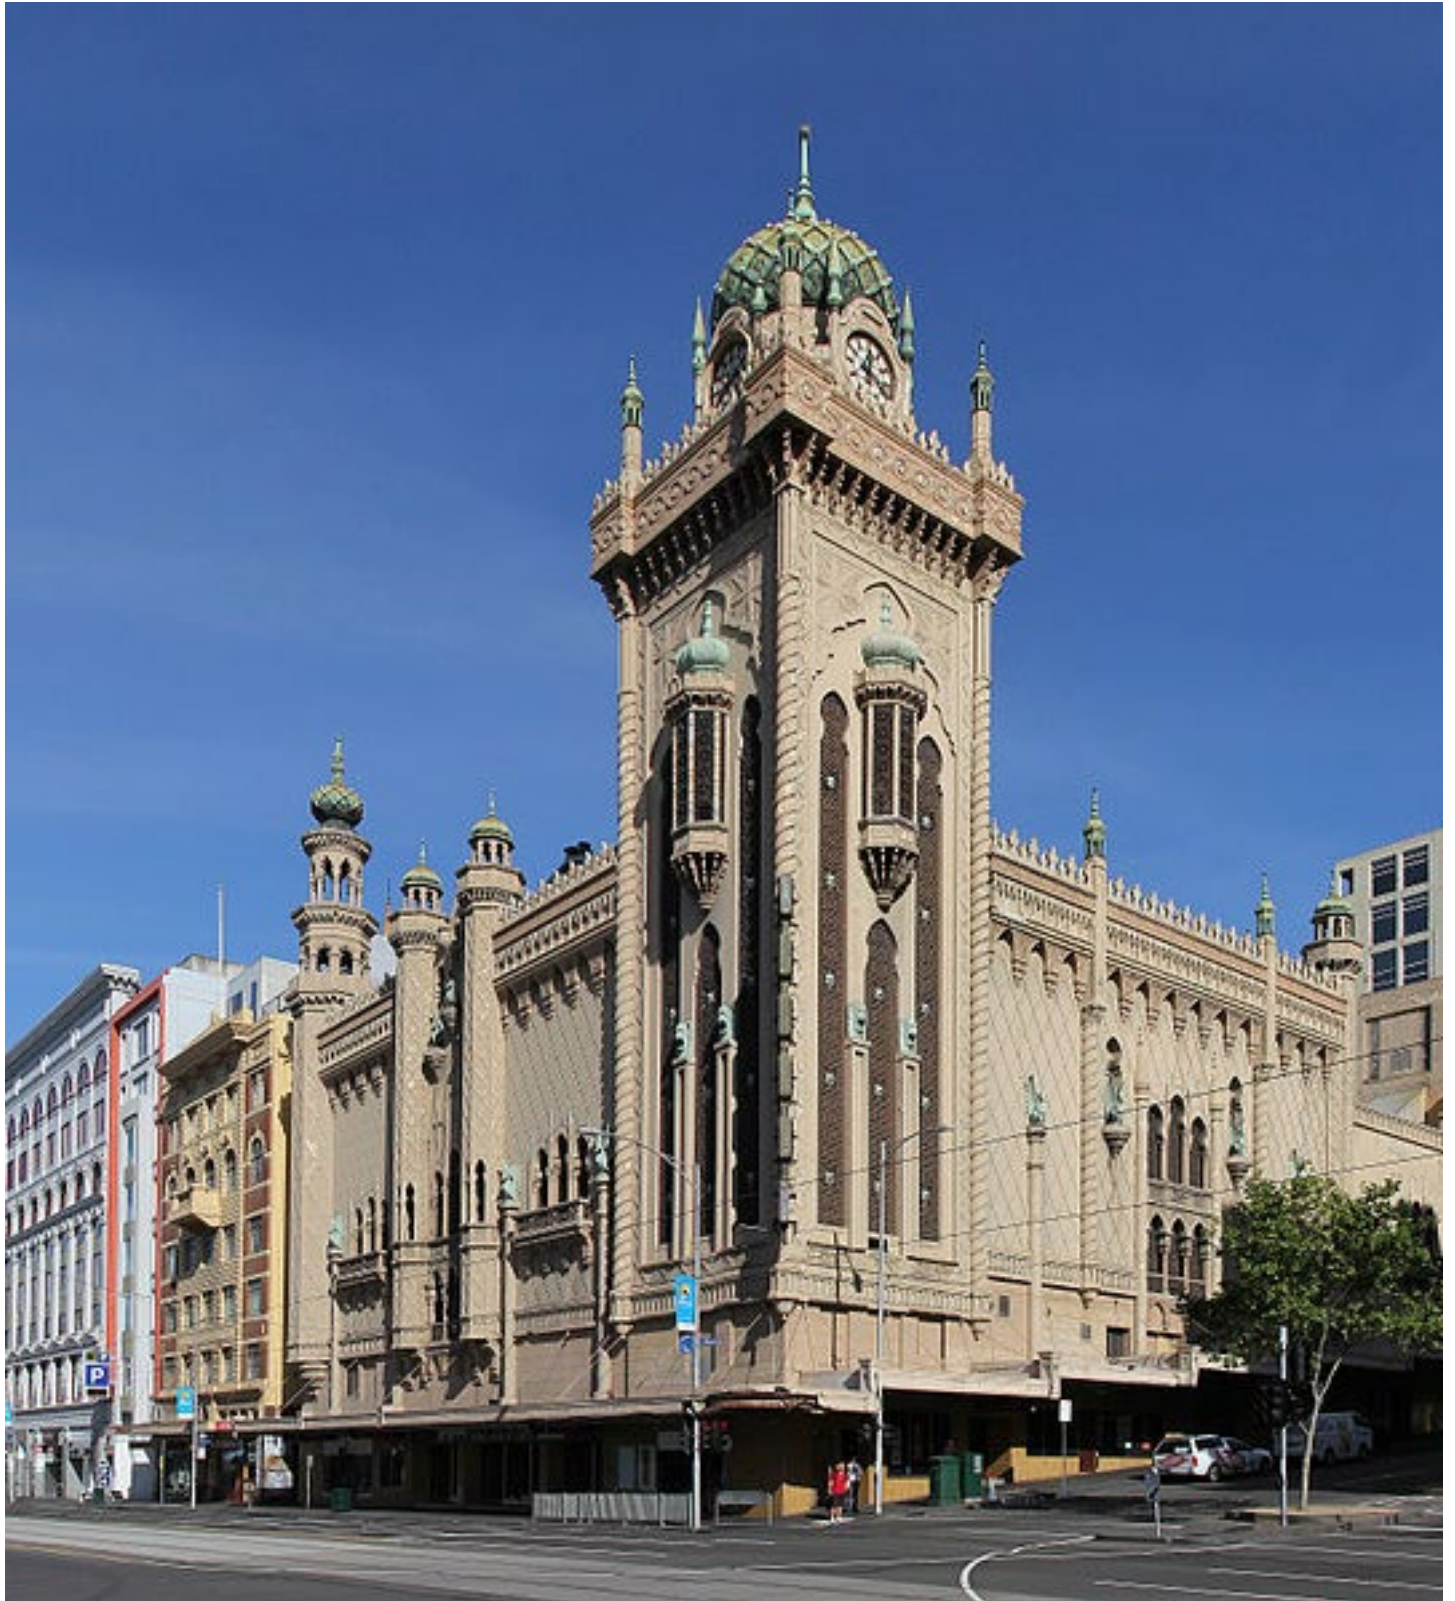
**Figure 2**  
View of the Forum Theatre.

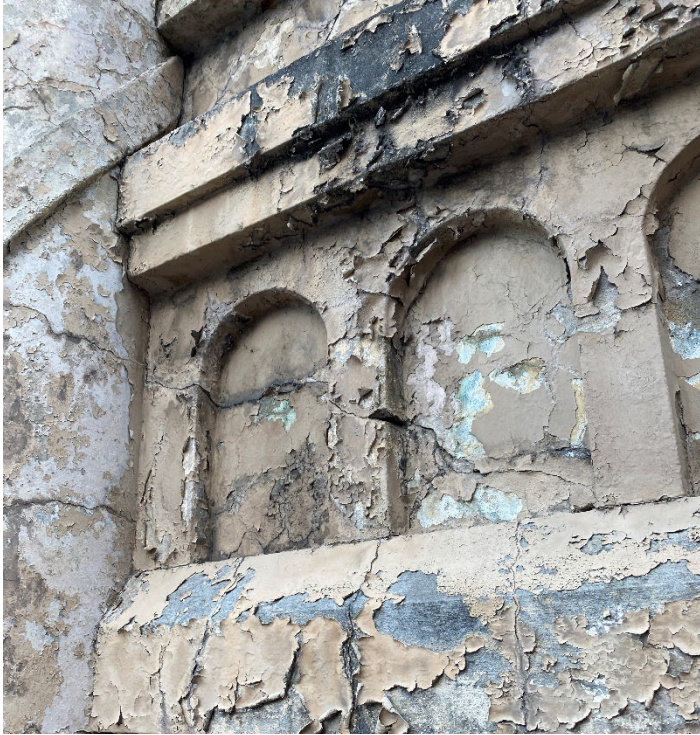
**Figure 3**  
Crack in the concrete parapet on the east elevation – northern wing.

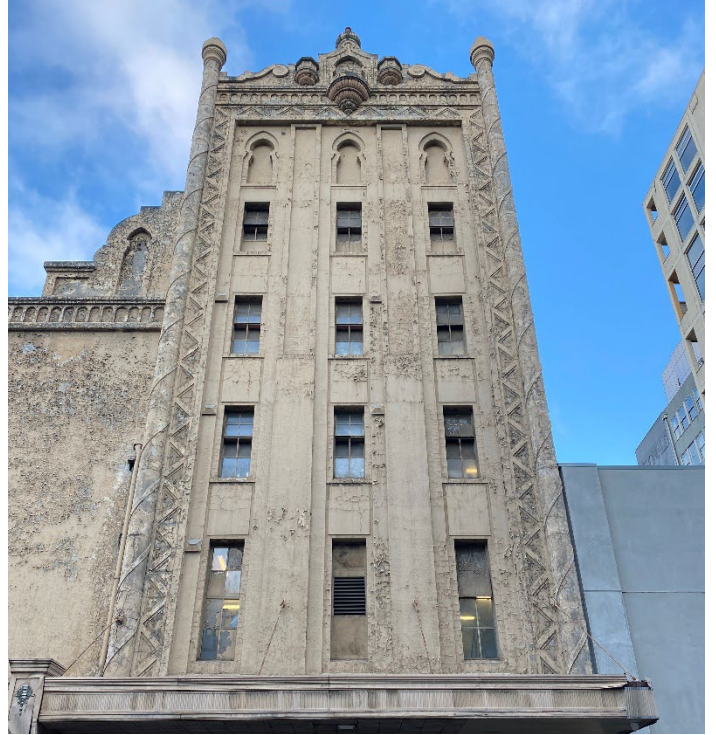
**Figure 4**  
View of the northern wing on the east elevations.

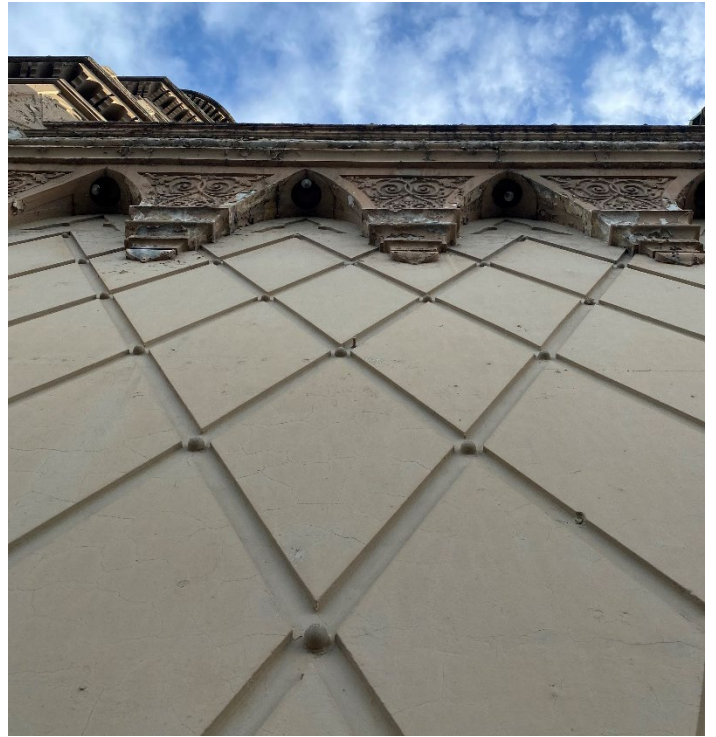
**Figure 8**  
View of the south elevation showing the concrete walls to be in good condition.

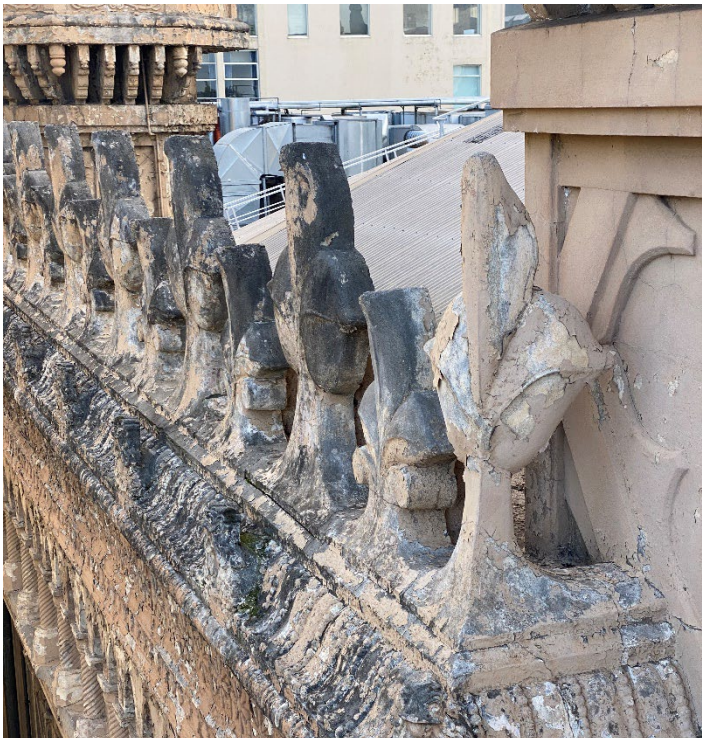
**Figure 9**  
Typical details of the crenulated parapet.

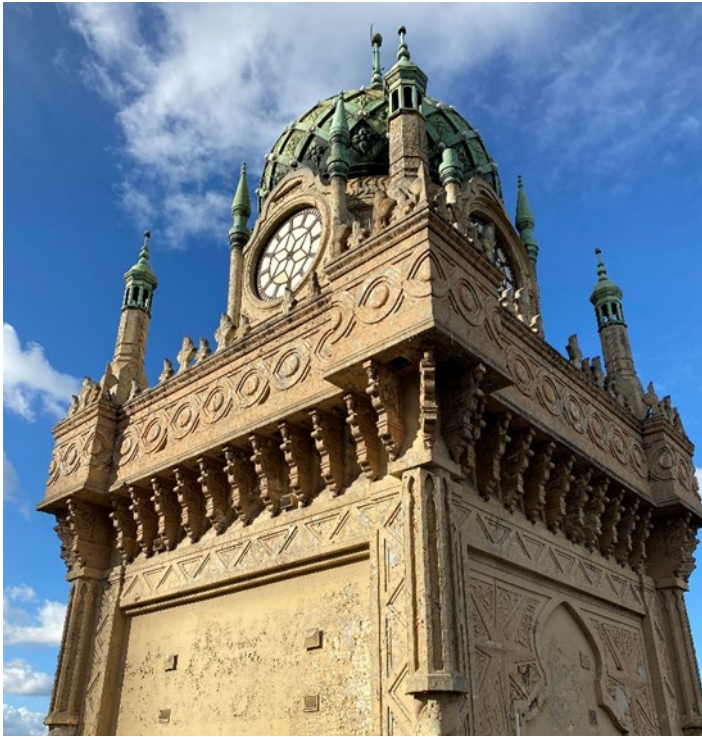
**Figure 11**  
View of the tower from roof.

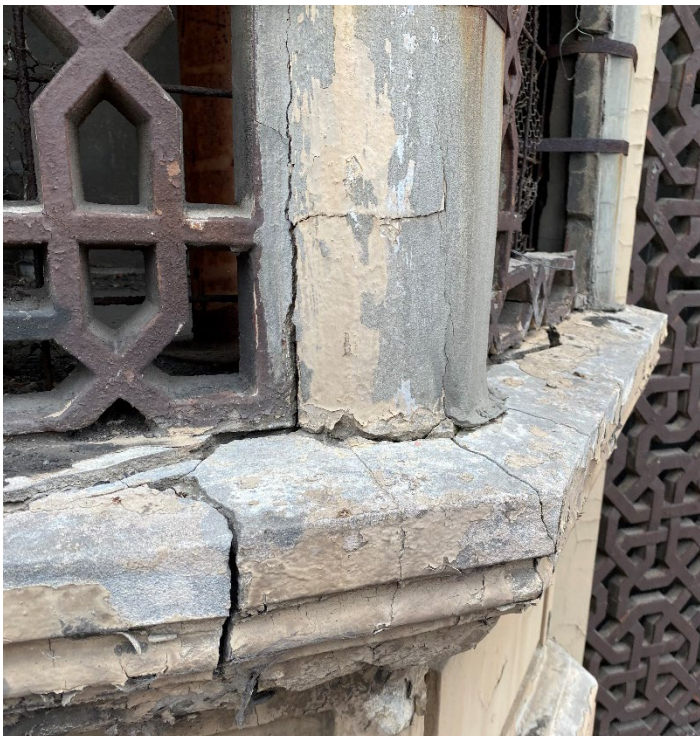
**Figure 17**  
Spalling concrete structure on the canted by balcony.

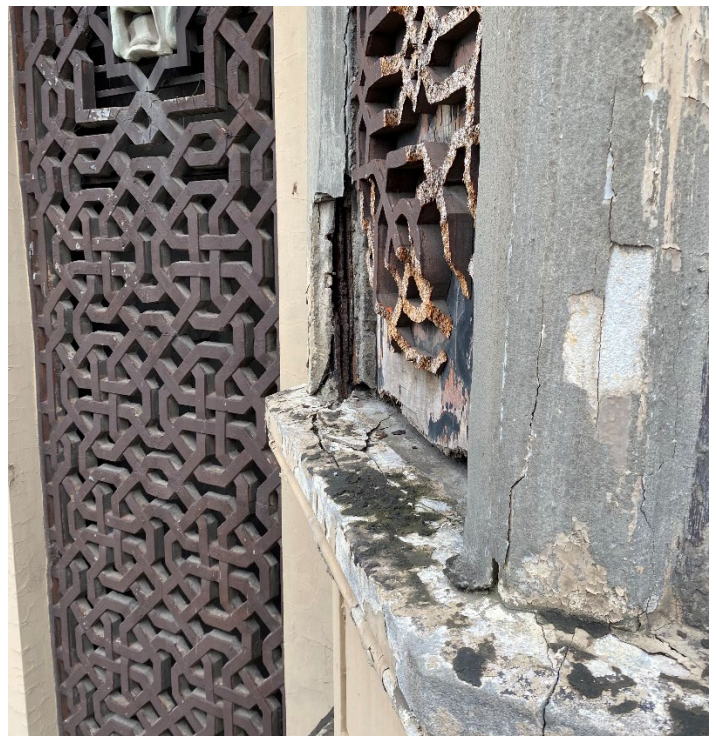
**Figure 18**  
Spalling concrete structure and previous poor repairs on canted bay balcony.

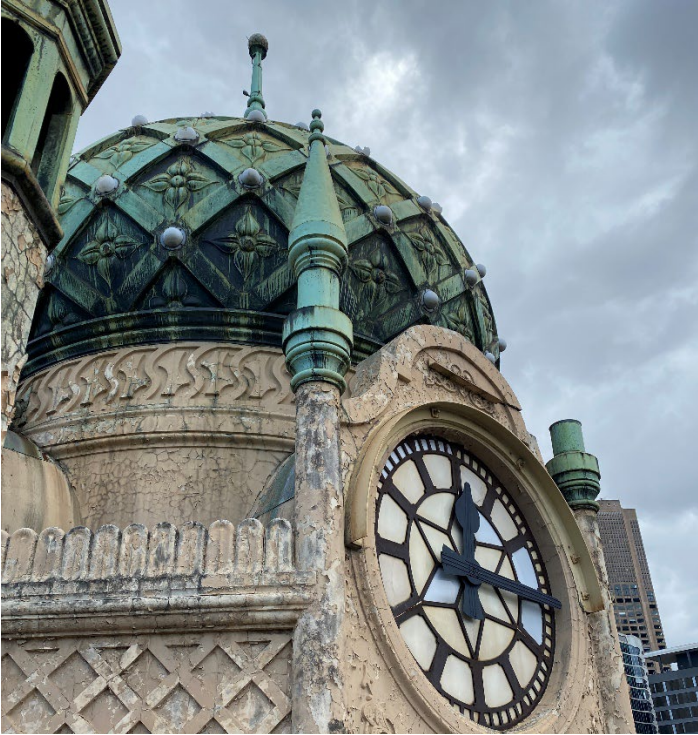
**Figure 19**  
View of the clock tower. Note missing copper turret.

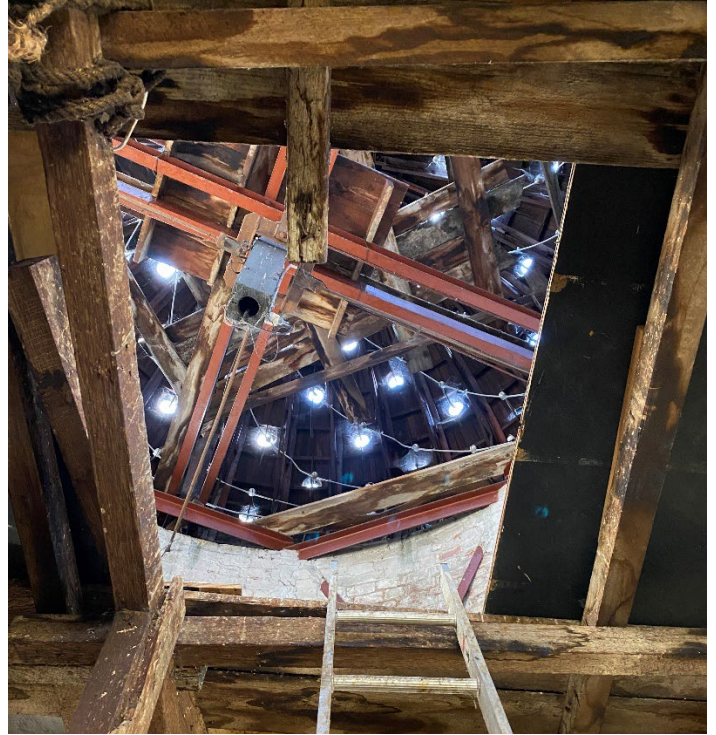
**Figure 20**  
View of the timber onion dome structure.

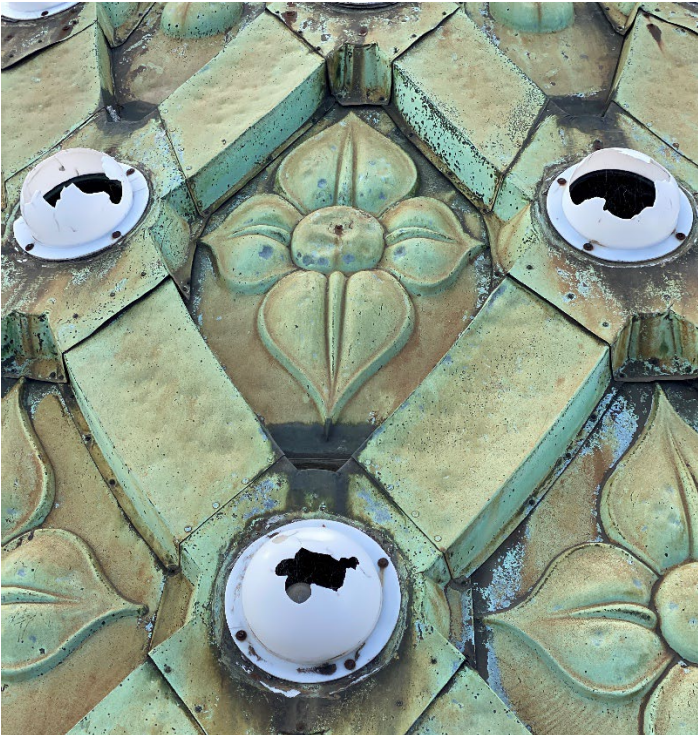
**Figure 21**  
Detail of the onion dome showing broken light fitting covers.

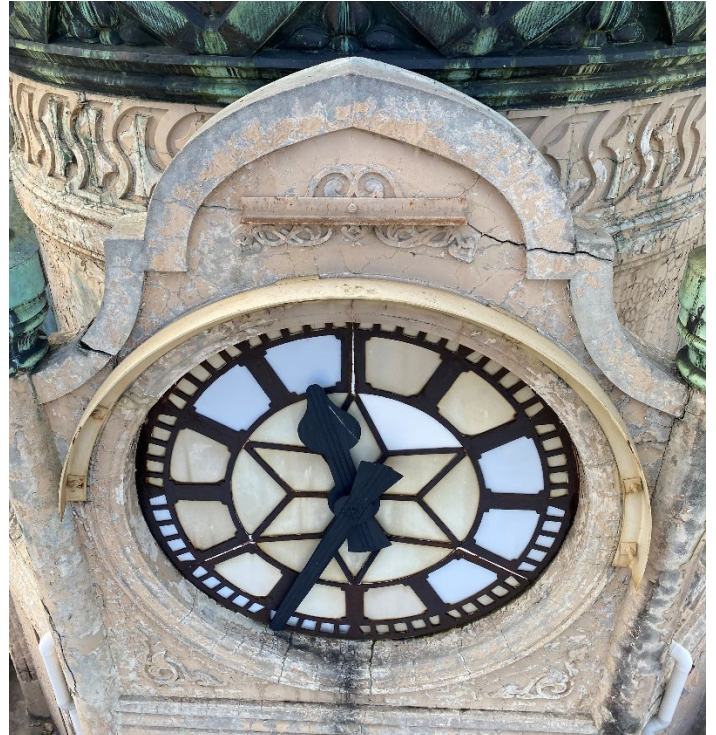
**Figure 22**  
View of clock tower with crack through top of parapet.

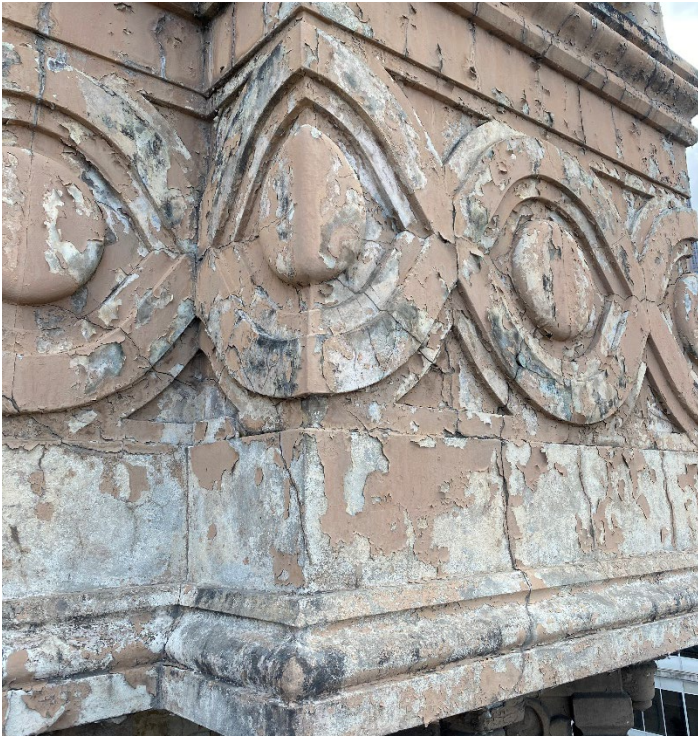
**Figure 23**  
Cracking in the decorative reinforced concrete facing panels of the tower balcony.

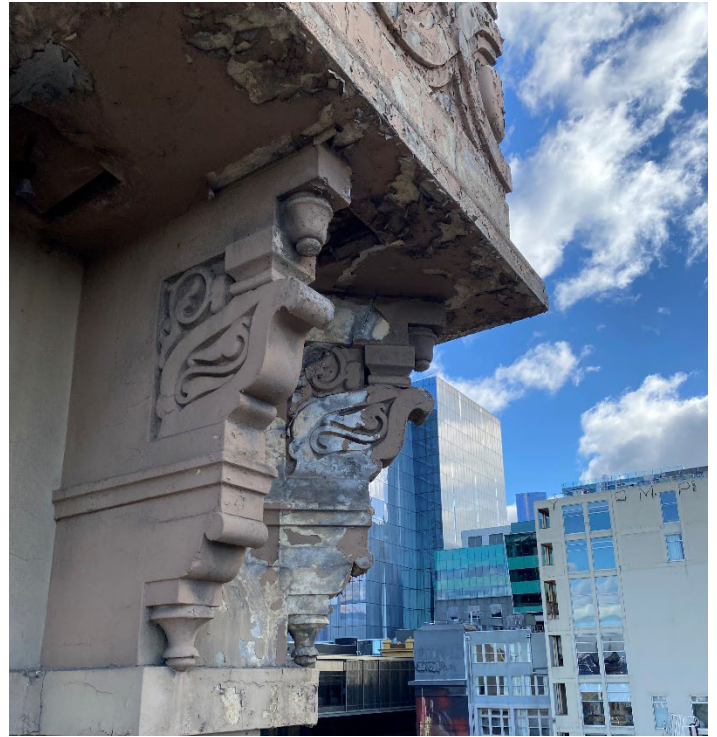
**Figure 24**  
Detail of corbel brackets below tower balcony.

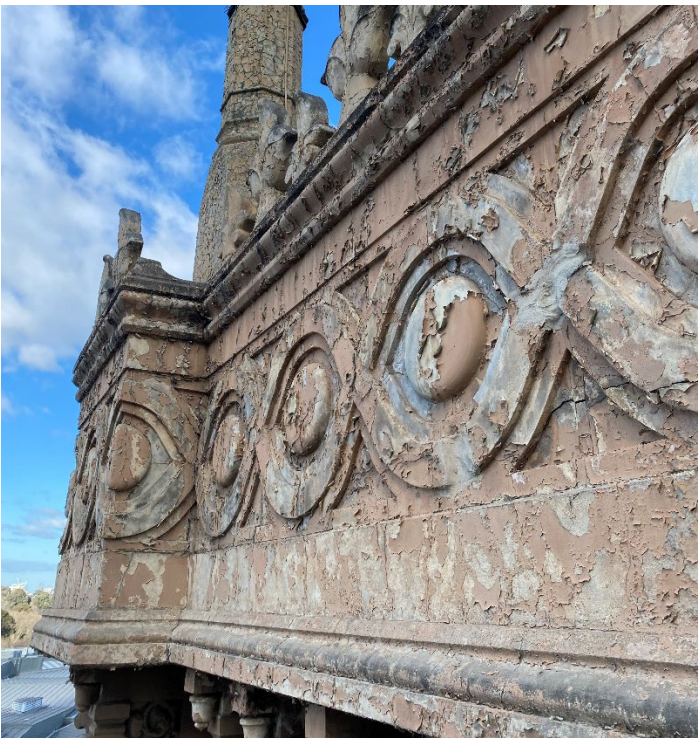
**Figure 23**  
Cracking in the decorative reinforced concrete facing panels of the tower balcony.

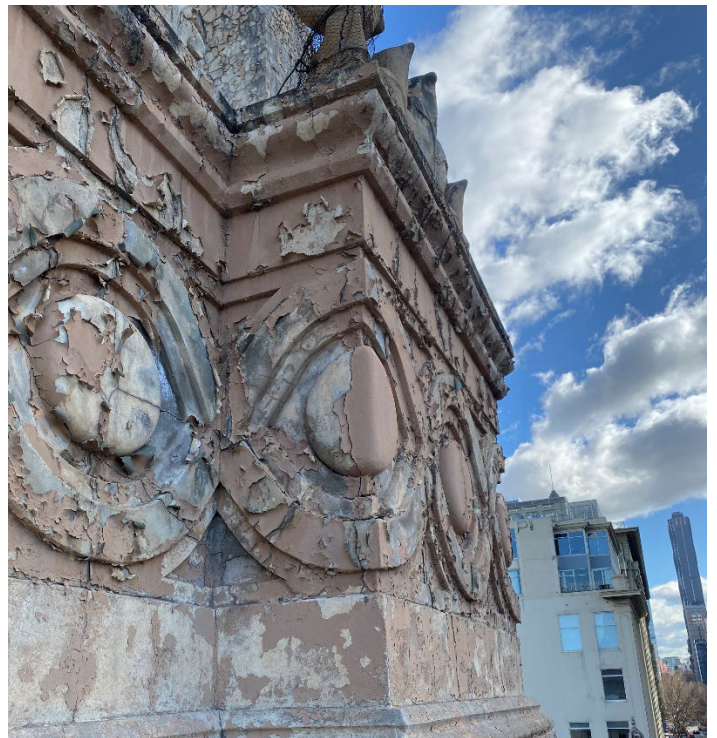
**Figure 24**  
Cracking in the decorative reinforced concrete facing panels of the tower balcony.

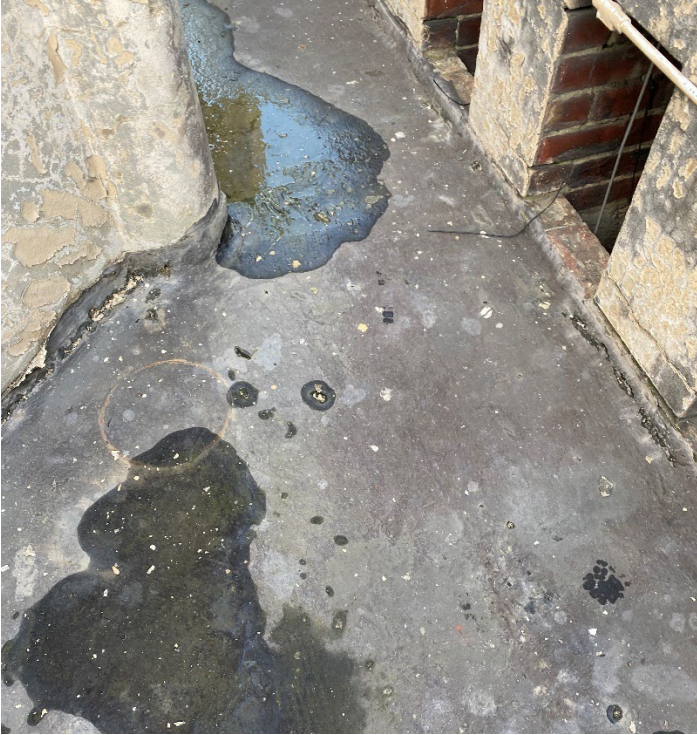
**Figure 25**  
Defective membrane on tower balcony.

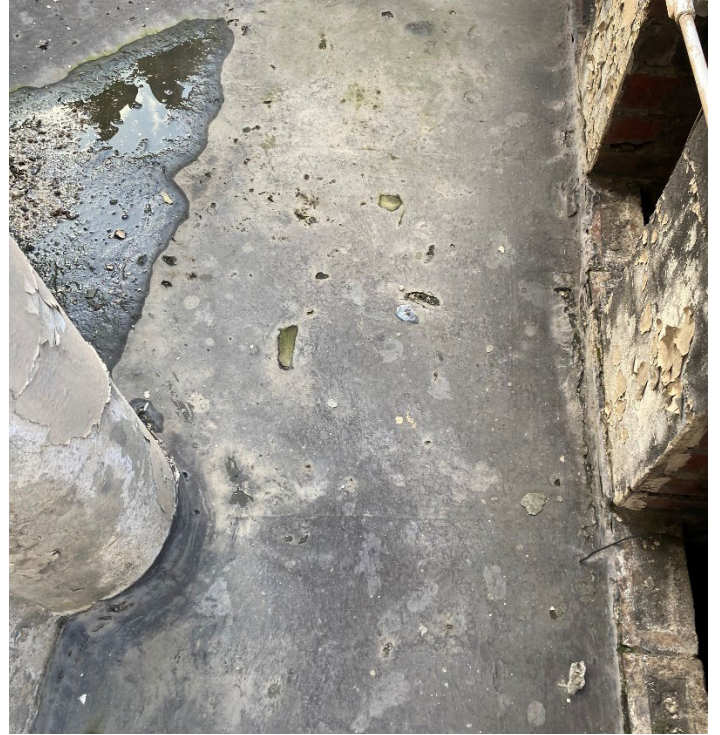
**Figure 26**  
Defective membrane on tower balcony.

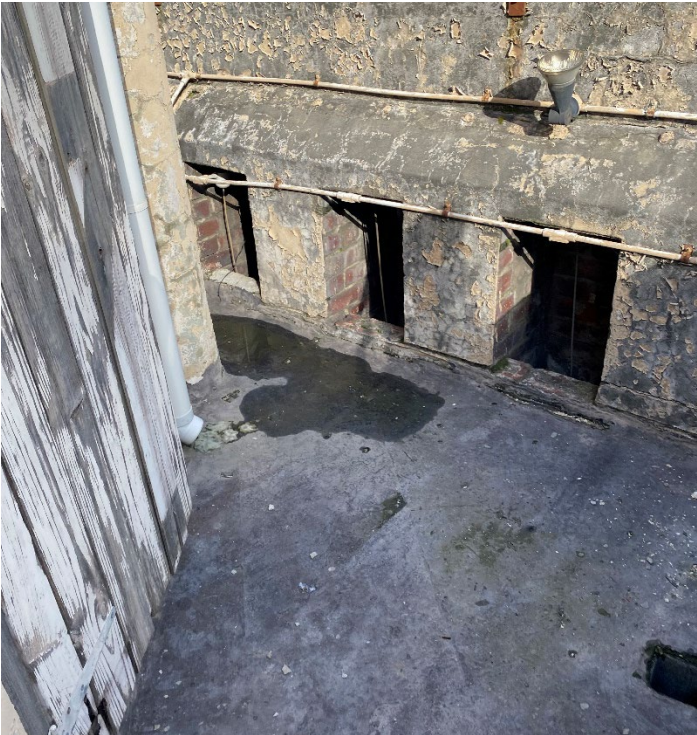
**Figure 27**  
Defective membrane on tower balcony

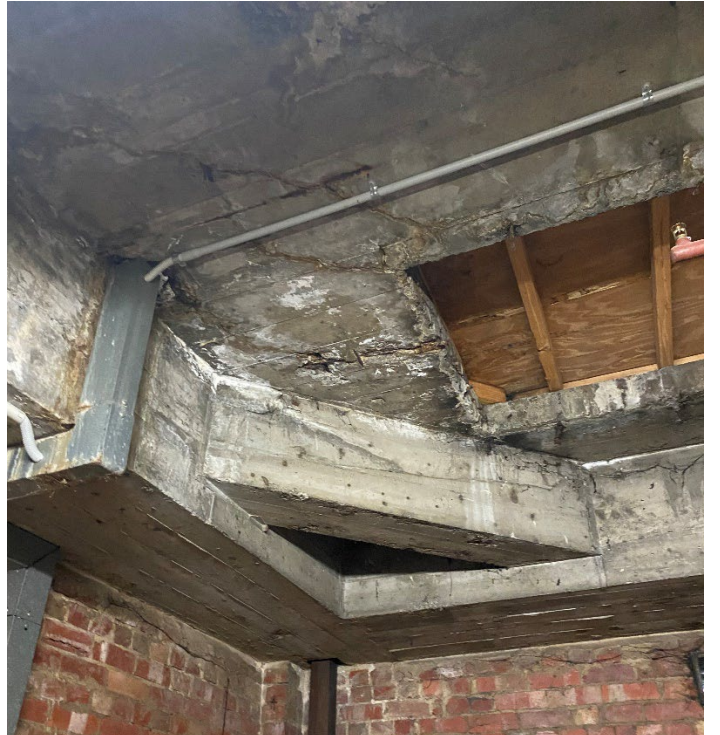
**Figure 28**  
Salt affected concrete slab of the tower balcony

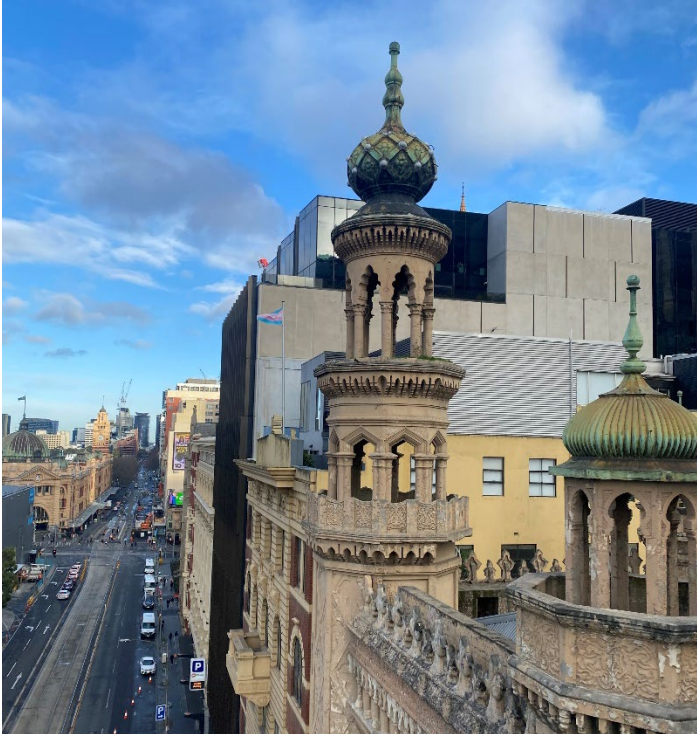
**Figure 29**  
View of south west corner minaret.

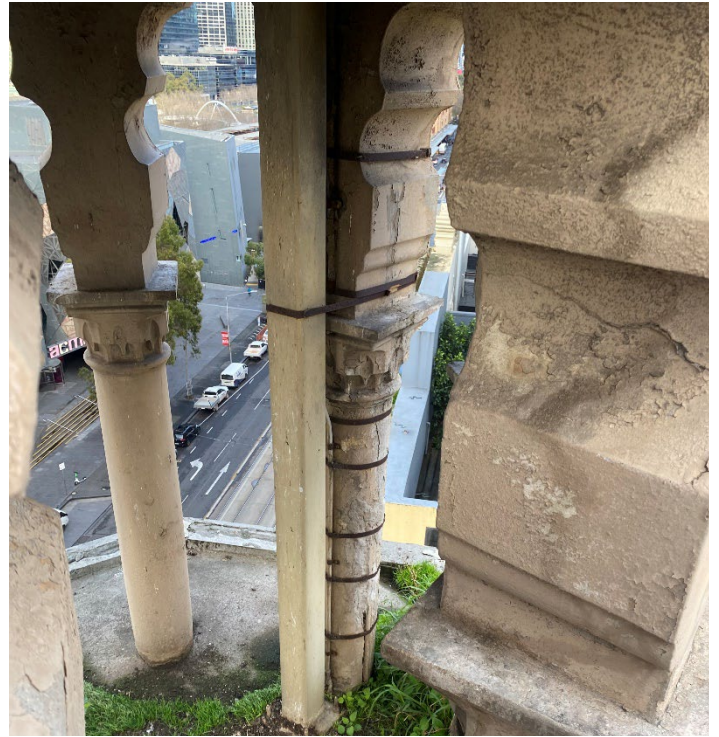
**Figure 34**  
Typical 1980s repair of minaret columns with past and strapping.

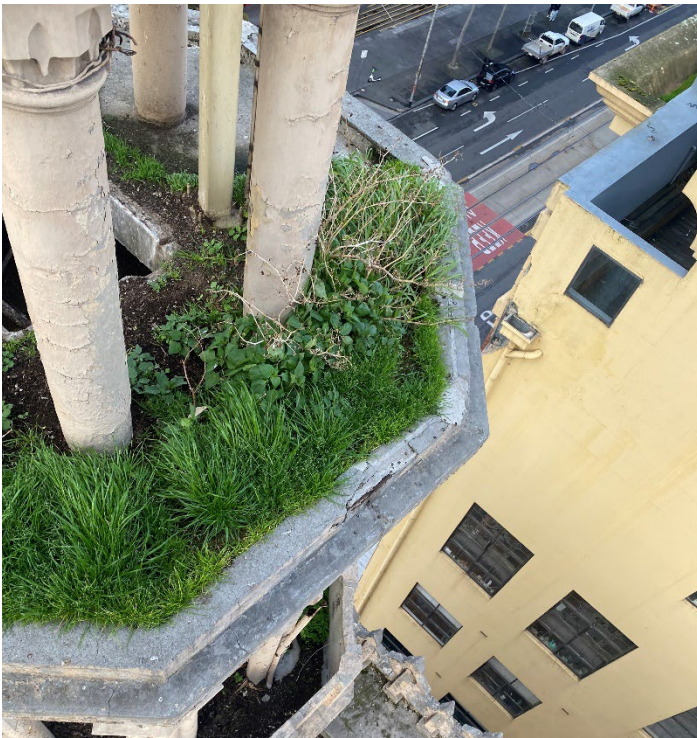
**Figure 35**  
Organic growth and vegetation on western minaret. Note balustrade is missing.

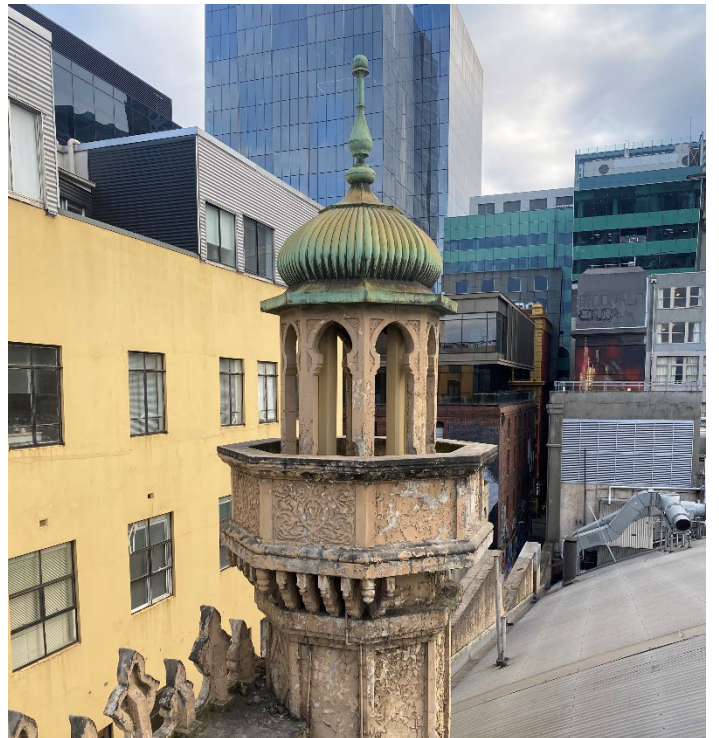
**Figure 36**  
View of minaret on west elevation.

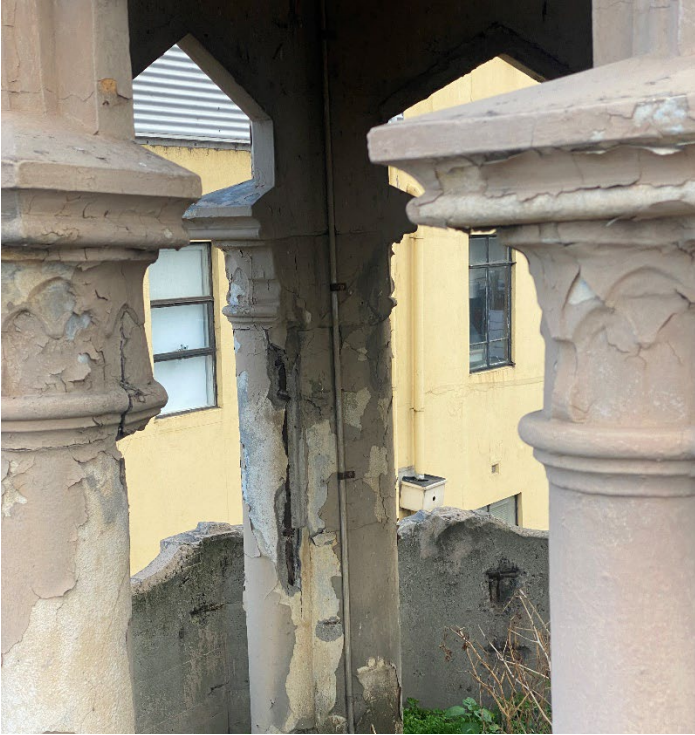
**Figure 37**  
Spalling concrete post in minaret.

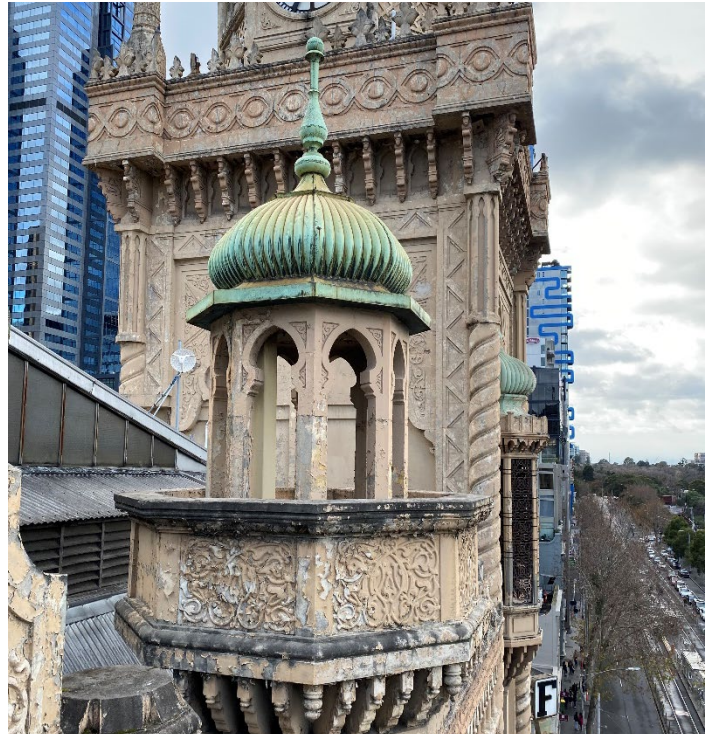
**Figure 38**  
View of minaret on south elevation

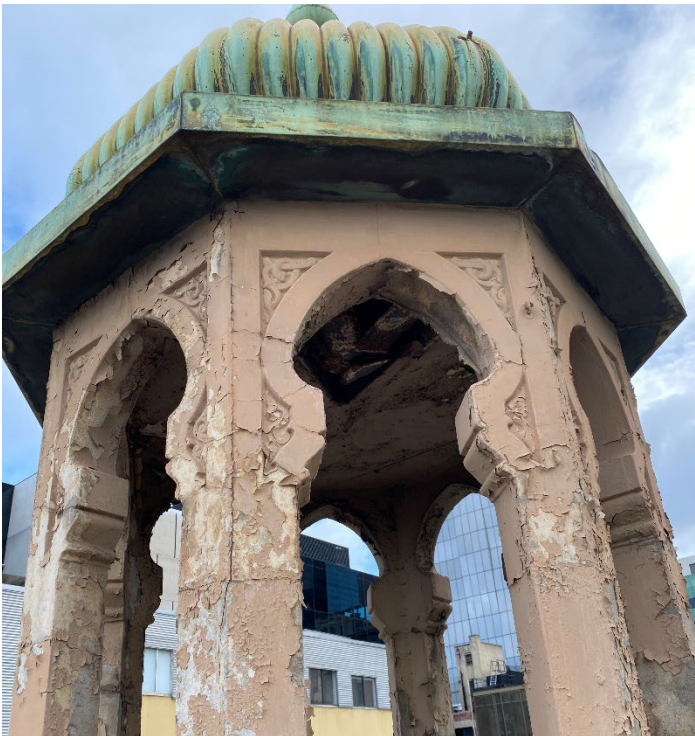
**Figure 39**  
Corded and spalling ceiling to minaret on south elevations. Joints in concrete beginning to open.

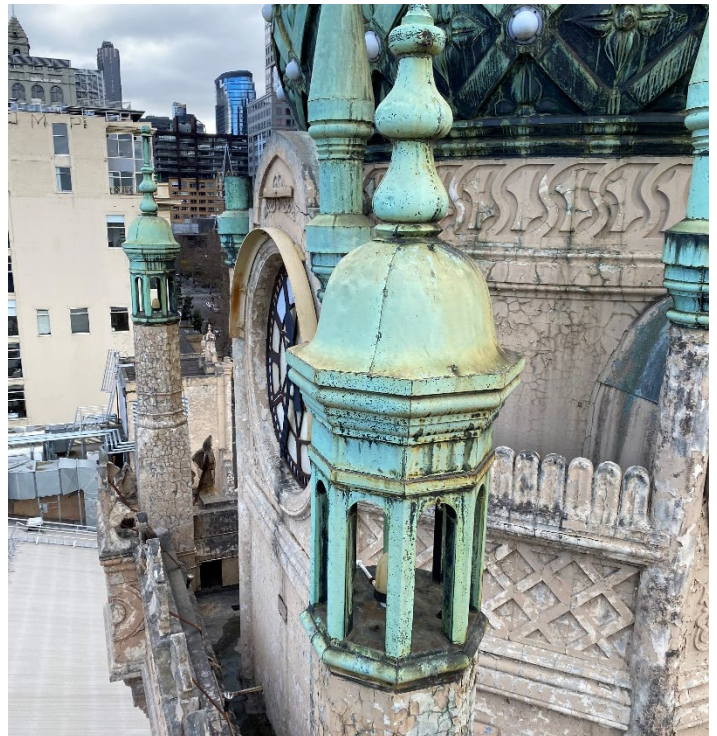
**Figure 40**  
Clock minarets with copper lanterns. Note existing light present.

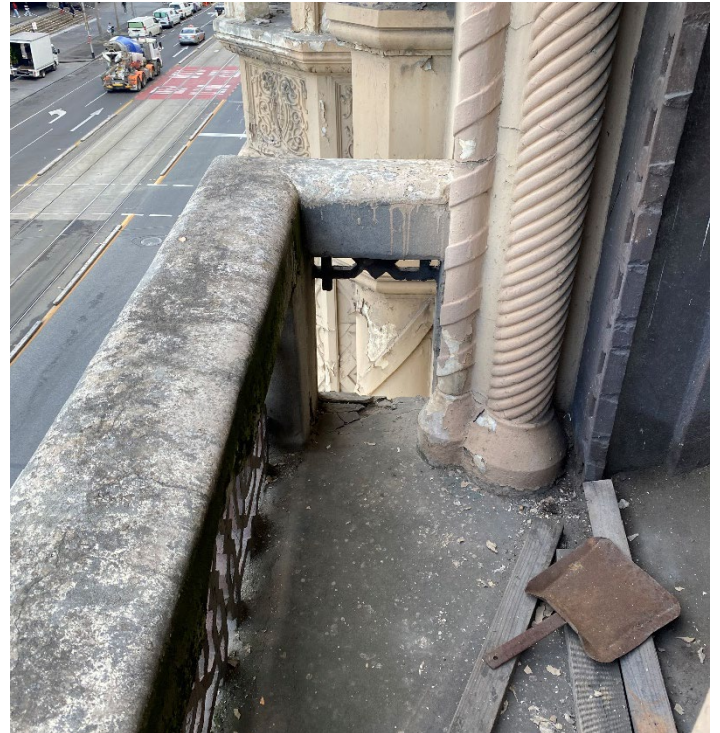
**Figure 41**  
View of south elevation balcony with missing balustrade in end panel.

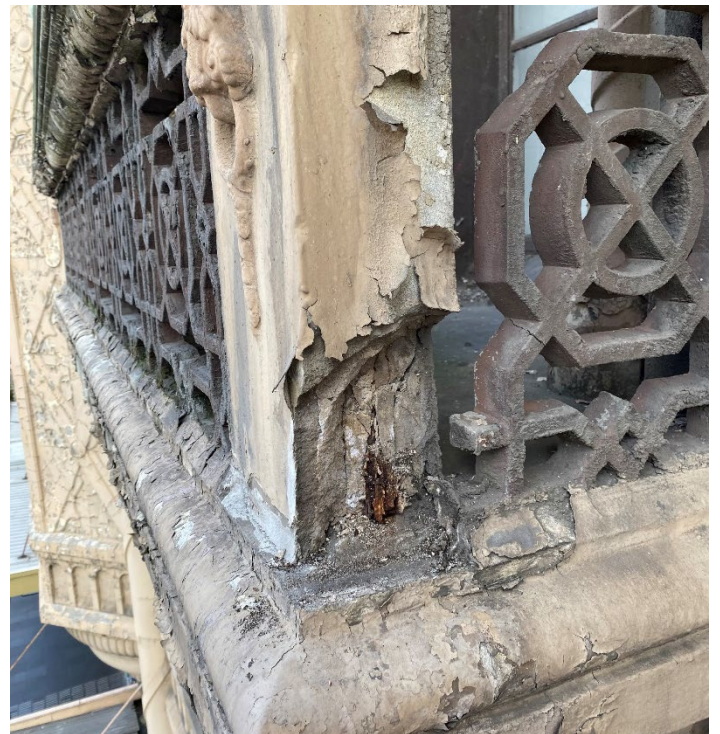
**Figure 42**  
Spalling corner of the balcony balustrade piers.

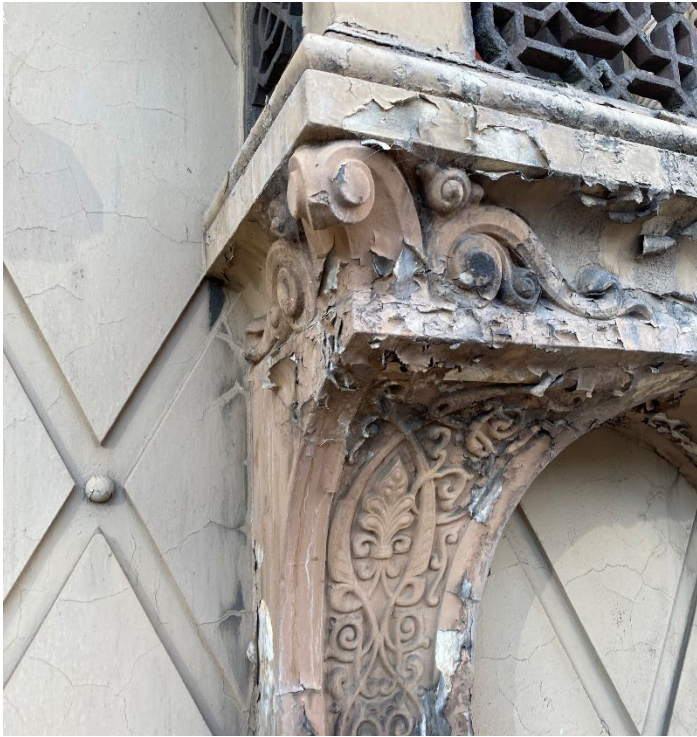
**Figure 43**  
Cast cement groin vaulted brackets that support the balconies.

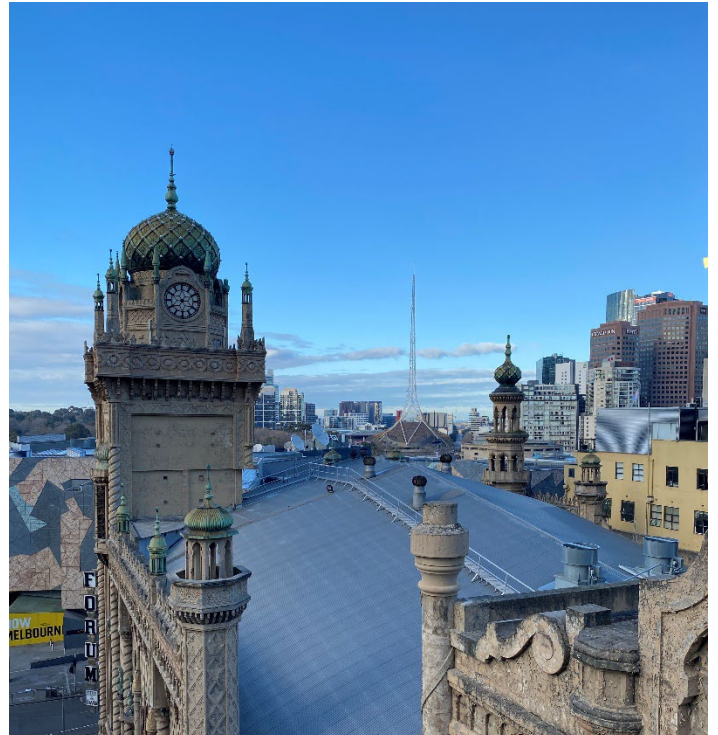
**Figure 49**  
View of the expanse of the main roof.

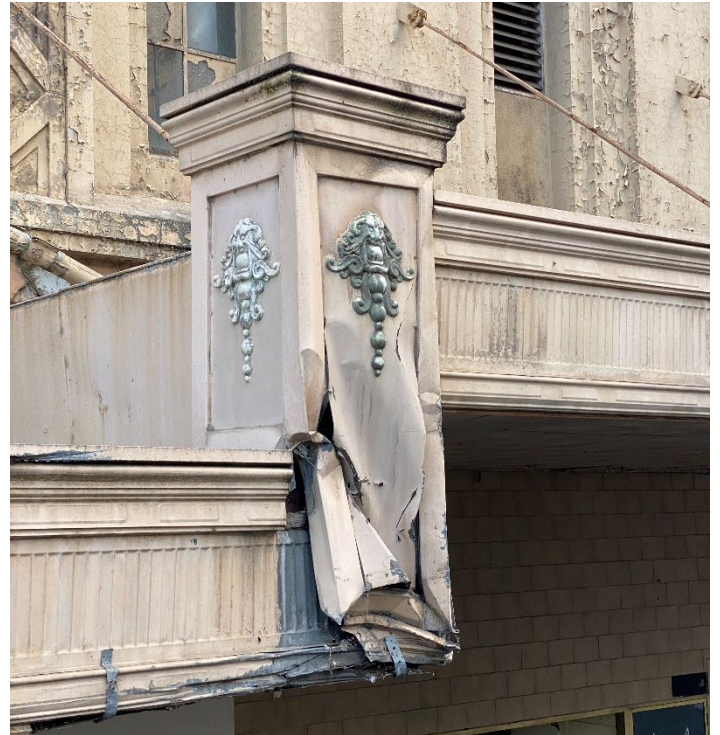
**Figure 51**  
Impact damage to the canopy on Russell Street.

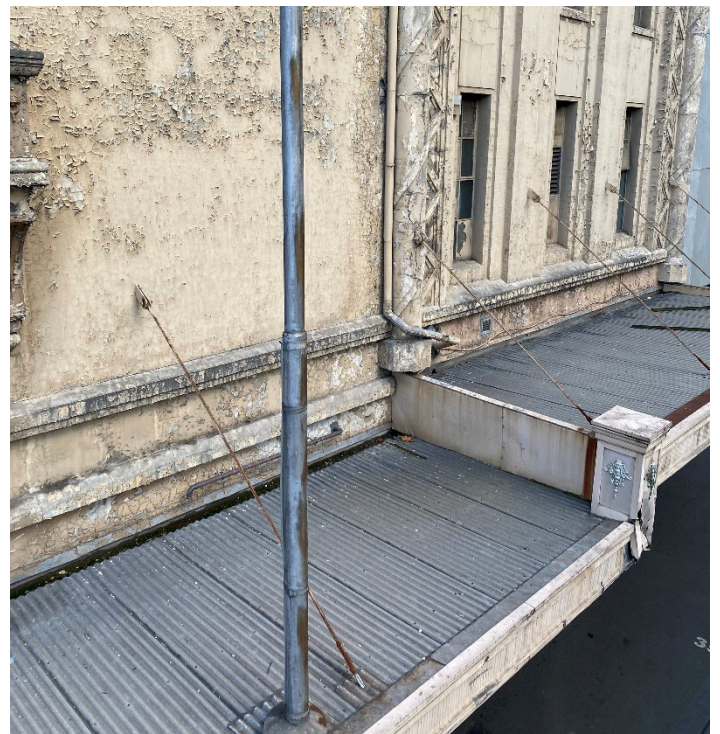
**Figure 52**  
View of the general canopy arrangement showing the suspension rods.

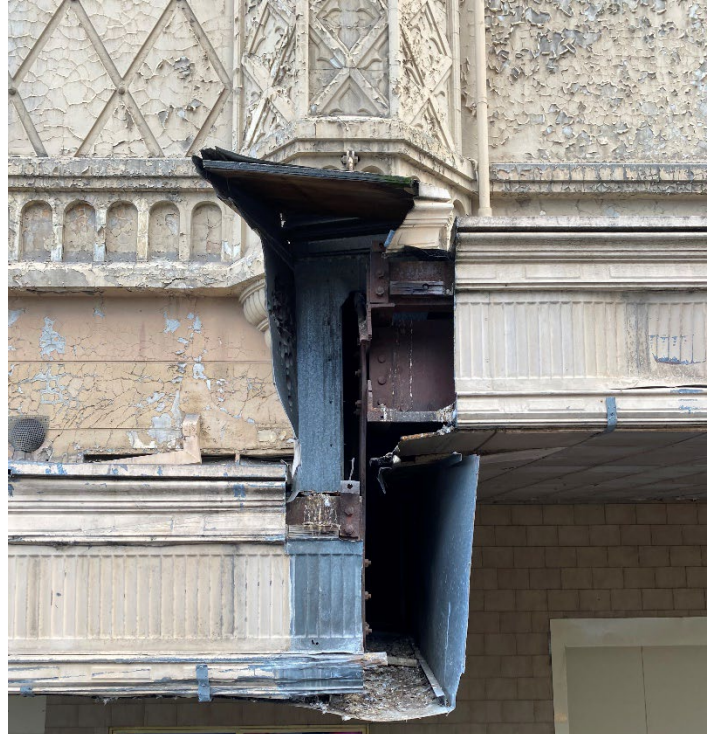
**Figure 54**  
Section of missing and damaged canopy cladding showing the steel structure within.

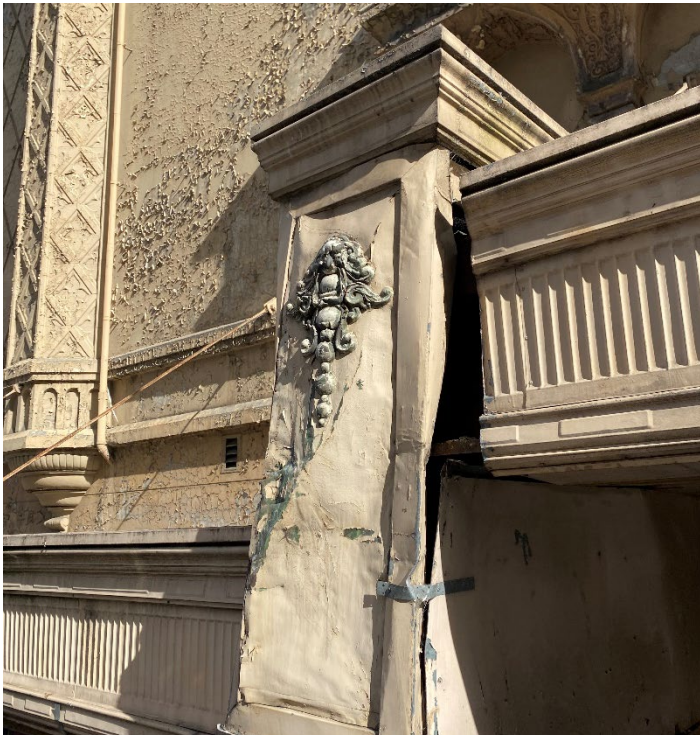
**Figure 55**  
Impact damage to the canopy on Russell Street.

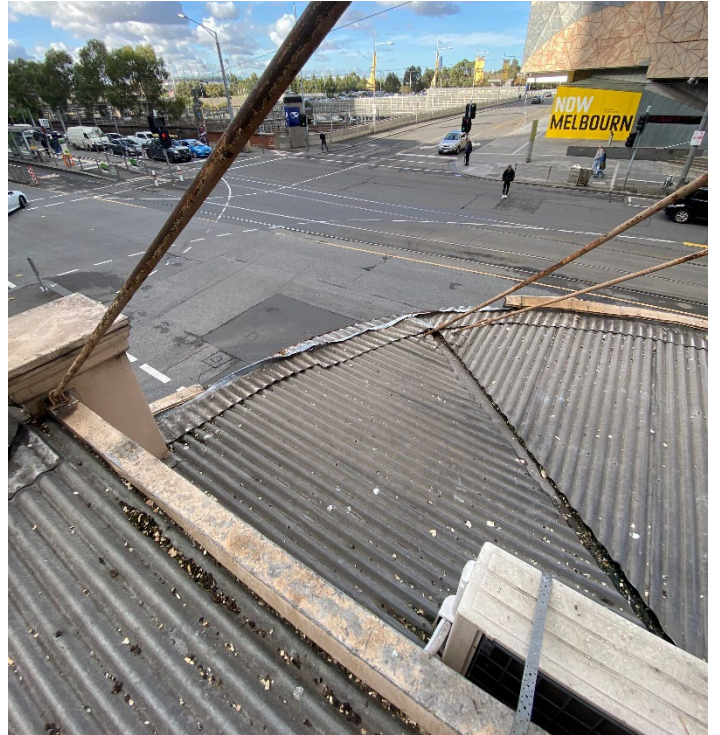
**Figure 56**  
Canopy at the street corner missing the capping and outer mouldings.
