Existing Conditions Report – Structural

342-348 Victoria St, Brunswick Fire Tunnel

Job Reference: 233211

Prepared for: Armitage Jones

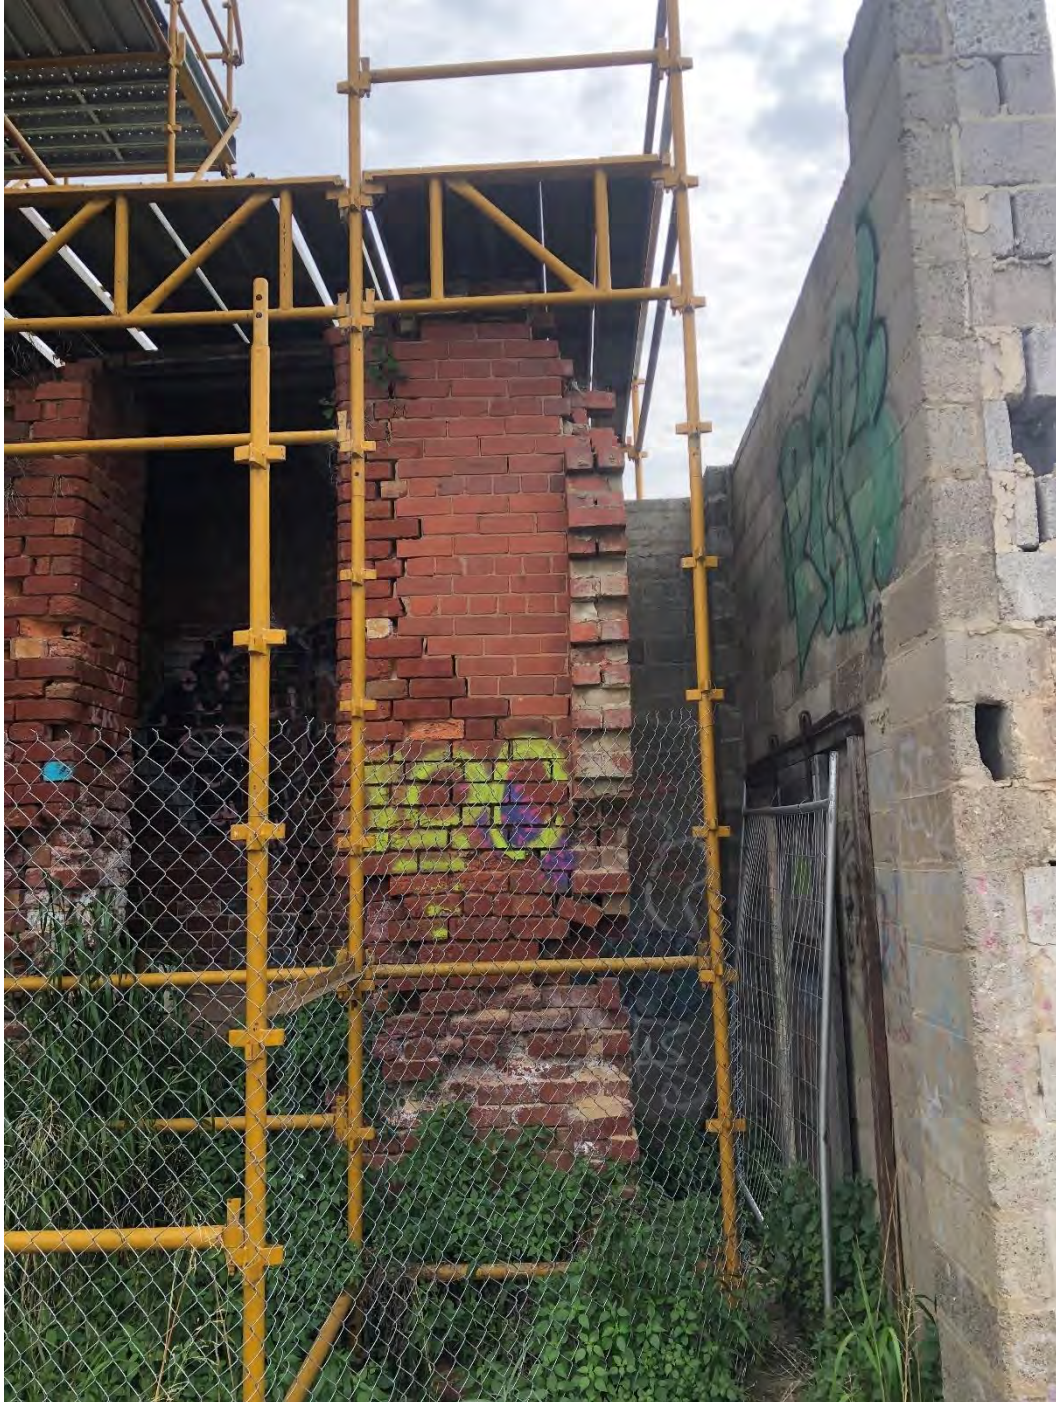
Image 1 – Existing Southern Nib with more recent brick infill

- In a number of locations, the original bricks had been removed and walls partially altered over time. It would be our recommendation that all areas of missing, loose or displaced bricks and mortar is rebuilt in accordance with Lovell Chen's requirements and scope.

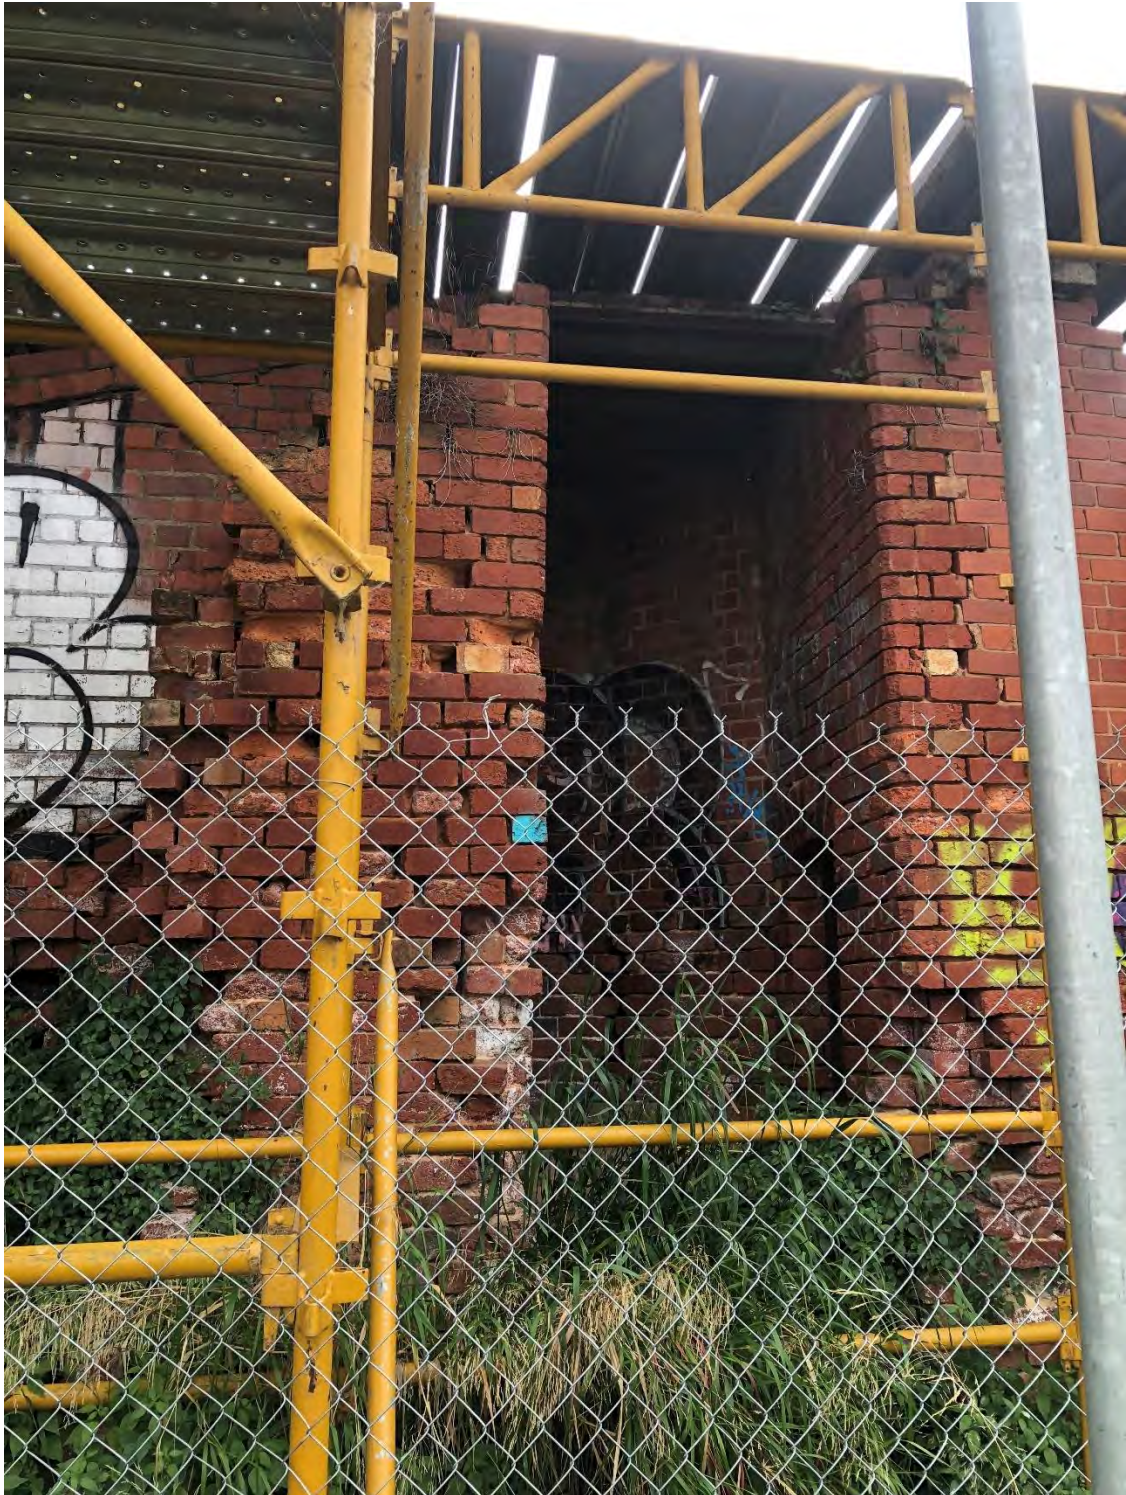
Image 2 – Existing Southern Walls showing previous alterations.

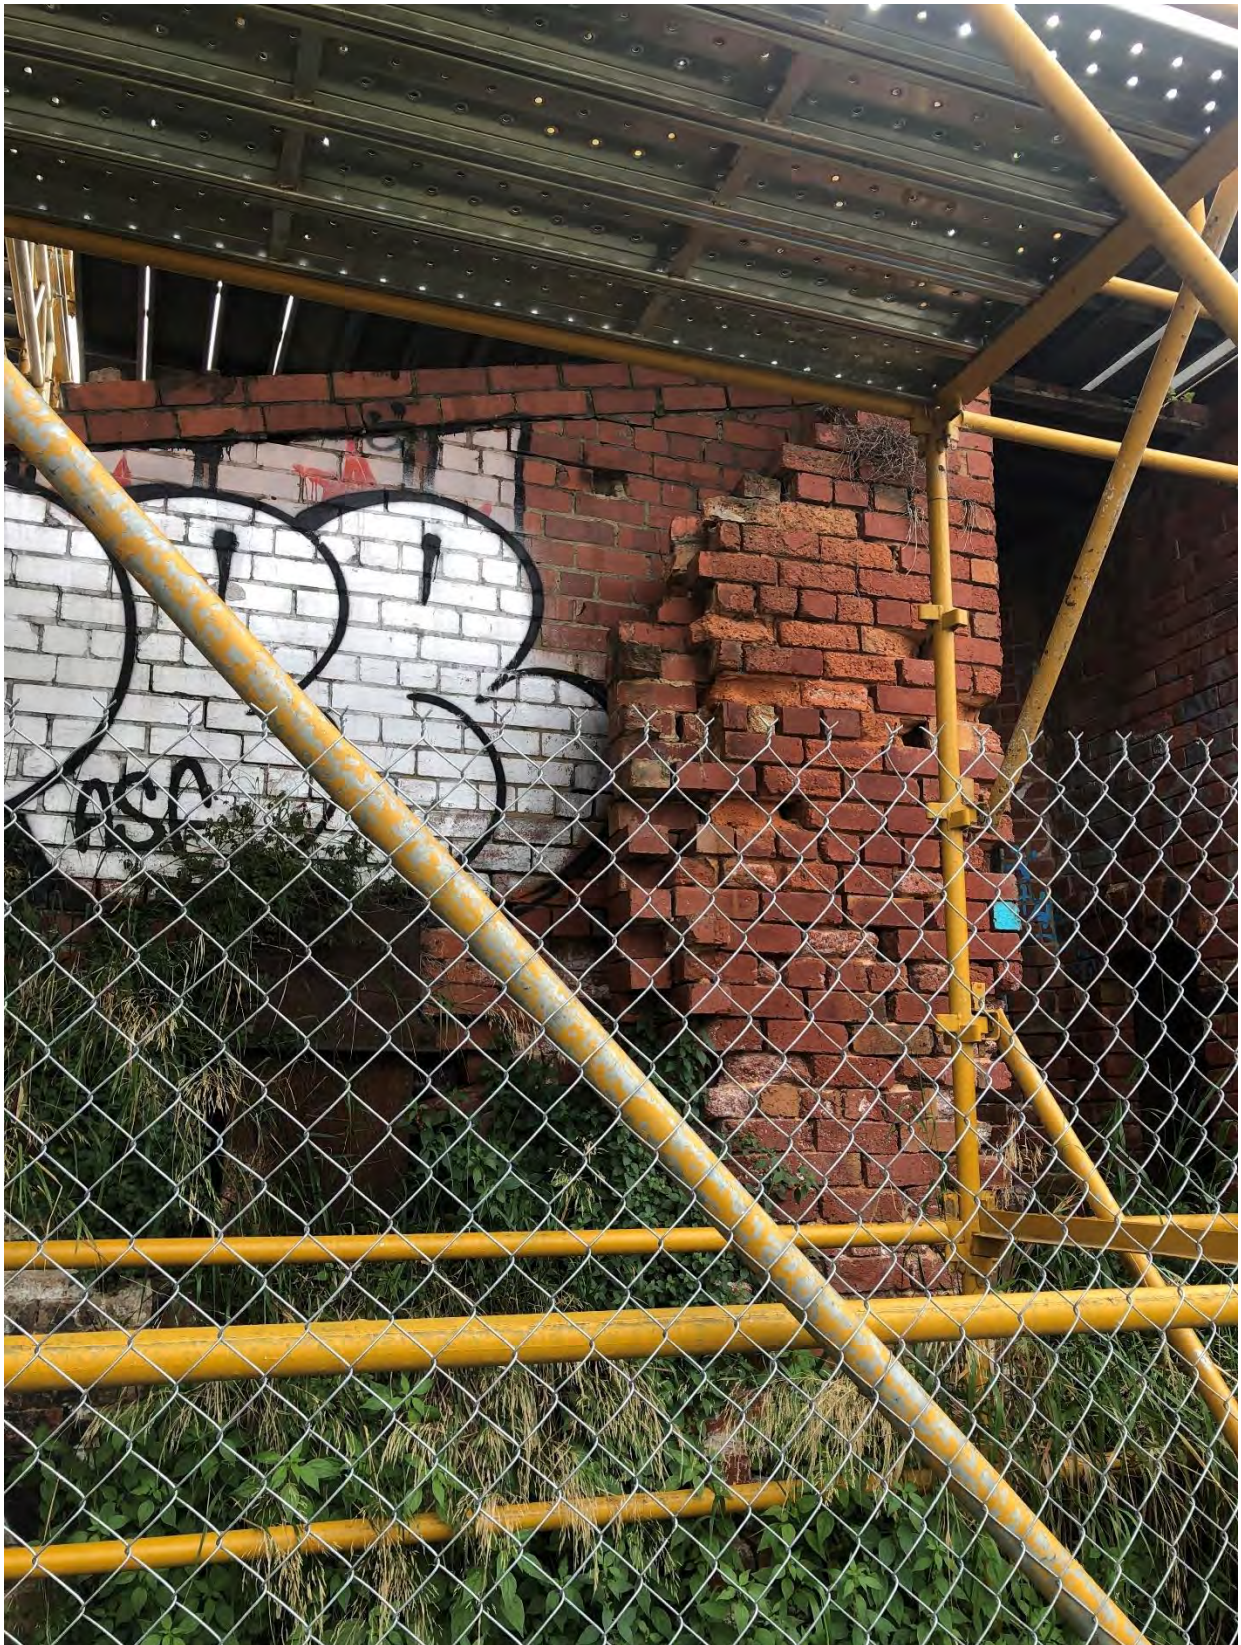
Image 3 – Existing Southern Wall

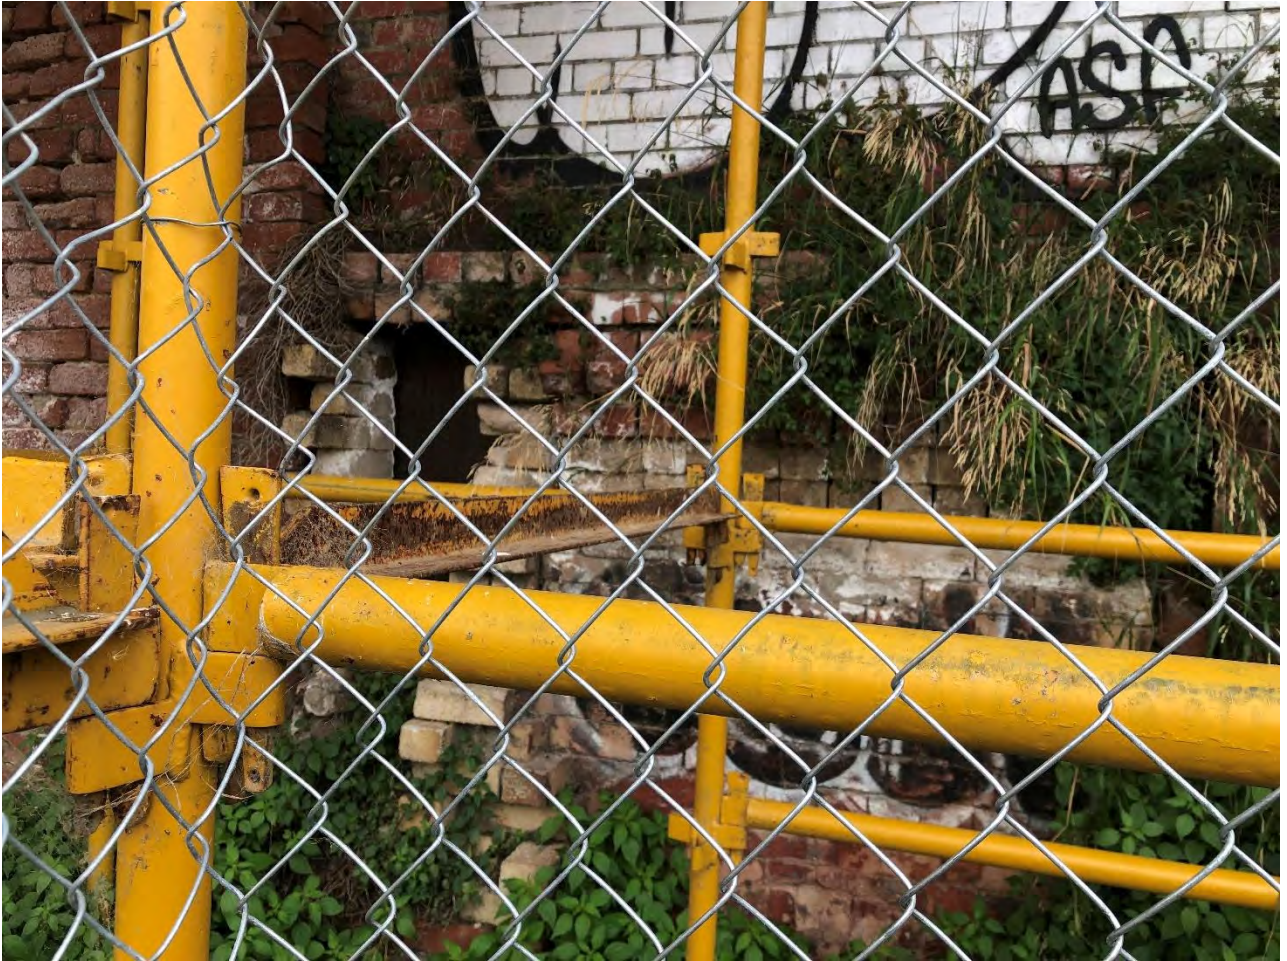
Image 4 – Existing Southern Wall opening

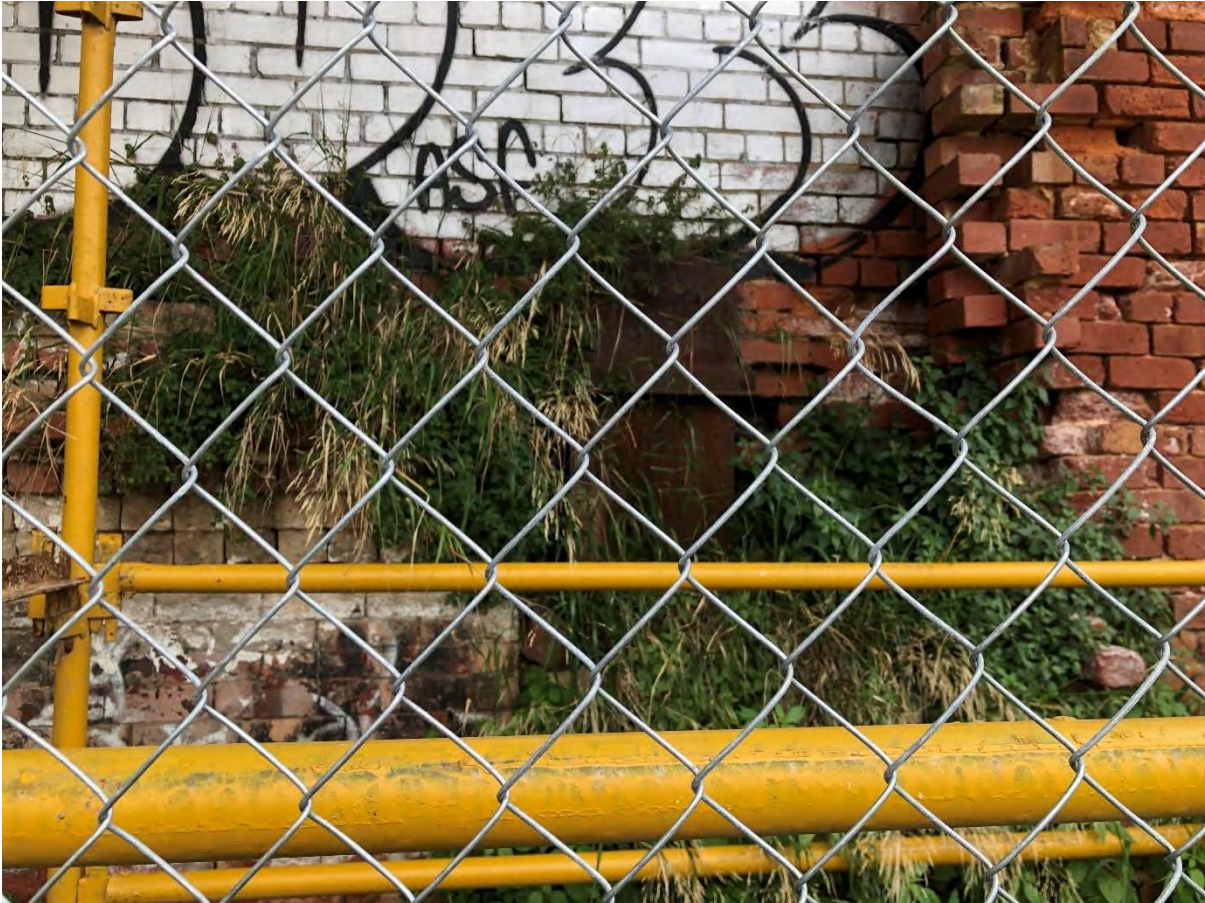
Image 5 – Existing Southern Wall

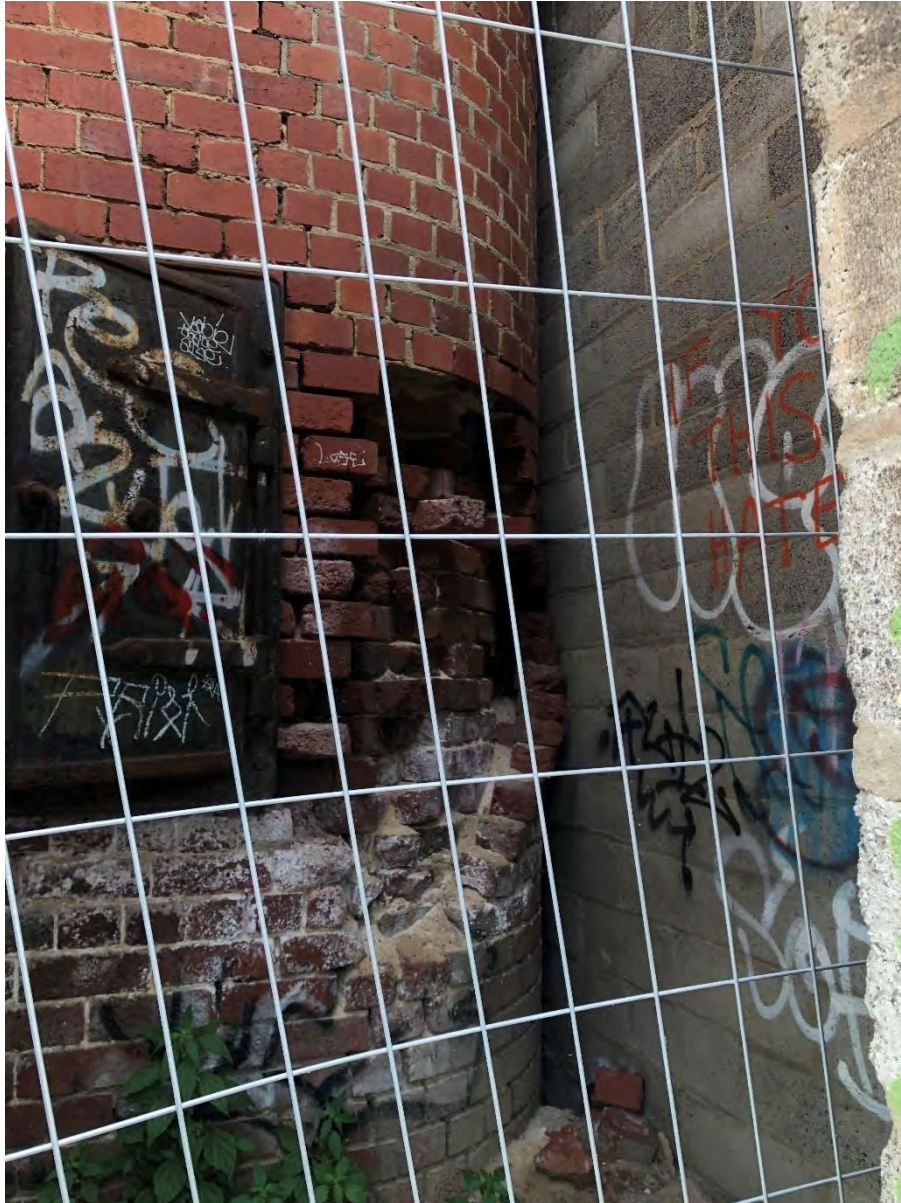
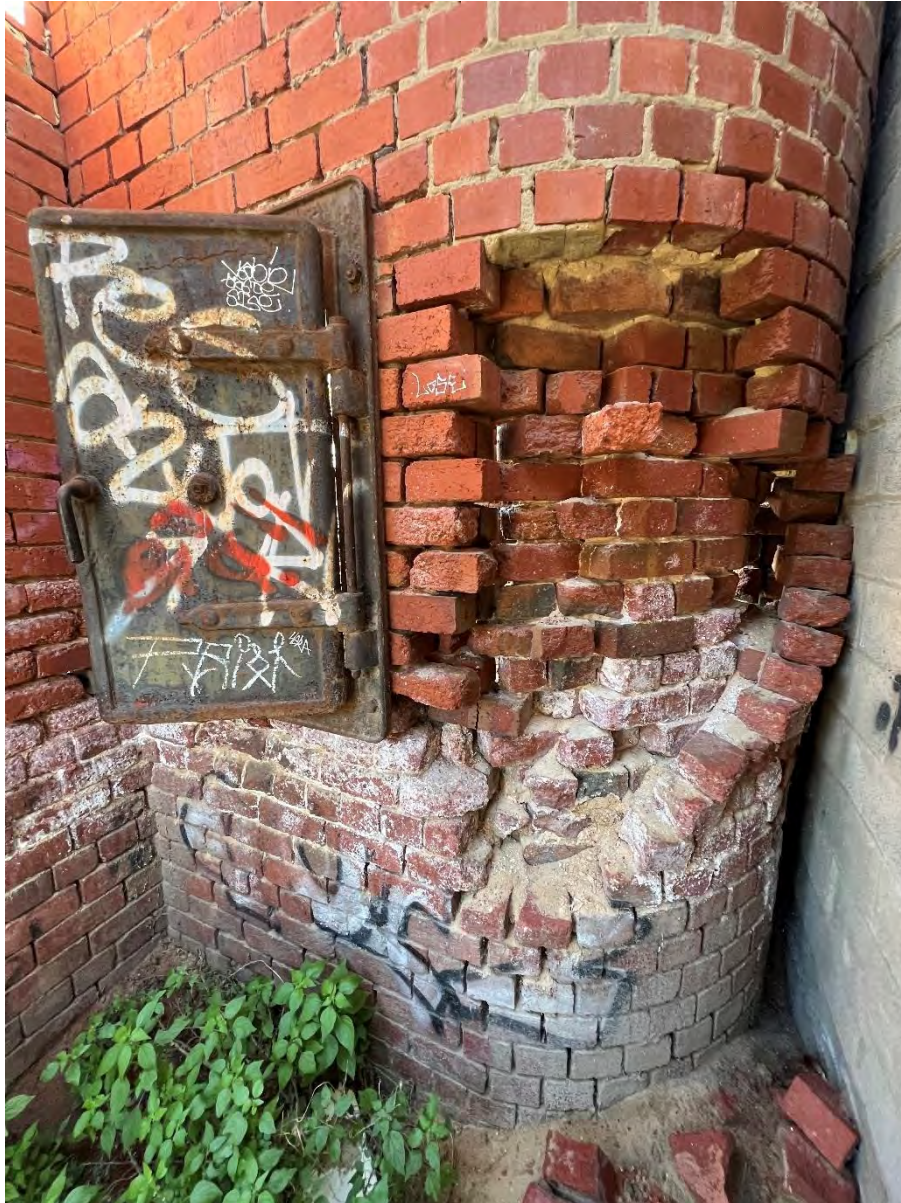
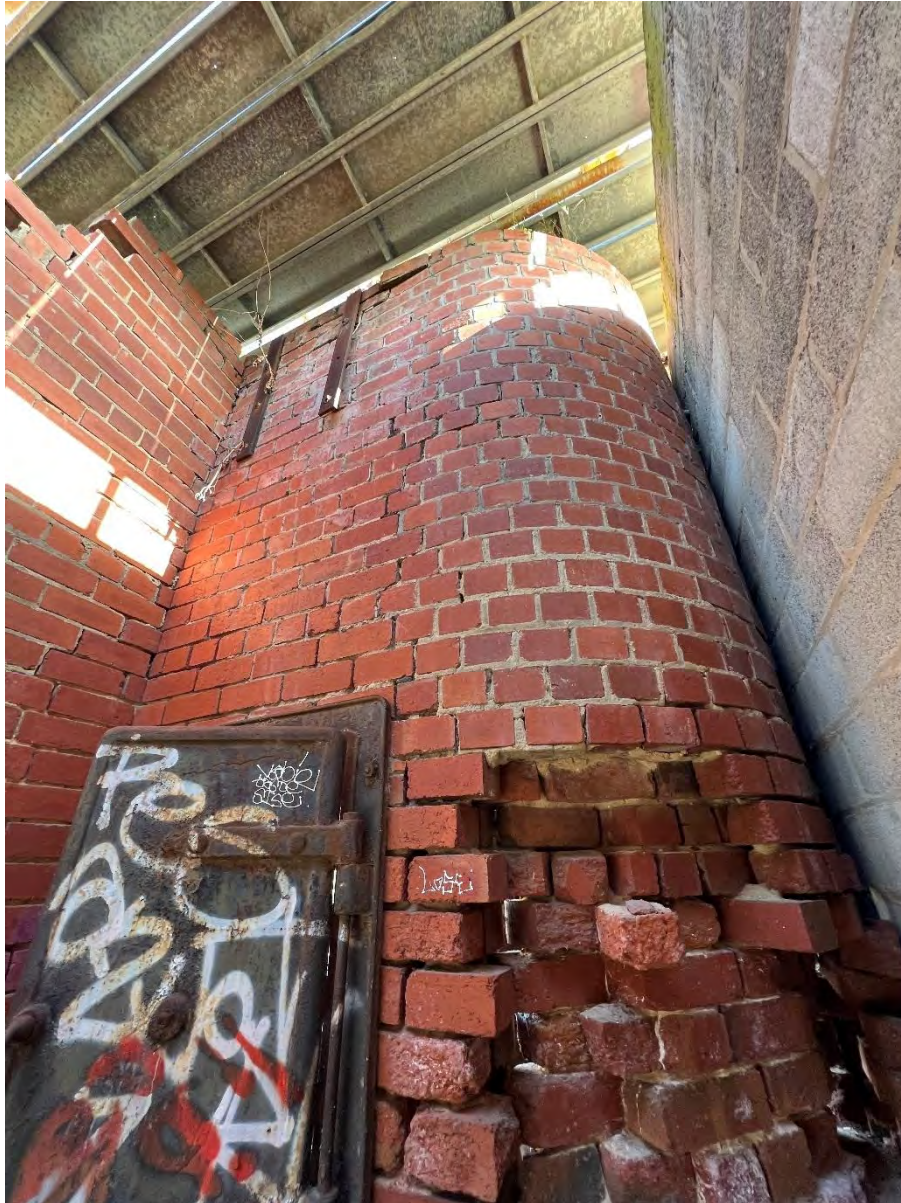
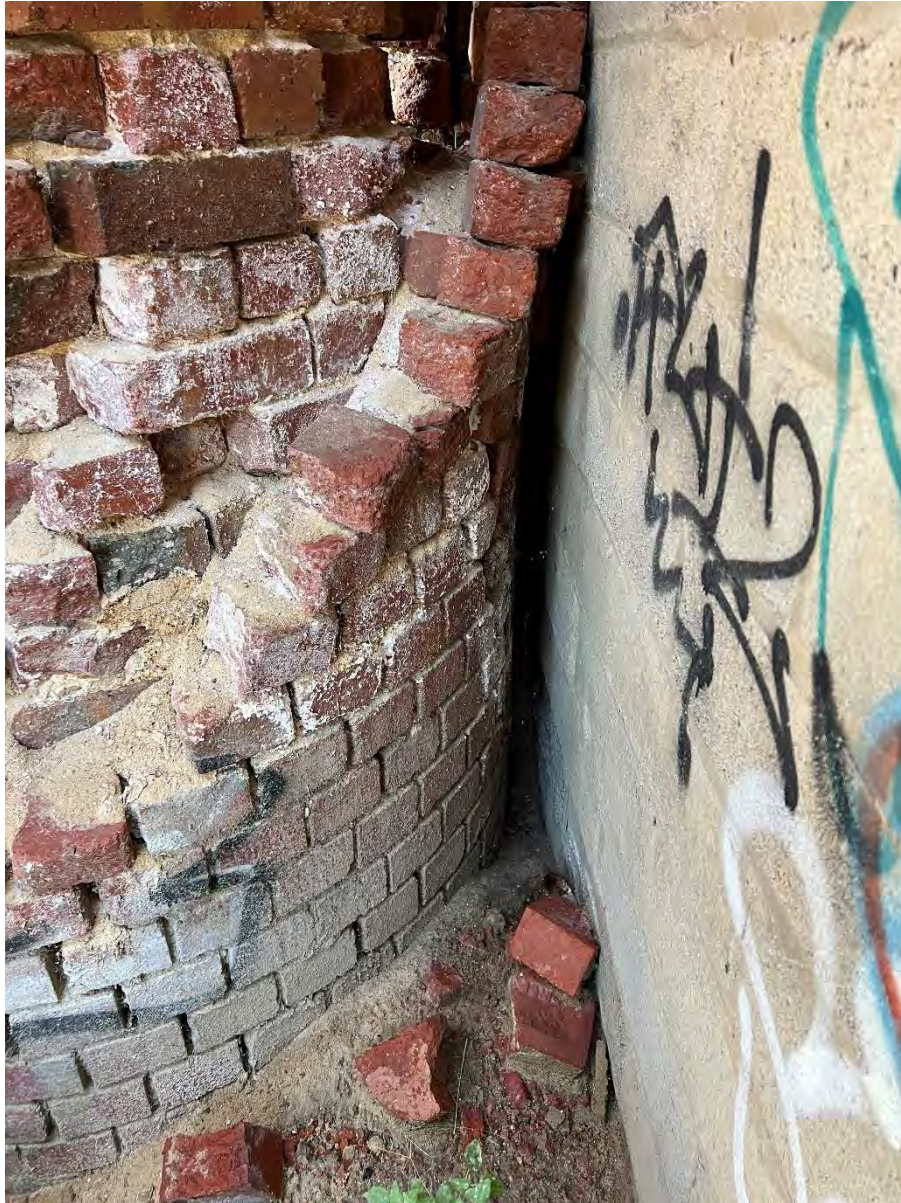
In the Northeast corner, in the curved section of the wall it was observed that the wall appeared to have a local bulge to the north and the outer skin of brick has displaced and collapsed outwards. It is not clear the likely cause of the localised failure of the curved wall as the complete loss of a localised section of the curved wall is not consistent with a failure caused by ground movements and footing settlements. Newer mortar was observed in the wall above the damaged wall which may suggest previous remedial works may have been undertaken to rectify historical damage.

Image 6 – Existing NE Corner Wall damage

Image 7 – Existing NE Corner Wall damage

Image 8 – Existing NE Corner Wall damage

Image 9 – Existing NE Corner Wall damage

- Further investigations and footing exposures would be recommended to understand the existing foundation conditions. In particular, the Northeast corner where potential ground movements and footing settlement may have contributed to the deviation of the existing walls measured in the survey.

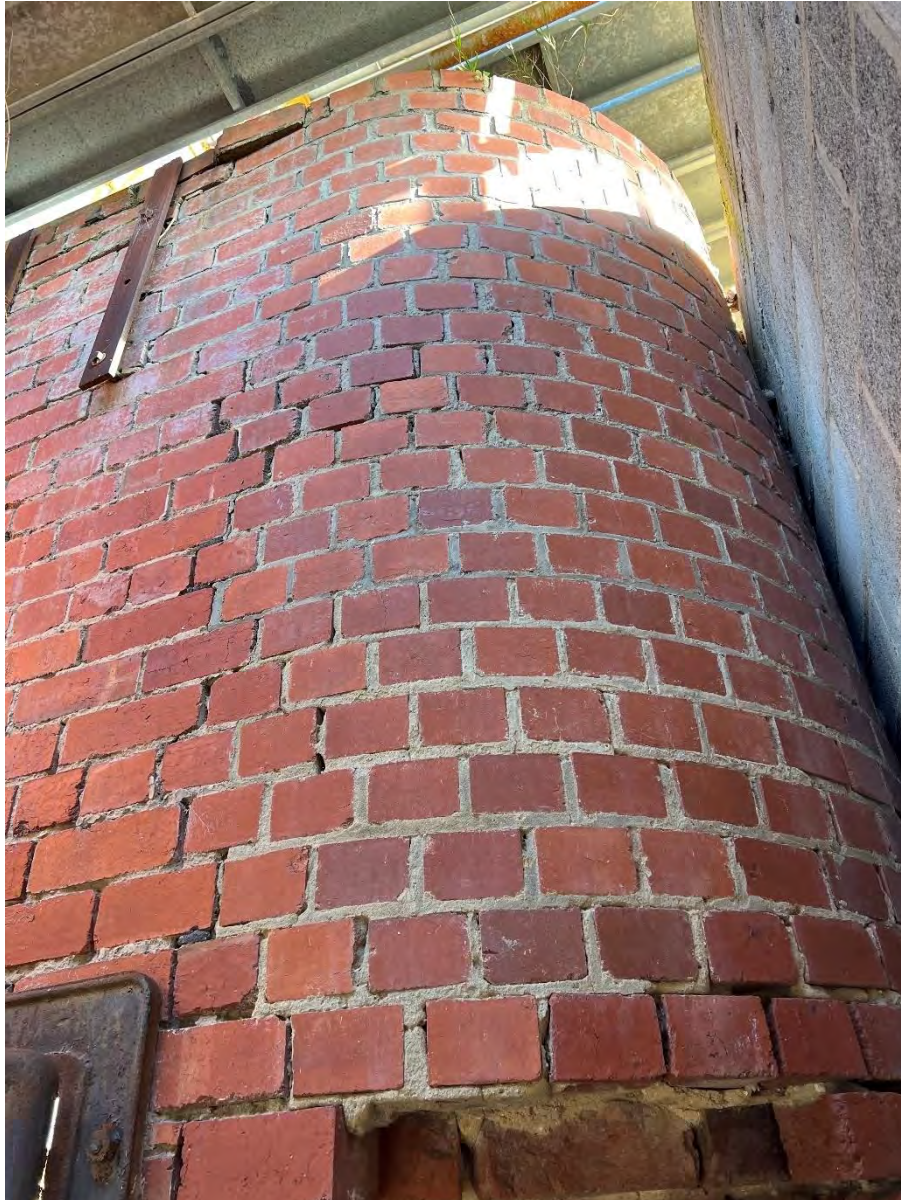
Image 10 – Existing NE Corner Wall with evidence of newer mortar repairs

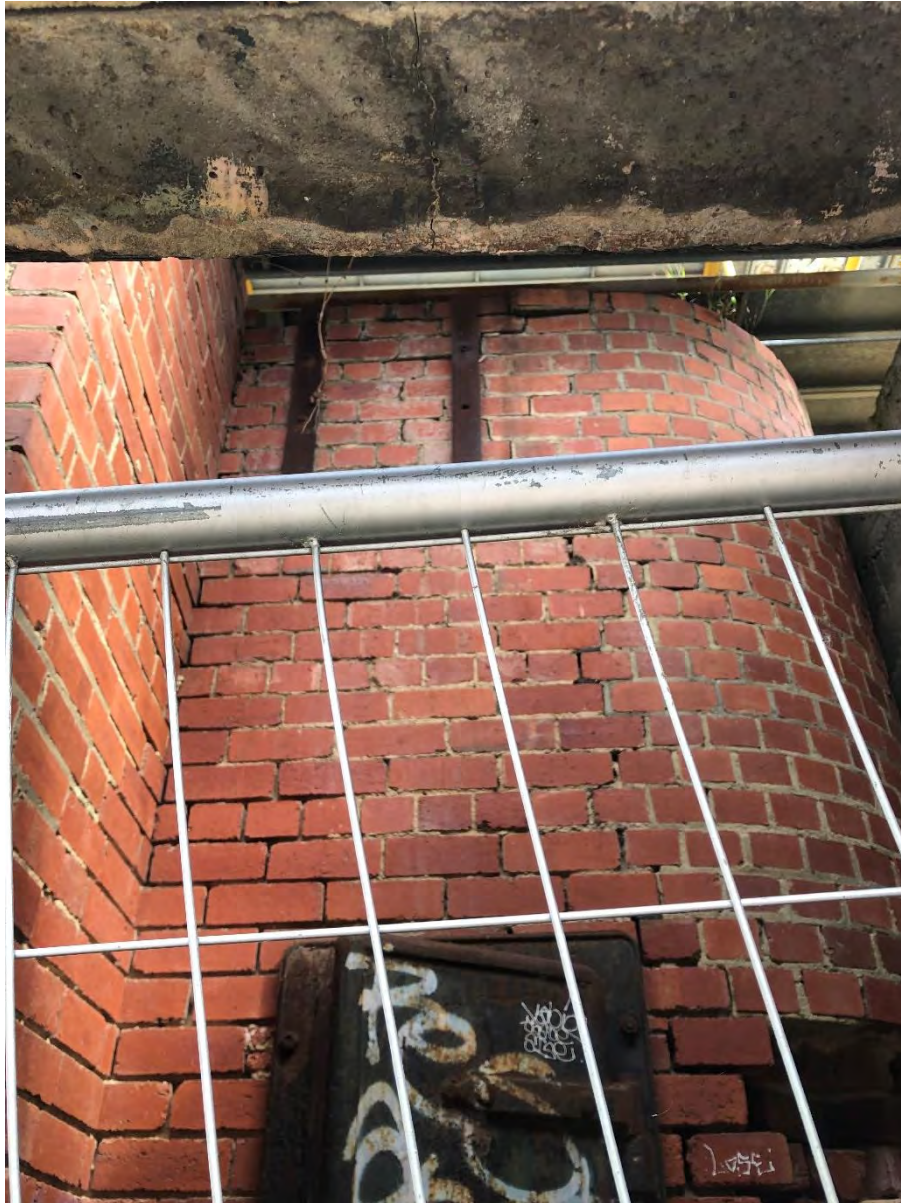
Image 11 – Existing NE Corner Wall

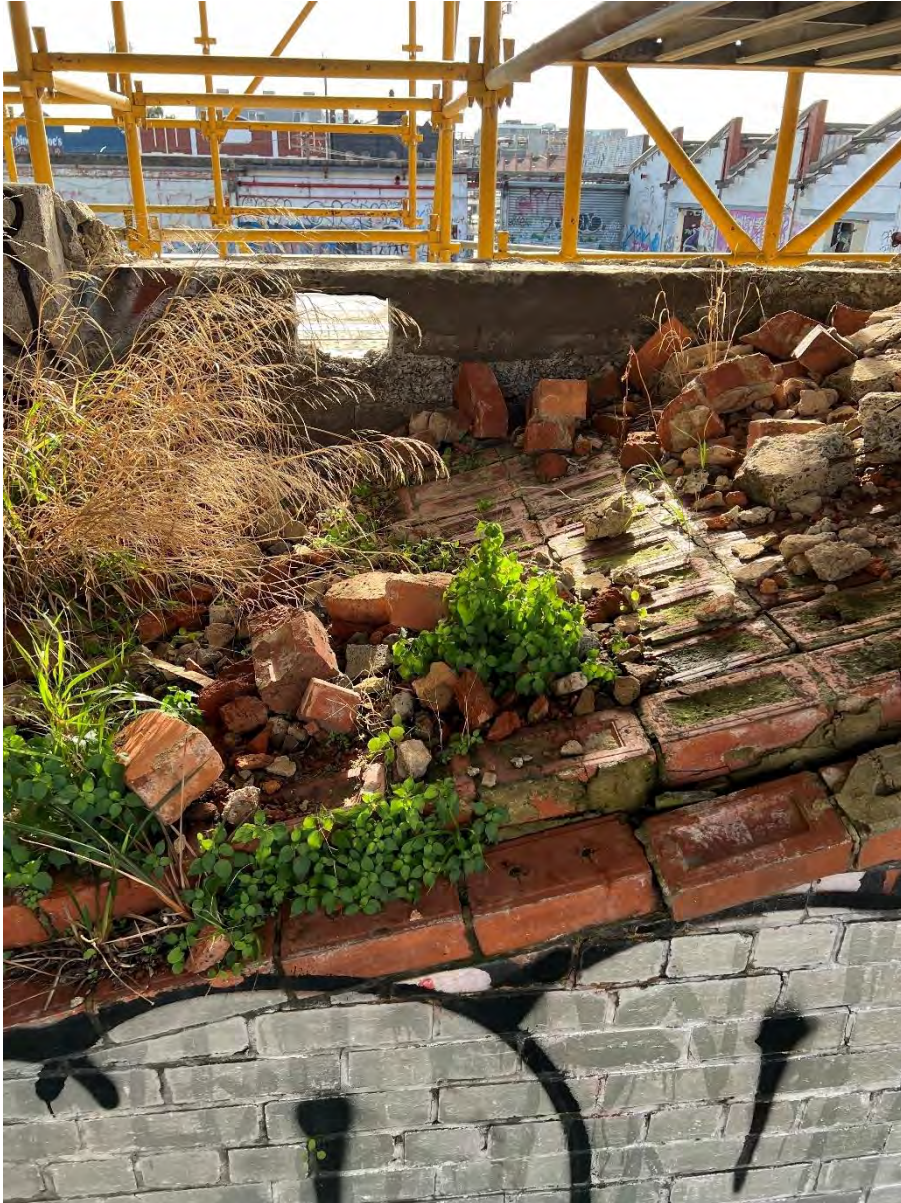
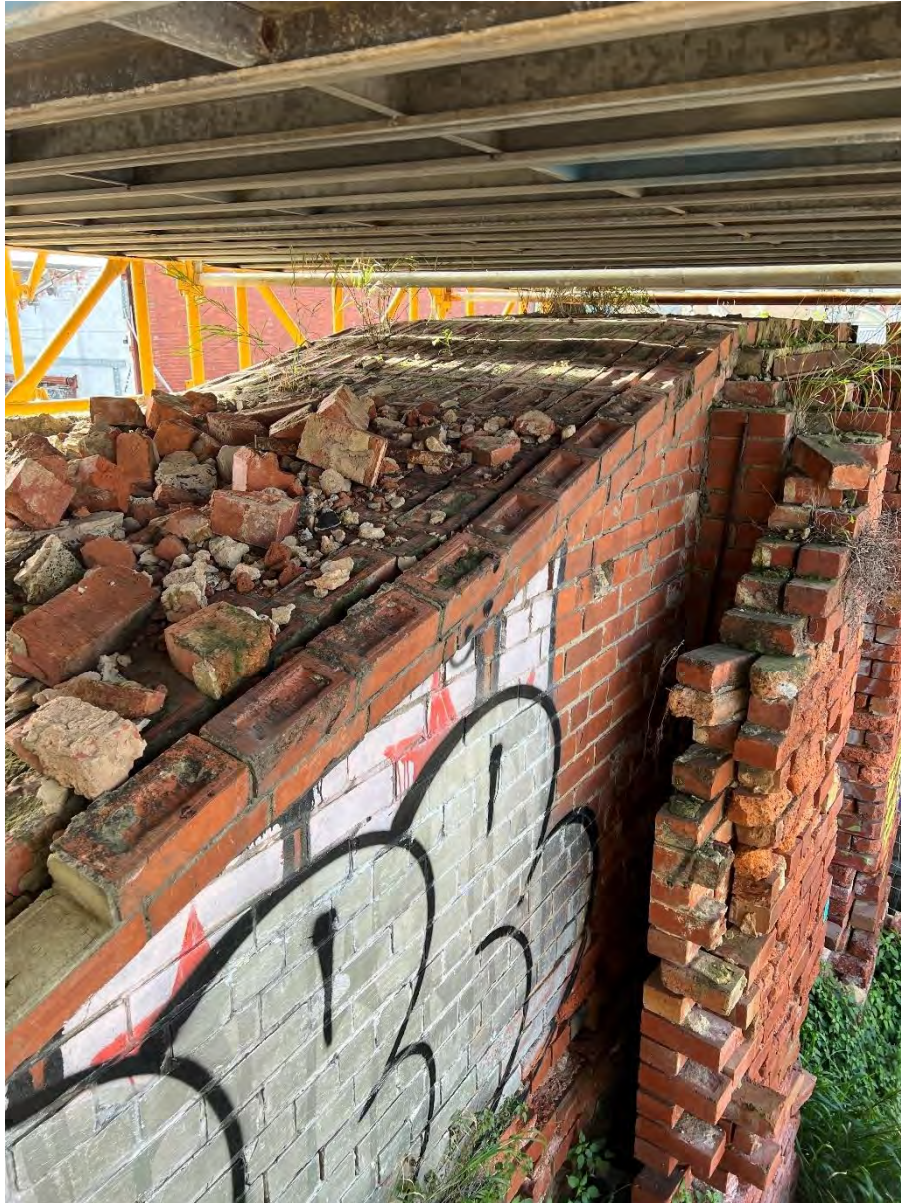
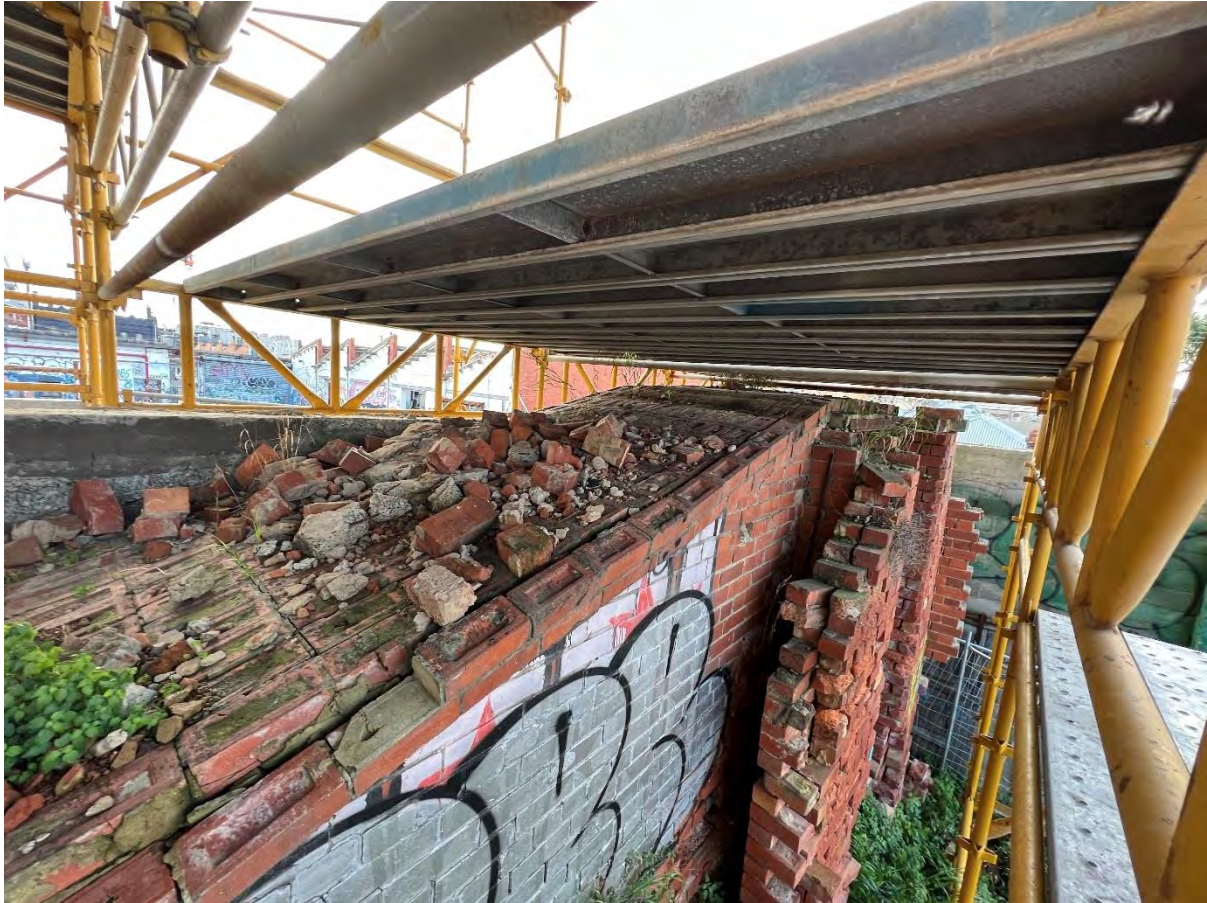
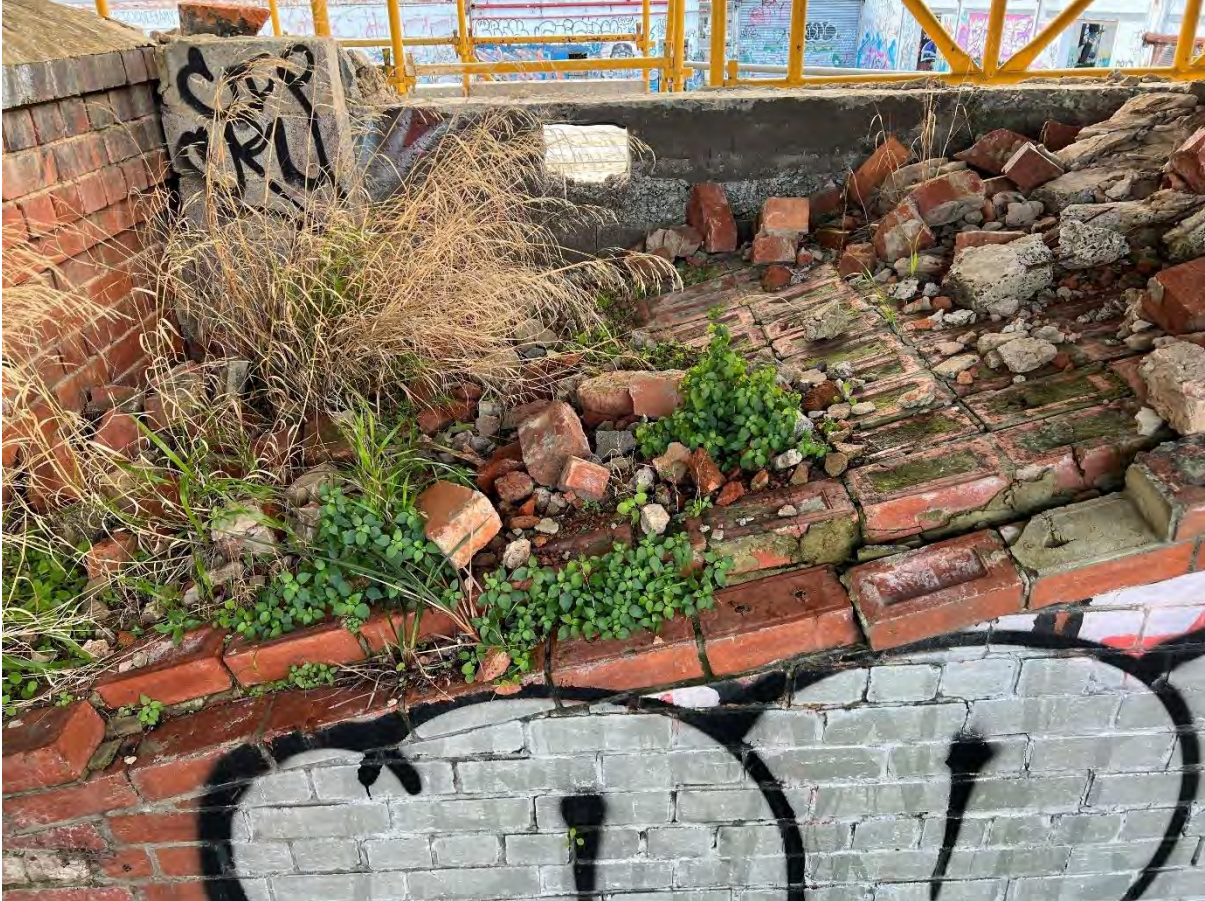
Image 12 – Existing Brick Roof

Image 13 – Existing Brick Roof

Image 15 – Existing Brick Roof

Image 16 – Existing Brick Roof

- Due to the deteriorated condition of the existing steel support angles supporting the brick roof, it would no longer be considered safe without remediation works. This could involve the complete removal of the brick roof and steel supports and replacement with a new roof if accepted. If this is not acceptable on Heritage grounds, the existing brick roof could be progressively removed or temporarily supported to allow for existing steel angles to be removed and replaced with new equivalent galvanised supports.

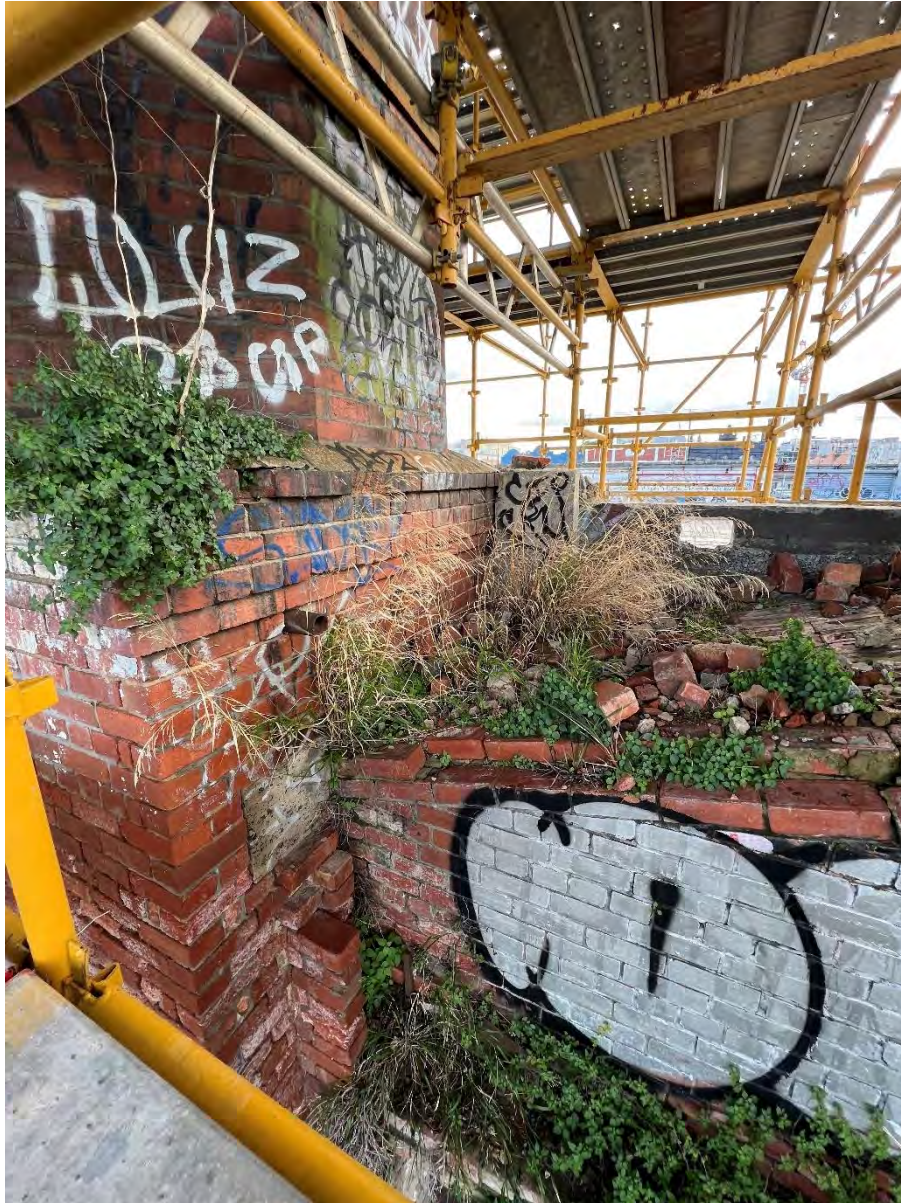
Image 14 – Existing Junction of Roof and Chimney

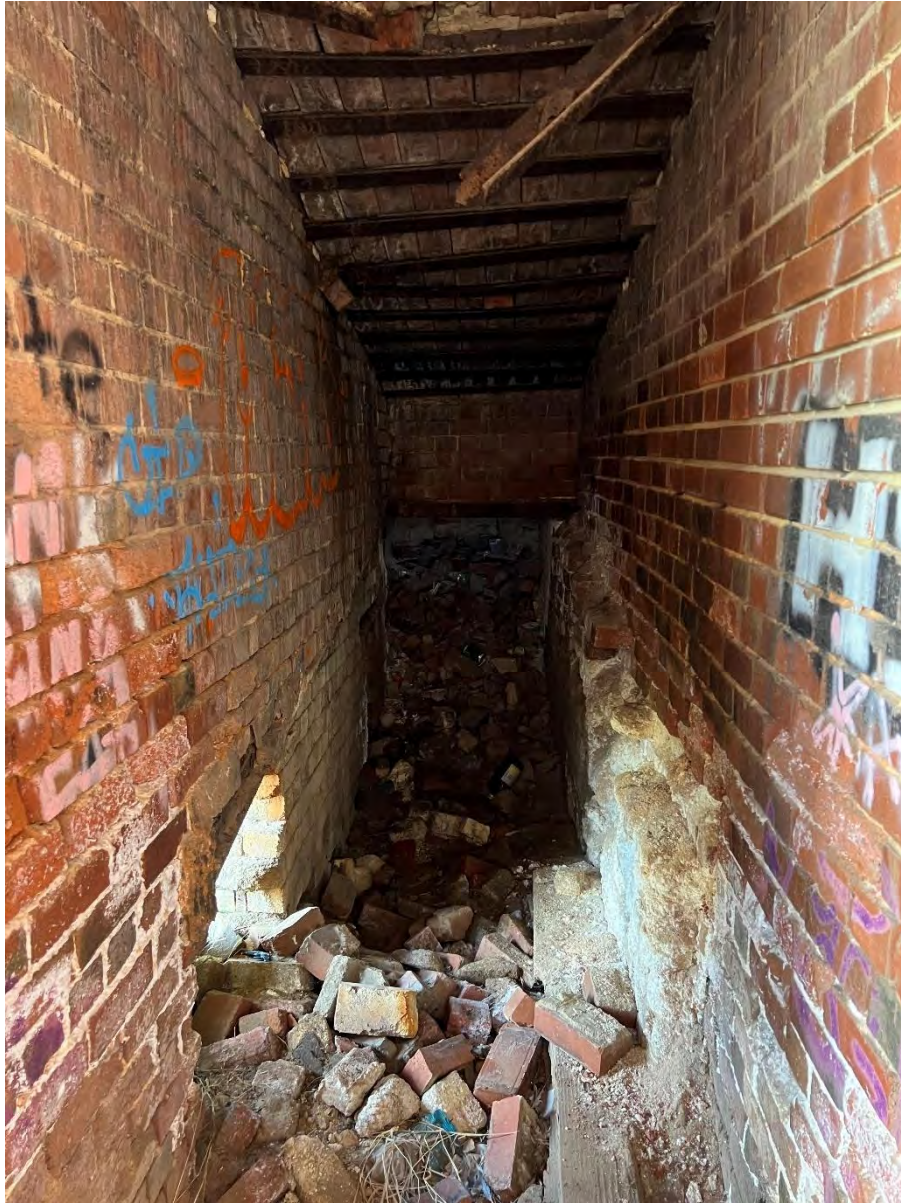
Image 17 – Existing Internal Walls and Roof

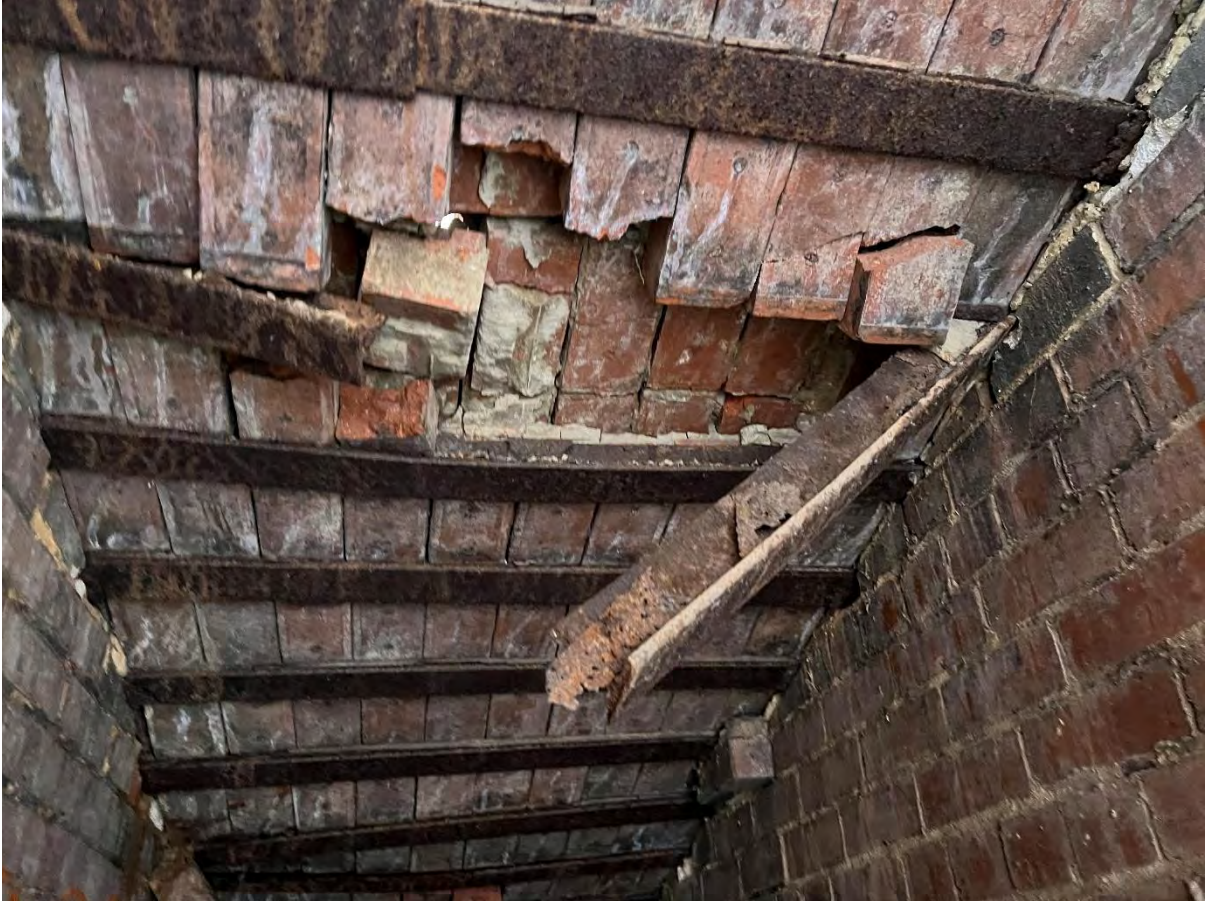
During the inspection access was not available to observe the condition of the internal walls and brick roof. For the purpose of this report photographs have been relied upon to undertake this review. The photos provided show evidence that the original steel angles supporting the brick roof have corroded and deteriorated. It is not possible to determine the extent of corrosion however one of the angles has fully corroded and failed midspan as seen in image 18 and it is reasonable to assume that other steel angles may also be close to failing in the near future.

Image 18 – Existing Damage to roof supports
