Existing Conditions Report – Structural

342-348 Victoria St, Brunswick Fire Tunnel

Job Reference: 233211

Prepared for: Armitage Jones

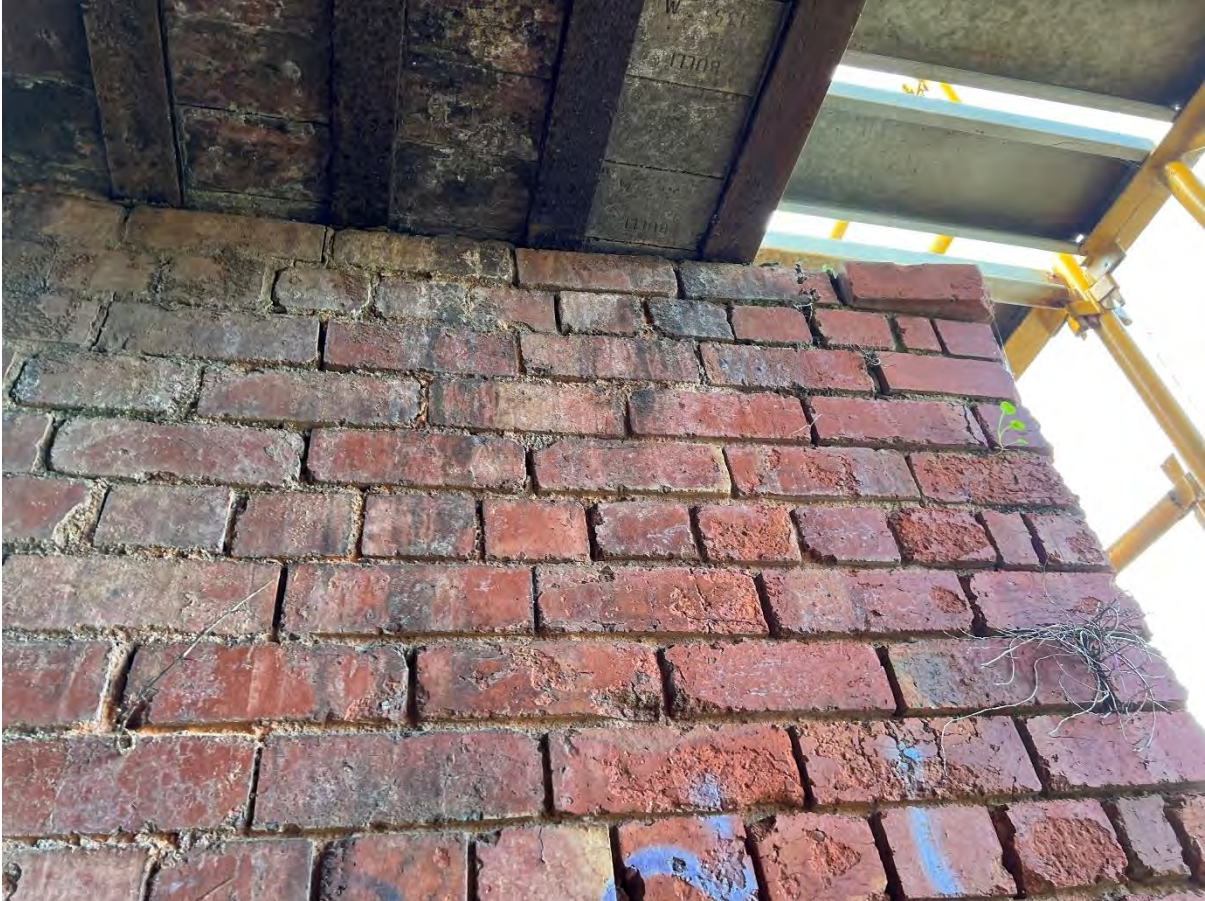
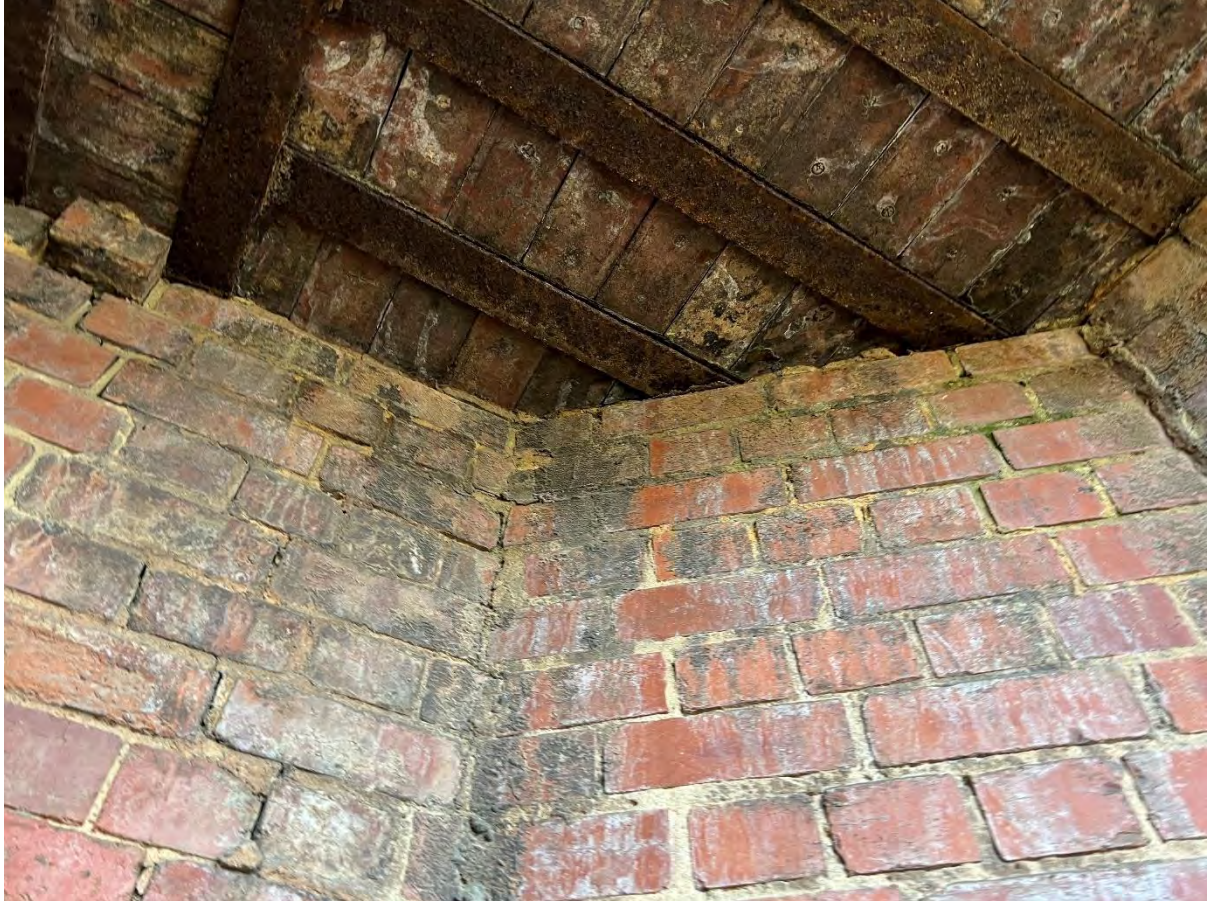
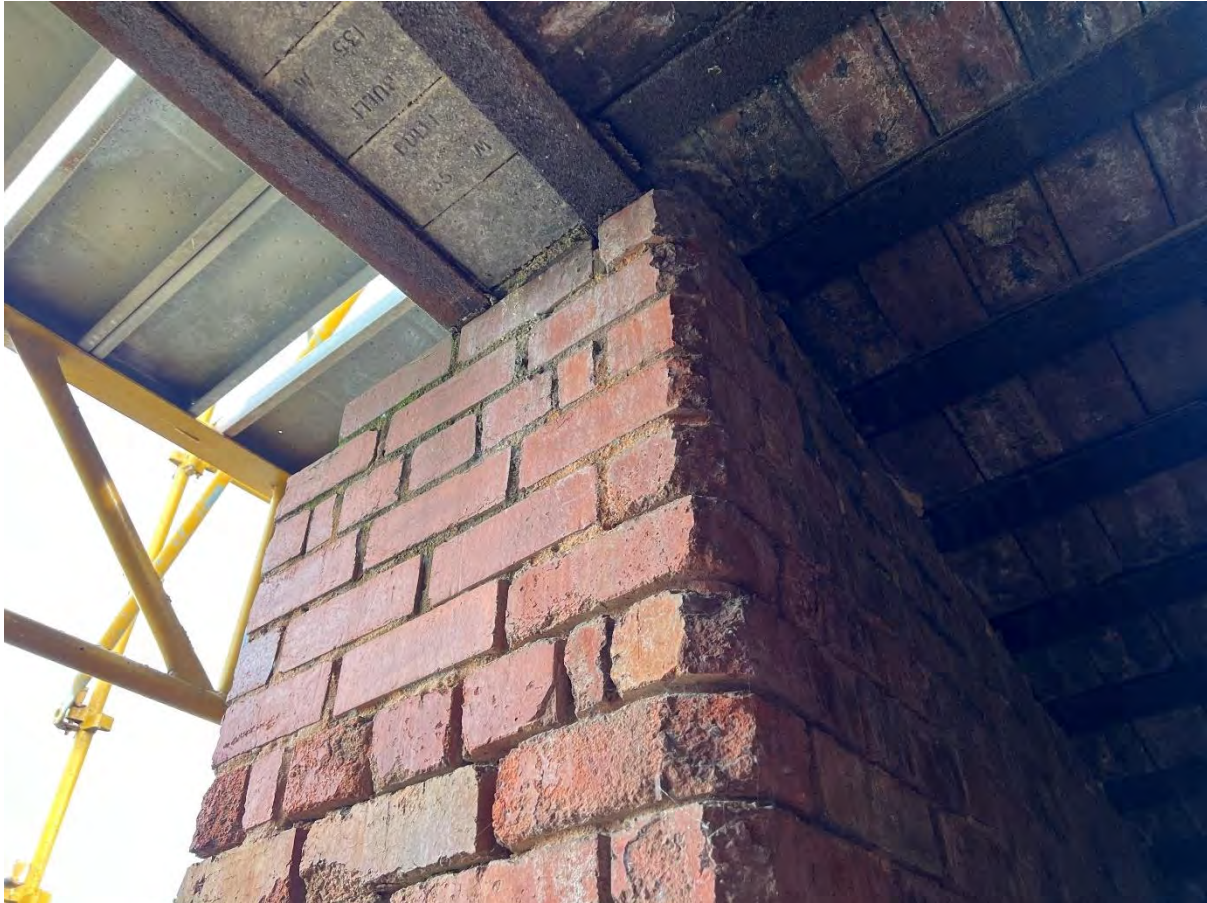
Image 19 – Existing Roof Soffit

Image 20 – Existing Roof Soffit

Image 21 – Existing Roof Soffit

- Due to the deteriorated condition of the existing steel support angles supporting the brick roof, it would no longer be considered safe without remediation works. This could involve the complete removal of the brick roof and steel supports and replacement with a new roof if accepted. If this is not acceptable on Heritage grounds, the existing brick roof could be progressively removed or temporarily supported to allow for existing steel angles to be removed and replaced with new equivalent galvanised supports.

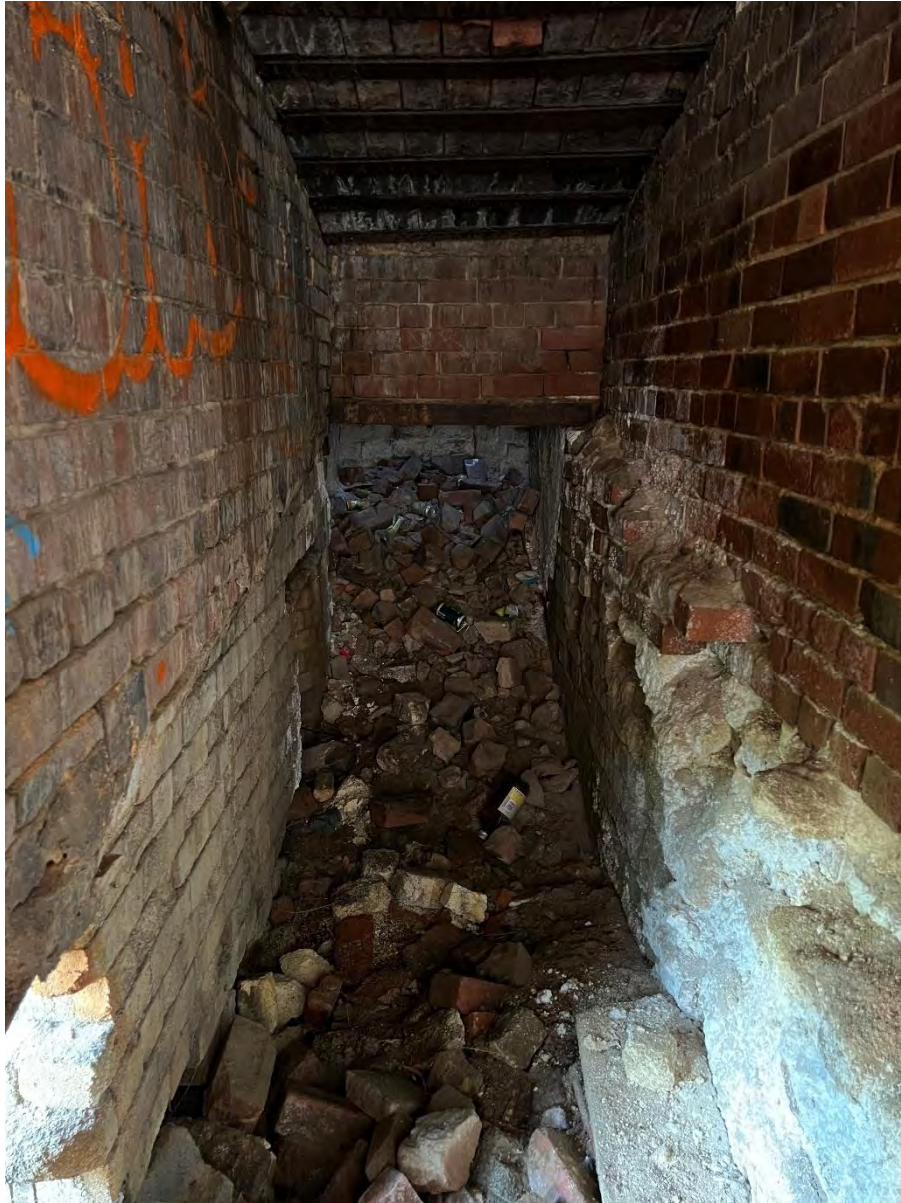
Image 22 – Existing Internal Debris

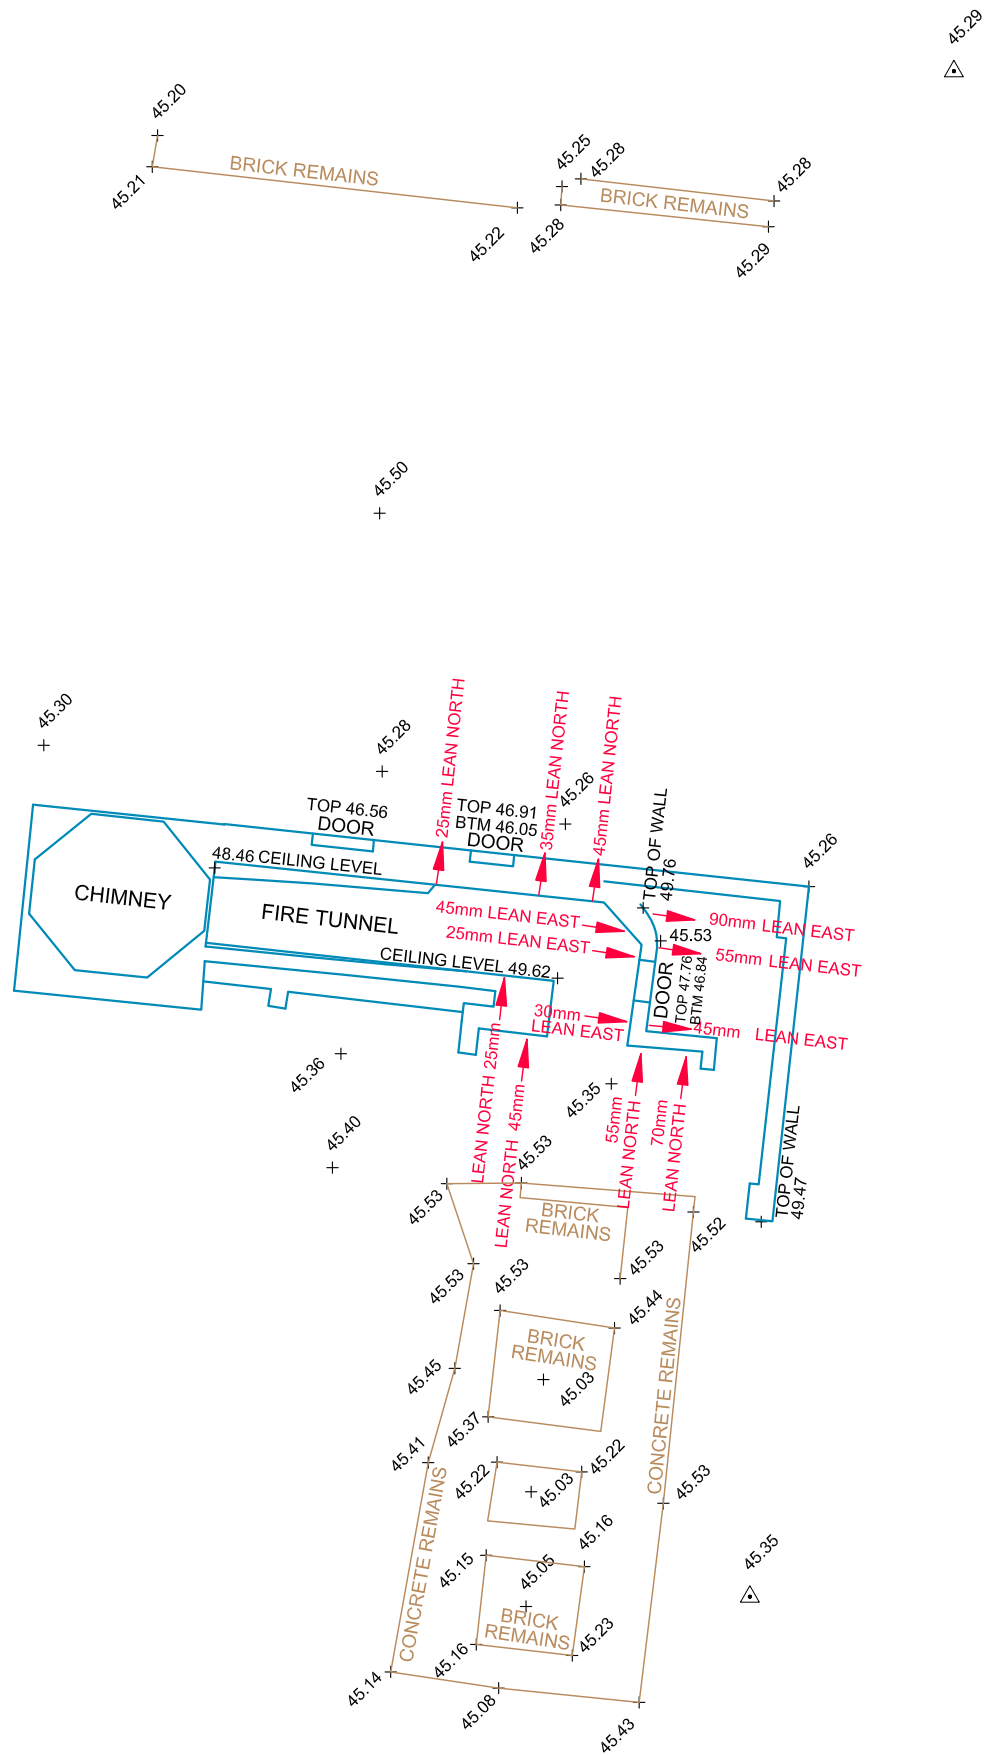
Annex B: Feature Plan Fire Tunnel Survey

The Feature and Level Survey produced by Goodison Surveying dated 30/10/23 has measured the verticality of the existing exposed brick walls. The survey has identified that both the north and south walls are leaning between 25mm and 70mm to the north with the lean linearly increasing to the east. The exposed eastern brick wall was measured to be leaning east varying from 25mm to 90mm. As all walls are leaning in the same direction this would be consistent with the foundations settling in the Northeast corner causing differential settlement of the footings and an overall rotation and lean of the walls.

- Further investigations and footing exposures would be recommended to understand the existing foundation conditions. In particular, the Northeast corner where potential ground movements and footing settlement may have contributed to the deviation of the existing walls measured in the survey.
