## **CONSULTANT ADVICE NOTICE**

**CHORA – 7 HARTINGTON STREET, NORTHCOTE**

**STRUCTURAL INTEGRITY REVIEW OF PROPOSED RETENTION  
SOLUTION ADJACENT TO EXISTING HERITAGE STRUCTURE**

Date: 30.03.2026  
CAN 1.2

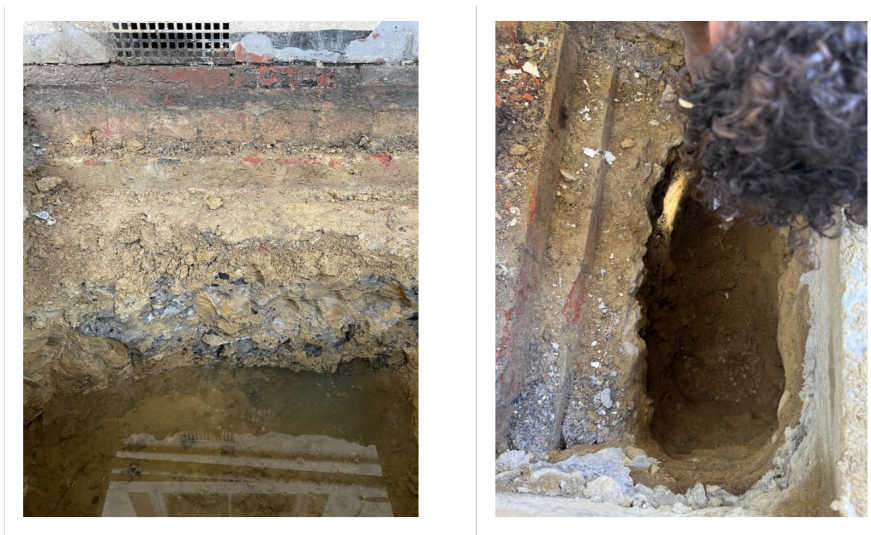
Source: Images provided by the client - investigation works of the existing footings along the exterior wall on the west elevation - heritage structure.

A historical investigation/review of the existing footings was undertaken by the client. The below images suggest the existing shallow foundations were constructed with masonry and bluestone foundations respectively. It is difficult to confirm the overall width of strip footings; however, they appear to only extend a maximum 400-500mm beyond the outer face of the existing heritage wall structure. This appears to be within the 700mm zone allowed in the current design documentation set.

The existing heritage footing depths and overall configuration will also be confirmed during a formal geotechnical investigation being scheduled for the near future. Nevertheless, the above photos and expectations are that the foundations for the heritage structure will consist of:

- Shallow strip footings constructed from historical bluestone foundations
- These footings will have unreinforced masonry (URM) walls
- Variable footing depths and bearing is expected for this structure due to its configuration.
- BOT is mindful of the sensitivity to ground movement, vibration, and changes in soil moisture respectively over the life of the building and adjacent structures respectively.
