Re: Window Condition Report – Alfred Stables Building  
Alfred Lane, Melbourne

# Window Condition Report

## 'Alfred Stables' Building

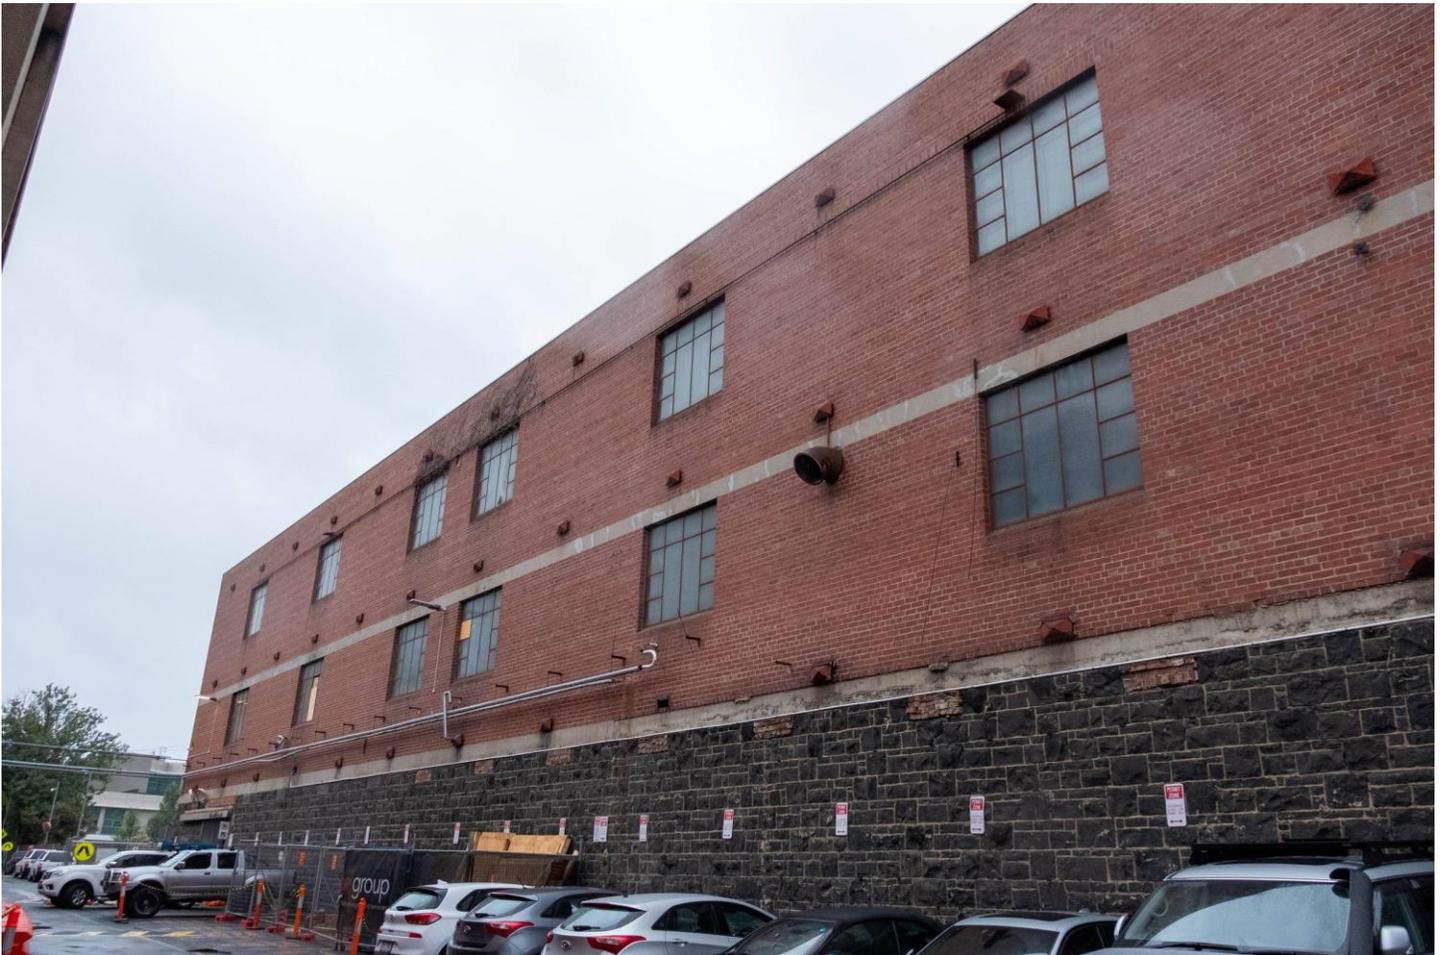
View of the Alfred Lane windows, showing that almost all retain chicken wire glass.

Only 19 of 144 panes need to be replaced. There should be enough chicken wire panes resourced from the other facades to replace these:

- 3.1.1. The existing chicken wire panes can be retained with broken panes replaced with ones obtained from the other elevations. Installation of panes should use a Silicon Modified Polymer (preferable) or polyurethane
- 3.1.2. Loose rust scraped off and rust convertor applied, followed by a suitable primer
- 3.1.3. All external glazing edges should have loose or flaking paint and putty scraped.
- 3.1.4. These edges should then be caulked with a suitable exterior paintable Silicon Modified Polymer (preferable) or polyurethane
- 3.1.5. Frame edges should be caulked with Silicon Modified Polymer (preferable) or polyurethane
- 3.1.6. Frames should be primed and repainted as per typical procedures

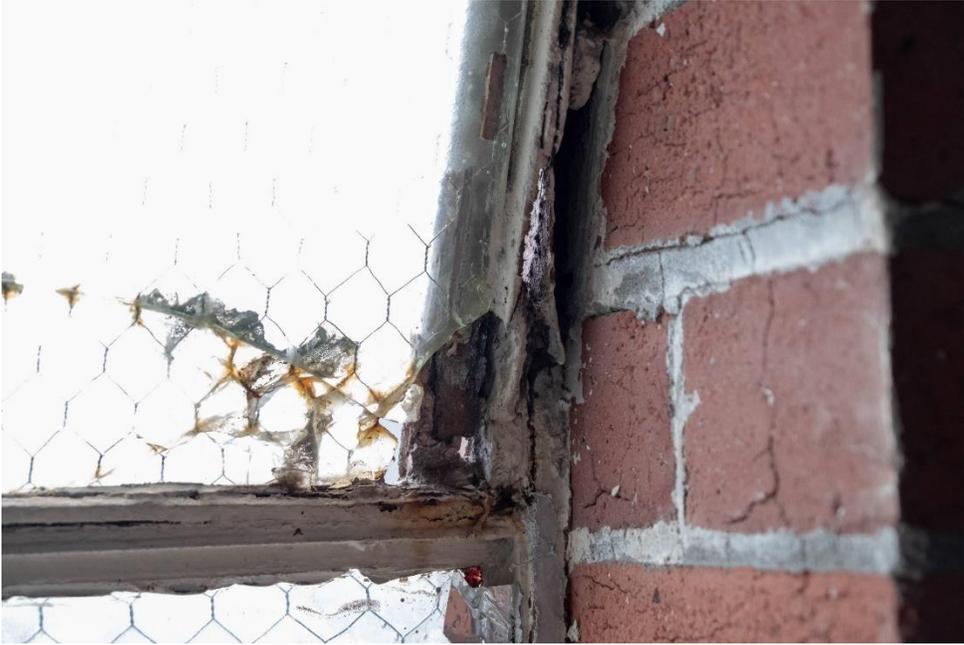
- 2.3. Almost all the hopper inserts (86%) are heavily rusted in their bottom corners and will require removal and, if still required, replacement. This is not unusual as this type of simplistic implementation creates a trap for dirt and moisture at the bottom corners. As noted above these sections were added/included onto a fixed pane section to allow for ventilation. None of the Alfred Lane windows, which share the same design (EW01) as some on the other elevations, had any hoppers installed.

This shows a typical hopper vent/pane frame condition:

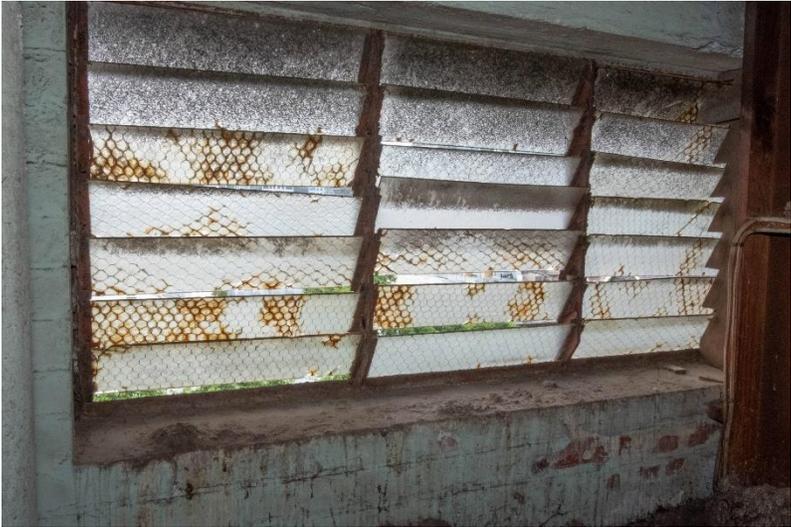
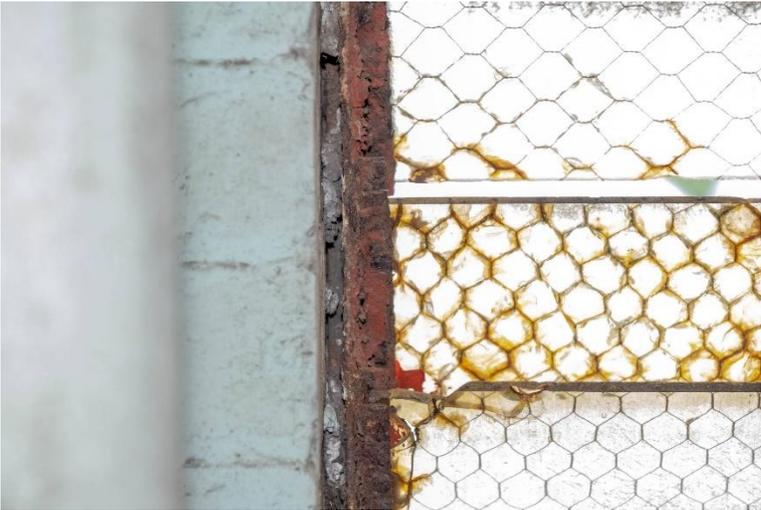
- 2.2. The louvre insert sections and panes are all in very poor condition, being heavily rusted and will require removal and, if required, replacement. The louvre panes used chicken wire glass, which is unsuitable for this purpose as the wire is exposed at the edges and eventually rusts down through the pane. These louvres are also difficult to reach and maintain.

Example of the condition of the louvre windows:
