Nissen Hut

Job Title:	Relocation of Nissen Hut, Maidstone Migrant Centre	VHR:	H2190
		ICS Job Ref:	18577
Client:	Department of Planning and Transport	Date:	20 March 2023

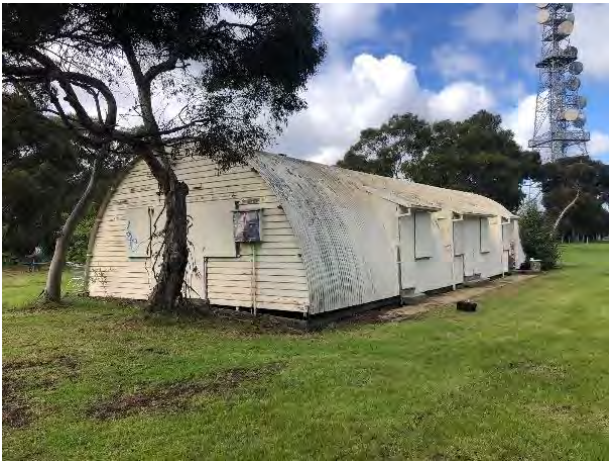
- The windows all appear to have been replaced with anodised aluminium.
- The remaining doors may be original with evidence of early door hardware. The doors to the end walls have been removed.
- Original windows would most likely have been timber framed

Figure 5: External of Nissen Hut. All openings have been boarded up with plywood. All windows and doors have previously been replaced with aluminium

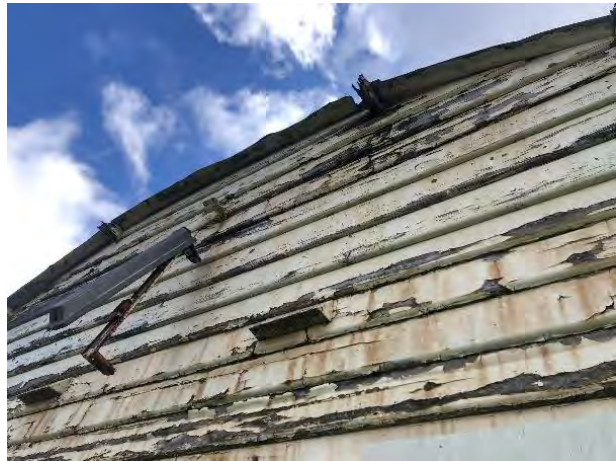
- Vertical timber splayed teardrop weatherboards
- Flaking white paint finish (likely to contain lead)
- Significant decay and rot in boards (Plate 4)
- Lower app. 900mm of cladding to the southern end has been replaced with a fibre cement board

Figure 6: End elevations clad with splayed teardrop weatherboards. Boards typically in poor condition

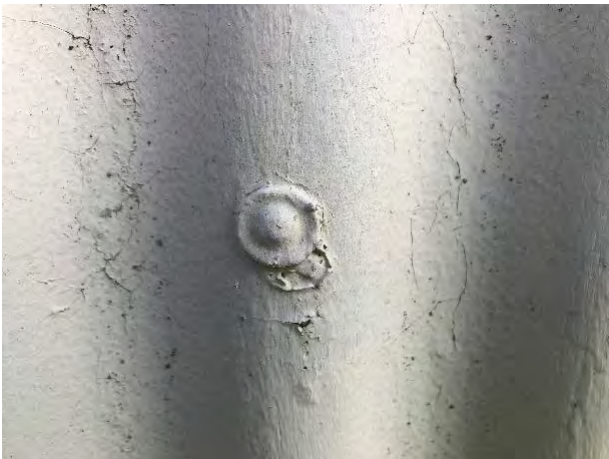
- Clad in curved heavy gauge (most likely 24 gauge) hot dipped galvanised corrugated iron roof sheeting
- Roofing fixed with galvanised roofing nails. Multiple examples of loose roofing nails (Plate 5)
- Cladding is covered in multiple layers of flaking off white / cream paint
- Generally, in sound condition with localised corrosion around roofing nail holes and at ends of sheets.
- Minor damage to exposed edges of sheets near ground level

Figure 7: Typical roofing nail

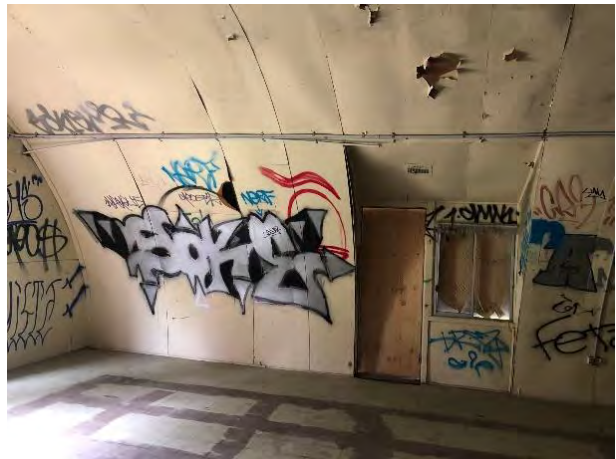
- The hut is lined with painted smooth faced Masonite. Typically, the Masonite from the 1950's was a heavier thickness than contemporary equivalents
- Masonite heavily water damaged and bowed.
- Significant graffiti and other damage (Plate 6)

Figure 8: Internal Masonite lining in poor condition with extensive deformation and graffiti

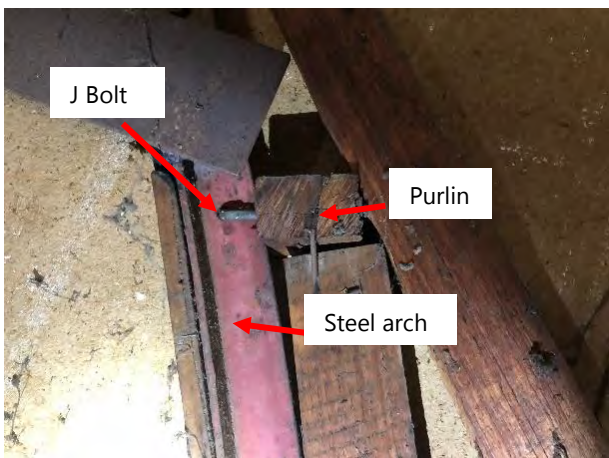
- The hut uses a proprietary 2" X 2" (50mm X 50mm) T-section steel arches developed by Lt Peter Nissen for the British Army in 1916. The arch is divided into 5 sections joined together using a metal plate. (Plates 7 & 8)
- The 24' span arches are spaced approximated at 6' centres.
- The external cladding is attached using 70mm X 45mm timber purlins that are attached to the steel arches using a proprietary J-hook.

Figure 9: 2" x 2" steel rib arch (reddish colour) Purlin is evident (the cut end of a purlin is shown) J bolt to hold purlin to outside of rib

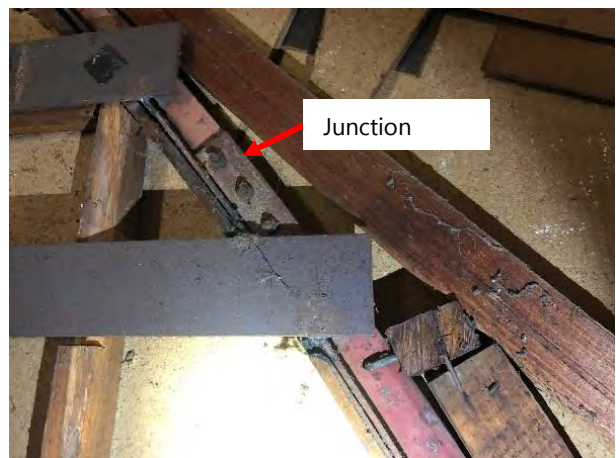
Figure 10: Junction plate bolting segments of T-shaped arch
