Condition Assessment and Conservation Works & Maintenance Schedule

Cullymont (VHR 0811)
4 Selwyn Street Canterbury

Proposal:
Works associated with proposed four car garage

Project #: 21.15
25 September 2023

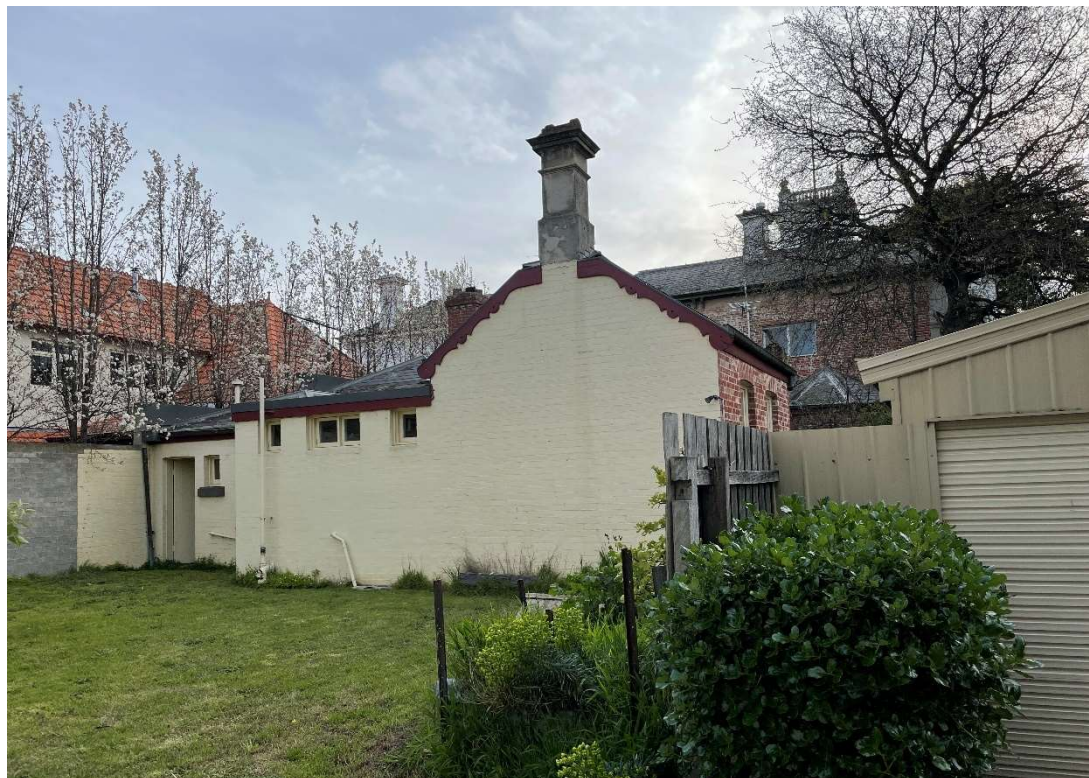
The condition of the outbuildings, including the former caretaker’s cottage to the north-east, and the eastern amenities section of the services wing, as well as the recent flat roofed infill addition, are in good condition and have been well maintained.

Figure 3: View from Laneway showing amenities outbuilding to left, the historic Cottage outbuilding with pitched roof and chimney to the right, and its contemporary addition in the centre.

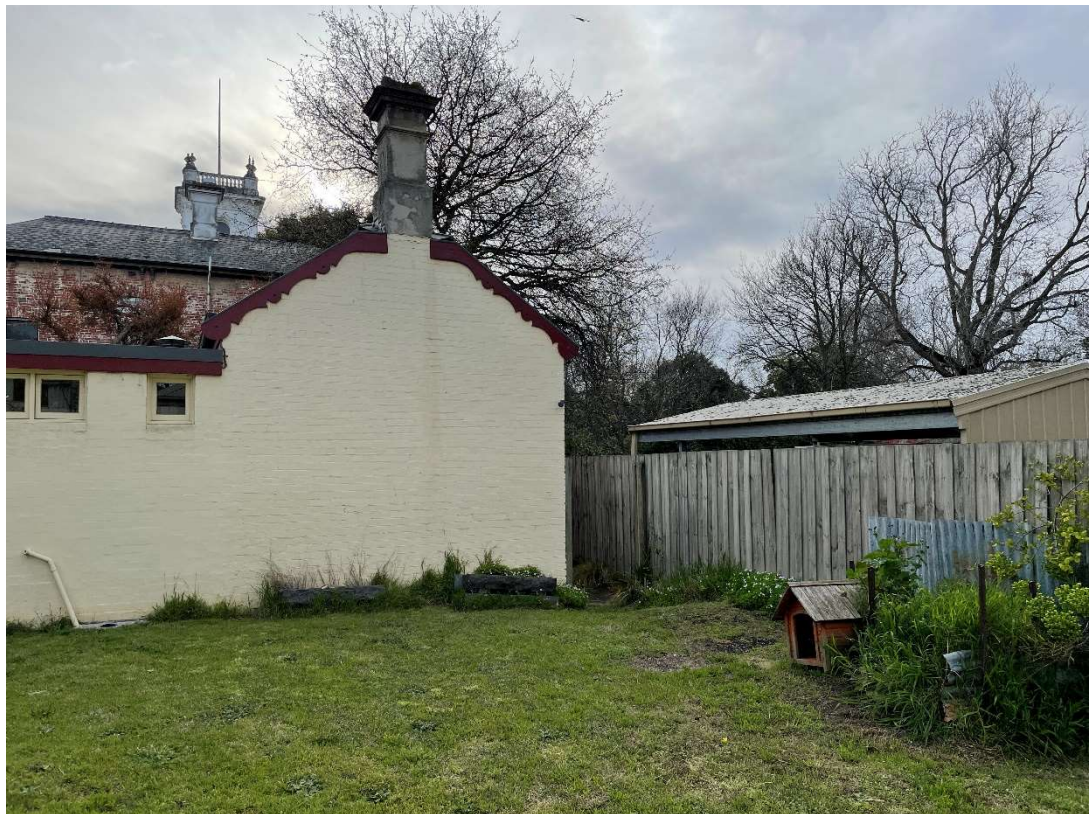
The former 1890 caretaker's cottage consists of extant slate roofing, with a rendered chimney shaft with a decorative corbel. The roof is in sound condition with no evidence of damaged slate. The chimney is discoloured, due to environmental affects, with slight cracking to the render, with some minor drummy sections, but is generally sound. The original gutters have been replaced with quad gutters and are in good working order, however, one downpipe is discharging directly into a lower gutter with no control to the flow.

The cottage walls are of face brick and have been finished in acrylic paint. The paint has been removed from the north and west walls, but some remnant paint remains. The masonry and mortar are in good condition. The double hung, weight and cord, timber window has been recently serviced and is in good condition. The four panel Victorian door appears to be original and is also in good condition. There appears to be adequate subfloor clearance, with subfloor vents located to the north wall only.

Figure 4: East elevation of the historic Cottage viewed from the Laneway. Contemporary addition on the left.

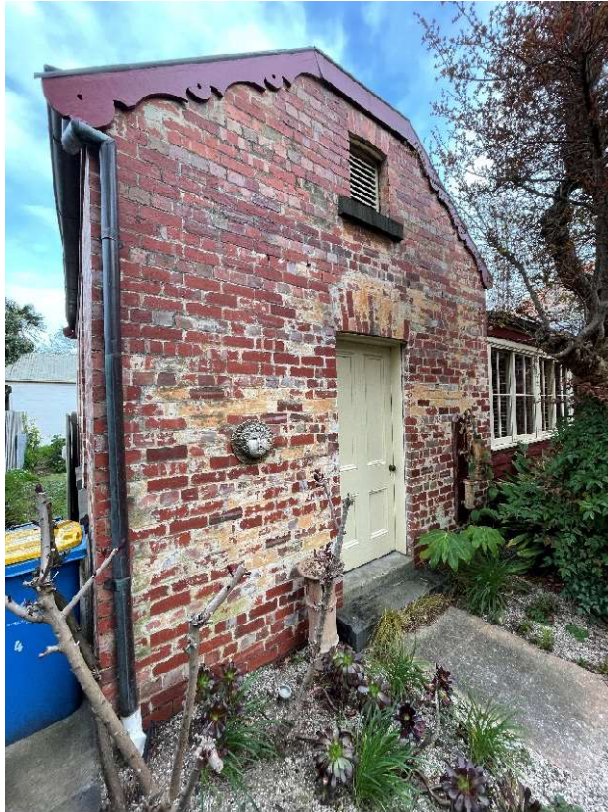
Figure 5: West elevation of the historic Cottage. The contemporary addition is visible on the right.

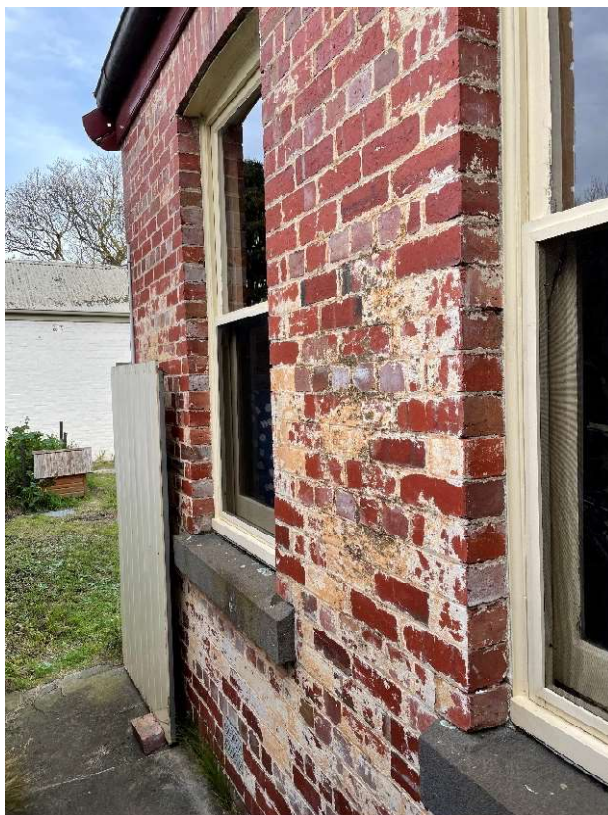
Figure 6: North elevation of the historic Cottage looking towards the Laneway.

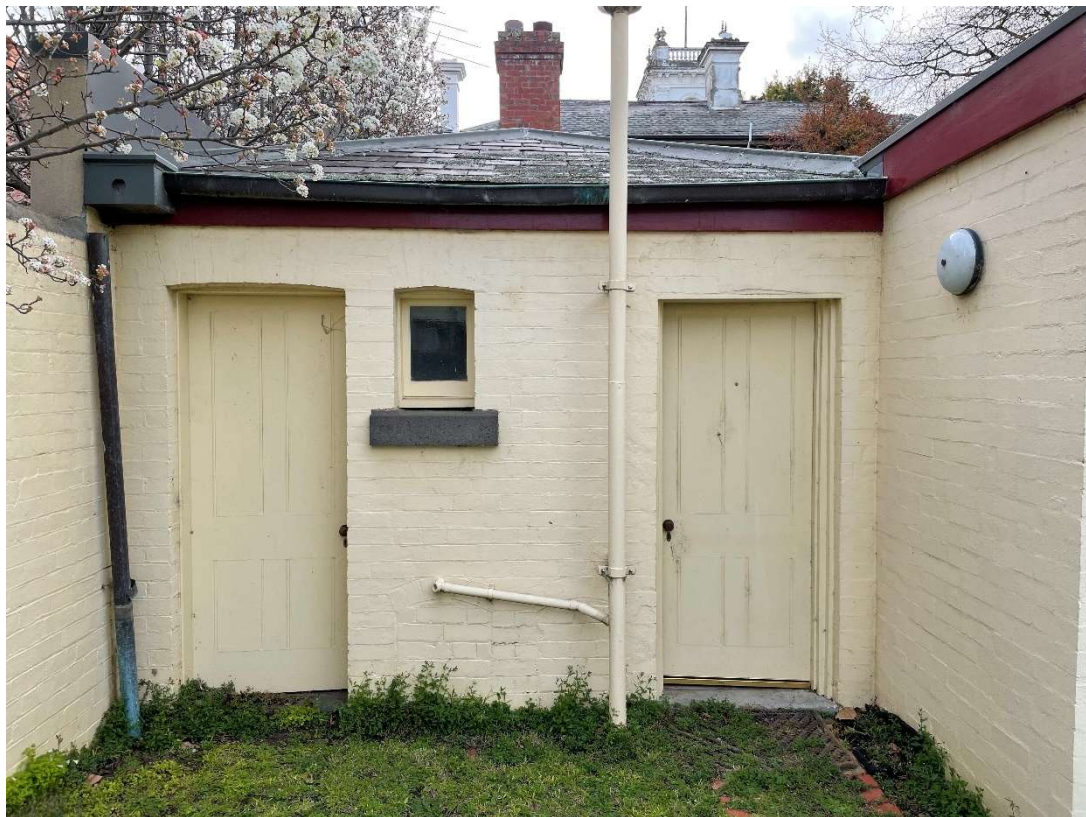
The amenities area, to the east section of the services wing, is delineated by a hipped slate roof that sits below the main roof to the west. The roof to the west and east sections of the services wing have been repaired with new matching slate. The downpipe from the upper roof is discharging directly into the lower box gutter of the amenities wing without any control to the flow. The external east wall is painted face brick and has been altered. The lower service opening has been bricked up and a new doorway has been installed to access the recent infill addition.

Figure 7: East elevation of amenities outbuilding viewed from Laneway.

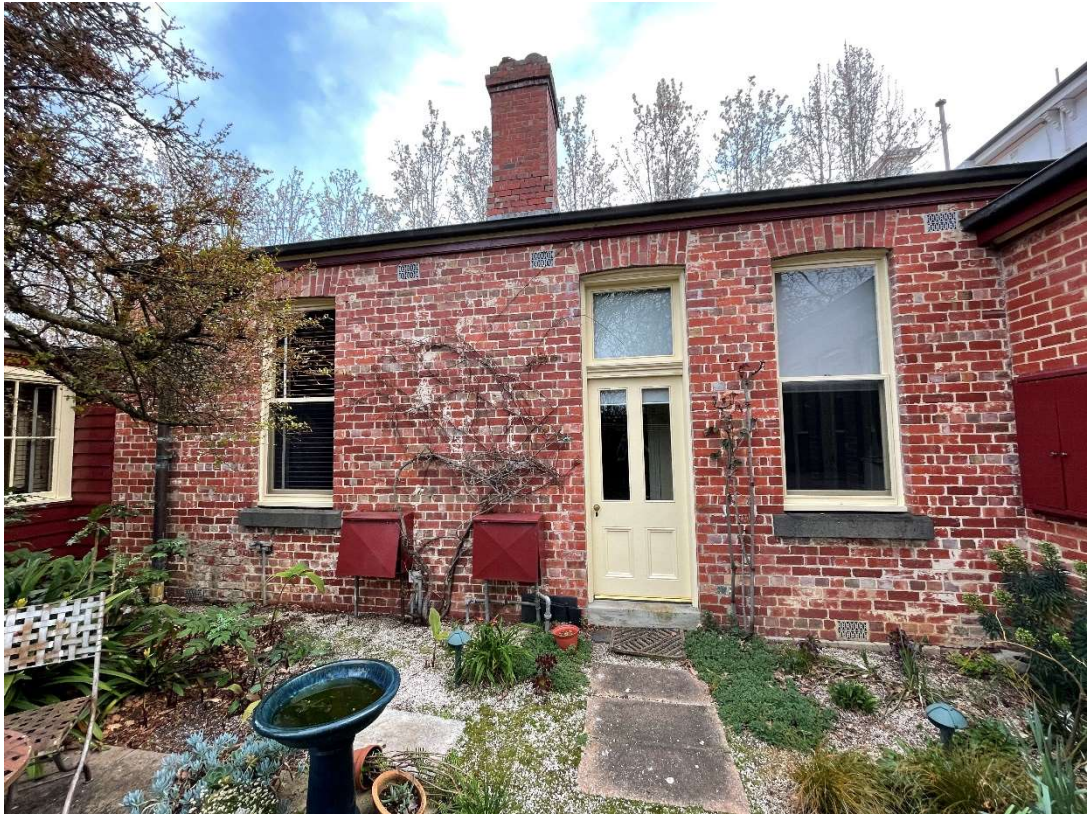
Figure 8: North elevation of amenities outbuilding.

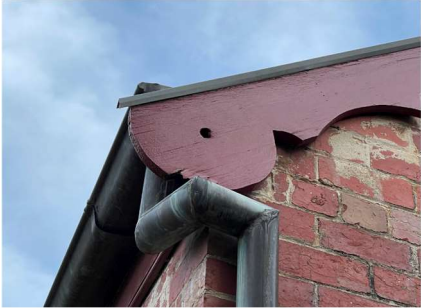
Item	Observations & defects	Recommended Actions	Image
1.0	Roof + Rainwater Goods		
1.1	<p>Cottage Eaves a section of the timber barge under the end is missing element or section of the barge.</p> <p>Other sections of the timber barge ends local to the gutters a showing early signs of water damage</p>	<p>Essential</p> <p>Barge ends to be stripped, primed, and painted to retard ongoing water damage. Check gutter ends to ensure there are watertight.</p> <p>Where timber is beyond repair, cut out damaged areas and scarf new matching timber, fix with 2-part epoxy, paint to match existing</p>

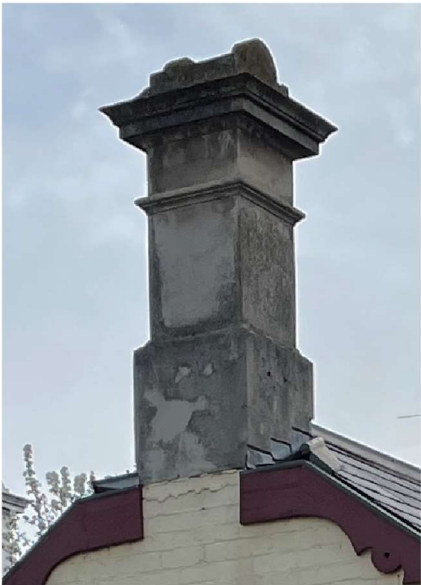
Item	Observations & defects	Recommended Actions	Image
1.2	<p>Cottage Chimney: Cement rendered chimney shaft with rendered brick corbel. The chimney shaft is of a similar style to the main villa. The lower expressed section of the shaft was accessed, and the upper section was visually assessed only. Fine cracks are evident, and the render is firmly fixed, the staining appears to be soiling rather than any obvious water damage.</p>	<p>Investigate</p> <p>Assess top of chimney to ensure no cracks or water ingress to the masonry or behind the render.</p>

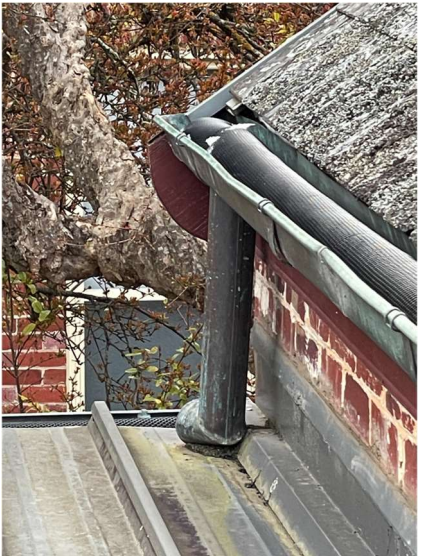
1.3	<p>Cottage rainwater goods: The gutters appear to have recently been replaced with quad gutters and are in good condition. A section of the gutter guard is missing. The downpipe is discharging directly into the gutter of the adjacent flat roof.</p>	<p>Urgent</p> <p>Replace missing gutter guard.</p> <p>Urgent</p> <p>Connect directly into lower downpipe or provide a spreader away from the gutter and cottage wall flashing.</p> <p>Urgent</p> <p>Ensure all down pipes and drains are clear and connected to the legal point of discharge.</p>

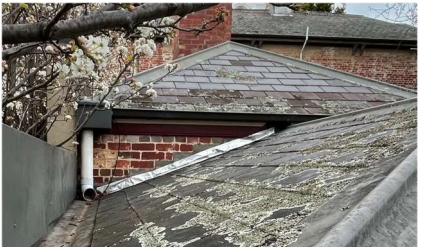
1.4	<p>Services Wing roof: The downpipe from the upper roof discharges directly into the box gutter of the lower toilet block roof. There appears to be temporary flashing installed to the junction of the upper and lower roofs.</p>	<p>Investigate</p> <p>Plumber to assess the condition of the existing stepped flashing to and the nature of the temporary flashing. Ensure all flashing is sound.</p> <p>Urgent</p> <p>Rectify downpipe discharging directly into gutter to meet regulatory requirements, plumber or building surveyor to advise.</p>

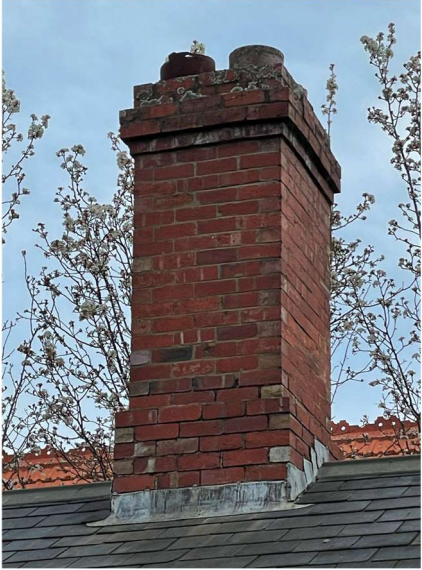
Item	Observations & defects	Recommended Actions	Image
1.5	<p>Services Wing Chimney: base section of the chimney appears to need repointing</p>	<p>Investigate</p> <p>Assess the condition of the chimney mortar.</p>

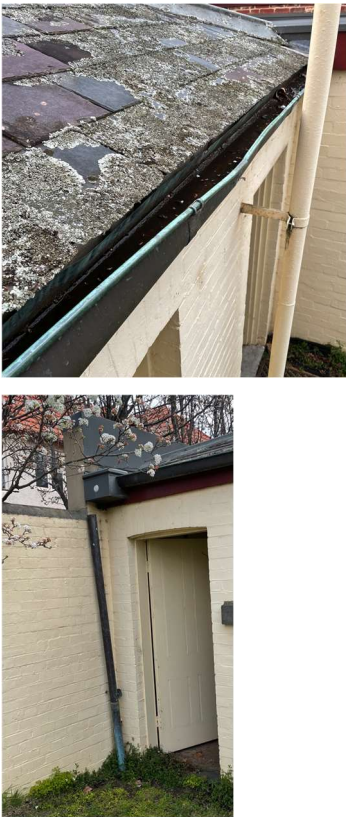
1.6	<p>Toilet block roof (cont.): The east quad gutter is deformed and has inadequate fall, water is ponding in the gutter. The down pipe has disconnected from the rainwater head, water is discharging into the ground.</p>	<p>Urgent</p> <p>Reconnect the downpipe to RWH and ensure all drains are sound and clear.</p> <p>Urgent</p> <p>Replace existing quad gutter and provide fall (1:500 min) to meet regulatory requirements.</p>

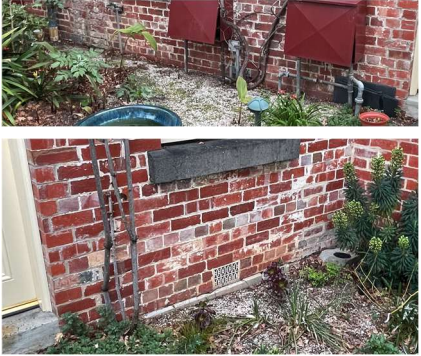
Item	Observations & defects	Recommended Actions	Image
2.0	Footings		
2.1	<p>Services wing: Minimal subfloor clearance (approx. 200mm). Sub floor ventilation to the north wall only. mechanical ventilation installed, not operational</p>	<p>Urgent Ensure mechanical subfloor ventilation is operational</p>

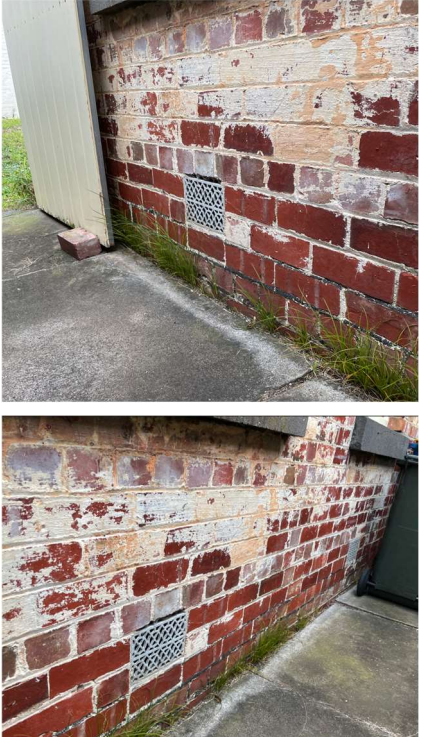
2.2	<p>Cottage: Minimal subfloor clearance (approx. 200mm). Sub floor ventilation to the north wall only.</p>	<p>Essential Provide additional subfloor ventilation to the west side.</p>

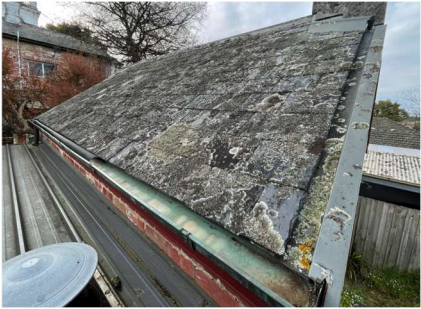
Item	Observations & defects	Recommended Actions	Image
1.0	Roof + Rainwater Goods		
1.1	<p>Cottage Roofing: The slate roofing and flashing is in fair condition. Roofing appears to be original and is covered in organic matter. No slipped or broken slates were visible, slates appear sound and were not delaminating.</p>	<p>Monitor Slate to be monitored for any damage or slipped slates, and to ensure slashing remain sound.</p>

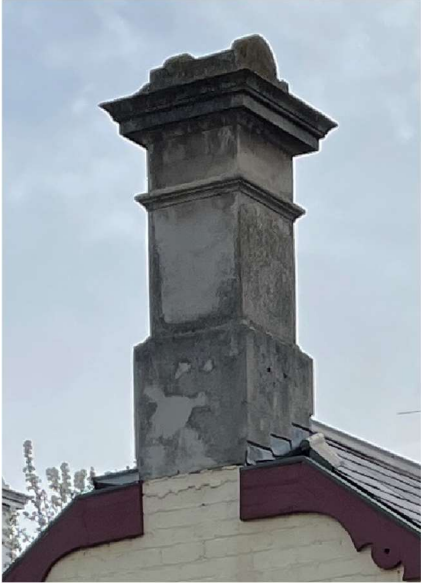
Item	Observations & defects	Recommended Actions	Image
1.2	<p>Cottage Chimney: Cement rendered chimney shaft with rendered brick corbel. The chimney shaft is of a similar style to the main villa.</p> <p>the lower expressed section of the shaft was accessed, and the upper section was visually assessed only. fine cracks are evident, and the render is firmly fixed, the staining appears to be soiling rather than any obvious water damage.</p>	<p>Monitor</p> <p>Monitor cracks and possible drumminess to the render which would indicate water ingress. Reassess and repair cracks in matching render material and colour.</p> <p>Recommended</p> <p>Replace/scarf in missing section of the barge.</p>

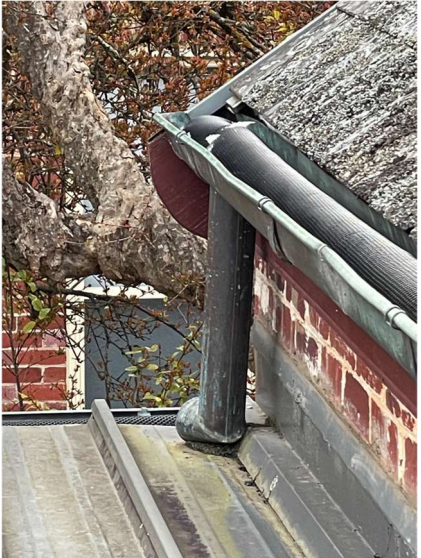
1.3	<p>Cottage rainwater goods:</p> <p>The gutters appear to have recently been replaced with quad gutters and are in good condition. A section of the gutter guard is missing.</p> <p>The downpipe is discharging directly into the gutter of the adjacent flat roof.</p>	<p>Monitor</p> <p>Regularly (2x annually) check and clear all gutters.</p>

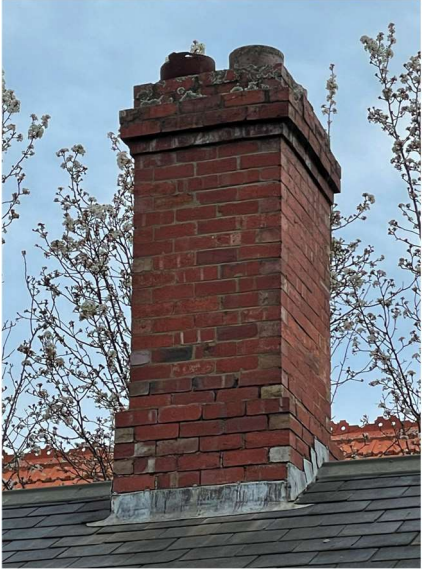
Item	Observations & defects	Recommended Actions	Image
1.4	<p>Services Wing Chimney: base section of the chimney appears to need repointing</p>	<p>Recommended</p> <p>Repoint in accordance with Heritage Victoria guidelines</p>

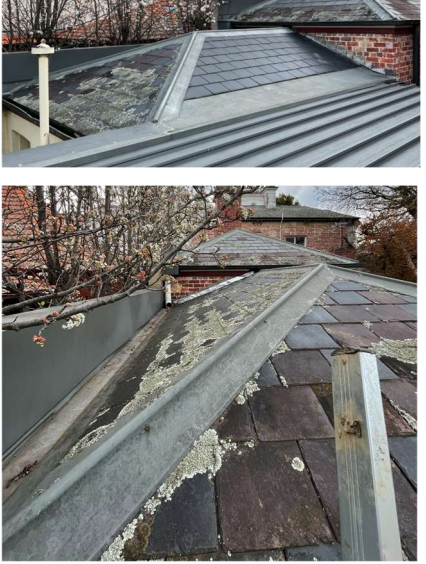
1.5	<p>Toilet block roof:</p> <p>The existing slate roofing is in good condition. No water ingress was observed.</p> <p>Sections of the extant roof are covered in organic matter.</p> <p>the north hip has been replaced with matching slate, and flashed into the recent flat metal deck roof addition (1999).</p>	<p>Monitor</p> <p>Monitor roof, regularly check (2x annually) to ensure all gutters, downpipes and drains are clear.</p>

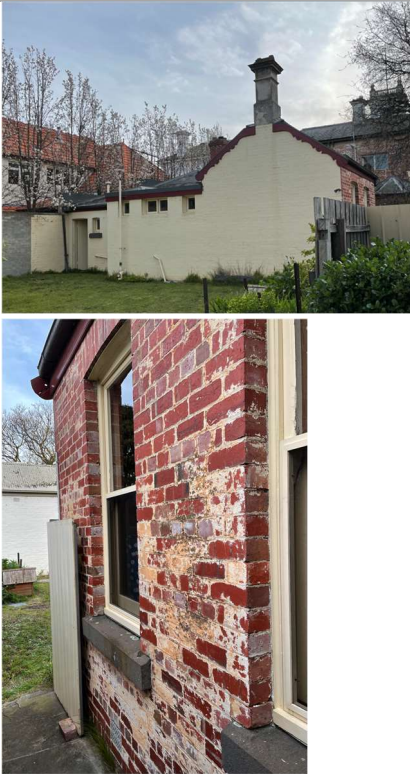
Item	Observations & defects	Recommended Actions	Image
2.0	Walls + Fenestration		
2.1	<p>Cottage & Services Wing:</p> <p>Extant walls are red face brick, English bond, with headers every fourth course. Struck joints, with lime rich mortar.</p> <p>The east walls of the outbuilding have been finished in acrylic paint.</p> <p>The north and west masonry walls of the outbuildings, and the north wall of the services wing have had the paint removed. There are residual sections of remanent paint remaining.</p>	<p>Recommended</p> <p>Carefully remove the paint from the extent cottage and outbuildings.</p> <p>Carefully remove the remnant paint from extant buildings.</p> <p>Note: Any mortar repairs must match the material (i.e., lime rich), colour and form of the existing joints.</p>

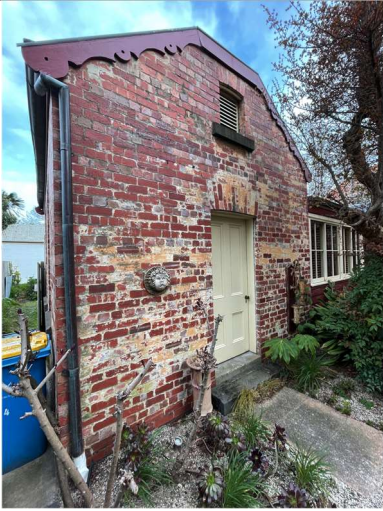
2.2	<p>Cottage Fenestration:</p> <p>Extant double hung timber windows have been recently serviced and are in good condition.</p> <p>Extant four panel Victorian door + hardware, and louvered roof vent are in good condition.</p>	No Action.

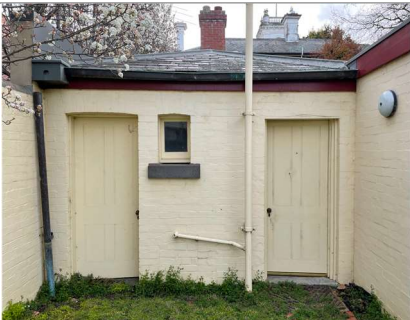
2.3	<p>Toilet block Fenestration:</p> <p>the east wall of the outbuilding to the east of the services wing has been altered, with a door to the recent addition, new doors, and the low-level service opening bricked up. It appears the small window to the toilet has been changed.</p>	No Action

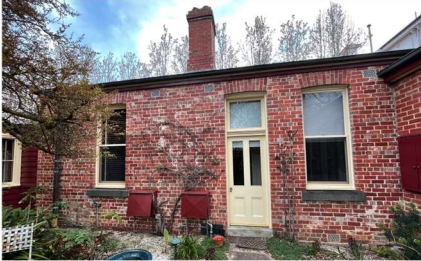
Item	Observations & defects	Recommended Actions	Image
2.4	<p>Toilet block Fenestration: extant double hung timber windows have been recently serviced and are in good condition</p> <p>Extant four panel Victorian door + hardware, and highlight are in good condition.</p>	No Action

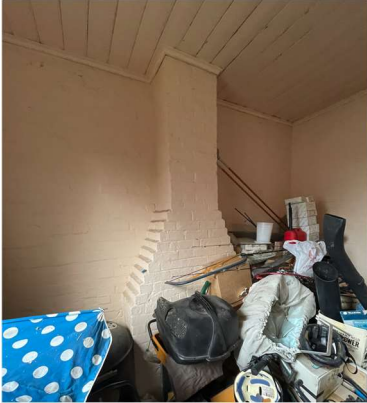
3.0 Interior			
3.1	<p>Cottage: extant timber floors and beaded timber ceilings are in good condition; walls are a painted finish. No obvious signs of water ingress</p>	No Action
