Heritage Impact Statement

Forum Theatre H0438 – Urgent Makesafe Works

150-162 Flinders Street, Melbourne

RE: PRELIMINARY STRUCTURAL PRIORITY ADVICE

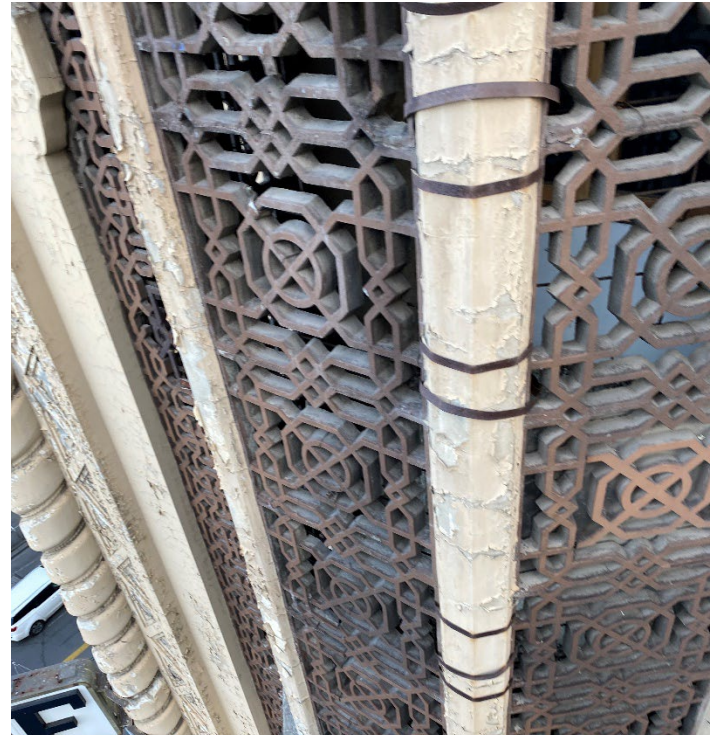
Figure 2

Past remediation strapping on the canted bay providing little to no structural support to the columns

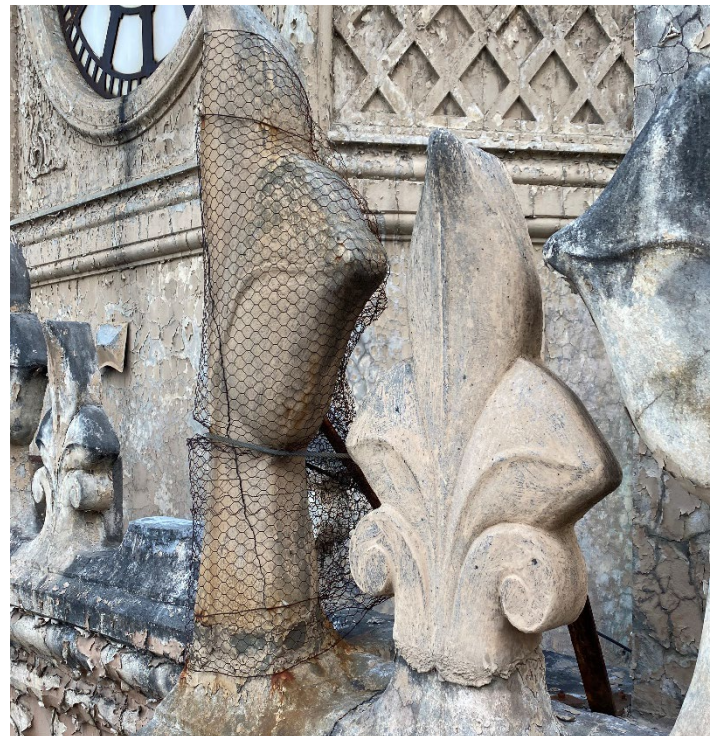
Figure 3

Crenelations cracked through and wrapped in mesh, also note 1981 replacement adjacent.

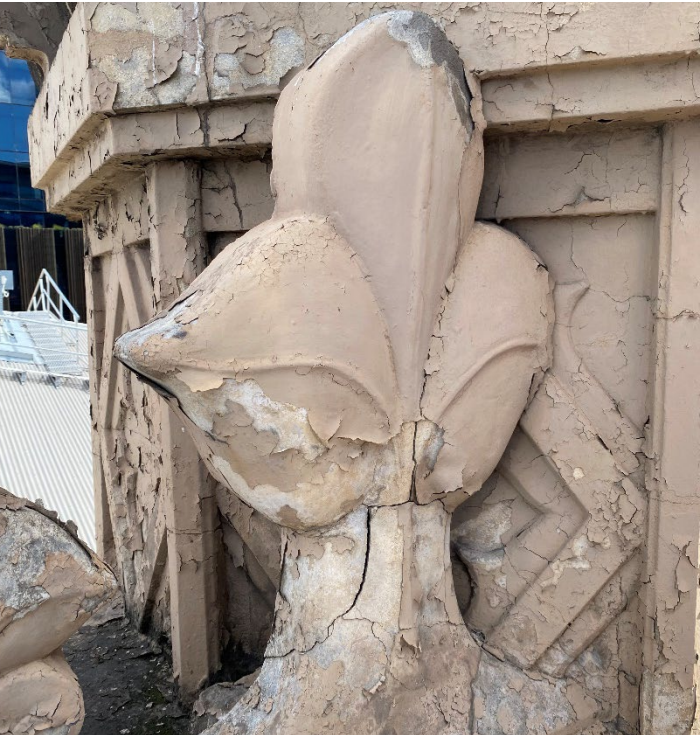
Figure 4
Parapet crenelations in poor condition and cracked through in a number of locations.

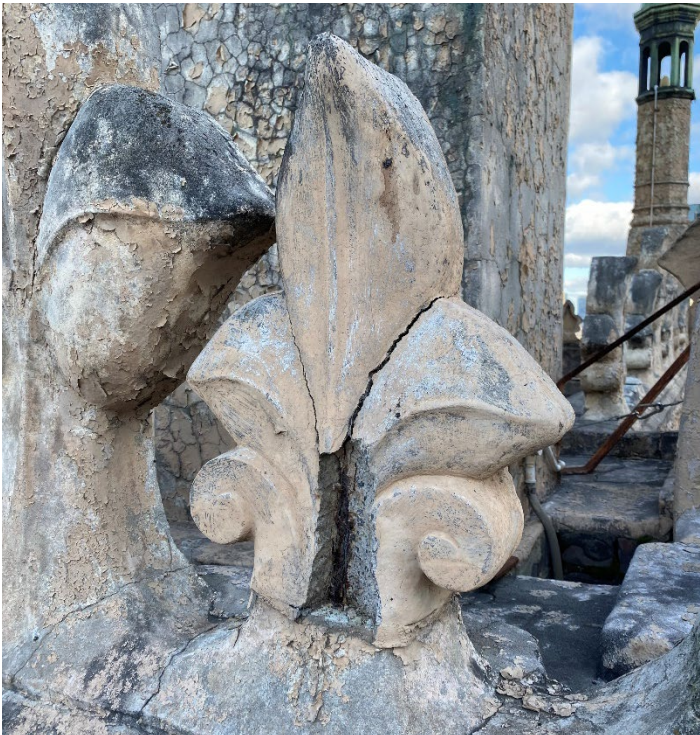
Figure 5
Spalling and cracker crenelations on the tower parapet.

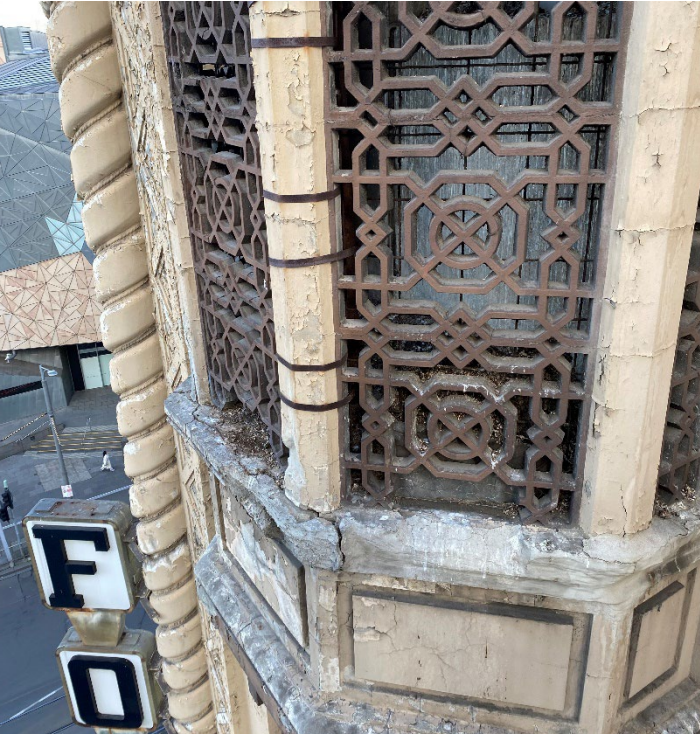
Figure 6
Dilapidated canted bay structure. Columns are vertically split due to corrosion of reinforcing and sills are spalling.

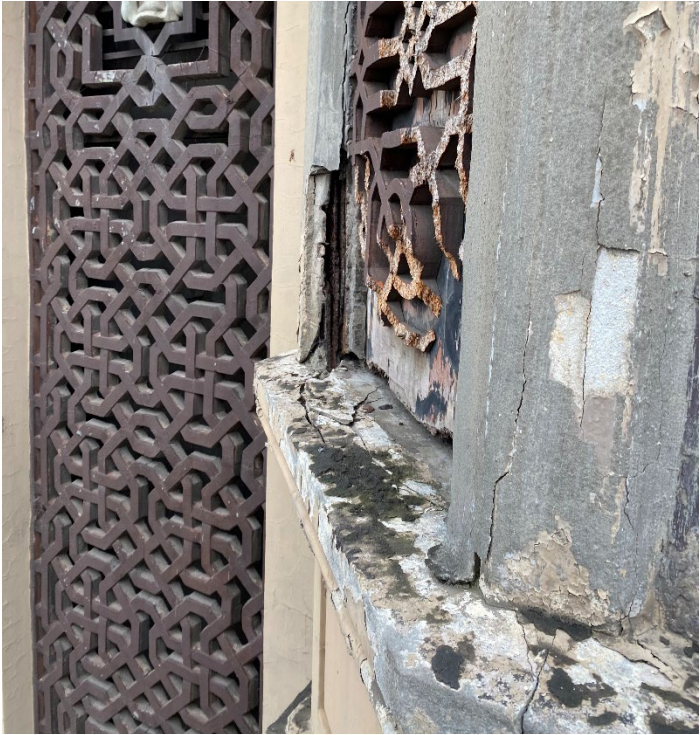
Figure 7
Canted bay columns busting apart as a result of corrosion of reinforcing.

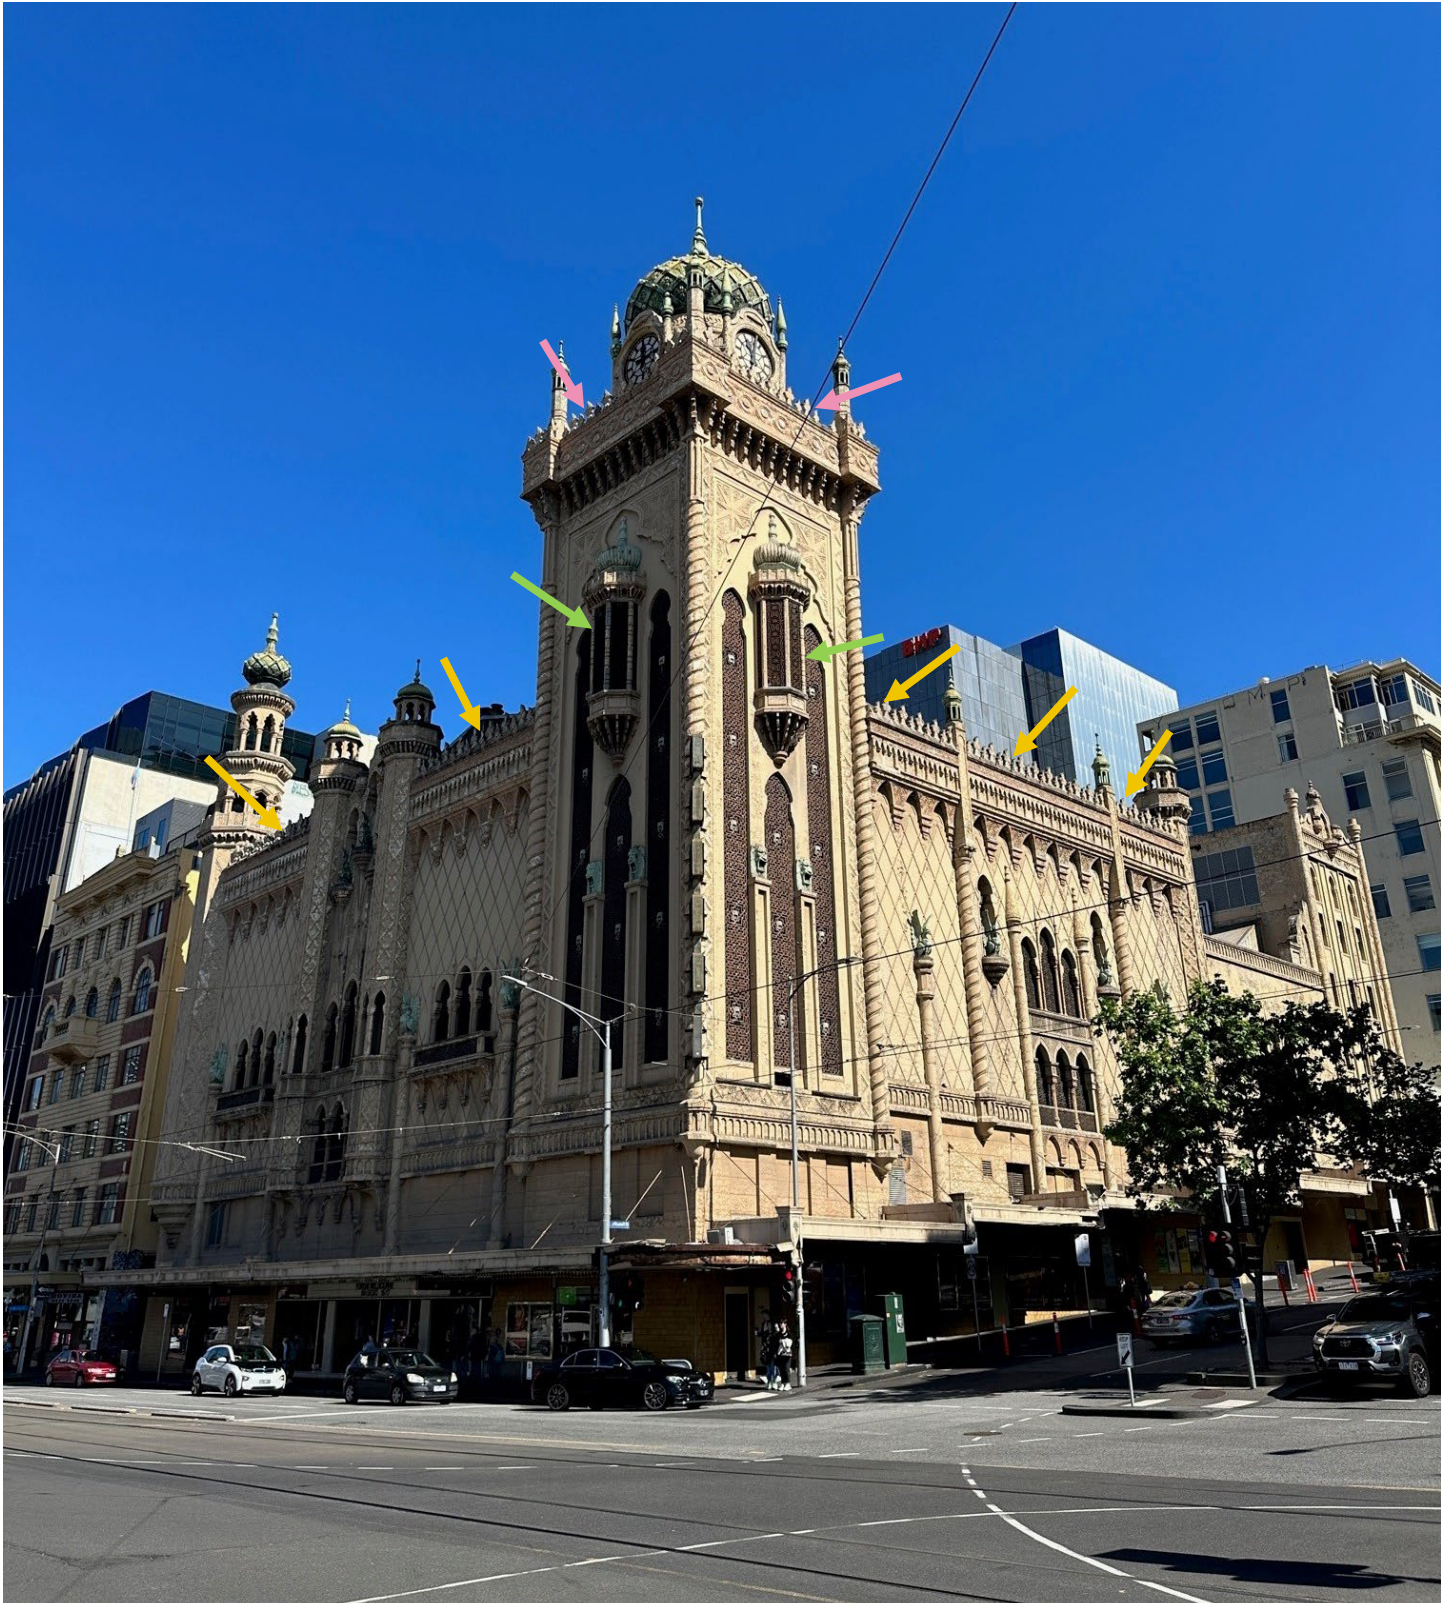
Figure 8

View of the Forum Theatre – green arrow showing canted bays – pink arrow showing tower crenellations – yellow arrow showing crenellations generally.

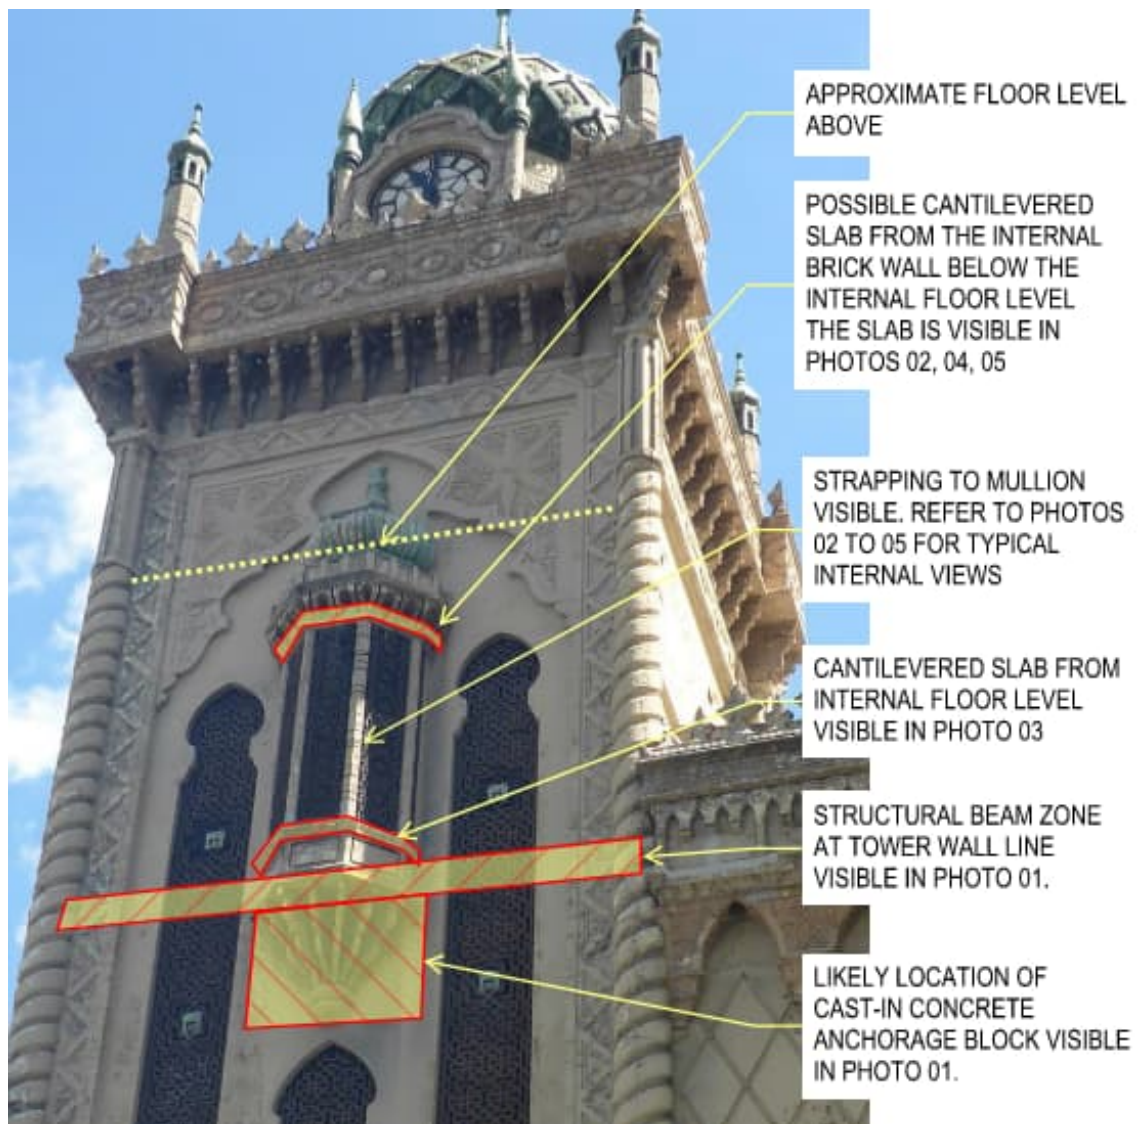
Figure 01: Eastern Canted Bay Window

At the top of the bay window screen, the soffit of a slab is visible that appears to cantilever from the brickwork wall below the upper floor slab and beam level. (Refer Photos 02 & 04). This also supports the upper corbels and copper dome.

At the base of the screen, a structural beam zone aligns with likely parapet and roof support to the north. From this a slab appears to cantilever out, perhaps from floor level but this has not been confirmed. This supports the base of the mullions and screen as visible in Photo 03. Within the tower, immediately below the balcony, a large cast in concrete block is built within the masonry, likely to support the precast concrete corbels. Whether these corbels are load bearing or decorative is unclear at present.

The condition of the concrete mullions is very poor. Extensive internal corrosion and spalling is evident to both the mullions and the underside of the upper slab, with additional external spalling of the base of the balustrade also visible. At some point in the past – potentially during the 1980's refurbishment – acrow props have been provided between the upper and lower slabs behind each mullion and light metal strapping provided to laterally support the mullion.

The acrow props provide additional vertical tying between the upper and lower slabs, but do little to stabilise the mullion, slab and corbel fabric against spalling and loss of sections of concrete. Spalling is evident and exposed reinforcement is visible in the mullions. The mullions themselves appear to be precast elements and are very slender. Repairing them in-

situ will be difficult and involve removal of the screens, further temporary support installation and extensive insitu repairs. The repairs will need to expose mullion reinforcement where corroded or in spalled areas, clean back to sound and unaffected material, repair or supplement reinforcement and reinstate adequate cover to the bars. The extent of existing concrete removal will be extensive and likely to be on all sides. The existing concrete will likely be fully carbonated so even if an area of reinforcement is not currently spalling, there will be no long-term protection against future potential water ingress and corrosion.

On the basis of the above observations, the danger of spalled sections of concrete falling is considered high and the probability of successfully executing a long-term repair of the mullions, balustrade and slabs in-situ in a safe and effective manner is considered to be very low. I therefore support the Conservation Studio recommendation that the canted balconies be immediately dismantled and rebuilt, reinstating as much of the original corbel, screen, dome and other elements as possible. New mullions should be fabricated or poured in situ to details to be confirmed after demolition. Slabs may be able to be repaired but this needs to be confirmed at the time of the works.

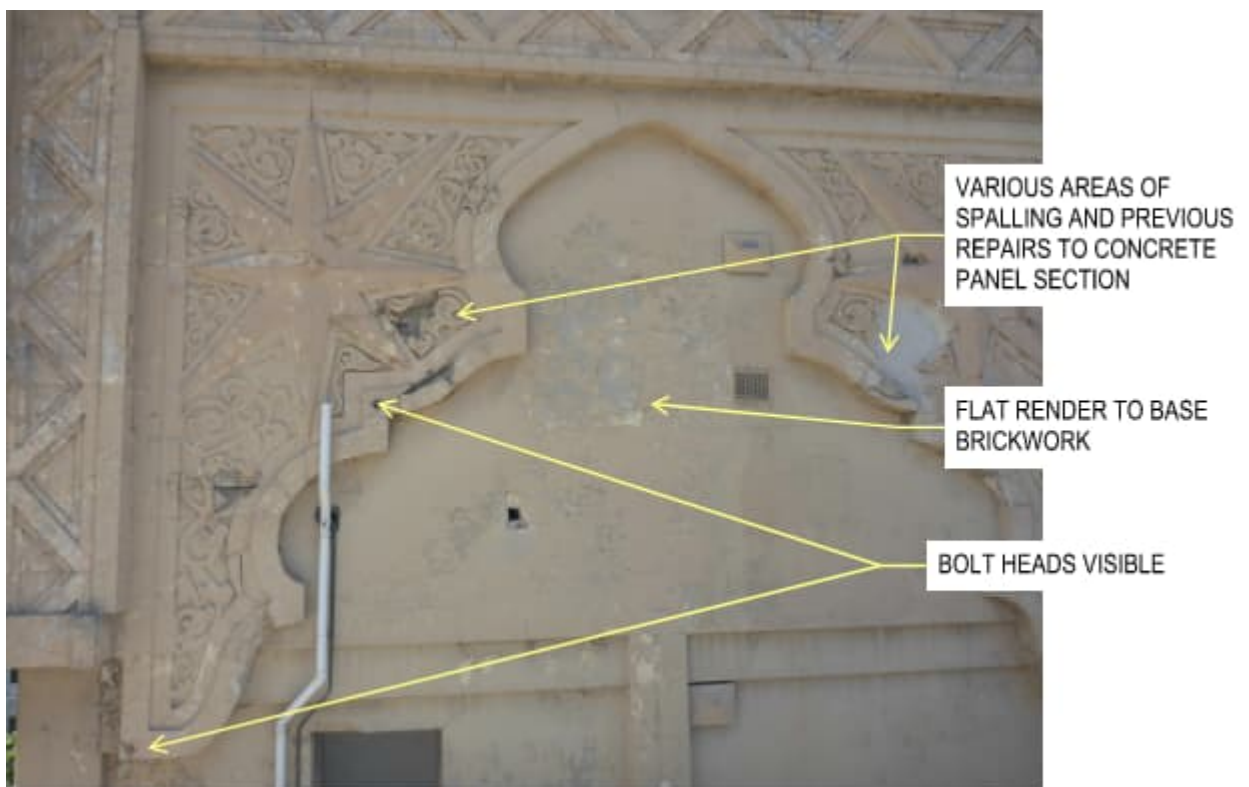
Figure 02: Typical concrete panel embellishments

If the panels are simply tied back to the base brickwork with metal anchors of some form, then it is possible that the support is compromised, given the corrosion to the general reinforcement. Investigation is recommended into the panel support as a priority, along with at least temporary stabilization or removal of spalling surface layers.

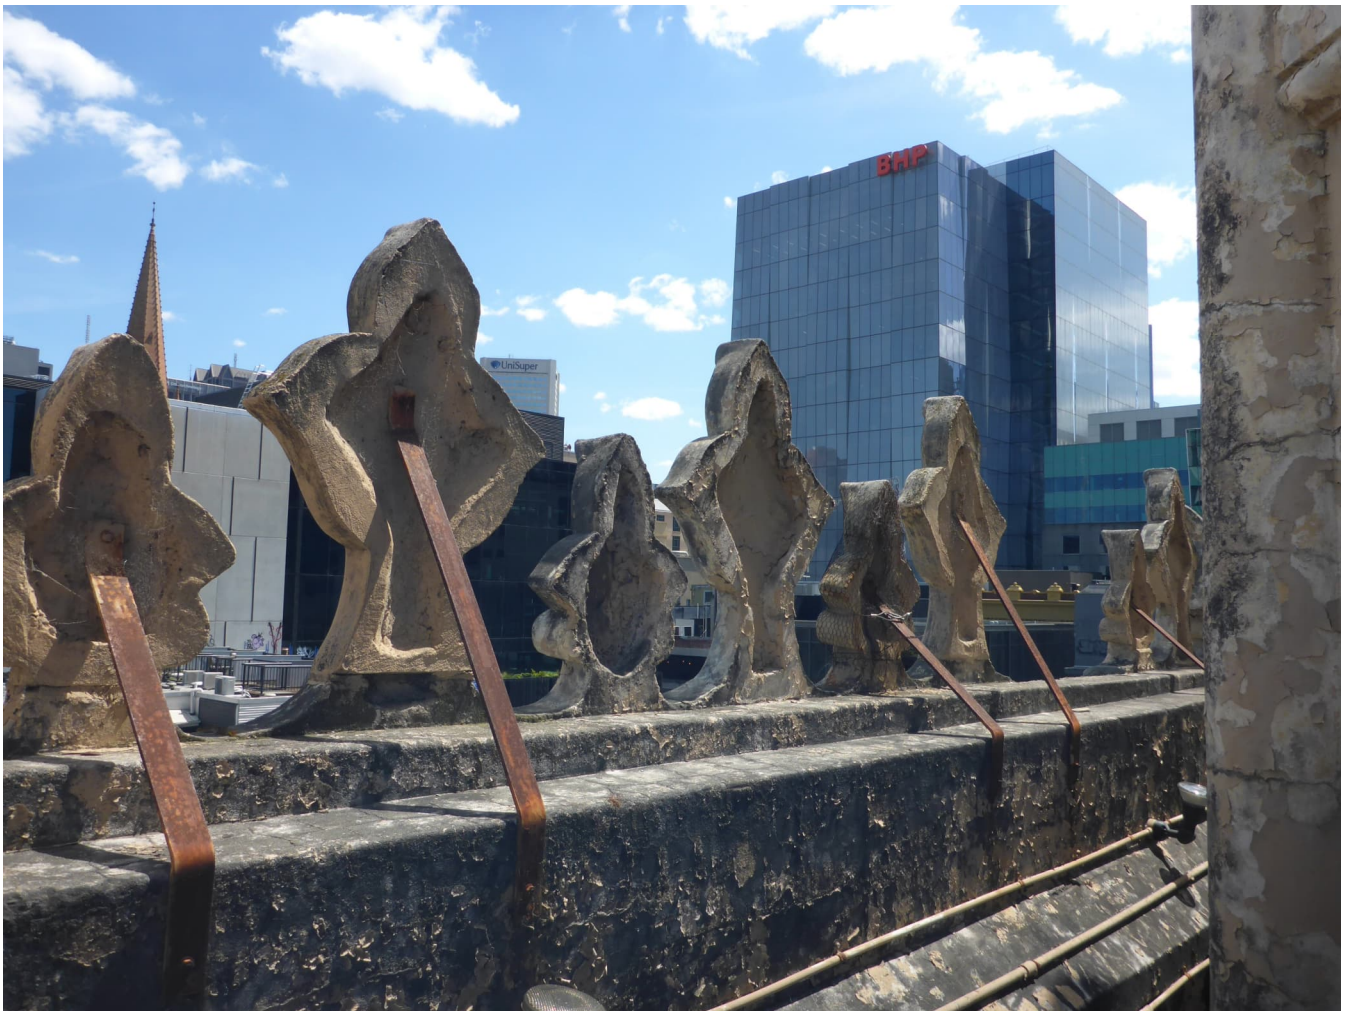
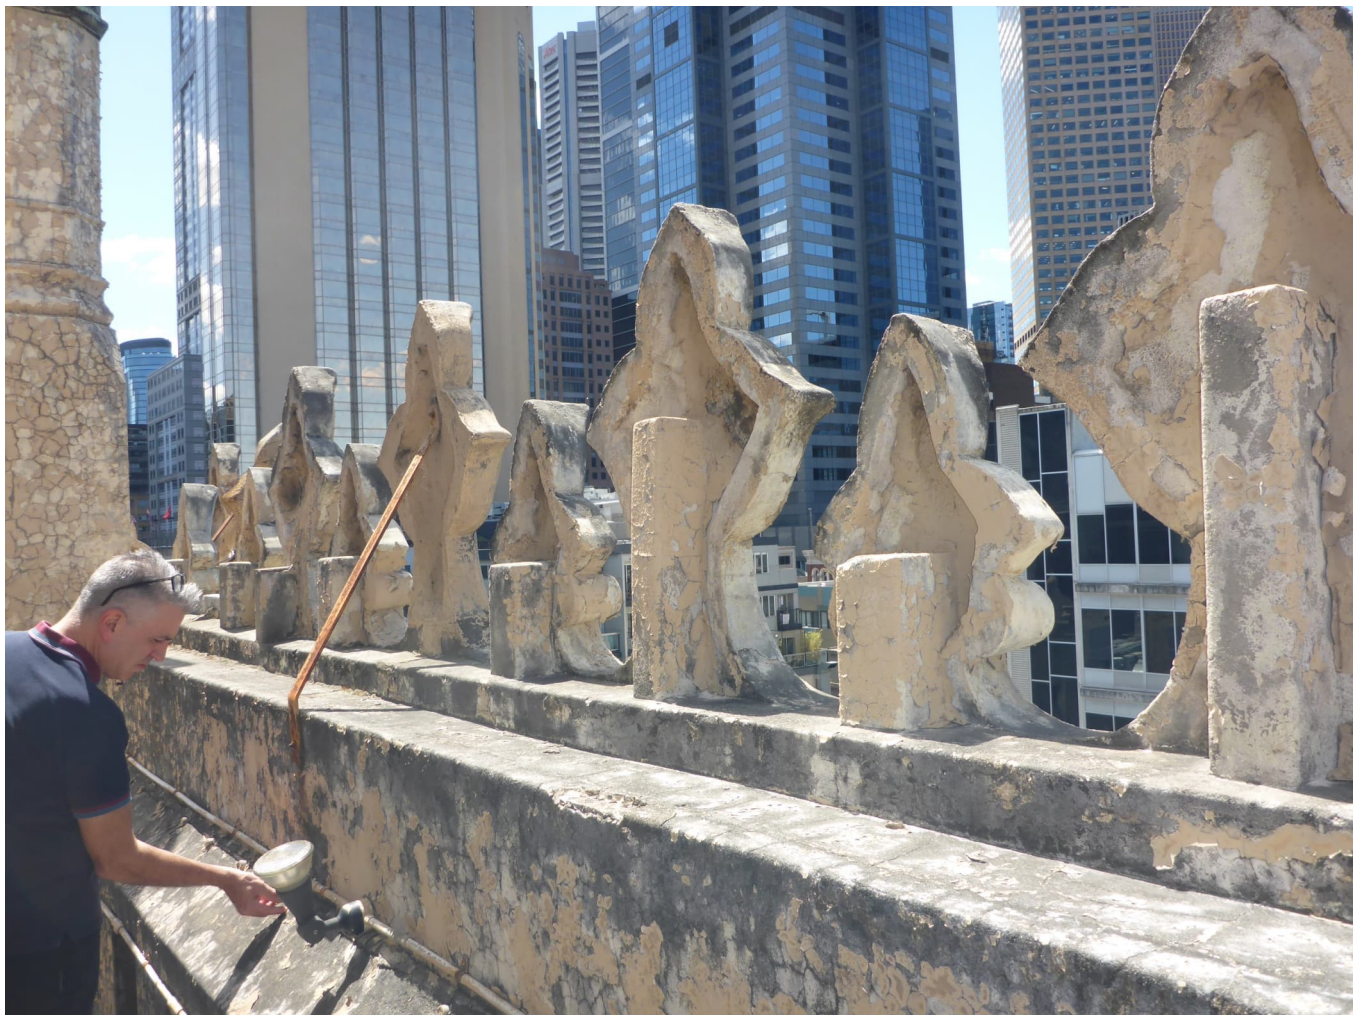
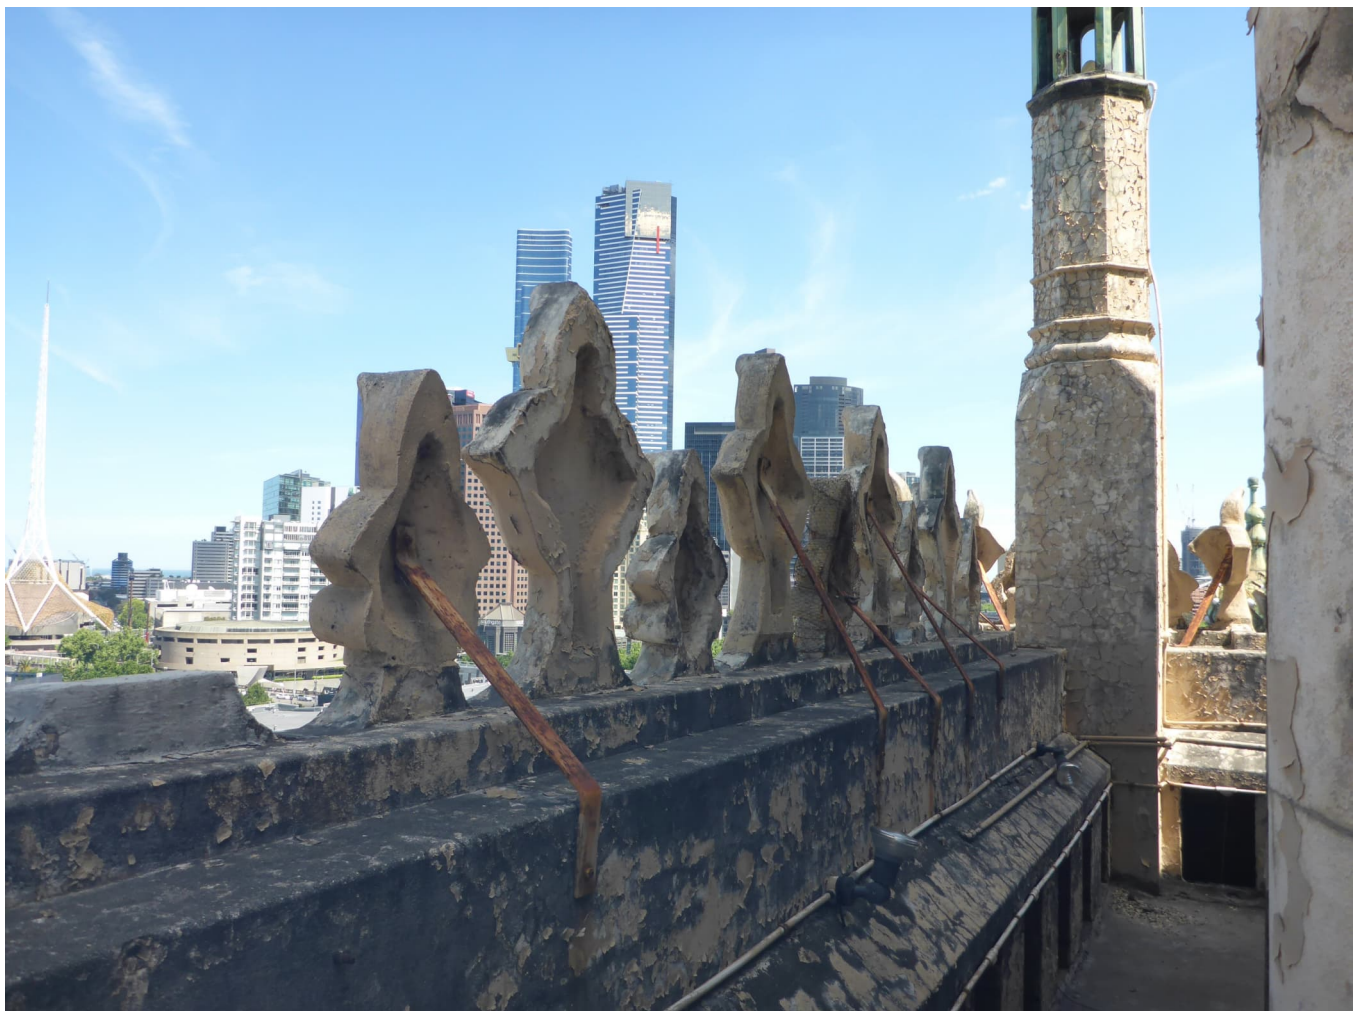
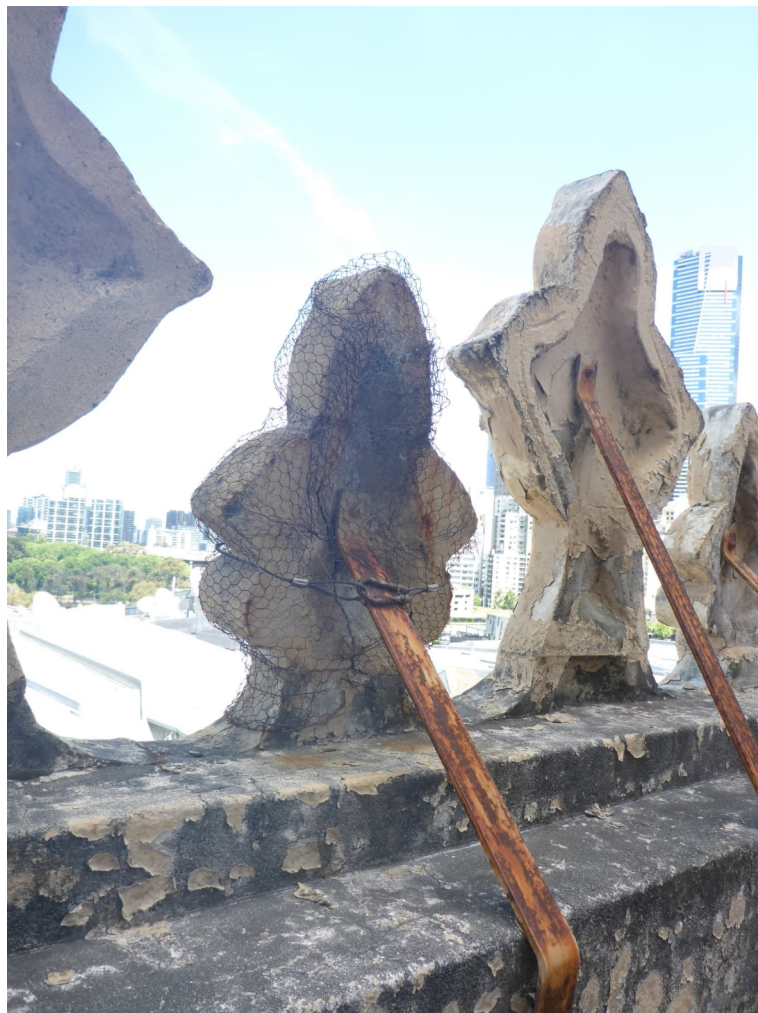
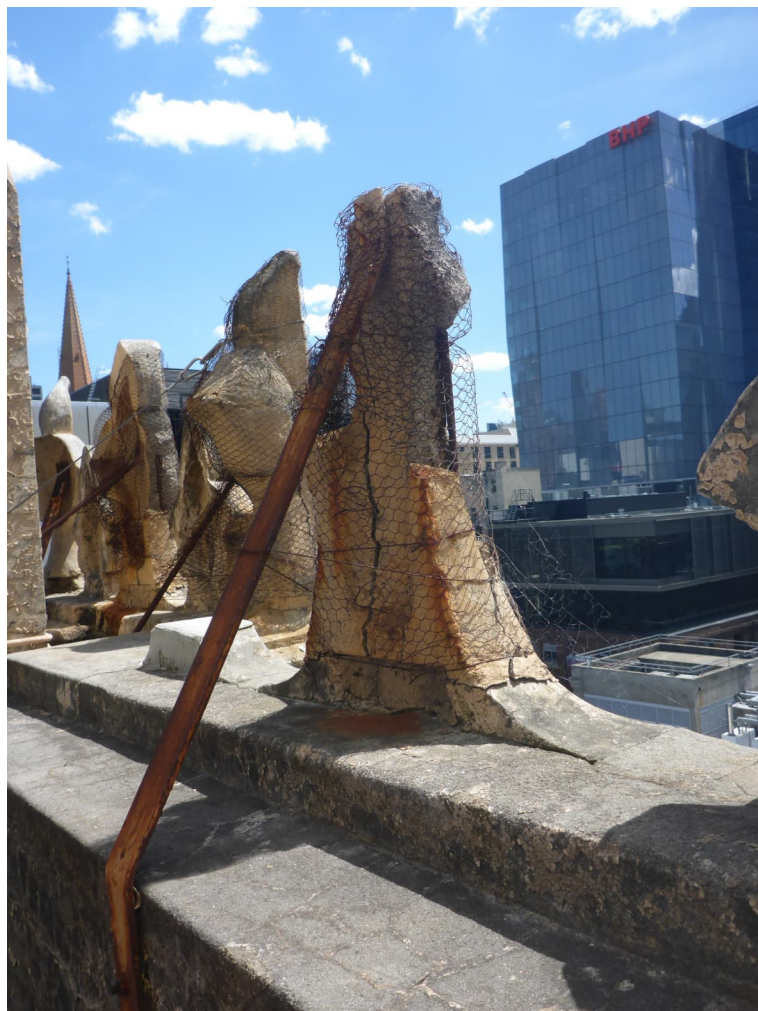
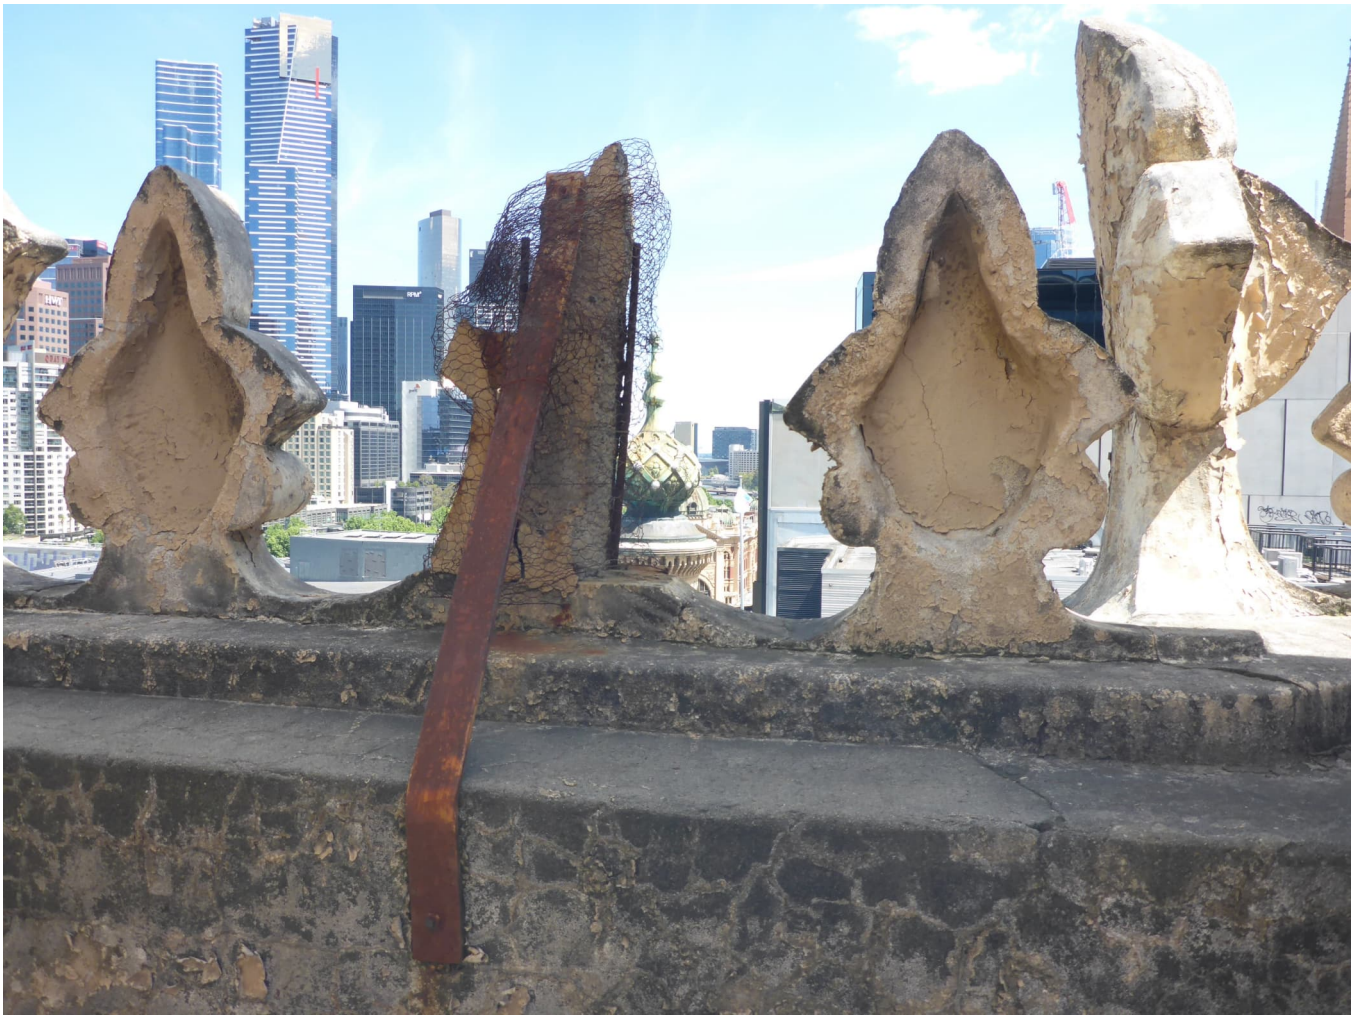
Photos 06 to 11 show various typical views of a pressed cement crenelations along the tower upper balustrade. Many, or most of these have been provided with supplementary metal support and wrapped in a light wire mesh. One or two have been tied back with a short cable as shown in Figure 03 below. The temporary support and mesh is past end of life and the units have continued to deteriorate since it was installed. The stability of these units is parlous both in terms of local spalling and overall stability and they are considered dangerous. I support the Conservation Studio recommendation to remove and store for replication and reinstatement as an urgent priority matter.
