Structural Compliance Strategy

**Cable Tram Engine House
253-263 Brunswick Road, Brunswick**

Prepared for Bensons Property

04 APR 2025

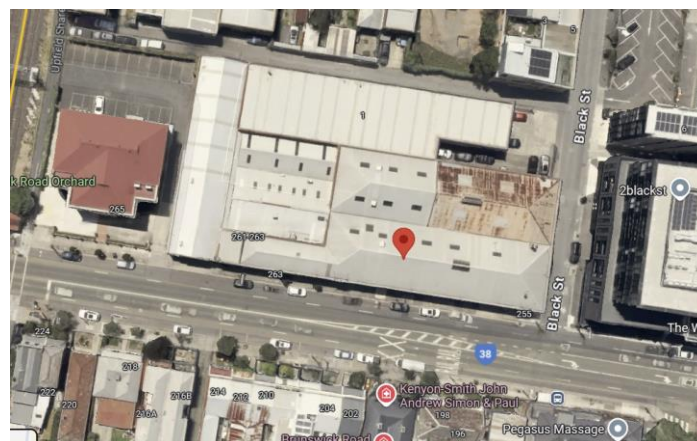
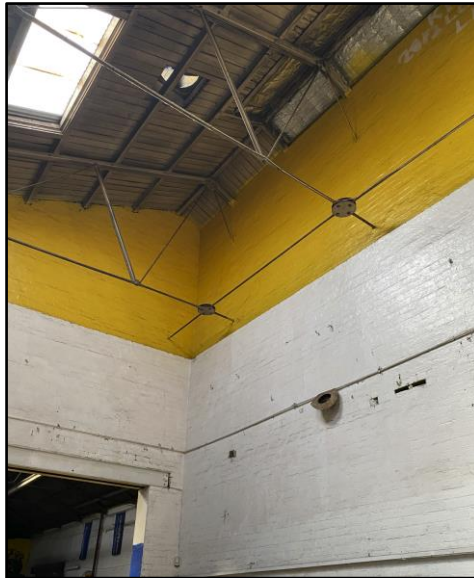
- At the time of inspection, part of the roof trusses structural elements can be seen to be concealed inside the internal brick walls (Figure 6). TTW anticipate these internal brick walls were built after the construction of the roof structure and considered as non-load bearing walls. An indicative location of the internal brick walls can also be referred to Figure 8 on plan

Figure 6 Roof truss bottom chord concealed inside masonry walls

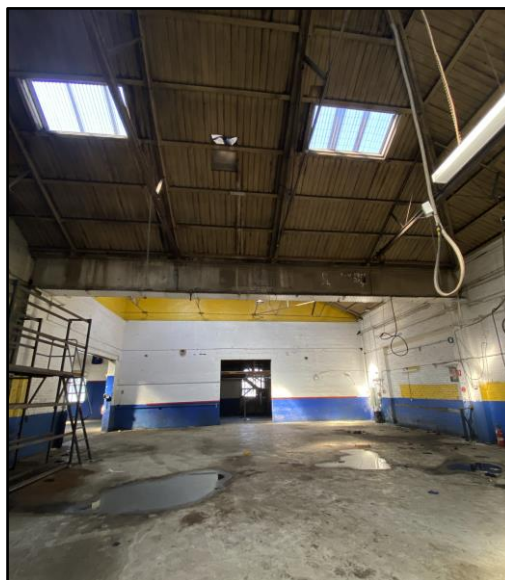
- A riveted transfer beam spanning at the east west direction which separates the northern roof and southern roof bay can be identified on site. This transfer beam is suspended over the steel columns and continues along the existing eastern brick walls (Figure 7 and Figure 8)

Figure 7 Riveted transfer beam

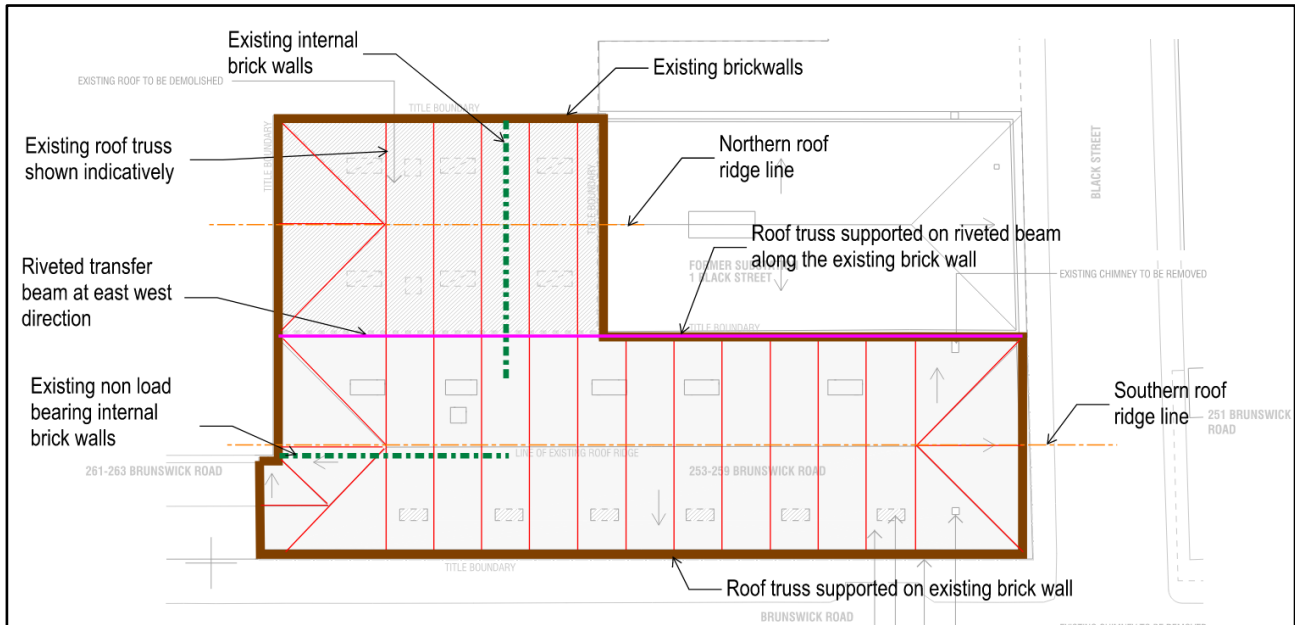
At the time of inspection, the building structure appeared to be generally in good condition, with no visible signs of cracking or foundation settlement. The arrangement of the roof structure framing can also be summarized in the existing roof plan (Figure 8)

Figure 8 Indicative arrangement of roof structural framing

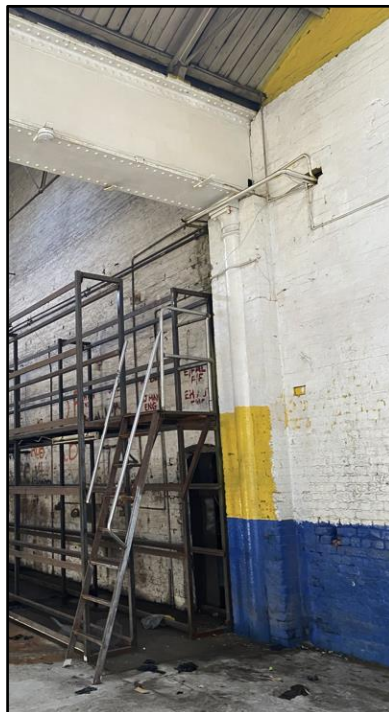
Given the age of the building, it is possible that the form of construction could vary from this. One alternative possibility is wrought-iron riveted beams. On site observation (Figure 9) also shows the form of construction to be identical to the 19th century cast-iron frame construction (Figure 10)

Figure 9 Site observation of riveted beam and steel column

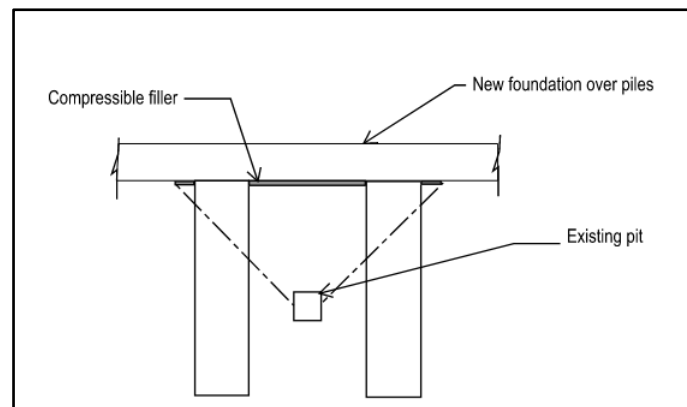
From the Heritage Victoria's letter, TTW also noted that under the former cable tram engine house building may contain deep underground pits, remains of underground tank and the existing footings of the chimney stack. It is important to conduct a detailed geotechnical investigation and feature underground scan prior to the next design stage. This is to avoid any intrusion to the construction of the new foundation. The alternative to the clash of existing pits or tanks with the new foundation is via a structural bridging detail (Figure 16).

Figure 16 Structural foundation bridging detail

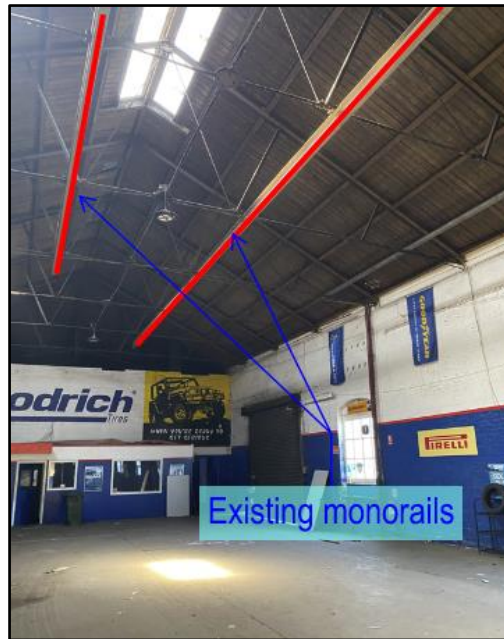
TTW understand the space within the former cable tram engine house will be occupied in the future and additional roof insulation is expected. From the site inspection, it can be observed that the eastern roof bay consists of steel monorails that tied under the roof truss bottom chords (Figure 17). It is assumed to support manoeuvring any heavy equipment during the operation of the building, hence there is a potential allowance for additional roof weight within this zone. The structural integrity of the roof trusses including the connection shall be further investigated to ensure the structural adequacy of any new additional roof weight.

Figure 17 Monorails at the underside of roof truss bottom chords

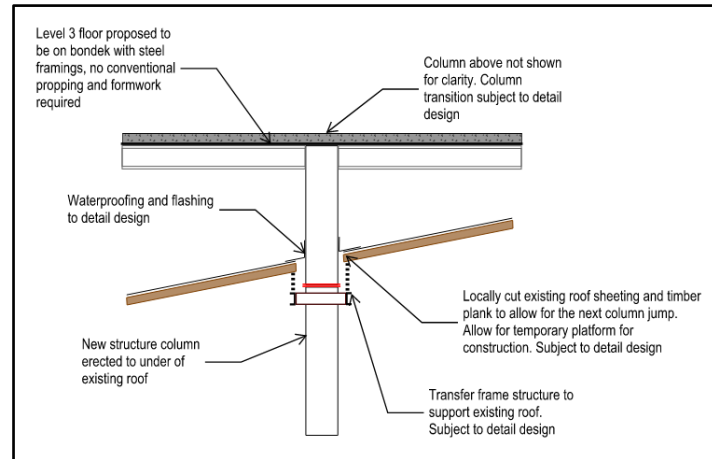
Figure 19 Proposed construction detail at roof penetration

The new structural columns below the proposed Level 3 floor are steel encased concrete columns. They can be erected to the underside of the existing roof and provide support for the trimmer beams of the new roof penetrations (Figure 19).

Without dismantling the existing roof, the roof penetrations can be locally removed after the trimmer beams have been installed. This will retain the structural adequacy and performance of the existing roof structure. Any waterproofing and flashing requirement over the existing roof will be further coordinated in the next design phase.
