7th December 2022

C+S Consult Group Reference N^o: CS22136

**ENGINEER'S REPORT ON DAMAGE TO WHITE HOUSE BUILDING, ST KILLIAN'S PARISH
161 MCCRAE ST STREET, BENDIGO, VIC, 3550**

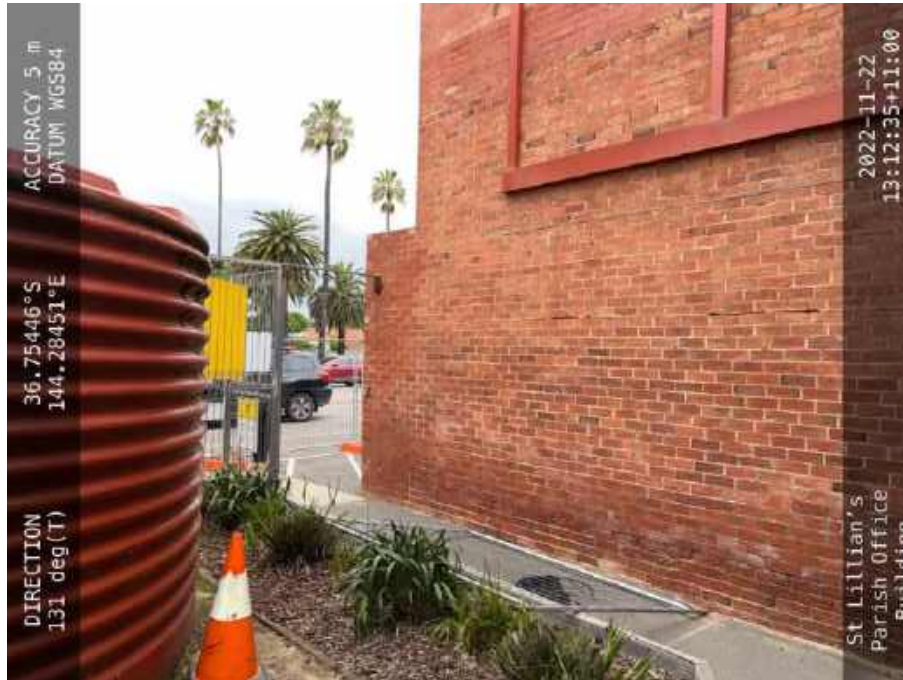
- 7 The remaining sink hole was found to be substantially larger, in both footprint and depth, and had undermined the foundations to a section of the North-Eastern wall of the White House Building (**subject building**).
Refer Figure 2 below for photo of the subject sink hole.

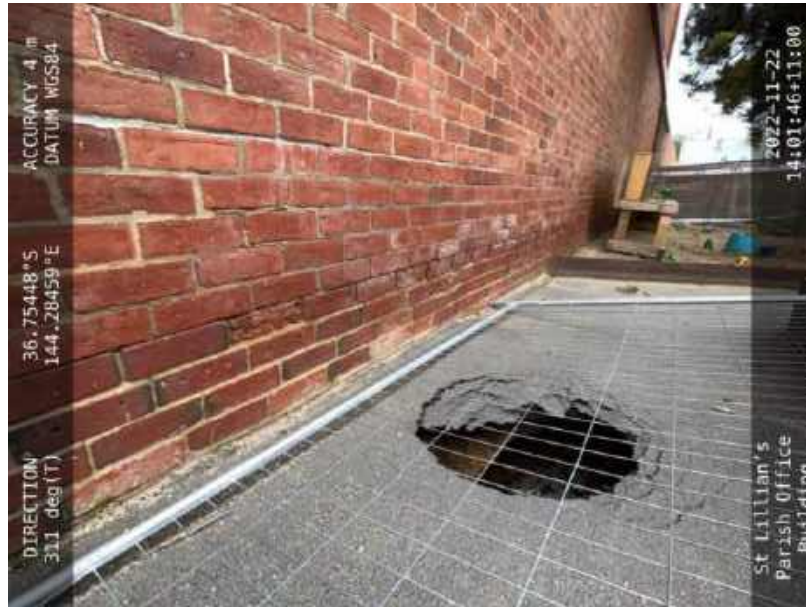
Figure 3 – Sink hole to North-East wall of building located within St Killian's Primary School site.

- 25 The ground subsidence has resulted in the footings to this area being undermined.

- 26 There is a risk that the structural stability of the substantial brick walls to the North-East and South-East walls of the building could be impacted by the footings being undermined.
- 27 Some *Moderate** stepped cracking was also noted to the North-East wall and South-East wall towards the Eastern corner of the building.

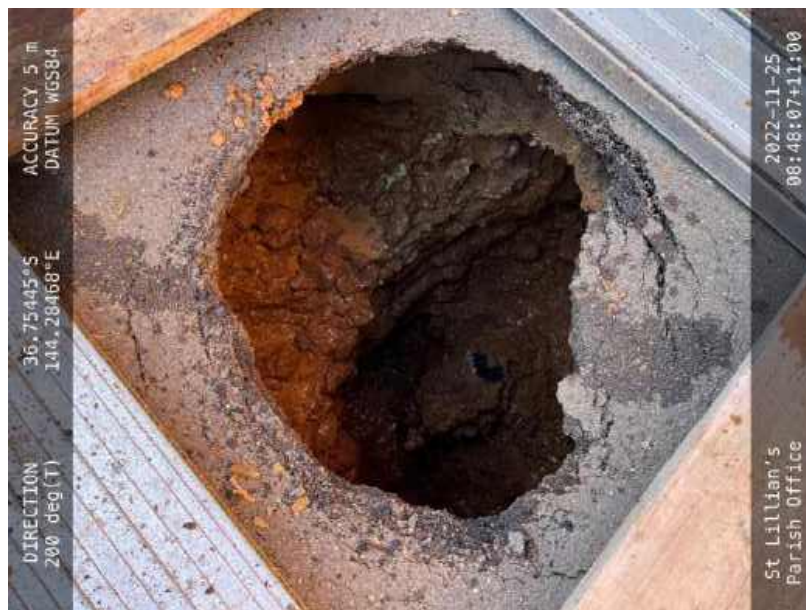
Figure 4 – Sink hole to North-East wall of building after hydro excavation.

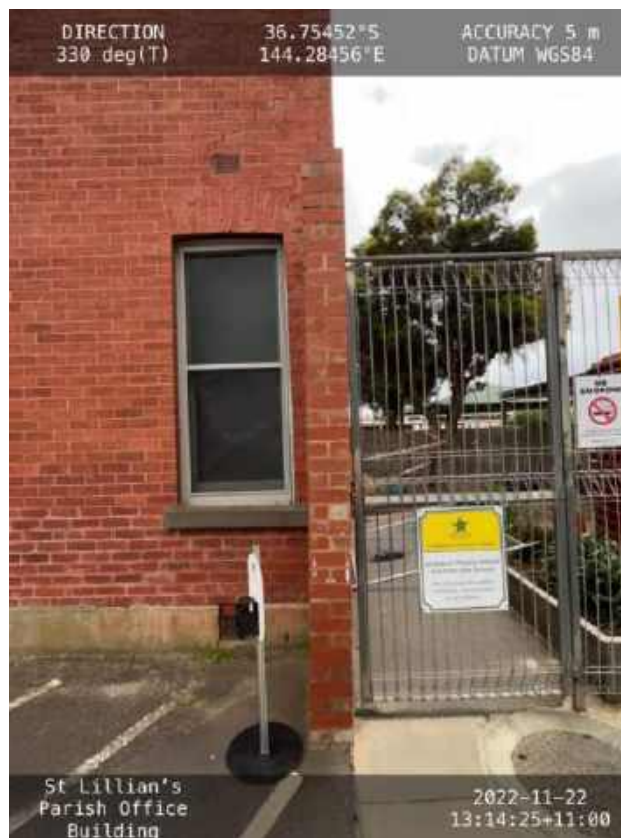
Figure 5: Blade wall significantly out-of-plumb.

- 29 The blade wall was found to be at least 60-70mm out of plumb over a 2400mm long spirit level.
- 30 This well exceeds normally accepted tolerance limits for outwards deflection.
- 31 Section 12 of AS3700 sets out tolerance requirements for masonry construction, which are tabulated in Figure 6 below. Whilst the tolerances are applicable to new construction, this still highlights the structural significance of the observed rotations.

- 32 Such lateral displacements place the centroid of the wall outside the middle third of the wall. This induces permanent tensile stresses in the wall due to bending caused by eccentric loading. Per AS3700, the flexural tensile strength of unreinforced masonry structures shall be taken as zero under permanent loading conditions. This suggests that the wall may be at risk of structural failure.

- 33 It is our opinion that this wall must be demolished due to the inherent risk of structural collapse.
- 34 Following consideration of the above existing conditions, C+S Consult Group recommended that a suitable exclusion zone be implemented for the affected area.

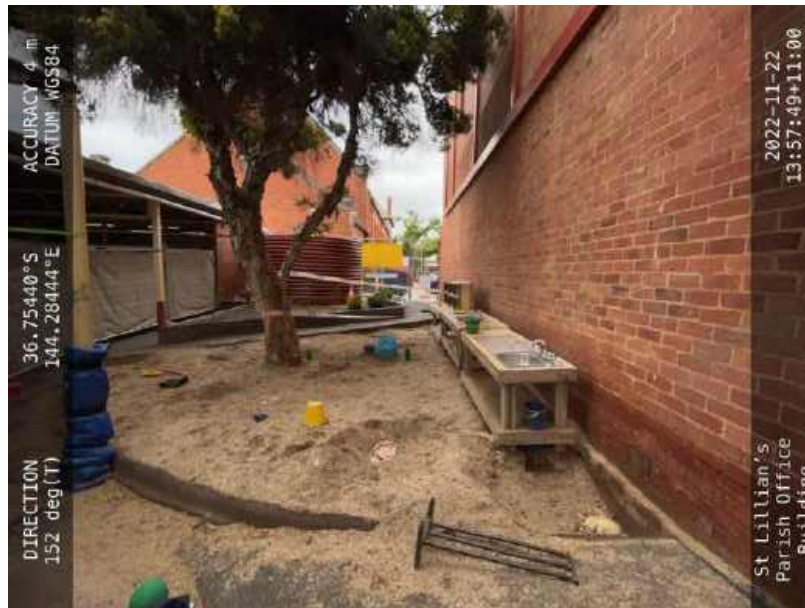
- 38 Further, surface drainage to the sandpit area against the North-East wall of the building is also very poor. The sand pit constructed against the North-East wall, as shown in Figure 5 below, provides opportunity for rainwater to pond and collect in this area eventually seeping into the soil below. This will create opportunities for variable moisture contents to develop along the length of the foundations to this wall which will cause differential foundation movement. This has likely had some contribution to the observed subsidence along the North-East wall.

Figure 5 – Sand pit constructed against North-East wall of building allowing for rainfall to seep into soils against building.

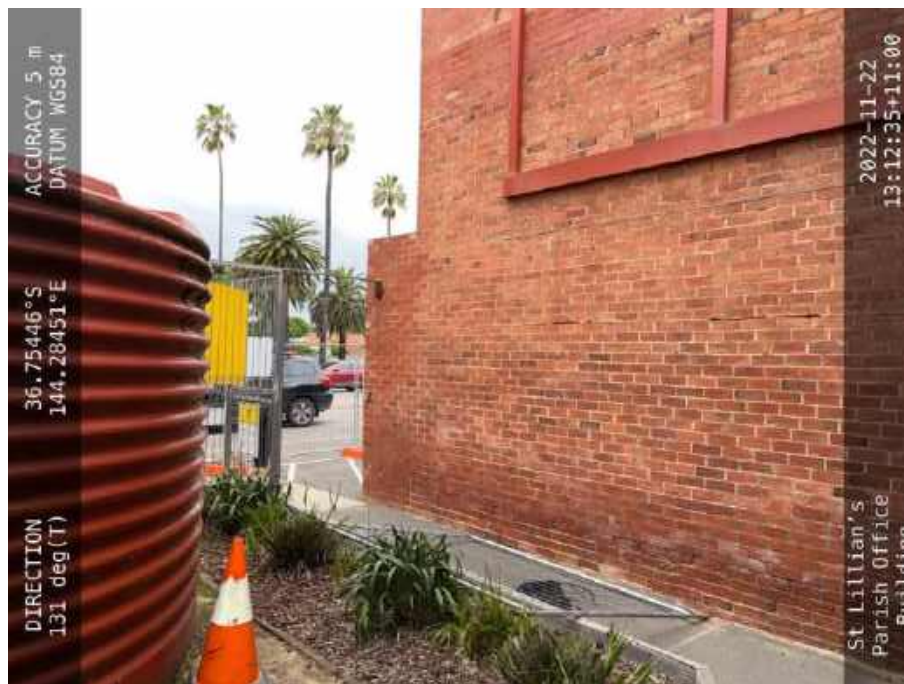
Photo 1 – Location of sink hole.

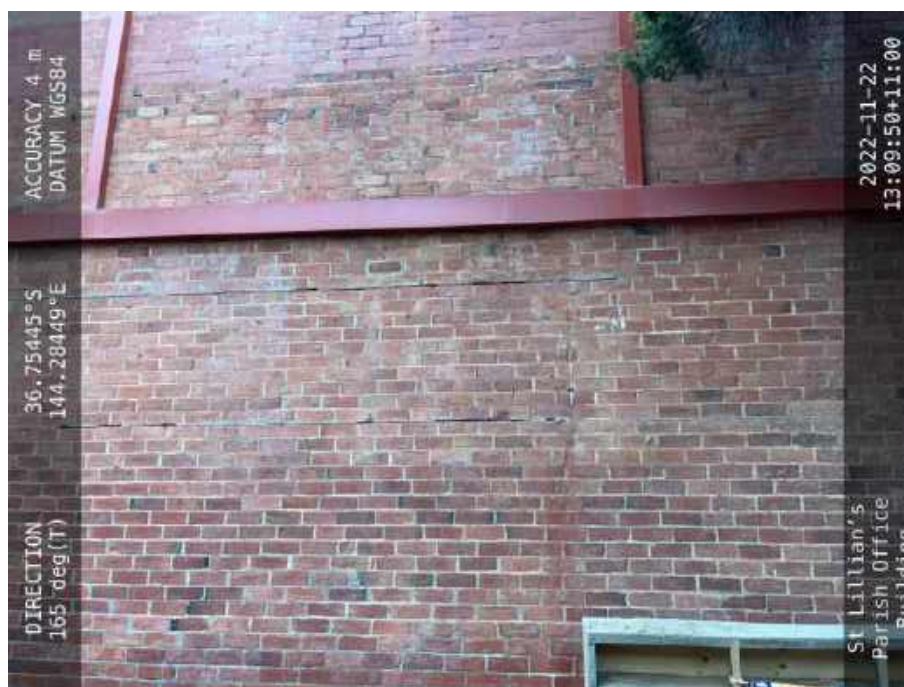
Photo 2 – Existing condition of brick wall in proximity to sink hole. Note cracking.

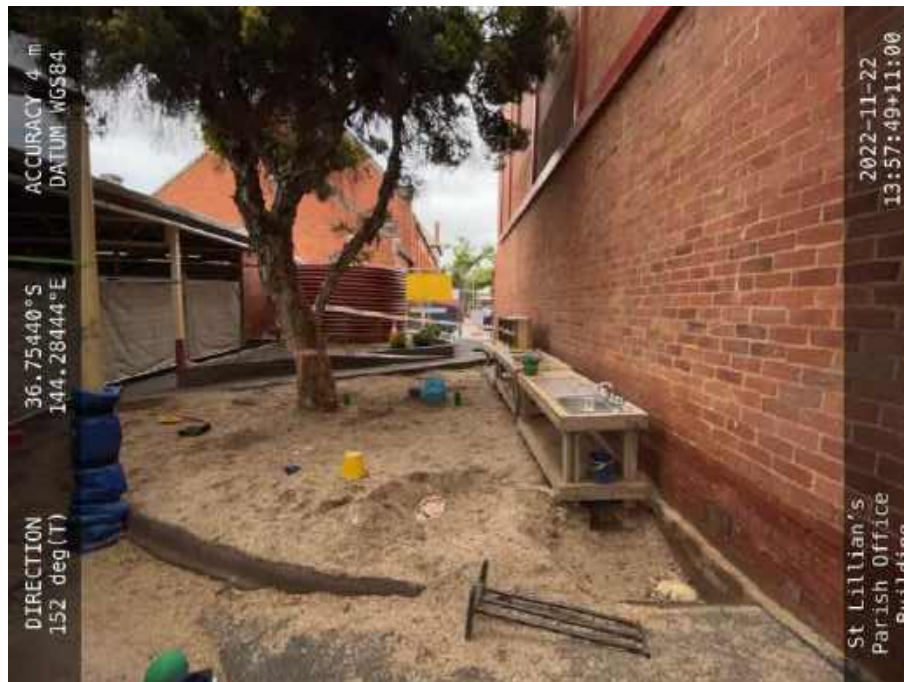
Photo 3 – Existing sand pit and tree in proximity to sink hole. Note also trench in sandpit against wall.

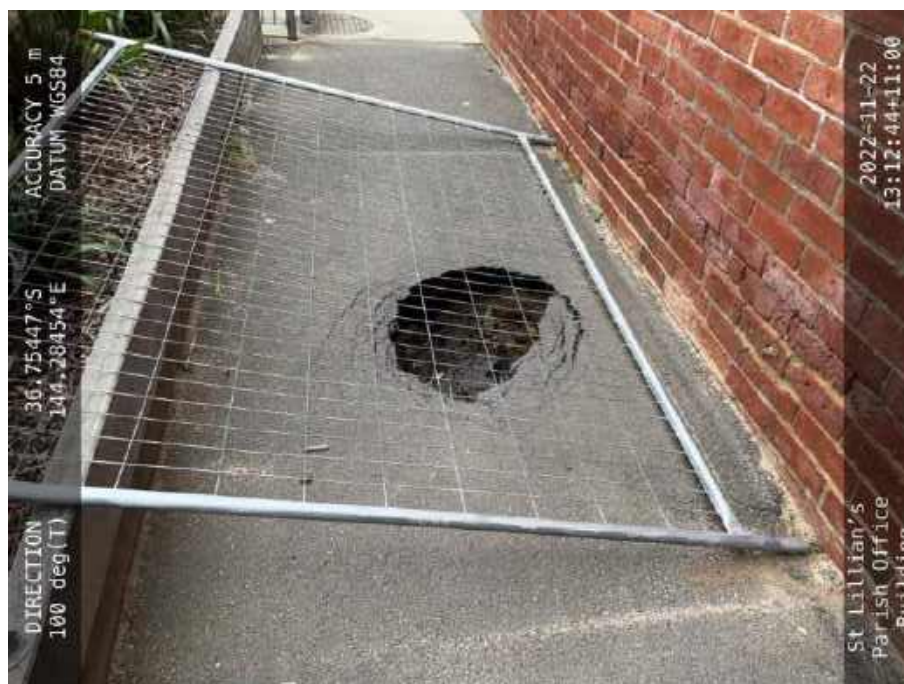
Photo 4 – Sink hole condition at first inspection.

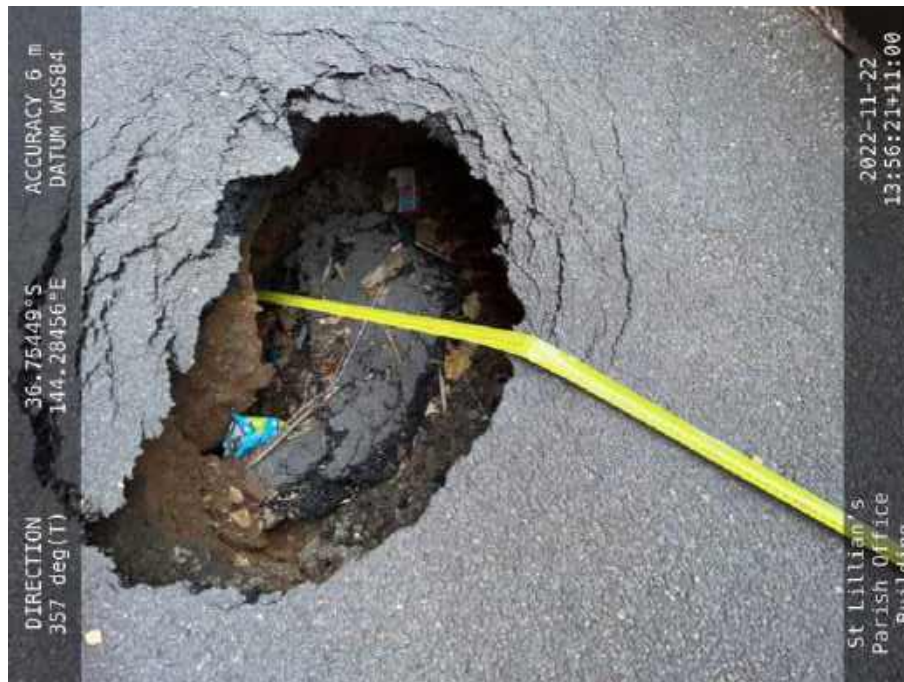
Photo 5 – Sink hole prior to excavation.

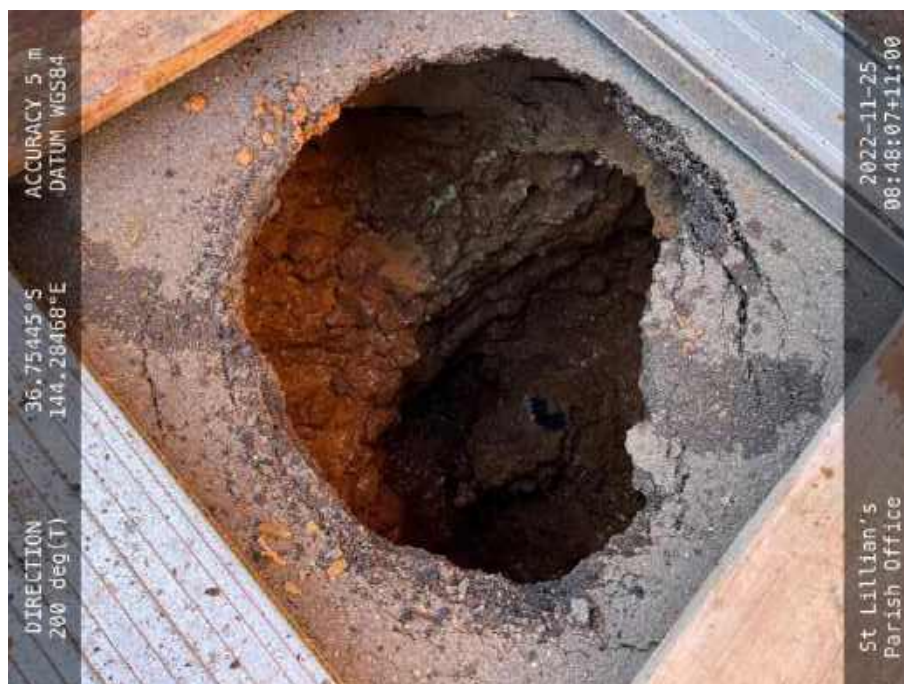
Photo 6 – Sink hole following hydro excavation.

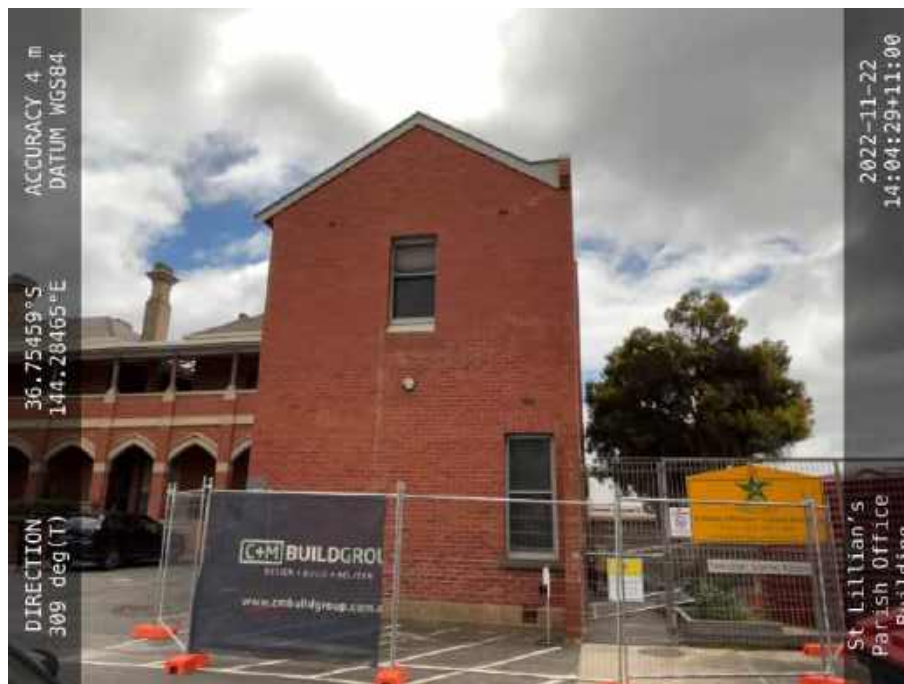
Photo 7 – Existing conditions to South-East wall of building.

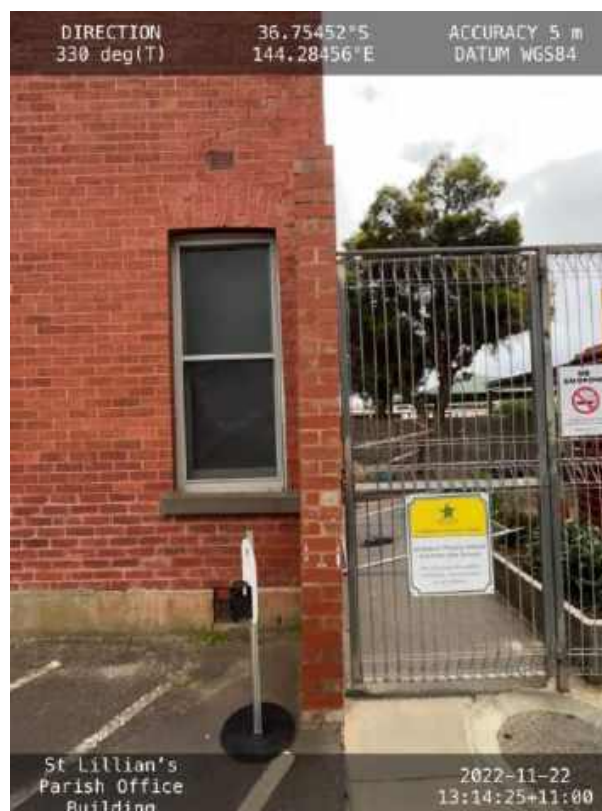
Photo 8 – Blade wall to Southern corner of building with significant out-of-plane rotations.

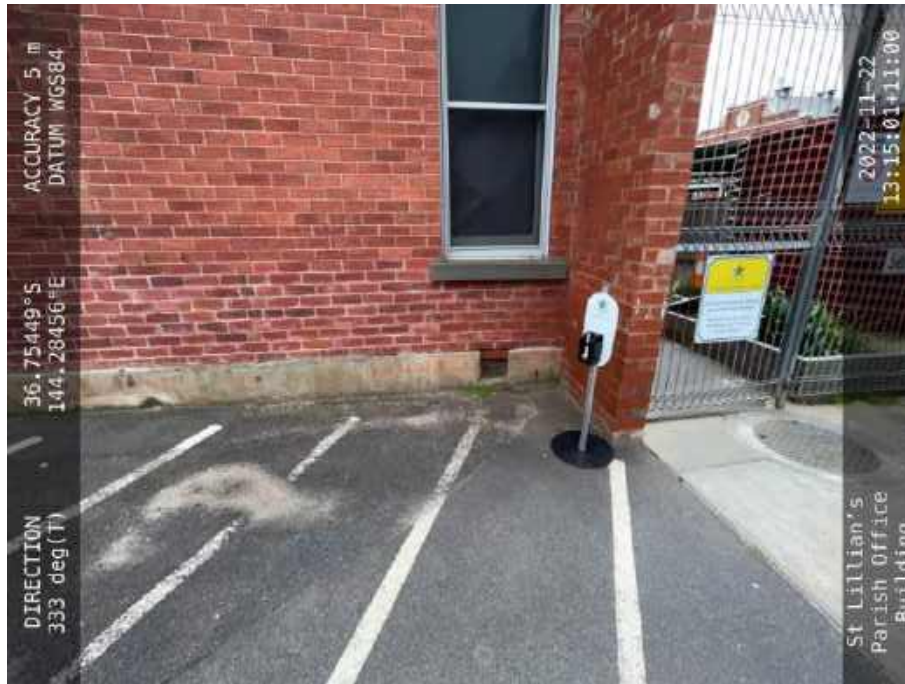
Photo 9 – Existing condition along South-East wall of building near sink hole. Note rising damp to base of wall and brickwork cracking.

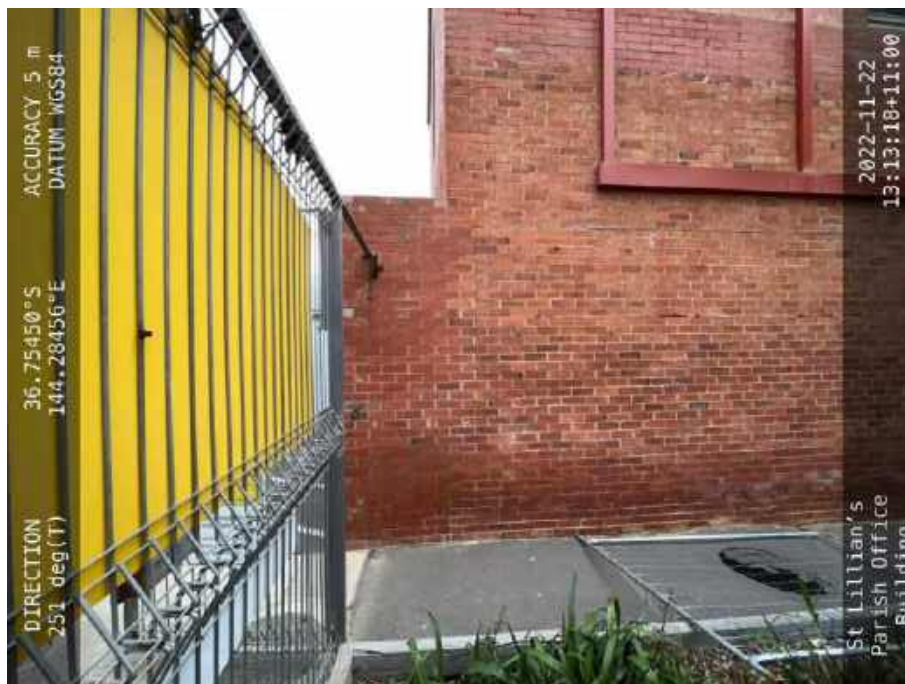
Photo 10 – Existing condition along North-East wall of building near sink hole. Note rising damp to base of wall and brickwork cracking.

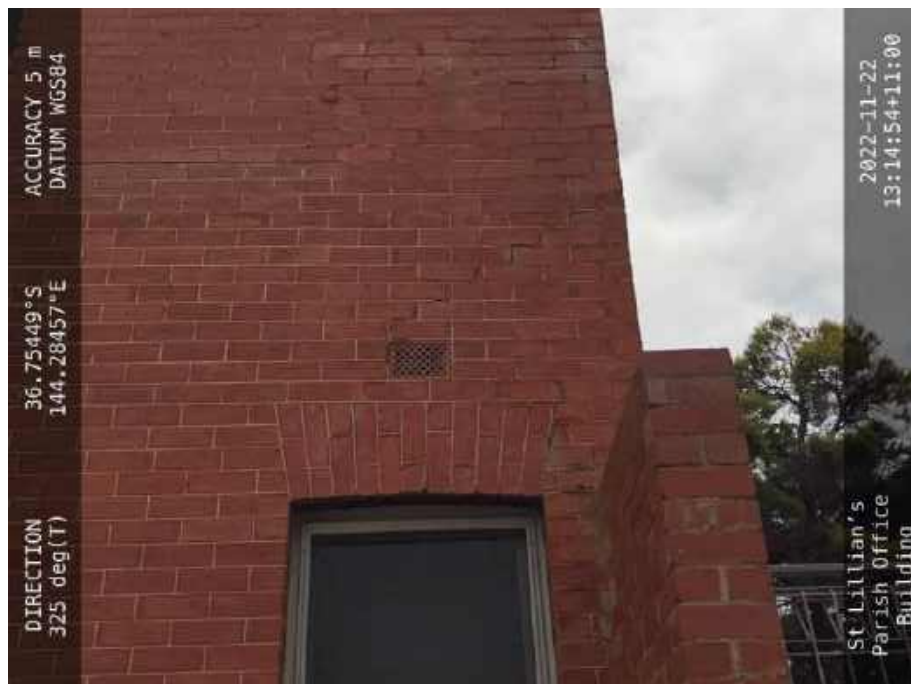
Photo 11 – Stepped cracking damage to Southern corner of White House building.

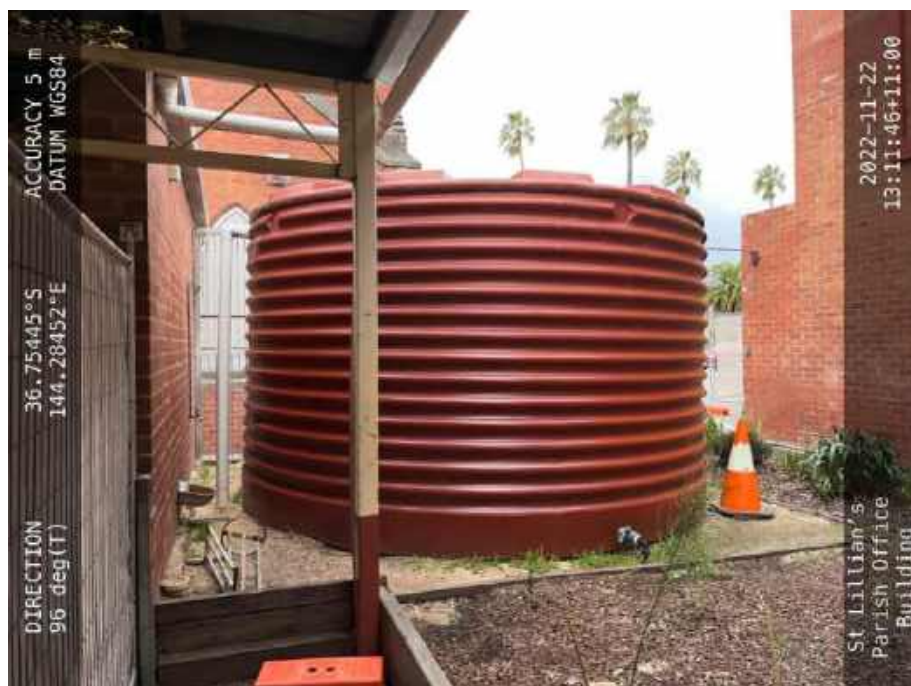
- 39 At the time of inspection, the rainwater tank adjacent the North-East wall, in immediate proximity to the sink hole, was found not to be full and the outlet tap at the base of this tank was not fully shut. Given the significant amount of recent rainfall received to the Bendigo area it is unusual for this tank not to be full which could indicate a potential leak or ongoing discharge that may have contributed to the observed ground subsidence.

Photo 12 – Rainwater tank found not to be full at the time of inspection. Outlet valve to base of tank also found not to be fully shut.

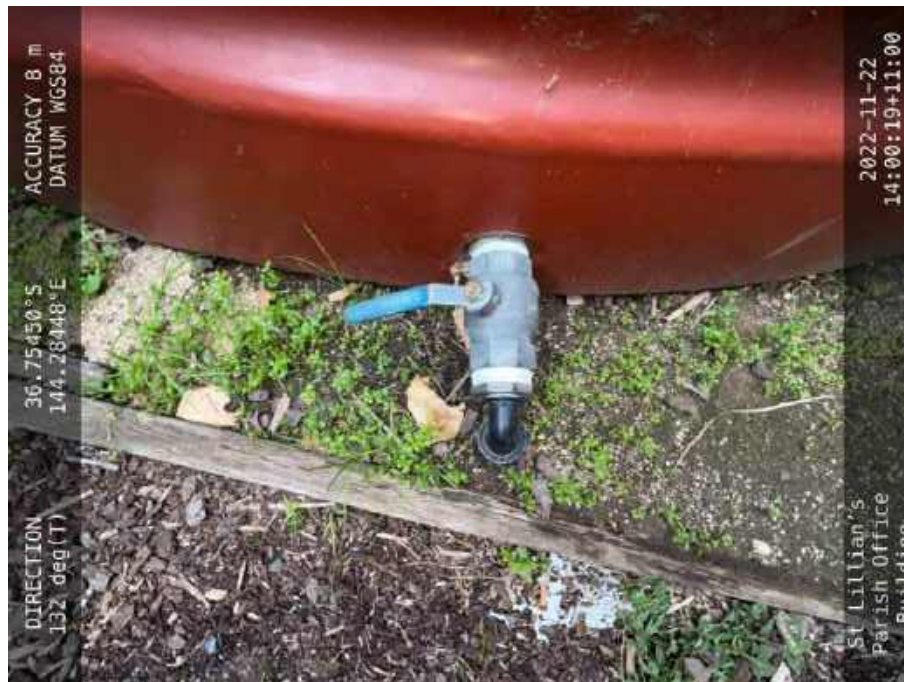
Photo 13 – Damp soil was found to the base of the tank outlet.

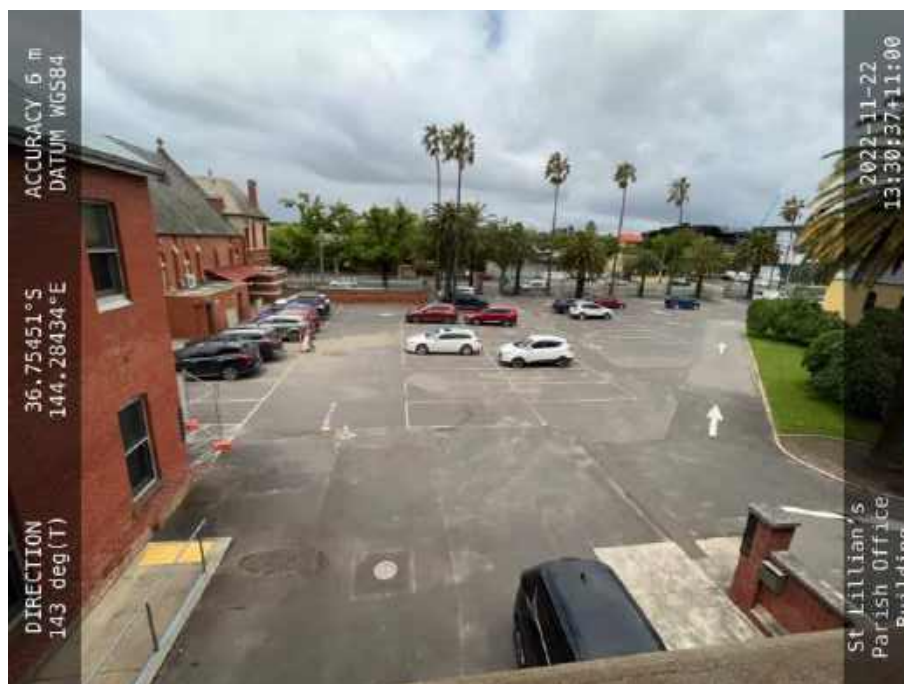
Photo 14 – Overview of existing carpark to St Killian's Parish. Note no surface drainage.

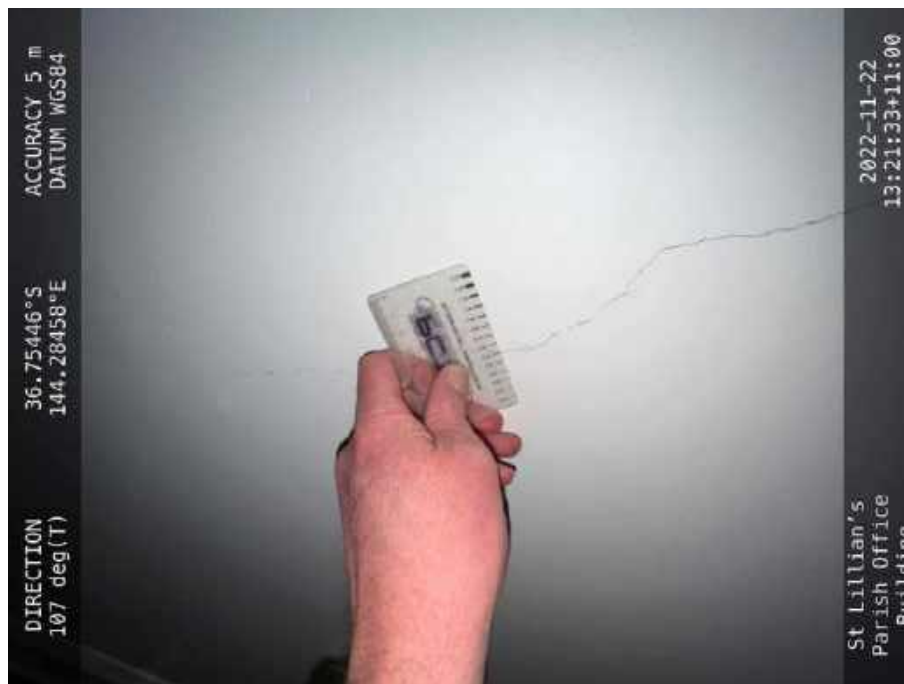
Photo 15 – Typical cracking to hard plaster to interior of White House building.

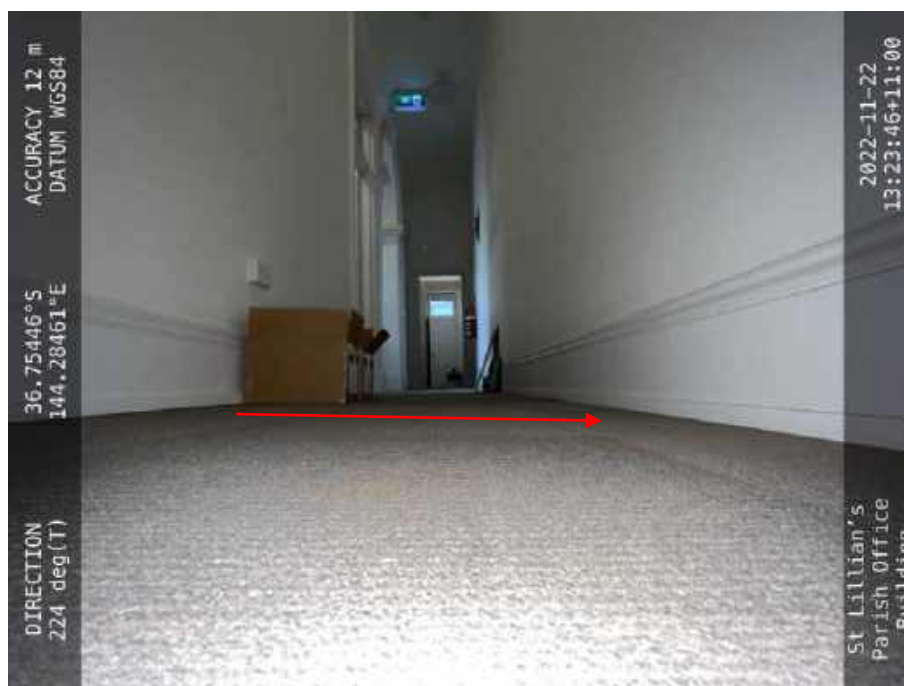
Photo 16 – Local grade in floor against North-East wall of White House building.

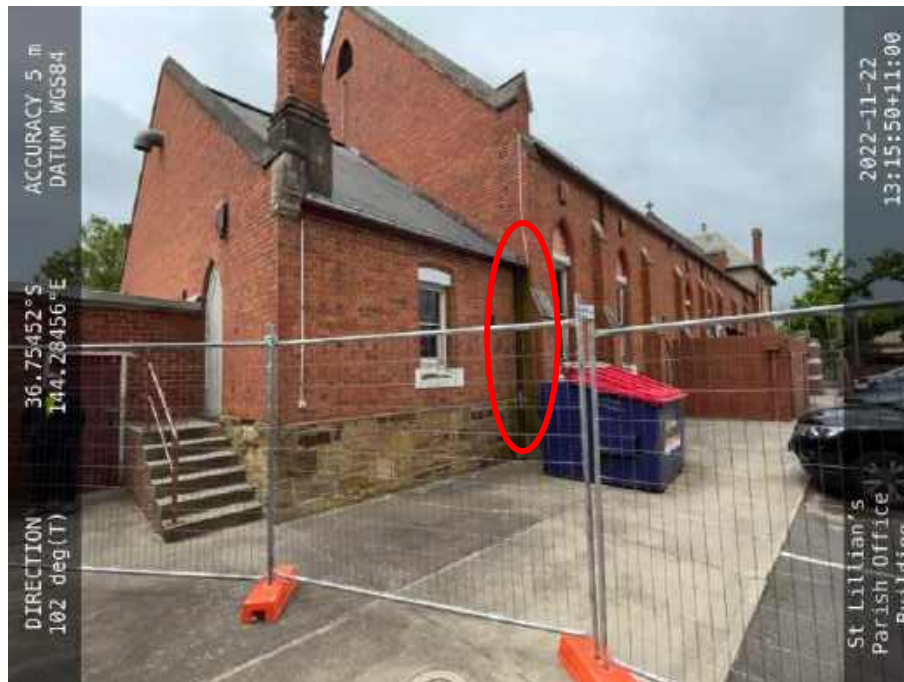
Photo 17 – Existing St Killian's Primary School, school hall building. Note possible defective down pipe noted to circled location.

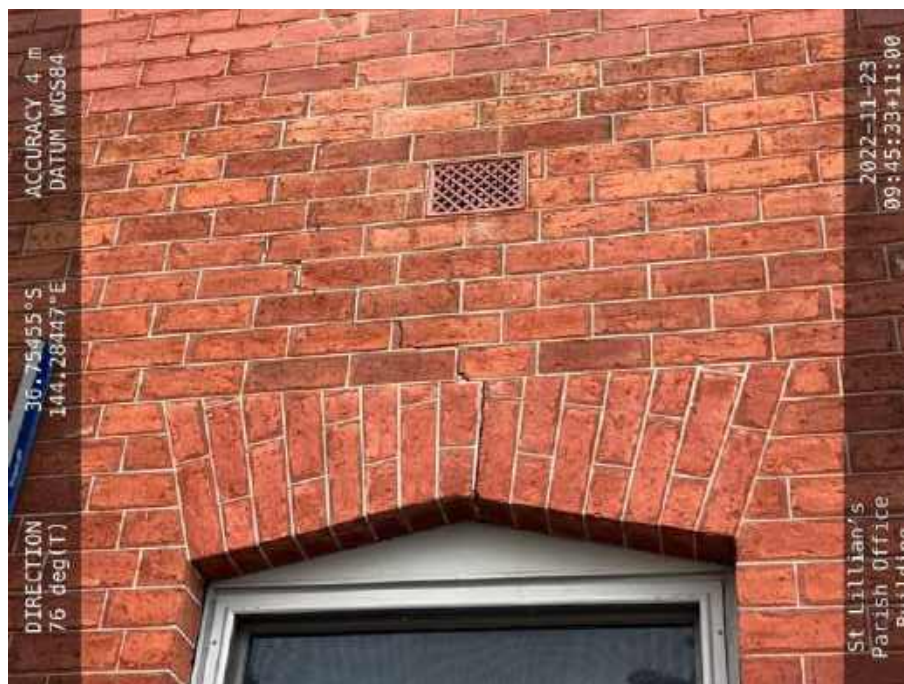
Photo 18 – Typical cracking to other walls of the subject building caused by historical foundation movements.
