History, Significance & Condition

Kardinia House VHR H0337 1 Riverview Terrace, Belmont 3216

AuthorTrethowan ArchitectureDate24 March 2025

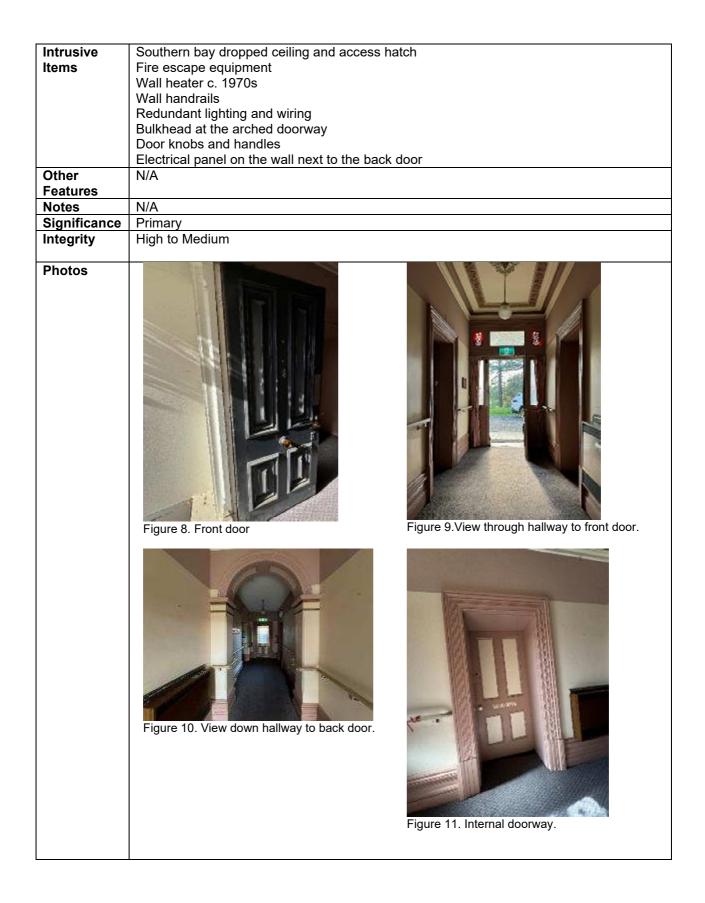
Room Condit 1 Riverview		mont (Kardinia House		Date Surveyed	14 May 2024			
Room No.	1	Room Name	Corridor	Surveyed by	JY			
Use	Main hous	se entryway / corridor						
Ceiling								
Coning	Divided into 2 bays Northern bay:							
			rose painted	in dusty pink, cream, pist	achio with gold			
	detailing		, ,		3			
	0	acks and bubbling paint	observed					
	Southern							
	Dropped,	non-original, plain ceiling	g with access h	natch				
	No mouldi	ng and ceiling rose, poo	r paint job con	npared with northern bay				
Walls			[,] pink at top, lig	ght dusty pink at bottom				
		at the top part of walls						
		int suggests an inner lay						
		and architraves are of da		colour				
		al handrailing affixed to						
			outhern bay ha	s paneling in dusty pink a	nd cream with			
	gold detailing to its underside							
	Chamfered corners at archway							
	Curtain rod brackets above archway and door openings							
	Early light switch overpainted in dusty pink Arched doorway to 8 blocked by a large, plain bulkhead

Damages observed at architraves and lower parts of walls							
Floor								
Doors	Non-original carpet 2x external doors – front door to driveway; back door to courtyard							
Doors	Front door:							
	Single swinging timber door with transom and sidelights							
	Transom has textured, transparent glazing							
	Top sidelights next to the transparent glazing							
	Middle sidelights have textured, transparent glazing							
	Below the middle sidelights are timber-boarded							
	There are curtains for the sidelights							
	The 4-panel door is painted in deep bronze green on the outside and has non-original							
	fixtures and door knob							
	It is painted in deep dusty pink internally							
	Back door:							
	Single swinging, windowed timber door with a glazed panel in the top 2/3 part							
	The window has a large, central glazing and 10x small, narrow side glazing bordering it							
	The door is painted in white on the outside and has a non-original door handle and hinge

It is painted in deep dusty pink internally							
	3x internal dears 1x to 2: 1x to 4: 1x to 7							
	3x internal doors – 1x to 2; 1x to 4; 1x to 7							
	Generally, all 3x doors have very deep doorways and a single swinging, 4-panel timber door at the end of the wall							
	Painted in dark and light dusty pink							
	Non-original door knob and push plate							
Windows	N/A							
Significant		ouldings and rose						
Items		orway and ornaments						
	Front door							
	Back door							
	Architrave	s, internal doors, skirting	IS

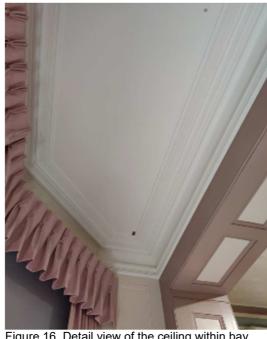
Figure 16. Detail view of the ceiling within bay window.

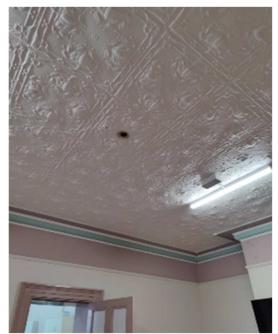
Figure 17. Detail view of the pressed metal ceiling.

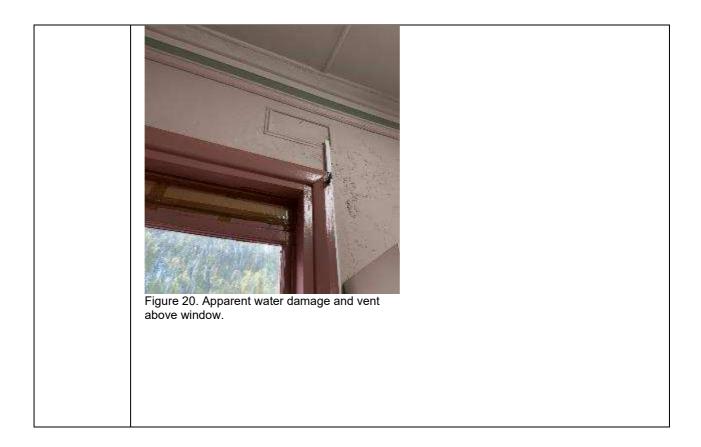
Room Condit	ion Survey errace, Belmont (Kardinia Hou		Date Surveyed	14 May 2024				
Room No.	4 Room Name		~	Surveyed by	 CM			
		AILIOO	Π	Surveyed by	CM			
Use	Art room							
Ceiling	Painted ceiling							
	Some small cracks – all direction							
	Elaborate cornice – possibly ad	ded to, som	e cracks					
	No cornice to bay window							
	Big ceiling rose – looks later							
	Overall, seems to be in a good	condition						
Walls	Plaster, painted							
	Picture rail							
	Some minor cracks	a naasihlu	haaayaa af	furniture				
	Damage to archway – both sides, possibly because of furniture							
Floor	Timber paneling below windows							
FIUUI	Later carpet Skirtings look later							
Doors	Original timber panel door to corridor and next room							
DOOIS	Later hardware, poorly painted							
	Frames possibly original							
Windows	Bay window – 3x double-hung sash							
Williaow3	Single double-hung sash

All windows have the same architrave detailing, possibly some original hardware							
Significant	Decorative plasterwork		inig, pecci	ny como originarria	anaro			
Items	Arch to bay							
	Doors and windows							
	Fireplace							
	Paneling below windows							
Intrusive	Carpet flooring							
Items	Picture rail							
	Decide – skirtings, compare with other rooms							
	Light fittings							
Other	Marble fireplace – blocked up							
Features								
Notes	Overall good condition and could be restored.							
	Some skirtings may be reproductions.							
Significance	Primary							
Integrity	High to Medium							
Photos

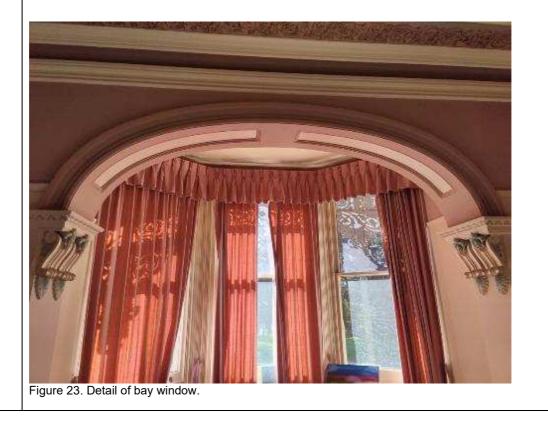
Room Condit		(Kardinia House)	Date Surveyed	14 May 2024		
Room No.	5	Room Name	Surveyed by	СМ		
Use	Classroom and kitchenette					
Ceiling	Painted plaster					
5	Later cornice, ve	ery simple				
	Later lights	, . ,				
	No ceiling rose					
	Minor cracks ev					
		vindow, higher ceiling lining w	ere in			
Walls	Painted plaster					
		er / moisture damage at south	west corner, low			
	Several covered					
		except at southwest)				
		or frame architrave different fro				
		g to bay frame opening and be	elow windows			
Floor	Fire place – late Carpet over					
FIOOP		sture at southwest corner				
	Probably timber					
Doors		I timber panelled door to room	1 – later architrave			
DOOIS		loor to room 6 – possibly later				
Windows	Bay – 3 window		opening but name not too n			
Significant	Overall form / la					
Items	Fireplace opening					
	Bay window + panelling + opening + windows + joinery					
	Consider – skirtings and architraves

Intrusive	Timber fire place					
Items	Cornice					
	Light fittings					
	Carpet					
	Later door					
Other	Covered wall ve	nts are interesting				
Features						
Notes	Altered but legible Cracks in walls are minor, moisture damage will need to be addressed.					
	Cracks in walls	are minor, moisture damage v	vill need to be addressed.			
	Primary Signific	ance				
Integrity Photos	Medium					
Photos						
			A			
		1111/111 Contraction				
		T HALAN ALL AND THE THE REAL OF	ANT -

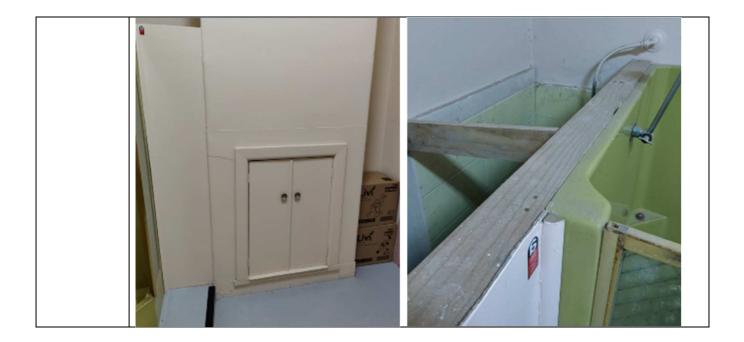
Room Condit		nt (Kardinia House)		Date Surveyed	14 May 2024			
Room No.	6B	Room Name	Bathroom	Surveyed by	CM			
Use	Bathroom							
Ceiling	Board or panel with texture and paint							
Cennig	No cornice							
Walls	Painted plaste	r						
Trano		re damage and spall	lina					
	Evident at sou	th wall under window	N					
	Small storage	cupboard at fireplac	e location					
		out, tiles behind						
	Damage to pla	ster at side of chimr	ney breast					
Floor	Vinyl – with ste	ep up to wet area						
Doors	Very thin early	door to 6A						
	Low							
Windows		ng, altered glazing to	o south					
Significant		glazing top sash						
ltems	Door to 6A							
Intrusive		hand basin etc.						
Items	Later step in fl							
		replace – reinstate fi	replace					
	Light fitting							
Other	Flooring	ly built out from wall						
		5						
Features	There is tile behind, suggesting an earlier bathroom arrangement Tiles for skirting near basin

Notes			d altorad					
NOLES	Looks like a nice room, divided and altered Need to address damp							
	Exterior vents may be covered – check							
		nstate an earlier arra		arance				
Significance	Secondary		angement / appe					
Integrity	Low							
Photos

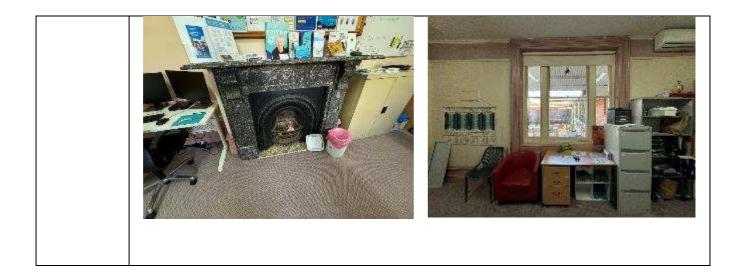
Room Condit 1 Riverview 1	tion Survey Ferrace, Belmont (K	(ardinia House)		Date Surveyed	14 May 2024			
Room No.	7	Room Name	Office	Surveyed by	JY			
Use	Office							
Ceiling	Plain, dropped cei	ling

-	Cornice around ce	iling						
	Access hatch to th							
	Light tubes affixed							
Walls	Top part painted in							
	Separated by a mo							
	Bottom part painte							
	Skirtings painted in An area next to the							
	Early light switches			ιþ				
	Hairline cracks ab							
	Lower part of sout			ae				
	Two wall vents on							
Floor	Grey carpet							
Doors	, <u>,</u>	doors in deep du	sty pink and o	cream, with original architra	ave and non-original			
	door knobs							
	Northern door to 1 (corridor)							
	Southern door to 6A							
Windows	1x north-facing tripartite window with fixed glazing on the sides and a double-hung sash in the							
	centre							
	Floor to ceiling window frame painted in deep dusty pink and cream Peeling paint and wood rot at lower areas of the frame, concealed by duct tape							
Significant	Fireplace and mar			frame, concealed by duct	lape			
Items	Tripartite window	lile

itemo	Architrave, doors,	and skirtings						
Intrusive	Dropped ceiling	and onliningo						
Items	Wall panelling							
Other	1x decommissione	ed fireplace to the	e west, chimn	ey breast extant				
Features	Mantle is made of black and white marble							
	Fireplace is made of cast iron							
	Area immediately below fireplace is of patterned tiles							
Notes	Water ingress pres	sent at the wall b	etween 6A ar	nd 7				
Significance	Primary							
Integrity	Low							
Photos

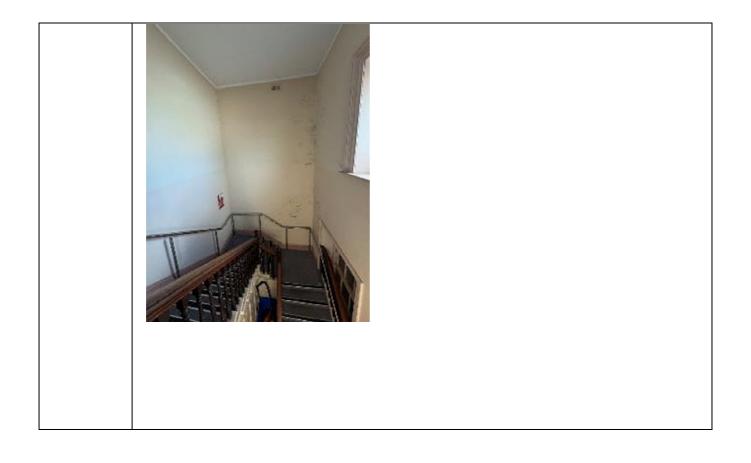
Room Condit	ion Survey ferrace, Belmont (k	(ardinia Houso)		Date Surveyed	14 May 2024					
Room No.	8 and 9	Room Name	G/F stairwell and 1/F stair hall	Surveyed by	JY					
Use	Stairwell to 1/F with under-stair storage and 1/F stair hall									
Ceiling		Plain ceiling								
Walls	Painted in cream									
	Doorway to 1 (cor	ridor) – refer to re	oom condition surve	y for 1						
	Doorway to 1 (corridor) – refer to room condition survey for 1 Built in cupboard next to the under-stair storage Skirtings are comparatively less ornate than the main house									
	Skirtings are comp	paratively less or	nate than the main h	ouse						
Floor	Dark grey carpet									
Doors			n original lock and kr							
			n the inside, white or							
			hitraves and door du							
Windows			n 6 panes of textured							
			th curtain rod bracke							
			a dark, hardwood h	andrail matching the	e stair balustrade and					
	above, a modern r		/

Cignificant			/F appears to be in g	good condition						
Significant Items	Staircase including	g balustrade, trea	ads, spandrei							
items	Sash window									
	Stained glass wind	woh								
Intrusive	Contemporary me									
Items	Redundant lighting									
	Carpeting and nor									
	Top of stair gate									
Other	Under-stair cupbo	ards painted in c	ream							
Features	Staircase spandrel with decorative panelling									
		Considerable wear-and-tear at spandrel and cupboard due to high use								
			to the top balustrade							
Notes			d east walls causing		moulding					
	Skirting near door	is detached from	n the wall		-					
Significance	Primary									
Integrity	Hight to Medium									
Photos	MAR

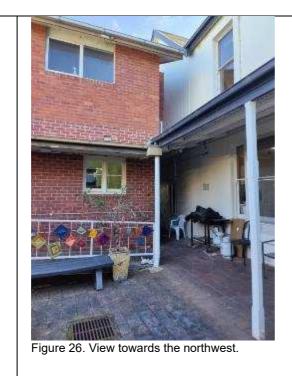
Figure 27. View south.

ion Survey errace, Belmont (Kardinia House)		Date Surveyed	14 May 2024		
Courtyard Room Name	Courtyard	Surveyed by	CM		
Courtyard					
N/A (open-air courtyard)					
Verandah roof to main house is cor	rugated iron				
To red brick the ceiling is timber lini	ng board				
Weatherboard					
)			
	oth, some rough				
	han / alamad				
		ha blugatana thrach			
			JIU		
			v original		
			x original		
	antea				
	n house				
A boat is placed in the passage					
Unusual wall finish partly rough and	I partly smooth				
Odd at left window, looks like the sr	nooth wall has been	cut out			
LOW					
	CourtyardRoom NameCourtyardN/A (open-air courtyard)Verandah roof to main house is cor To red brick the ceiling is timber liniWeatherboardRed brickGlazing (metal sheet to the narrow Stone / render painted – some smo Evidence of damp to rough wallsPaving Central element and two drains with Later doors to additions Original openings with panelled time 	CourtyardRoom NameCourtyardN/A (open-air courtyard)Verandah roof to main house is corrugated iron To red brick the ceiling is timber lining boardWeatherboard Red brickGlazing (metal sheet to the narrow passage to the west Stone / render painted – some smooth, some rough Evidence of damp to rough wallsPaving Central element and two drains with standing water Later doors to additionsOriginal openings with panelled timber / glazed Door with bluestone threshold – altered frame and mayl Other door is later, later opening but possibly original lin Main house – tripartite window with bluestone sill; single sash but altered to p sash, all overpainted Later window for extensionsWindows and door openings to main house Arrangement / connection to courtyard VentsLater extensions and doorsA boat is placed in the passageUnusual wall finish partly rough and partly smooth Odd at left window, looks like the smooth wall has beenSecondary significance (historical)	Courtyard Room Name Courtyard Surveyed by Courtyard N/A (open-air courtyard) Verandah roof to main house is corrugated iron To red brick the ceiling is timber lining board Weatherboard Red brick Glazing (metal sheet to the narrow passage to the west) Stone / render painted – some smooth, some rough Evidence of damp to rough walls Paving Central element and two drains with standing water Later doors to additions Original openings with panelled timber / glazed Door with bluestone threshold – altered frame and maybe bluestone threshol Other door is later, later opening but possibly original lintel Main house – tripartite window with bluestone sill; single window possible 1: sash but altered top sash, all overpainted Later window for extensions Windows and door openings to main house Arrangement / connection to courtyard Vents Later extensions and doors A boat is placed in the passage Unusual wall finish partly rough and partly smooth Odd at left window, looks like the smooth wall has been cut out

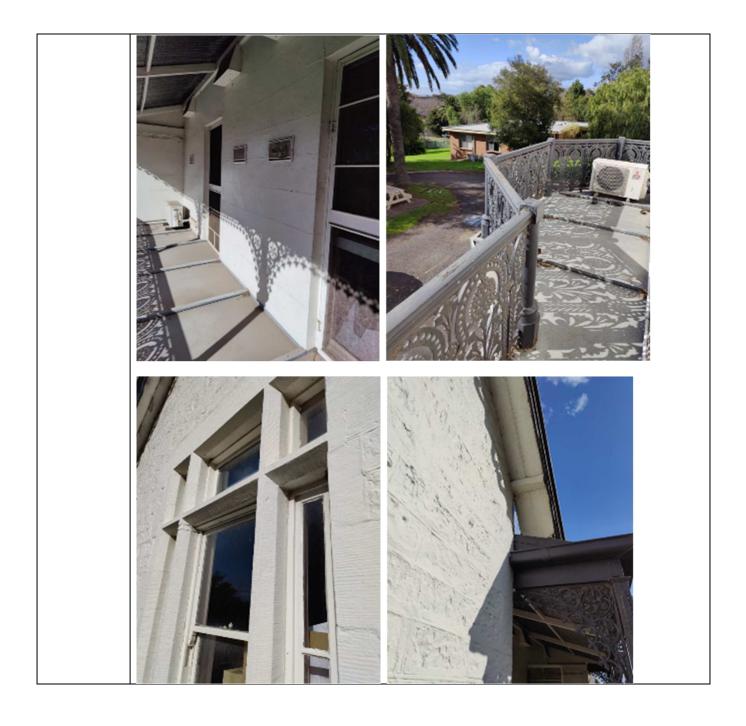
1 Riverview 7	tion Survey Ferrace, Belmont	t (Kardinia House)		Date Surveyed	14 May 2024	
Room No.	16	Room Name	Verandah	Surveyed by	СМ	
Use	Verandah					
Ceiling	Verandah roof	galvinated iron

•	Some rust	-				
Walls	Condition good	, overpainted tuck	pointing with over	painted bluestone quoi	ning.	
	Vents to rooms	visible				
Floor	Metal deck					
Doors	N/A					
Windows		hed verandah in bi	rick / stone above	the flat parts of the sid	e gables.	
Significant	Vents					
Items	Lacework					
Intrusive	AC units					
Items	Floor	· · · ·				
Other		ome decay to panel	over bay window	Ι.		
Features	4x ports and tin					
Nataa	One balustrade					
Notes	Not really accessible, a bit dangerous Primary Significance, Medium integrity.					
		cance, Medium Inte	grity.			
Integrity	Medium					
Significance Photos	Primary	No. No. 700 (100 (100 (100 / 100 / 100 / 100 / 100 / 100 / 100 / 100 / 100 / 100 / 100 / 100 / 100 / 100 / 100	1 THERE A
