**RE:     Assessment of trees and vegetation, 48 Howe Crescent, South Melbourne**

I inspected the above site on 20 March 2026. The property is occupied by a single Victorian Terrace dwelling and is located on the west side of Howe Crescent at the southern end of *Hazelwood Terrace*. *Hazelwood Terrace* is included on the Victorian Heritage Register as VHR H0223 and includes 46, 47 and 48 Howe Crescent.

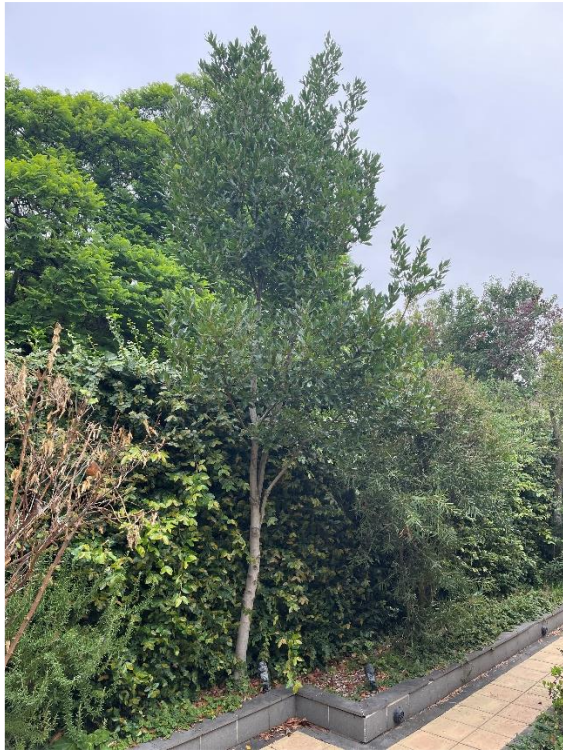
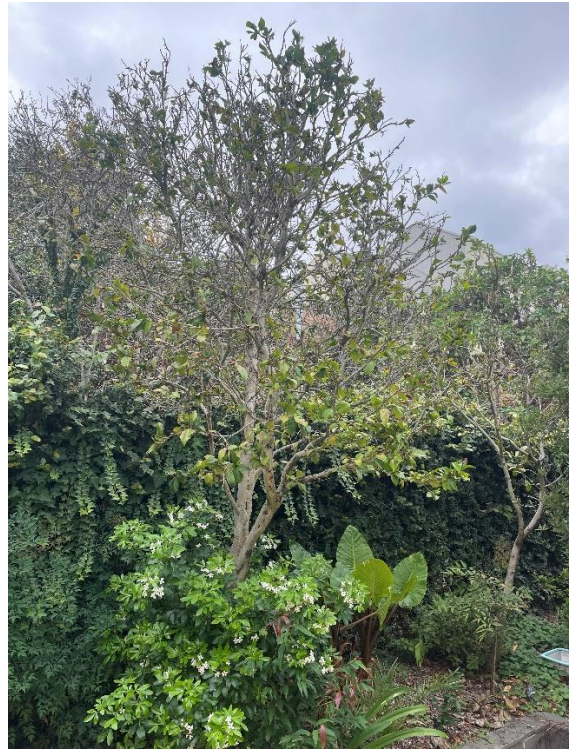
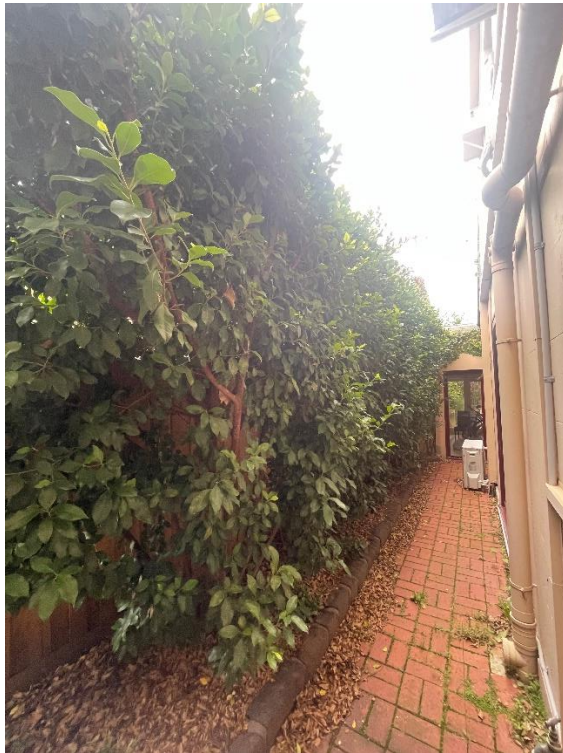
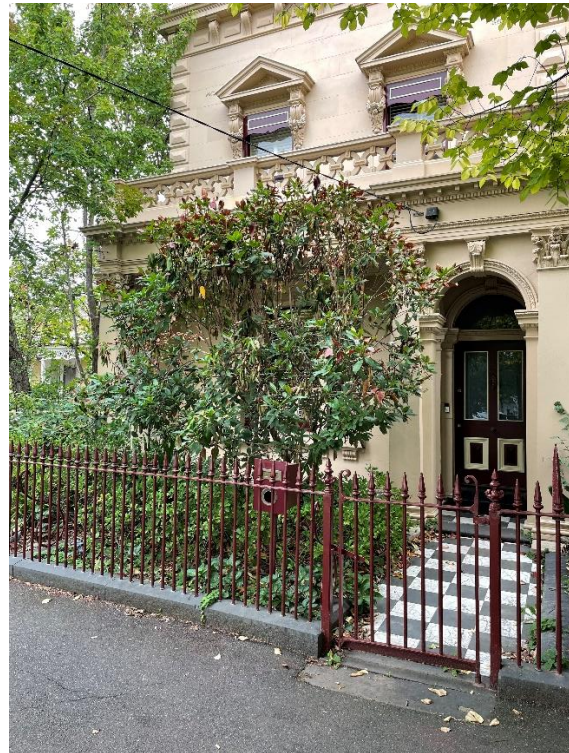
Site vegetation in the rear garden comprises modestly scaled shrubs including Callistemon (*Callistemon linearis*), Camellia (*Camellia sasanqua*) and Bay (*Laurus nobilis*), Figure 1.

A row of young Hills Weeping Figs (*Ficus microphylla* var *hilli*) is planted to the boundary of the southern courtyard/lightwell, with a Rhododendron (*Rhododendron* CV) located in the front garden.

None of the vegetation within the site triggers a permit for removal under the Port Phillip planning scheme nor Port Phillip's tree protection local law. All vegetation in the site appears to be of late 20th century/ 21<sup>st</sup> century origin and is not considered to contribute to the heritage values of the place as described in the Victorian Heritage Database citation for *Hazelwood Terrace*.

*Figure 1 Typical site vegetation, clockwise from top-left Bay Laurel in rear garden, Camellia in rear garden, Rhododendron in front garden, row of Hills Weeping Figs in side courtyard*

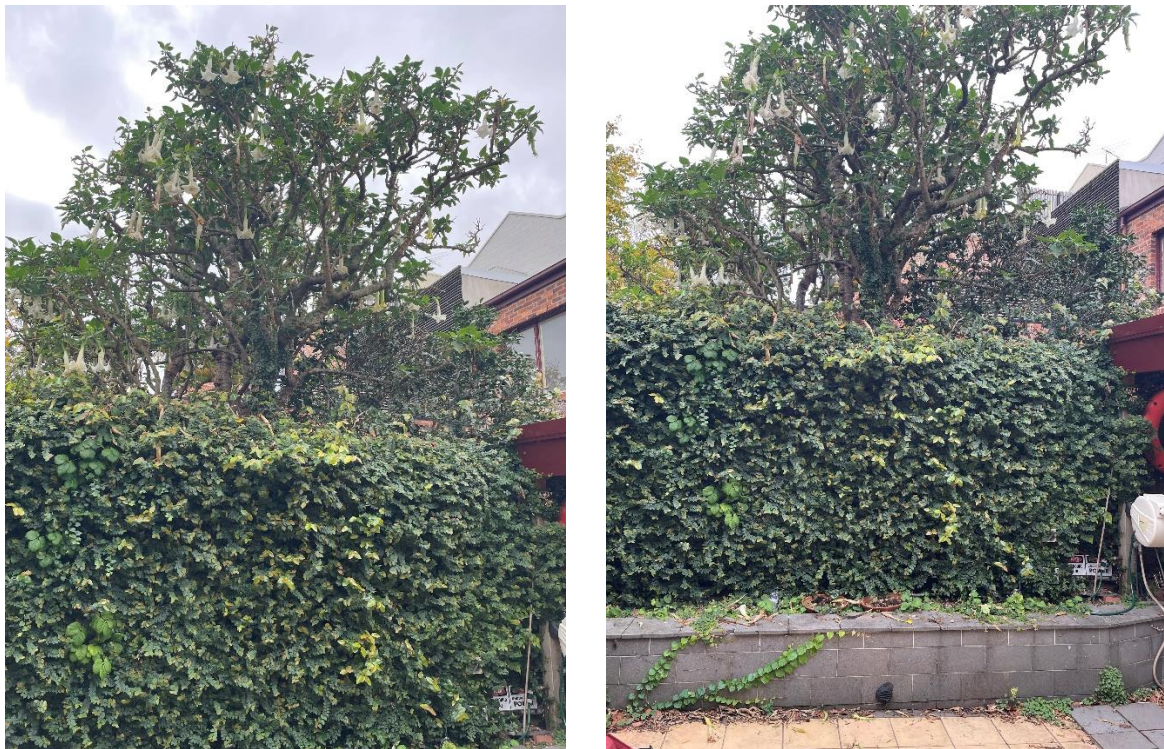
The most notable vegetative element is a mature Angel's Trumpet (*Brugmansia x candida*) located in the rear of 47 Howe Crescent close to the common boundary with the subject site, Figure 2. This is a large shrub less common in cultivation in recent times due to the hallucinogenic alkaloids contained in its flowers<sup>1</sup>, making it undesirable in domestic gardens.

Figure 2 Mature Angel's Trumpet to the north of the subject site and retaining wall likely to be significantly limiting root growth from this shrub into the site

A low retaining wall within the subject site is likely to be significantly limiting root growth from this shrub into the site. Any excavation proposed for a rear extension to the dwelling or associated landscaping on the boundary would need to be preceded by root pruning to the boundary to limit the potential for tearing roots from this large shrub closer to its base.

This shrub can be readily pruned back to the boundary to accommodate any new built form.

Root and crown pruning must be undertaken in accordance with AS4373-2007 *Pruning of amenity trees* and undertaken proactively prior to any works undertaken on site to provide sufficient construction clearance.

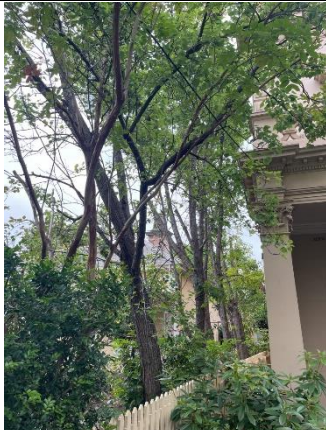
| TREE: 1 | | Pyrus calleryana, Callery Pear | | |

| NOTES Row of trees with asymmetrical growth form due to proximity to south side of subject house.<br>Western trees lopped over adjacent site | | | ARBORICULTURAL RATING:<br>Moderate | |

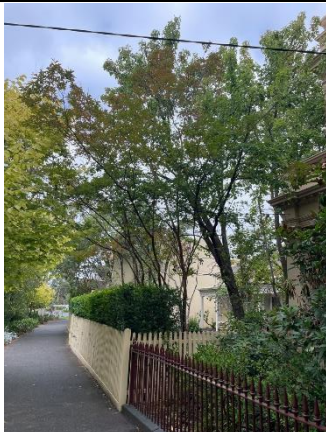
| | TREE: 2 <i>Lagerstroemia indica</i> , Crepe Myrtle | | | | |

| | NOTES Slightly sparse | | | ARBORICULTURAL RATING:<br>Low | |

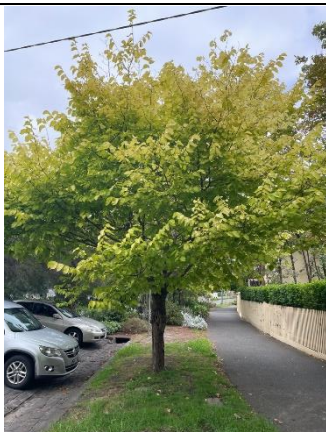
| | TREE: 3 <i>Ulmus glabra 'Lutescens'</i> , Golden Wych Elm | | | | |

| | NOTES    Trunk decay, borer damage | | | ARBORICULTURAL RATING:<br>Moderate | |
