Our Reference: 14567F

Re: Pavilion Café, Mineral Springs Reserve Road, Hepburn Springs, Victoria.

As requested we have visited the above site to undertake a geotechnical investigation to determine the cause of differential floor settlement within the main dining area of the pavilion.

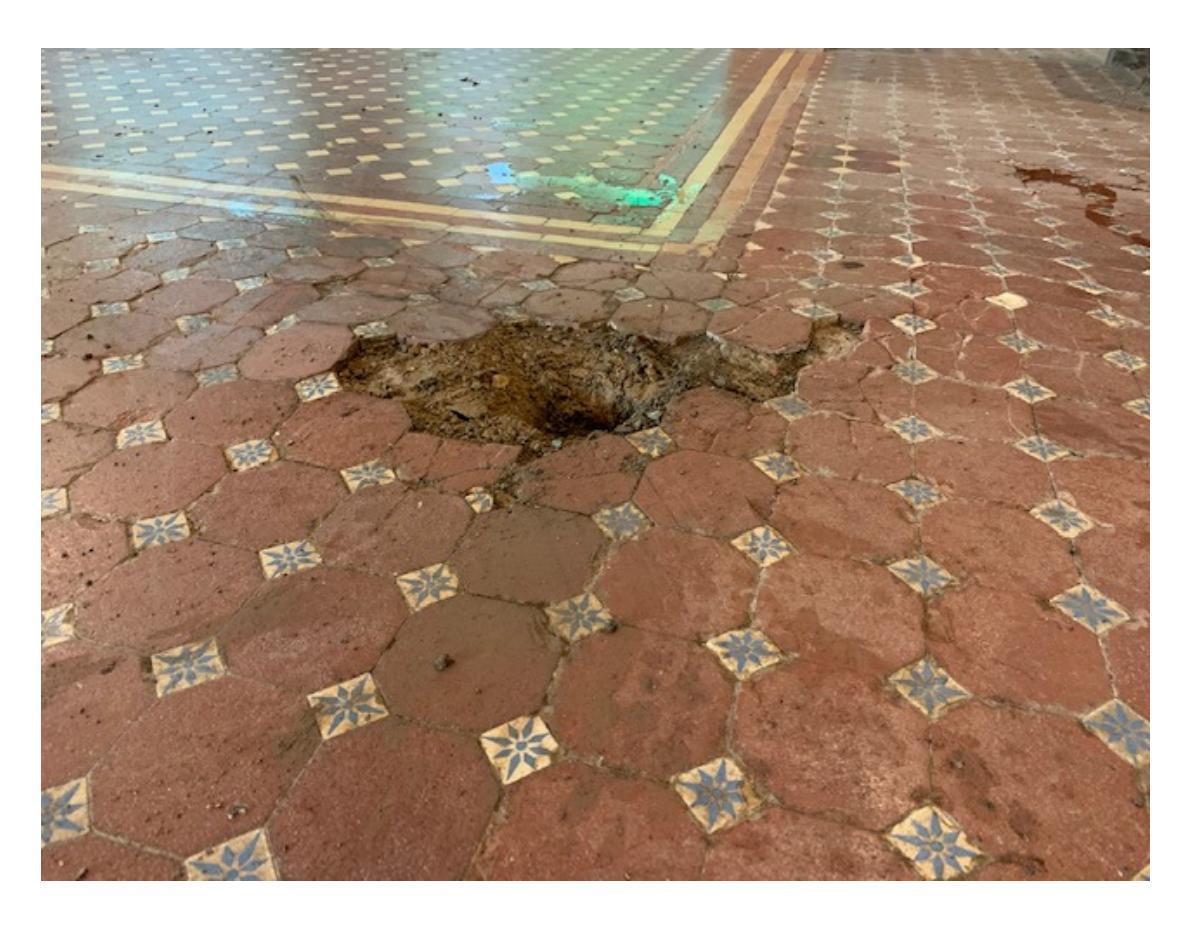
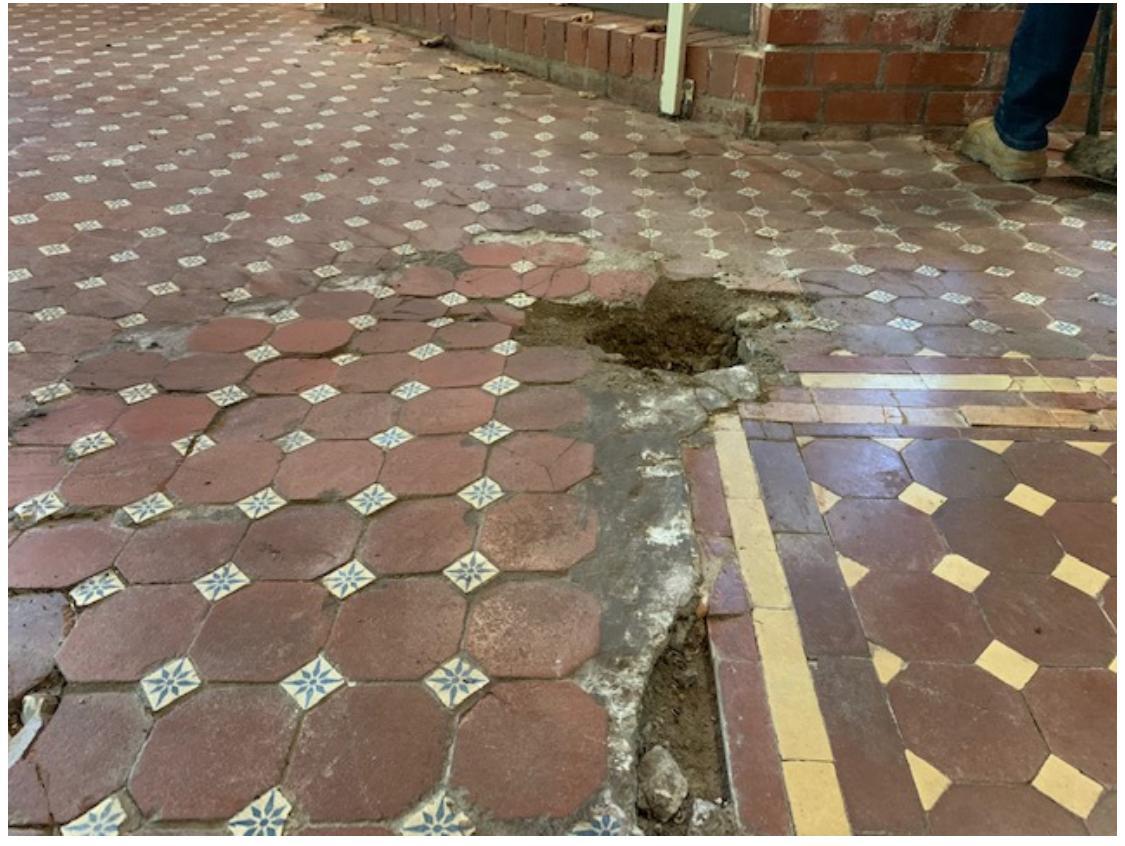
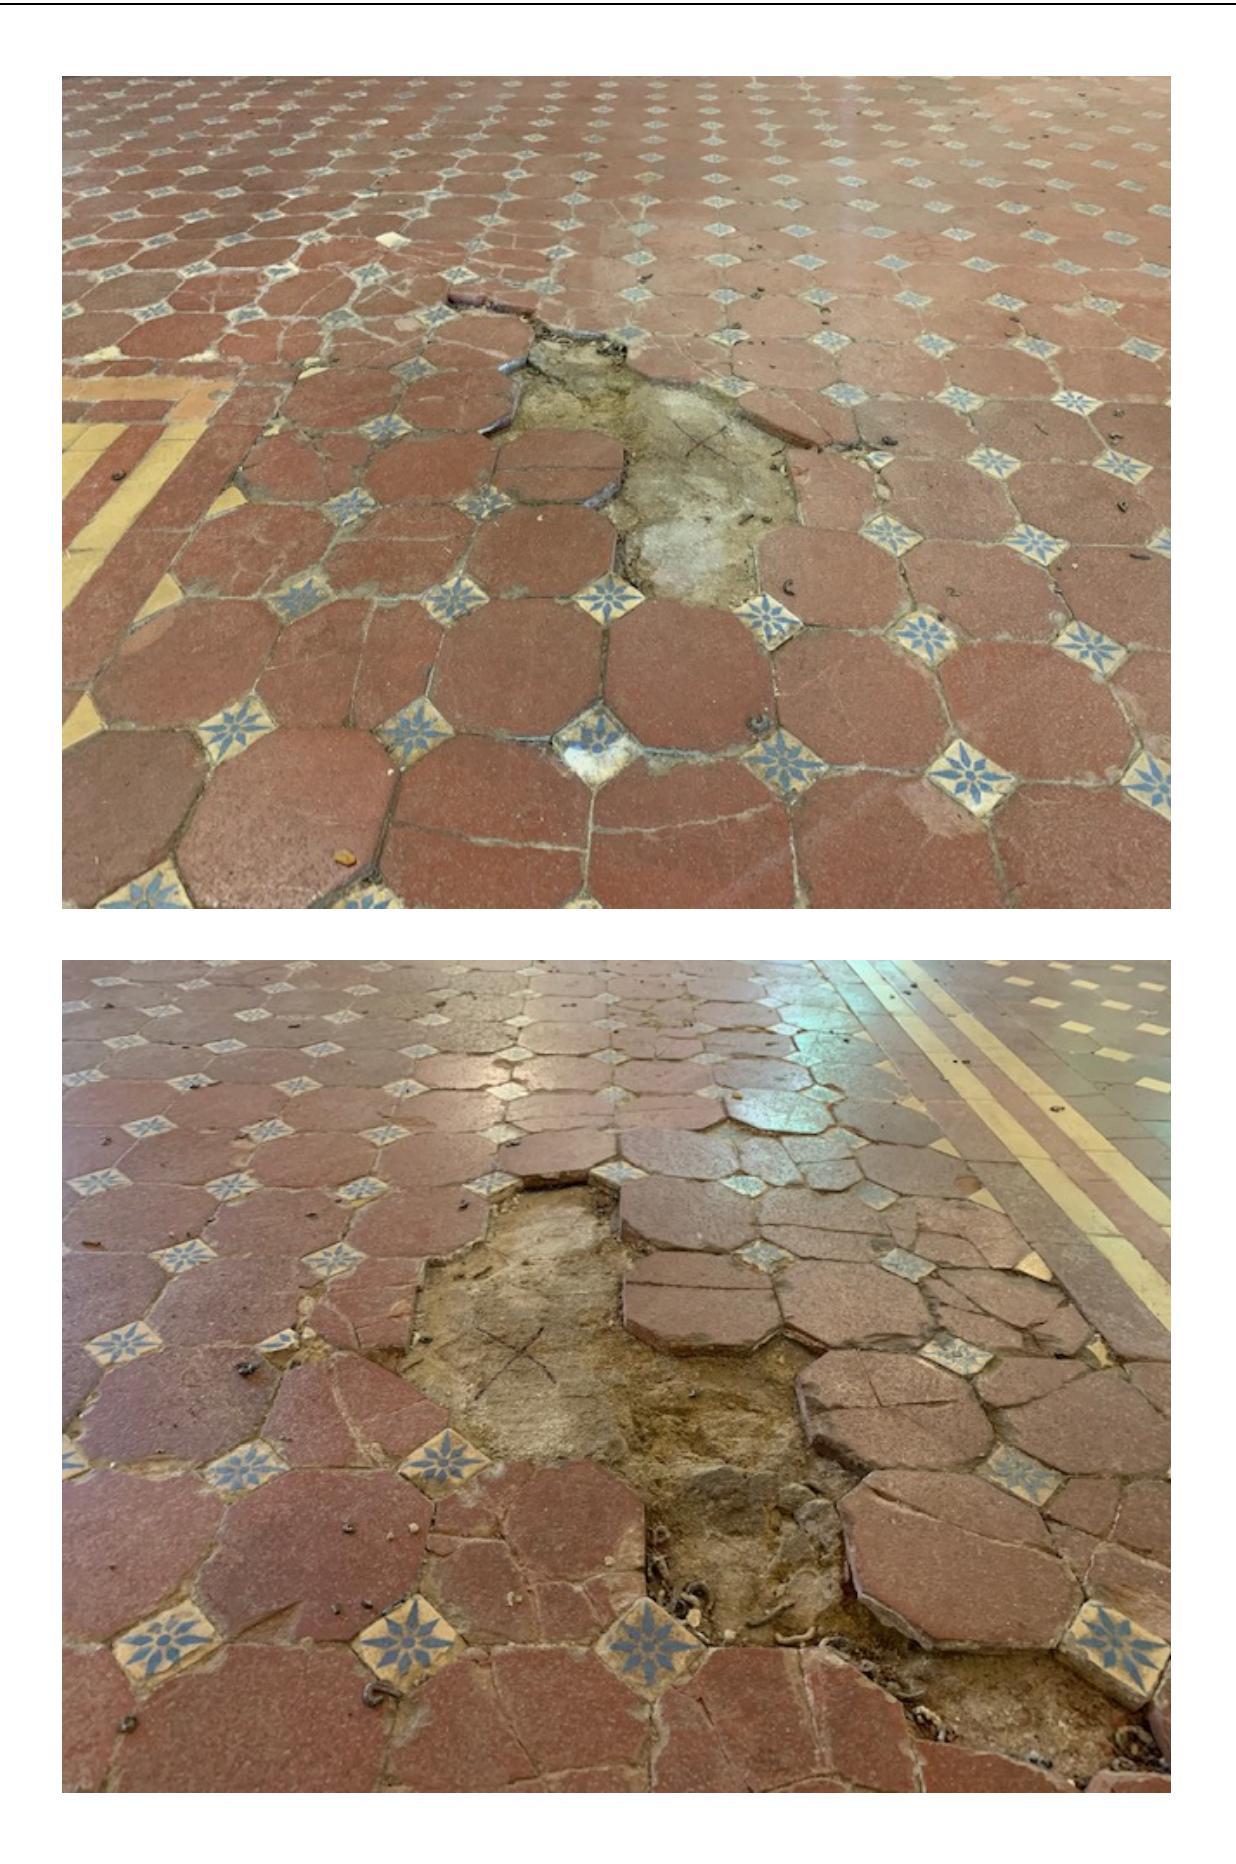
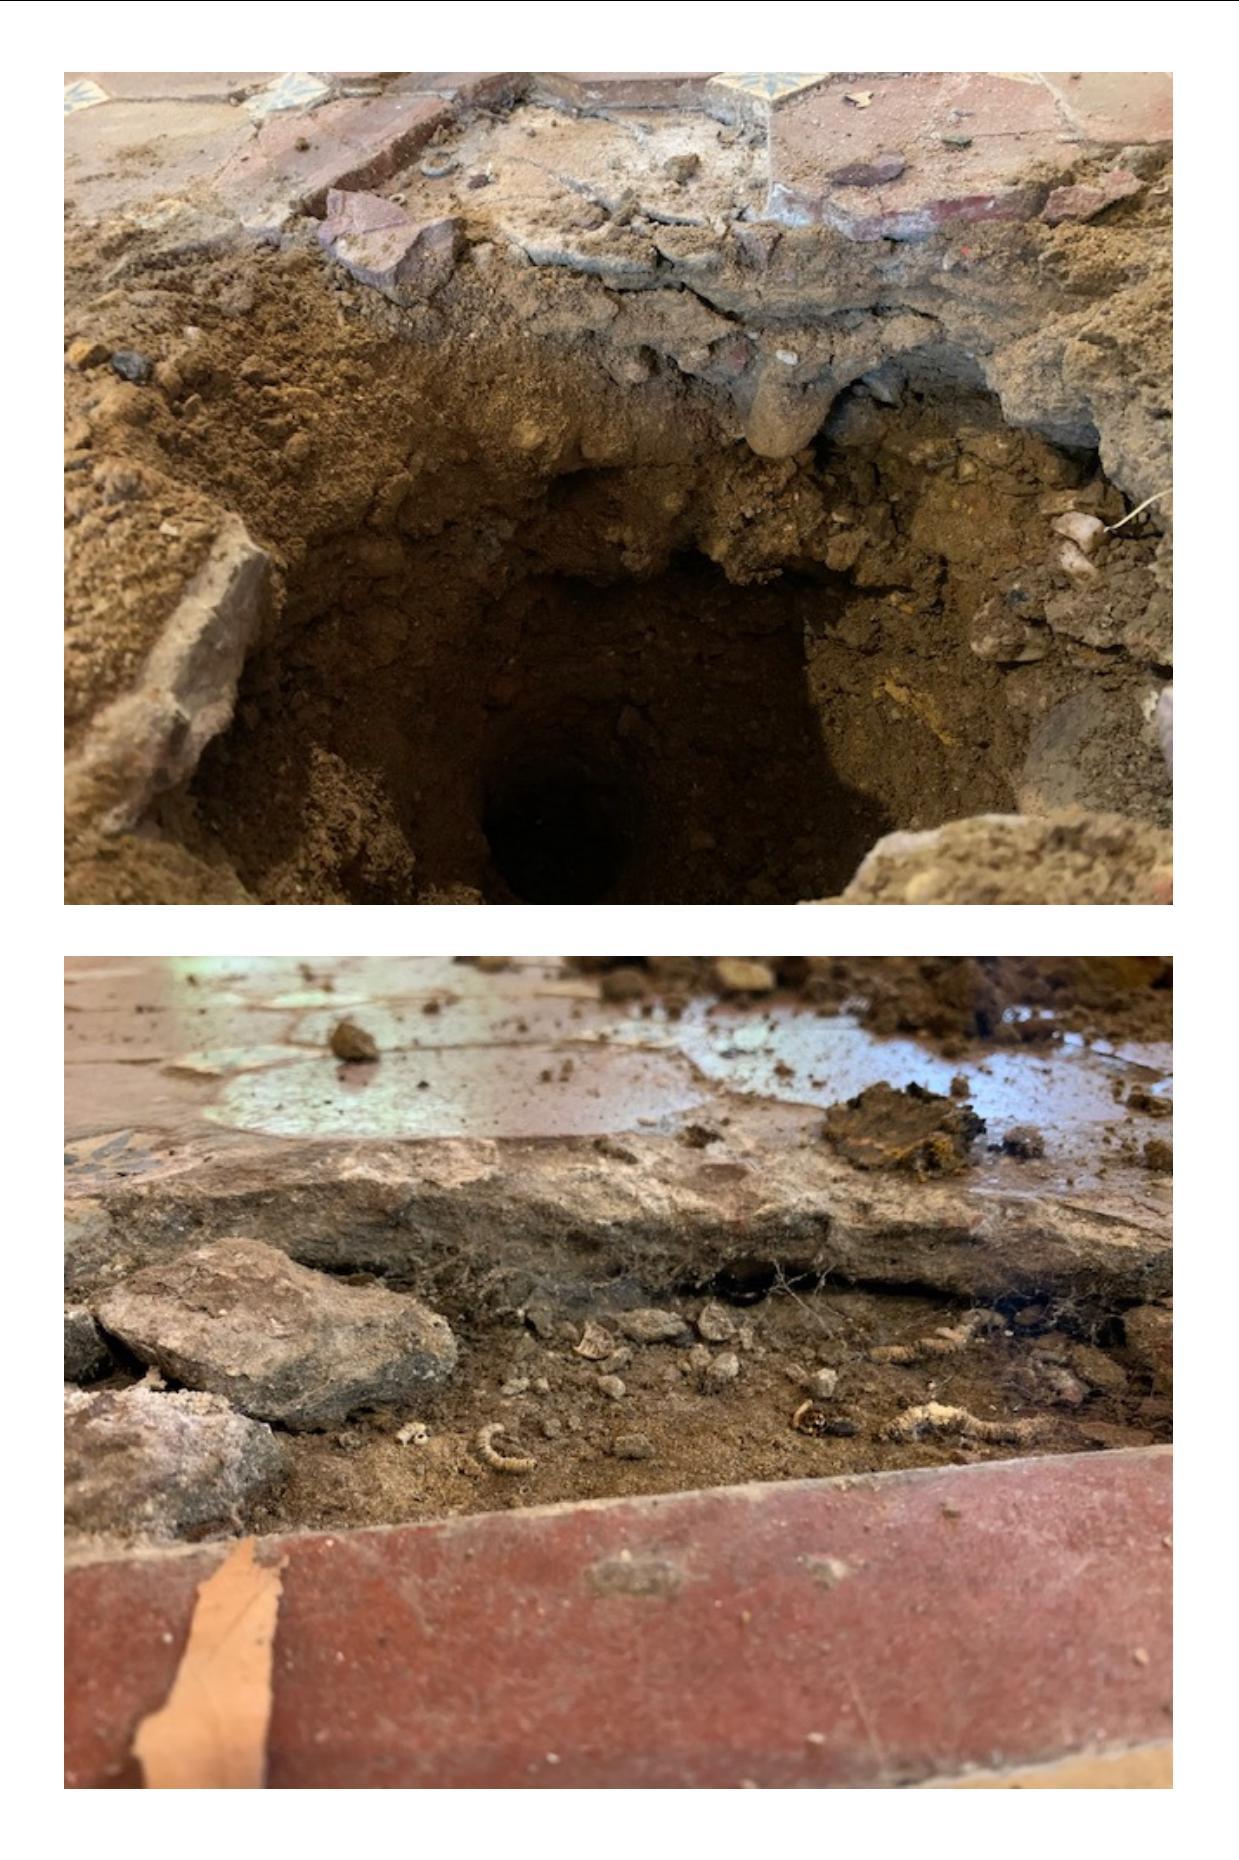
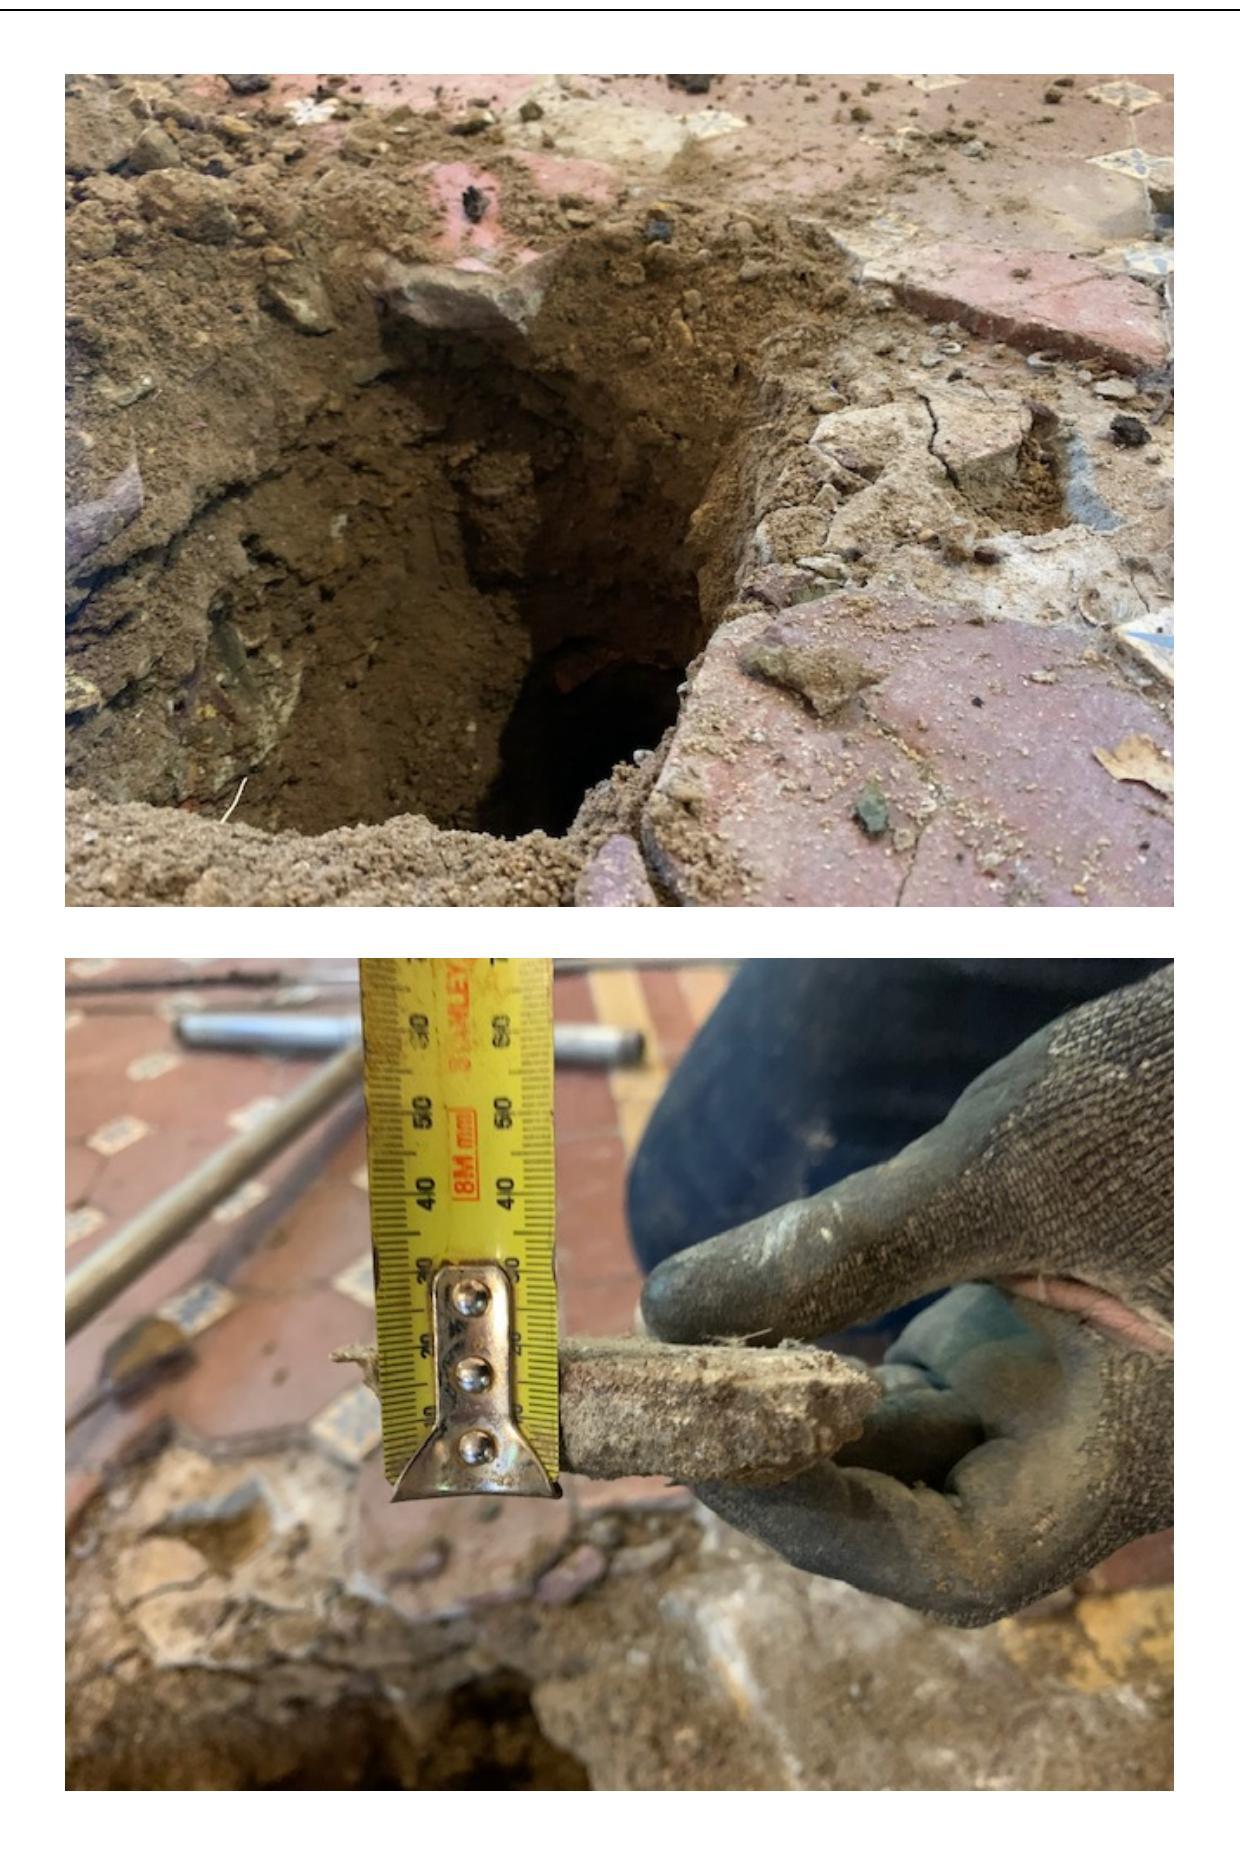
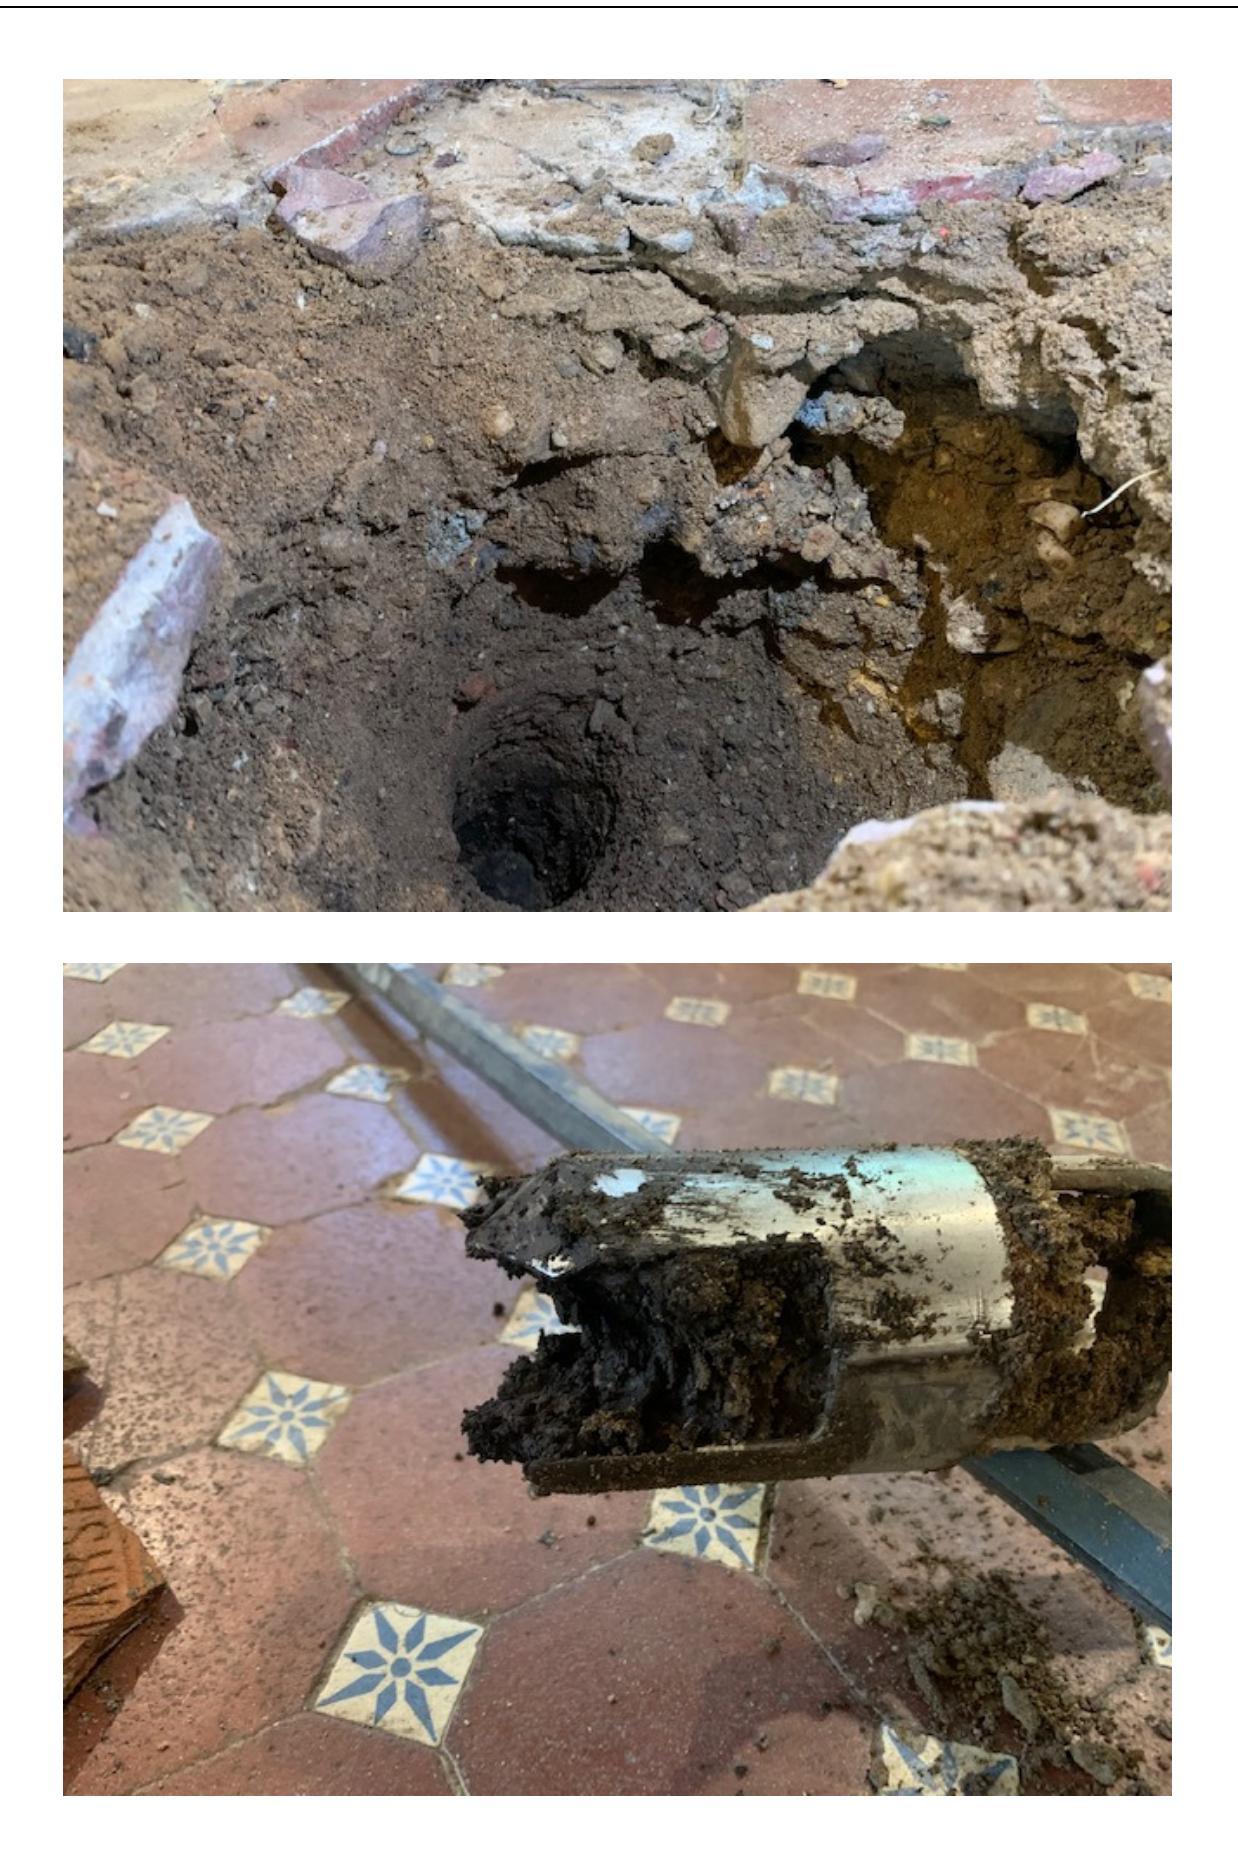
SITE PHOTOGRAPHS

Nevertheless, our examination of floor and subgrade conditions at the two locations (Test Sites 3 and 4) provided sufficient information to determine the geotechnical issues that are causing the floor damage to the pavilion.

Essentially the two major discoveries that we have made are firstly the lack of a floor slab of any acceptable integrity and secondly the subgrade or foundation being poorly consolidated filling to a depth of at least 1200mm.

It appears that the floor area has then been infilled up to the required floor height with a soil mix, predominantly a silty clay/clay/gravel mix. This has then been overlain with the equivalent of a sub-base of a sand/gravel mix approximately 350mm thick. This in turn has been overlain by a mortar bed approximately 20mm thick in which the tiles have been set.

Our view is that the passage of time has seen water ingress and differential settlement of the subgrade throughout the building floor but especially at the two locations tested resulting in cracking of the mortar bed and tile dislodgement.

Rectification works will need to be invasive as opposed to grout injection which can passively level floor slabs without the need of excavations and soil removal and replacement. However, as discovered, there is no floor slab to inject under.

Considering the longevity of most of the floor, reinstatement along a similar methodology of creating a geotechnically proven subgrade and sub-base with an infill floor slab upon which the tiles can be replaced it is our opinion this is the preferred option for rectification.

As to the extent of these works, that is an economical imperative and in the likelihood that the whole floor is not reinstated in one project we suggest that a staged series of works be designed for with the replacement slabs being designed for integration as the stages proceed, allowing structural integrity of the floor eliminating potential differential movement between sections.
