SEPTEMBER 2024

HERITAGE IMPACT STATEMENT

HEPBURN BATHHOUSE AND SPA PAVILION FLOORING PROPOSAL

PREPARED BY ANDRONAS CONSERVATION ARCHITECTURE

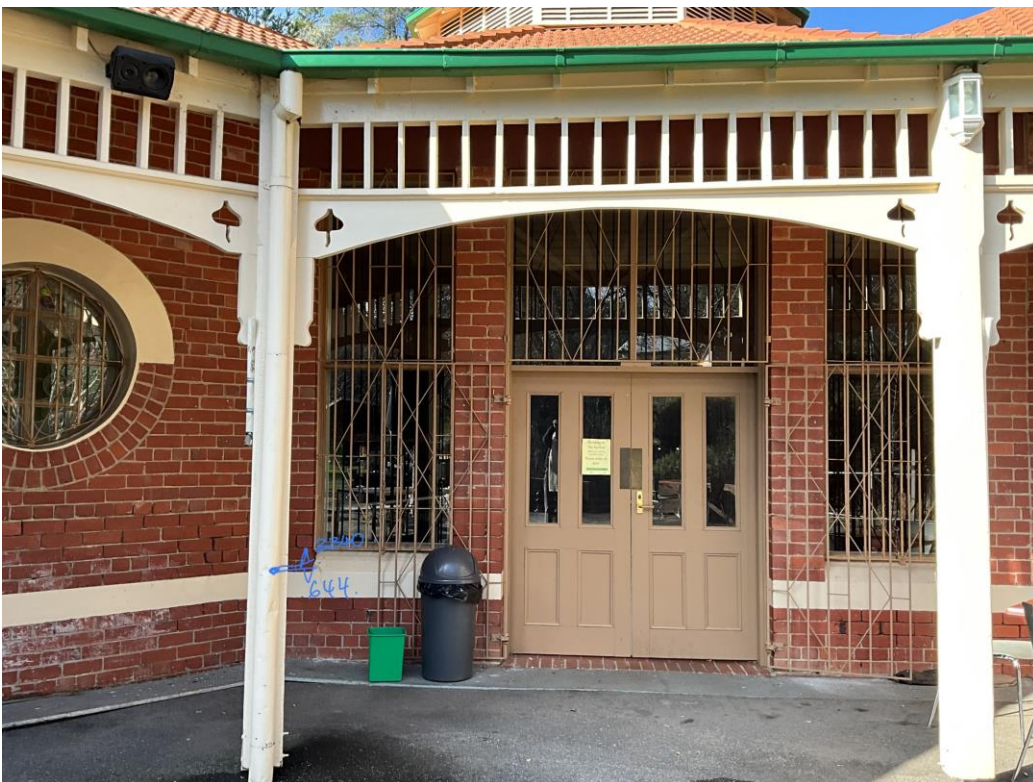
Access to the Pavilion's interior is provided by masonry stairways at all entrances and a non-compliant ramp at the main entrance, all later additions.

Image 2 *The main entrance to the interior space, works propose to raise the interior floor level to reach exterior ground level*

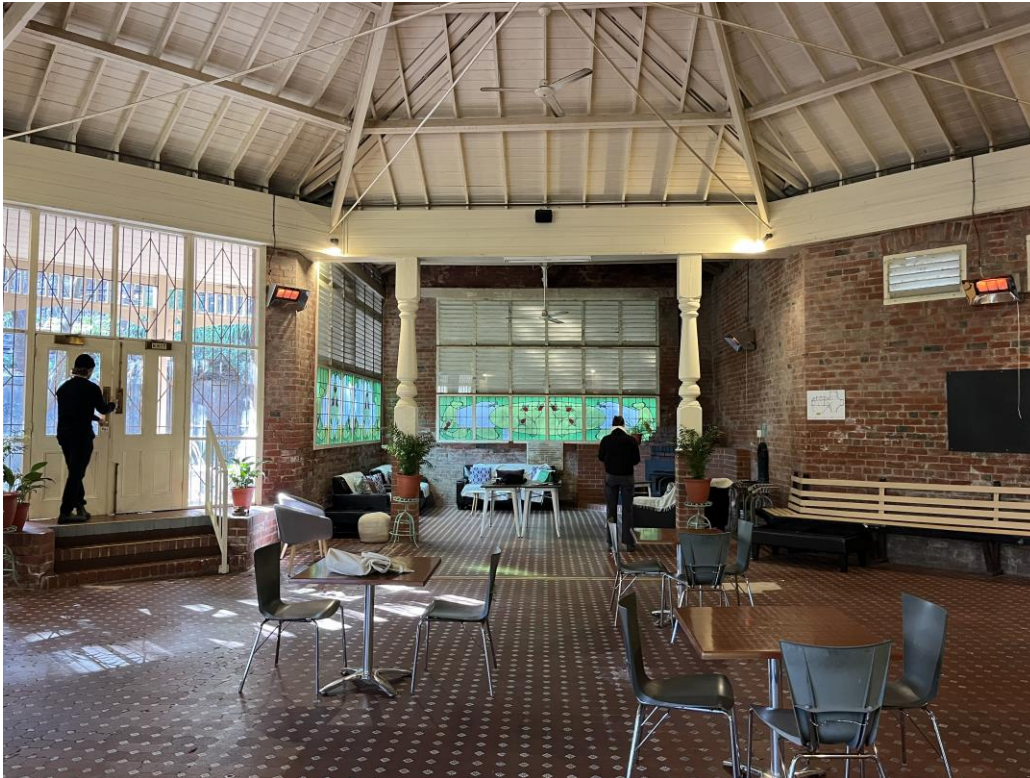
Image 3 *The view from the foot of the entrance stairs to the eastern transept*

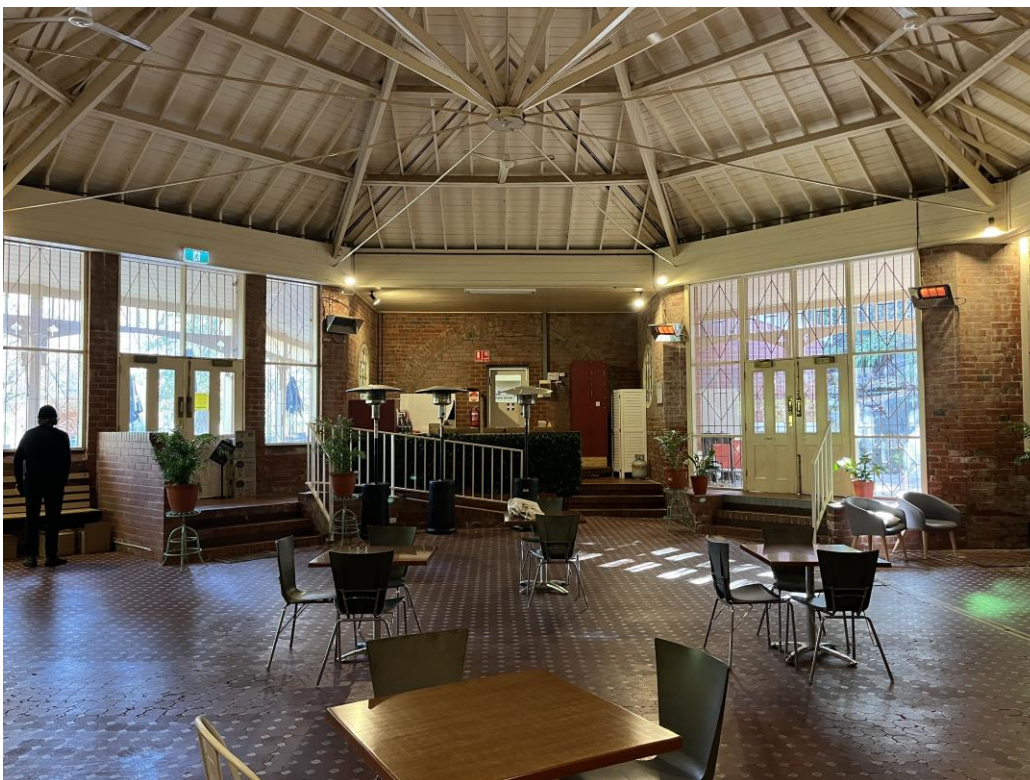
Image 4 *Interior image looking back towards the main entrance., the height of the existing masonry thresholds to stairs and ramps of later date indicate the new proposed floor levels*

Whilst altering the volume and original intent, raising the interior floor level to align with the exterior ground level within the octagonal space will address current accessibility and safety issues. The existing stairs and ramps, later additions, do not meet current code requirements. Installing a compliant ramp would require nearly eight meters of length within the confined space. Existing stairs and ramps would be retained in situ and used as structural support for the proposed flooring.

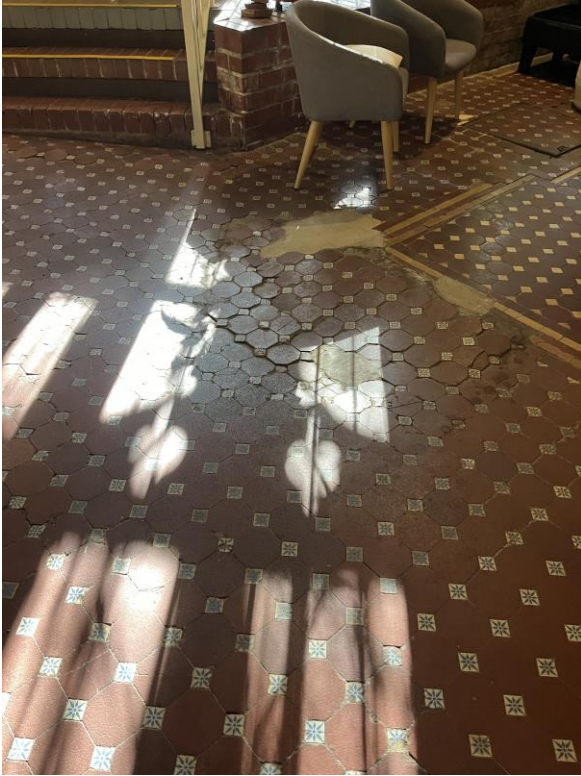
The internal flooring is mainly original, comprised of square red encaustic terracotta tiles accented by smaller white buff tiles at the intersections. The original, intact encaustic flooring has experienced severe differential settlement, resulting in significant undulations of up to 200 mm across the internal space. The original flooring was laid over a 20 mm gravel bed atop 350 mm of sand and gravel. While this system does not meet modern structural standards, it allowed subterranean moisture to diffuse and evaporate through the louvred apse, contributing to the structure's longevity. The covering of the open louvres has further disrupted this moisture diffusion system to accommodate heating for user comfort. The significant undulation of the flooring poses serious accessibility and safety concerns and limits the space's use and ongoing viability.

Image 5 Example of more significant settlement and undulation to original encaustic tiles at the base of the stairs adjoining the eastern transept

Therefore, before new works commence, we propose thoroughly documenting the original flooring through drawings and photographs. Additionally, the existing encaustic tiled flooring would be thoroughly inspected, and areas of loose, lifted, or damaged tiles would be consolidated to the existing 20mm mortar substrate with a lime mortar adhesive.

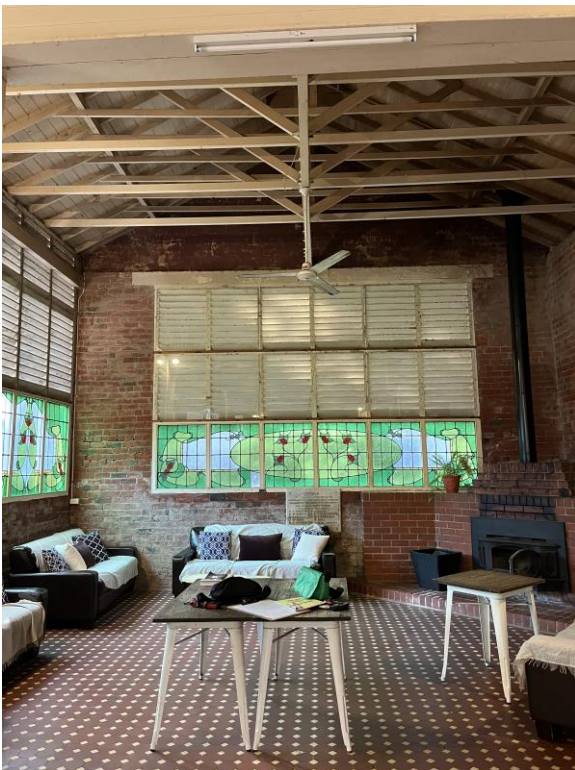
The internal eastern transept features a non-original brick fireplace with a steel flue, two large timber posts, an exposed truss ceiling, and a marble foundation stone. The encaustic tiles in this area are of a later date, and the corresponding masonry fabrics exhibit more pronounced rising dampness and efflorescence. This suggests that the newer tiles were laid over a slab or mortar bed that impedes moisture diffusion, leading to hydrostatic pressure and accelerated deterioration of the original brickwork.

Image 6 View of the eastern transept with tiles and fireplace of later date, note the significant efflorescence and evidence of penetrating damp in this area

The system will be secured laterally to a perimeter angle fixed with stainless steel fasteners into the mortar joints of the original masonry. Steel C-Channel joists will be attached to the pedestals, supporting a waterproof board, which will, in turn, support the new flooring. The floor level to the eastern transept (fireplace) would remain as is, accessible via a proposed floating staircase, retaining a sense of the place as intended. The flooring to this area is of a later date, and does not pose an accessibility issue, further; this would allow the continued monitoring of the masonry fabric where the most significant efflorescence and penetrating damp is occurring (Image X).
