Heritage Impact Statement

Heritage Impact Statement for: Beehive Company Gold Mine

Victorian Heritage Register Number: H1361

Address and location description: Main Street, Maldon (Chimney feature)

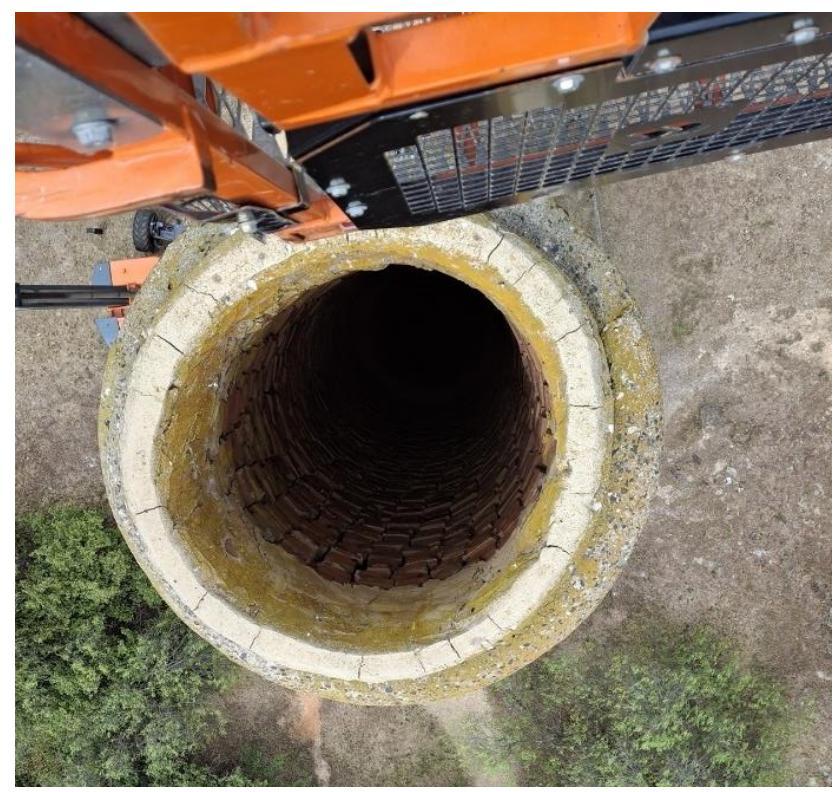
- There is severe weathering to bricks and mortar at top 6.7m section, particularly internally. The absence of capping has contributed to this, and enabled water/wind ingress. See *Figure* 2.

Figure 2: A view looking down inside the Beehive Chimney showing no capping, and severe erosion of interior mortar at the top section (January 2025)

There is significant mortar missing from the interior of the top 6.7 metres. The structural assessment confirms that this is due to the chimney being uncapped, and water and rain ingress inside the chimney, scouring out the mortar over time. To address this, works to the top 6.7 metres is required.

The 'material deterioration defects' will be addressed (repointing the mortar, replacing bricks where required, and deconstruction of the top 6.7m), and these works are therefore minimising the risk of any further bricks falling from height in the short-term.

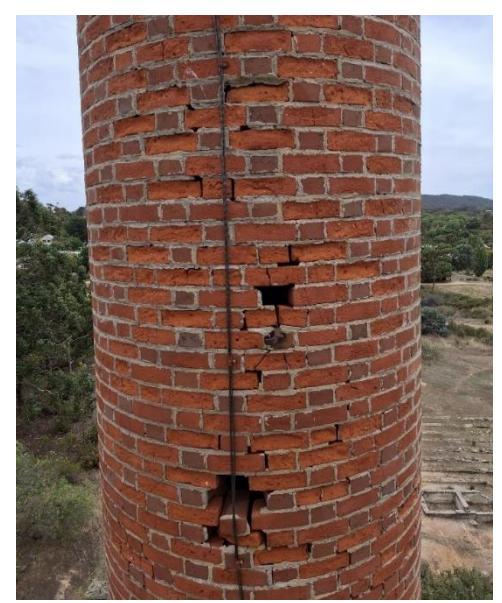
- Missing and badly-pitted bricks as a consequence of previous repairs using an inappropriate mortar (causing salts to damage brickwork, resulting in pitting, exfoliation, and brick fall). See *Figure 3*.

Figure 3: A section of the Beehive Chimney (south face) showing mortar, pitted bricks, and loss of brickwork (January 2025)

Further down the shaft, there are also many gaps where bricks have dislodged and fallen out, and many severely deteriorated bricks. The structural assessment confirms that this is due to salt attack and efflorescence. To address this, works are required to rake out areas with a sub-optimal mortar repairs and re-point using a lime- rich mortar. The condition of each brick can also be assessed during this process and replaced only where required, or left in-situ if deemed to be in good condition.
