# Tree Impact Assessment

## Croydon Community Wellbeing Precinct

Version 4 (29 November 2024)  
Tree Logic Ref. 012527

Including addendum for 1 Civic Square,  
Croydon 3136 (2 April 2025)

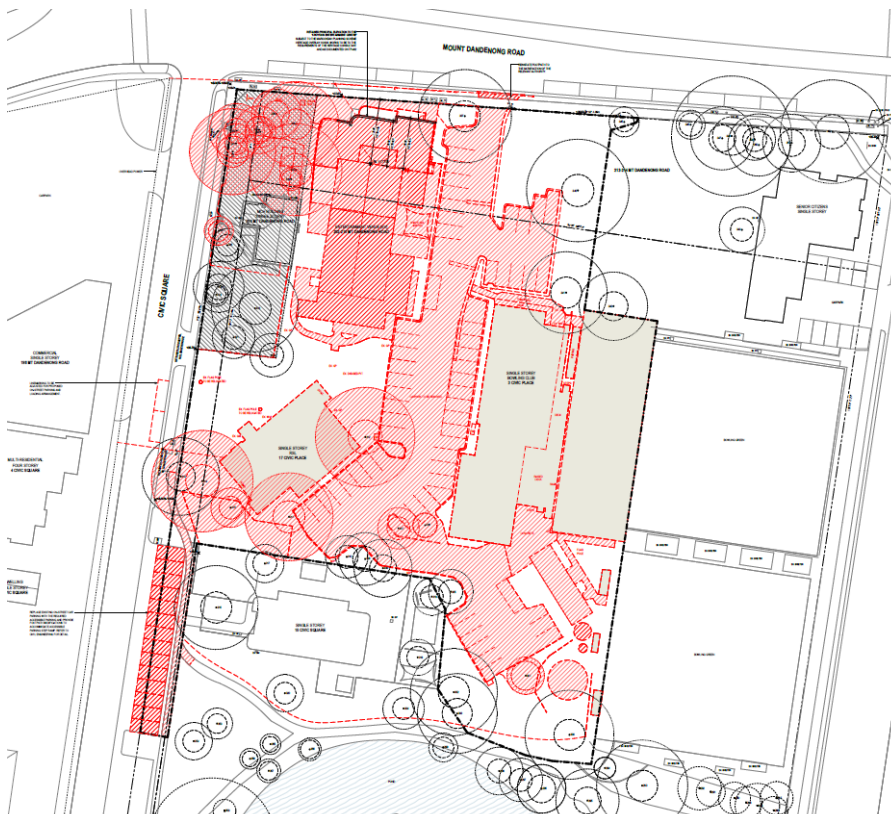
**Figure 1:** Excerpt from Demolition Plan with seventeen trees proposed for removal shown in red.

An excerpt from the Existing and Demolition Plan (A001 Rev J) is shown at Figure 1. In conjunction with the proposed development, eighteen (18) of the remaining 63 trees are earmarked for removal. These are Trees 301, 306, 307, 311, 314, 315 and 327 through 336 as listed in Table 1.

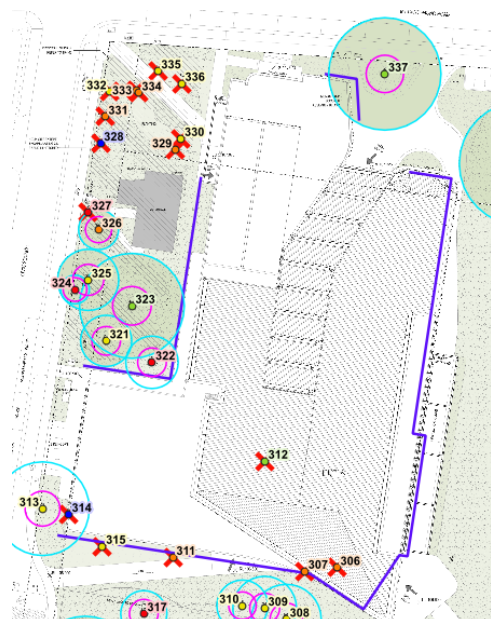
**Figure 2:** Locations of proposed root barriers (purple lines) overlaid onto Site Plan.

The plan at Appendix 2 includes the trees' TPZs and Structural Root Zones (SRZs) and shows where encroachments have been identified from the design plans reviewed. Two of the trees intended to be retained (Nos. 313 and 337) would have built form extending into their TPZs while intrusions for other trees would primarily come from drainage lines and root barriers that it is understood are proposed to protect the new building from the effects of potential future root growth. Concept root barrier locations and drainage lines are shown on the plan extracts at Figure 2 and Figure 3 respectively.

Particular attention is likely to be required around Tree 337 as the proposed encroachment is currently close to 10% on account of the proposed root barrier. While the tree currently has hard surfacing over much of its TPZ, additional root disturbance over and above the root barrier should be avoided.

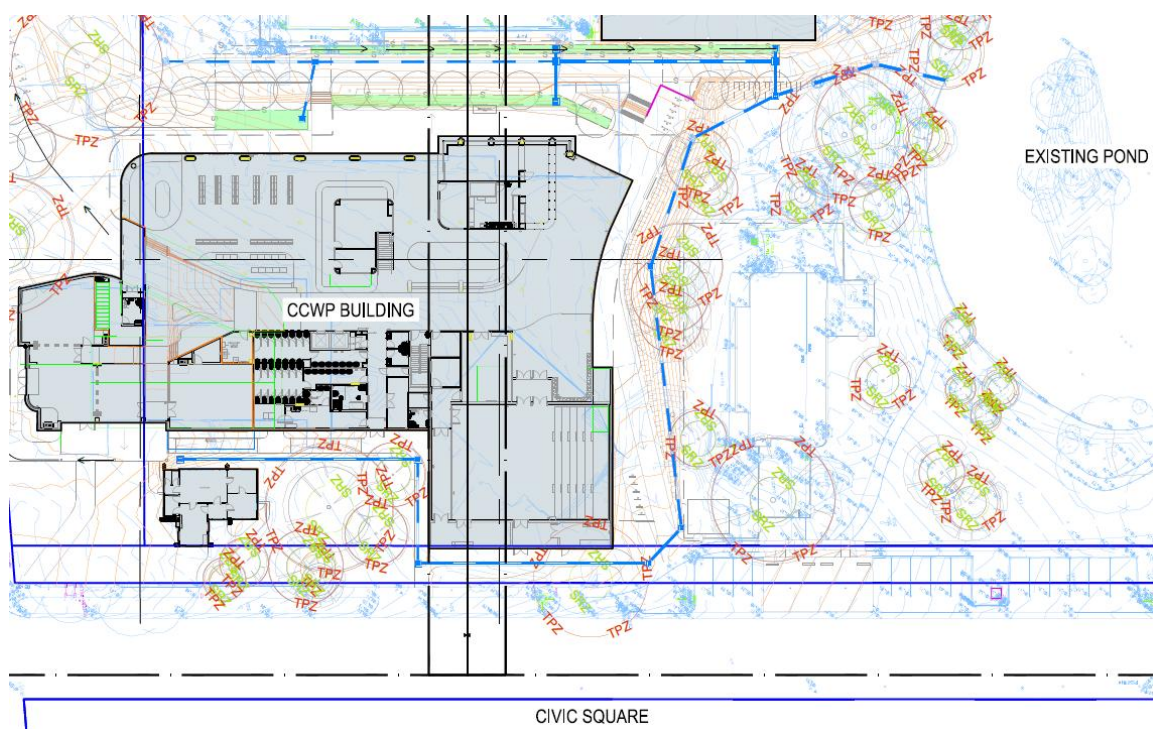
**Figure 3:** Extract from General Site Plan (Civil) with drainage indicated by blue lines.

Twelve (12) trees have been identified from the supplied plans as having construction or trenching works proposed within their TPZs. Six (6) of these have encroachment calculated as being minor (less than 10% of their TPZs being impacted) while six other trees would be subjected to major TPZ encroachment. (Table 2).

- **Trees 305, 308, 309 and 310** would be impacted by the proposed drainage alignment. Relocating the drainage to impact none or only a minor proportion of their TPZs would appear feasible. Otherwise, the feasibility of boring below the rootzones would need to be investigated.
- **Tree 313** would also have its TPZ most affected by proposed drainage. Boring drainage lines below the root zone would reduce intrusion to approximately 14% from the building footprint. This tree, a *Melaleuca linariifolia*, would be expected to tolerate this level of intrusion.
- **Tree 322** is a small Cherry Plum (*Prunus cerasifera*) which is of little arboricultural merit. Design amendment would not be warranted to preserve this tree over providing a new replacement planting within the site.

- Tree 322 is of little arboricultural value and design amendment is not considered warranted to preserve its condition.
- To preserve trees 305, 308, 309, 310 and 313, proposed drainage alignments would need to be bored below the rootzones or amended to affect no more than 10% of the trees TPZs.

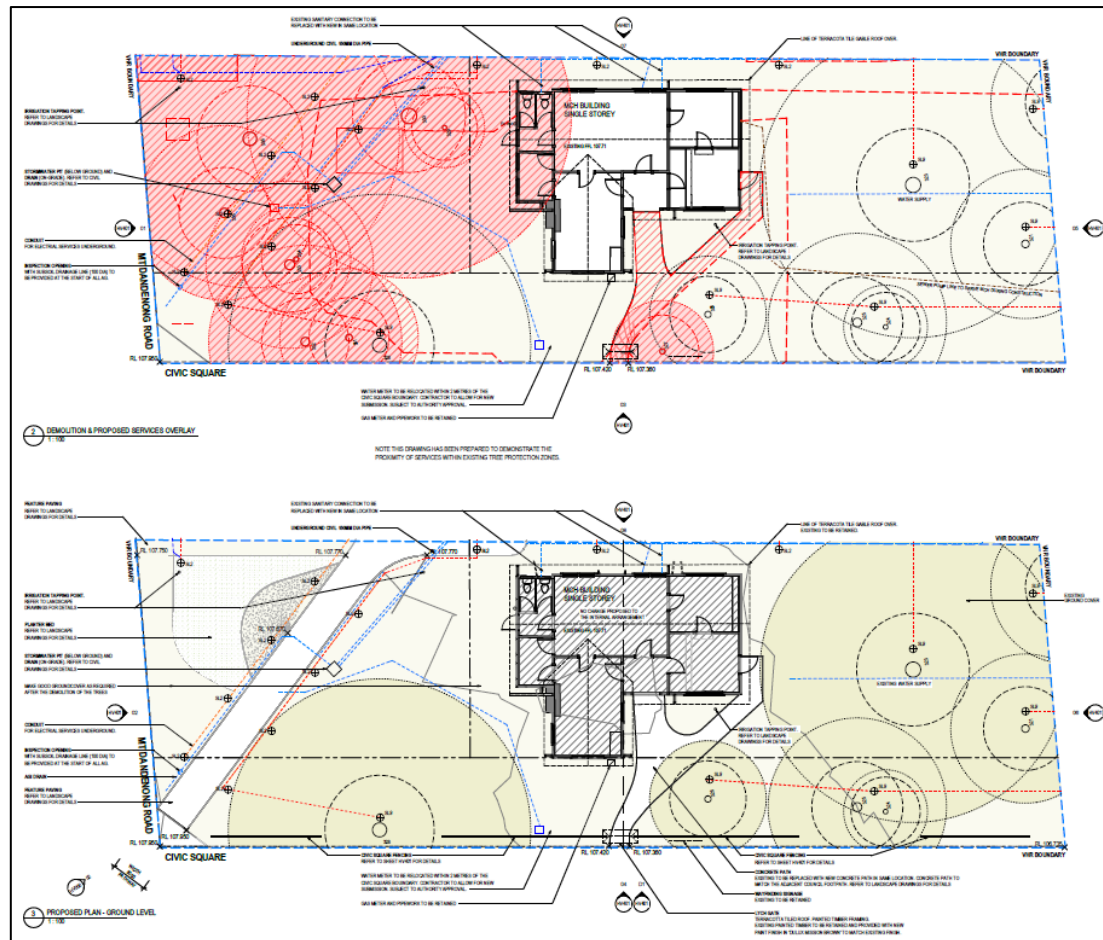
*Extract from 'HV201/Existing & Proposed General Arrangement'*

Trees within/near the Heritage Victoria VHR Site HO0054 area:

- Retention of Tree 328 will preserve moderate landscape character in this immediate vicinity, but removal of Trees 329-336 will significantly degrade streetscape character. Removal of all these trees is not justifiable based on their individual condition.

- No evidence of damage to the buildings adjacent to Trees 330 & 336 was noted during assessment, and no evidence of building damage has been provided.

- Based on the absence of recorded damage and the maturity/age of Trees 330 & 336 (which limits further root calliper increase), it is considered

unlikely that damage to these heritage buildings from roots will occur in the future.
