**15 ST. VINCENT PLACE SOUTH, ALBERT PARK.** (17.09.26).

## Further Information Request

*This response provides further clarification in relation to the matters outlined in the Further Information Request issued by Heritage Victoria on 21.08.26.*

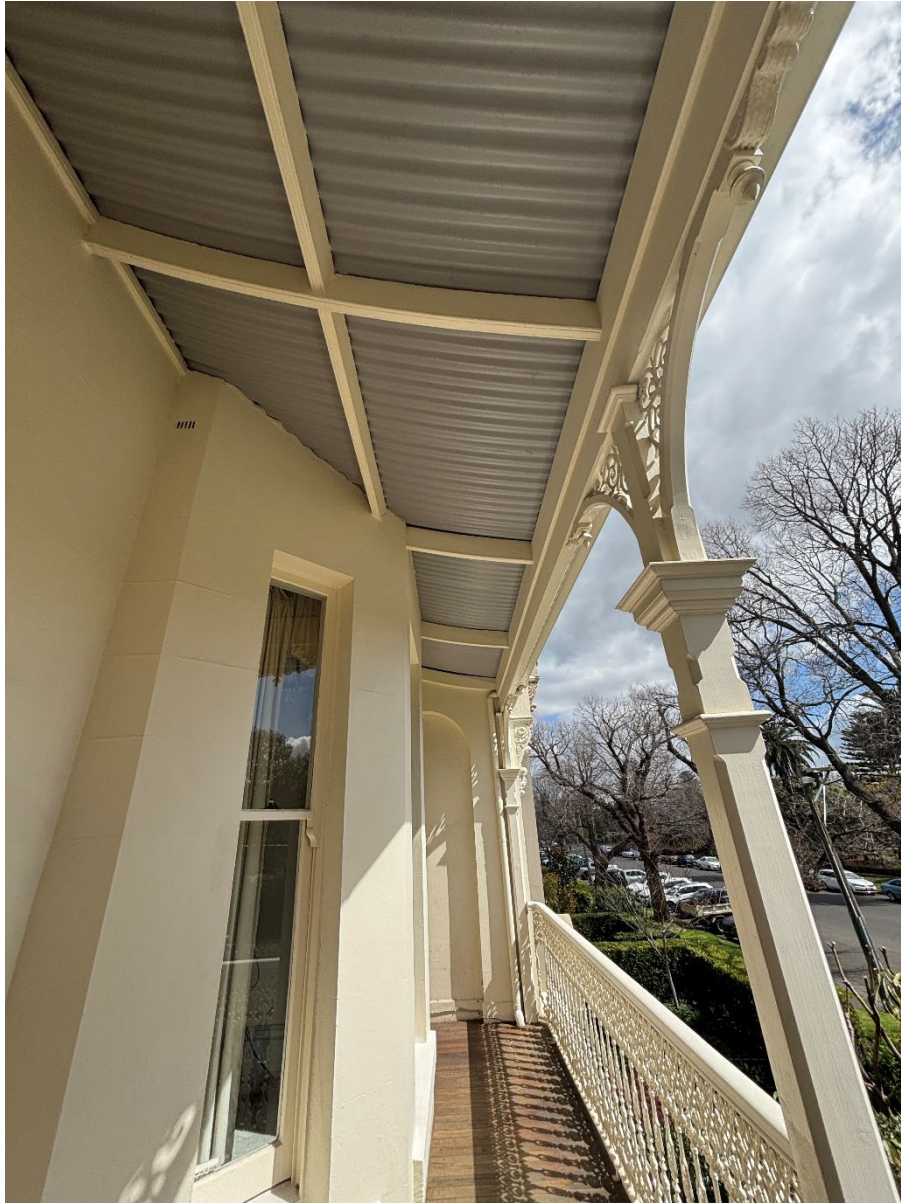
*Figure 1 – The photo above shows overpainting of the original ashlar tooling. This is particularly evident on the left hand side of the first floor bedroom window.*

*The proposal seeks to reinstate the original render and ashlar tooling, as noted in RBA’s Heritage Impact Statement. As such, the note on HV05 stating there will be “new 20mm thick natural render over as required” has been removed. Furthermore, notes on HV02, HV03, HV05 and HV06 relating to original render works have been revised to “remove overpainting using a non-abrasive and non-caustic paint, to reinstate original render and ashlar tooling”. Refer to Figure 1 in the appendix.*

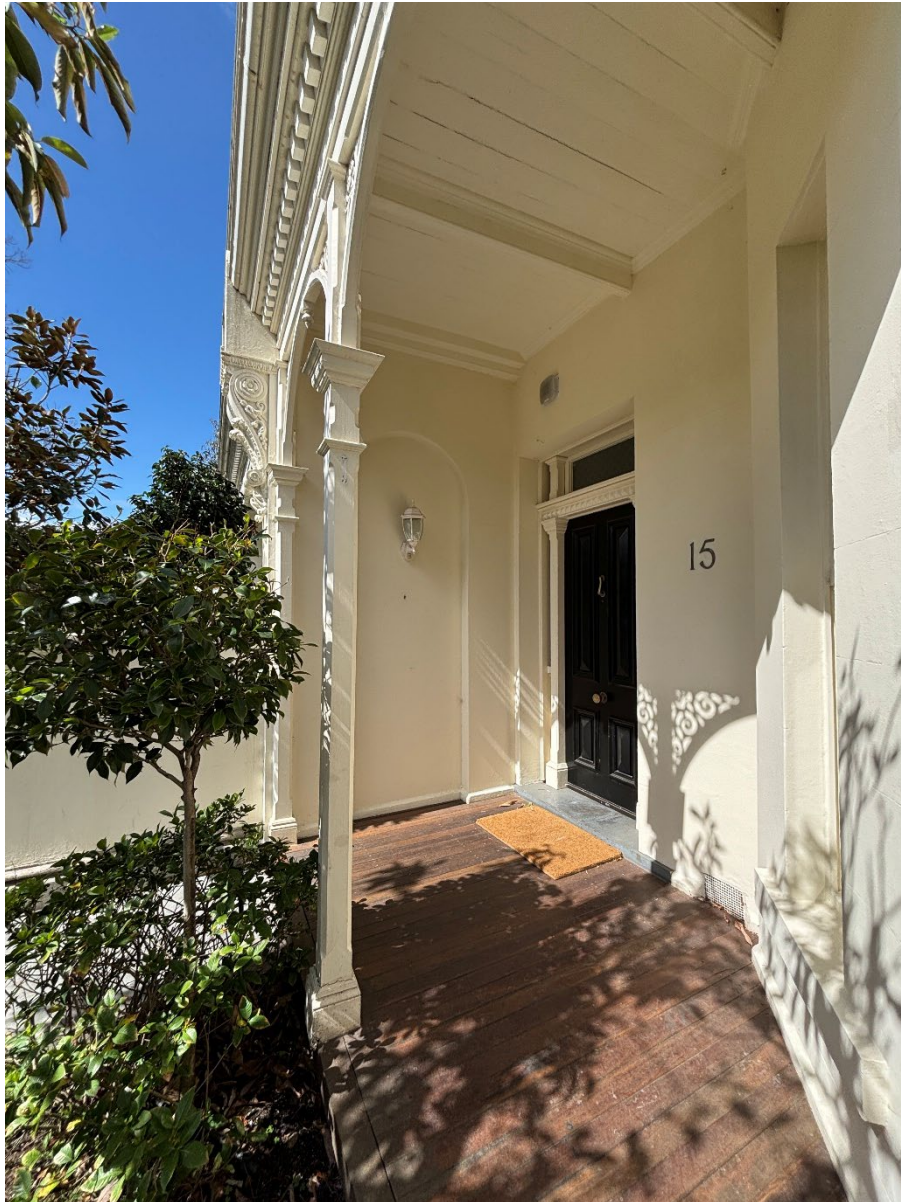
*Upon closer inspection, the front façade is generally well-maintained and in good condition, so no repairs to the original render are required. All references to “repair original render” have been removed on HV02, HV03, HV05, HV06 and HV07. Refer to Figure 2 and 3 in the appendix.*

*Figure 2 – The photo above shows the existing façade, generally in good condition.*

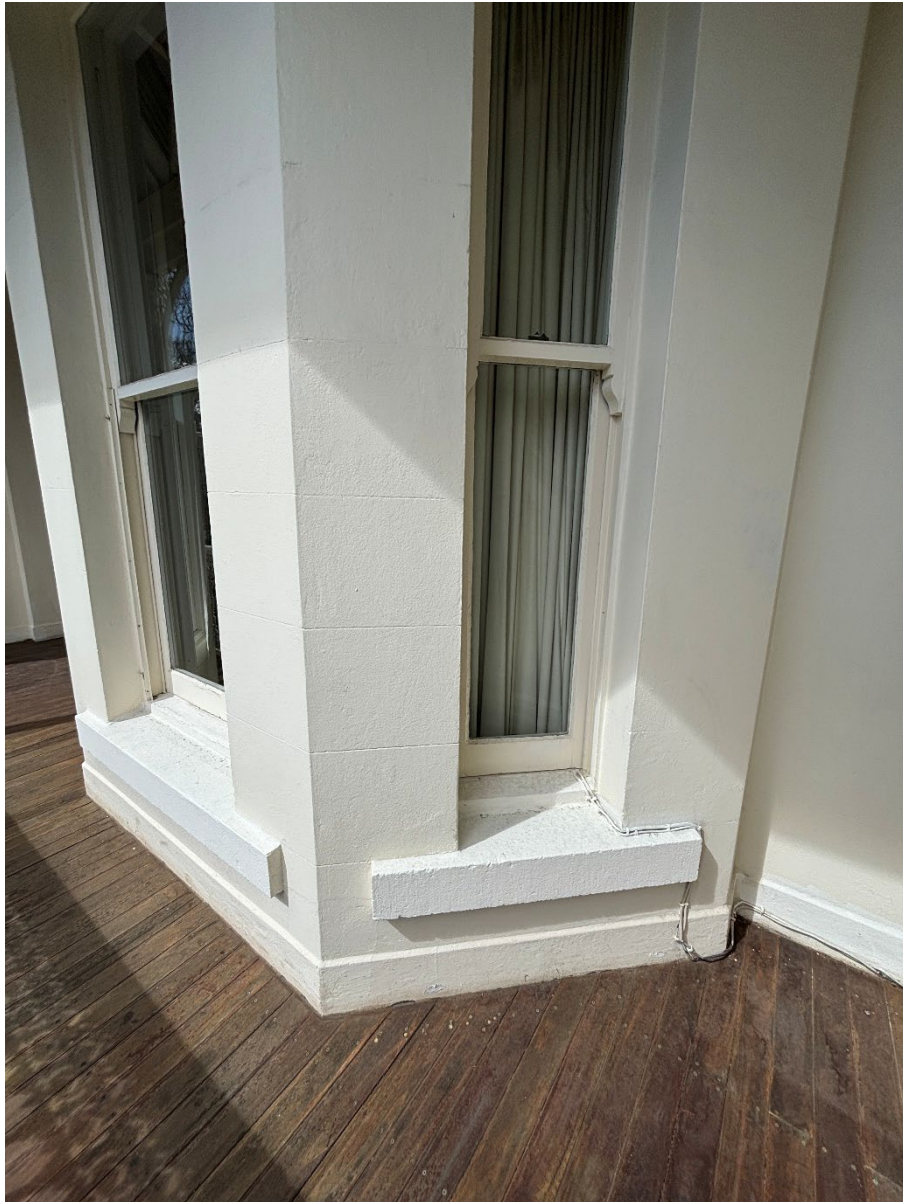
*Figure 3 – The photo above shows the existing façade, generally in good condition.*

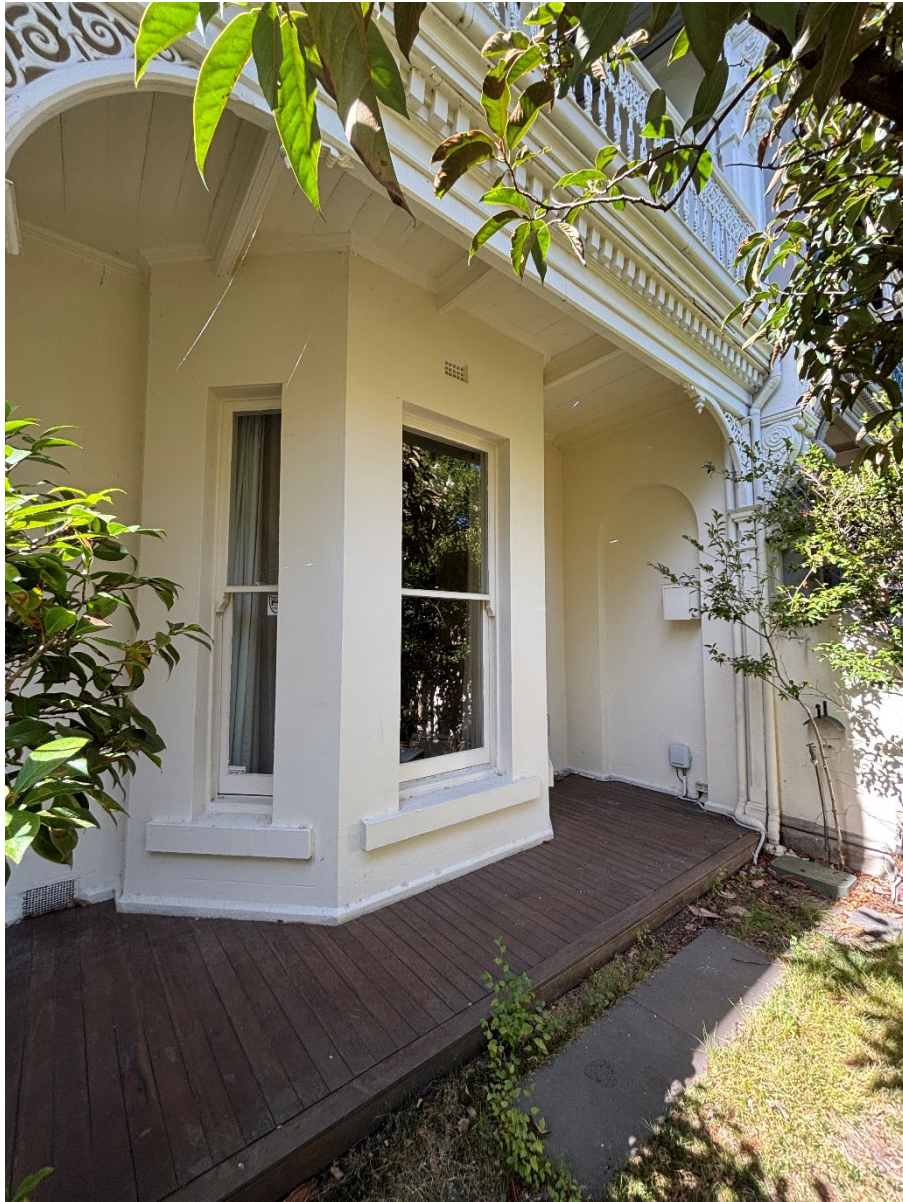
*Figure 4 – The photo above shows the existing verandah timber decking. It is proposed to remove the existing timber edging and reinstate it with basalt edging to match No. 11.*

*The proposal seeks to retain the existing timber deck at ground level (verandah). It is our intention to reinstate the edging with basalt in a bullnose profile to match No. 11. TO do so, the existing vertical timber edging will be removed. Notes on HV02 and HV03 have been re-worded for clarity. Refer to Figure 4 and 5 in the appendix.*

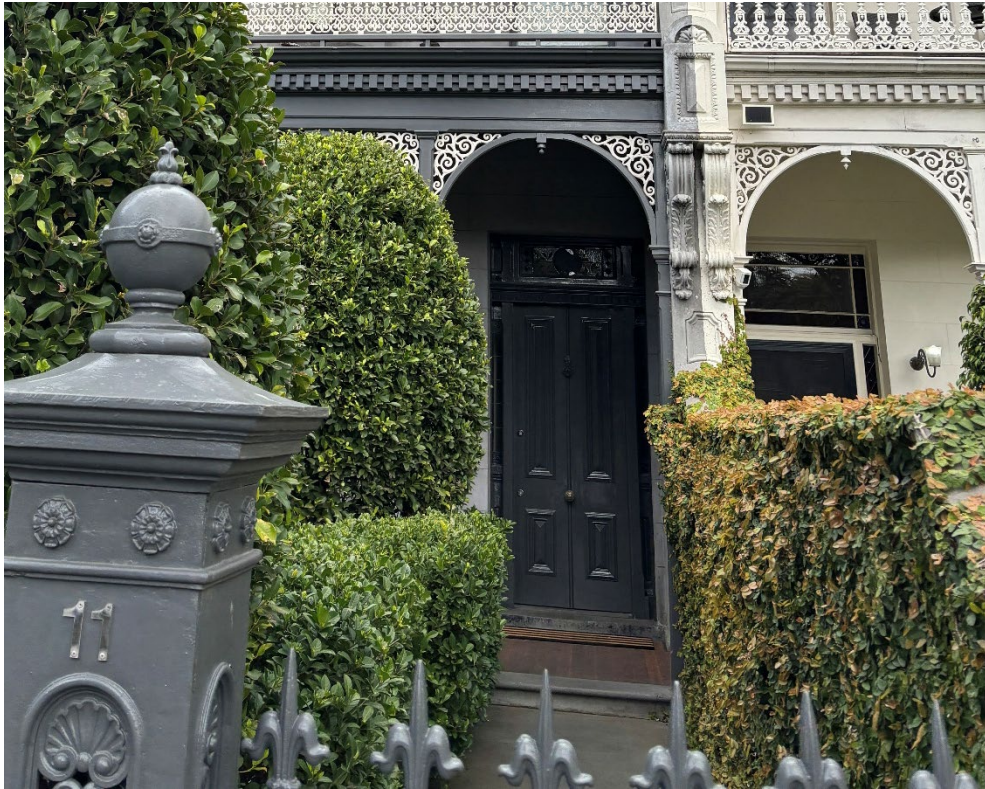
*Figure 5 – Basalt edging to verandah of No. 11 pictured above. The proposal seeks to match this detail.*

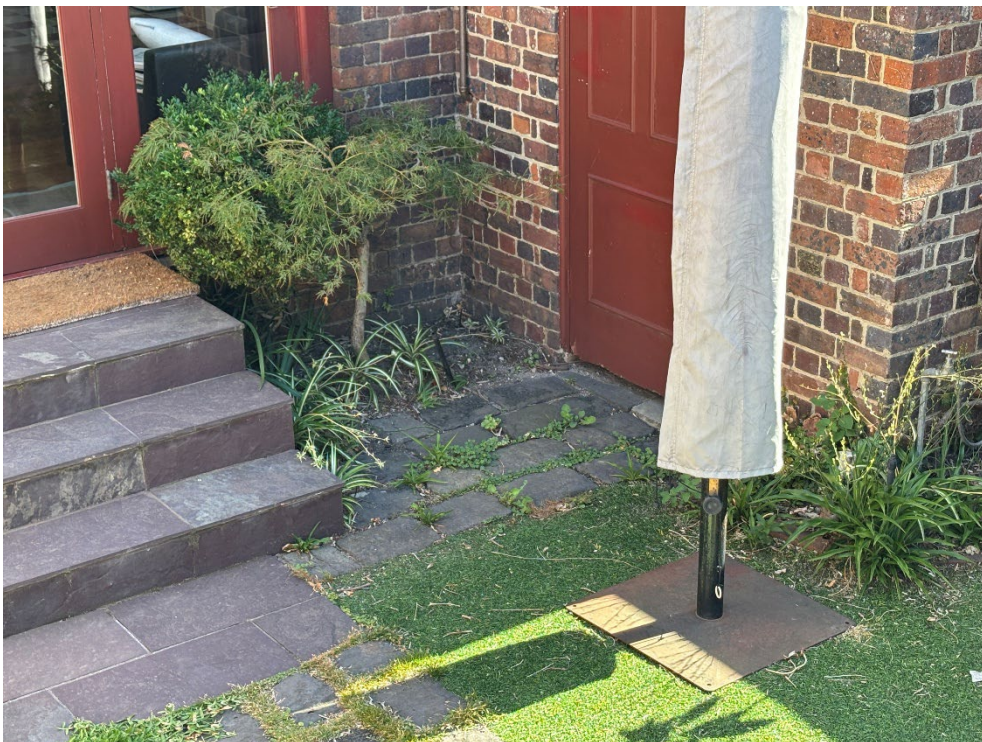
*Figure 7 – Original flagstone pavers leading to the shed pictured above. These will be repurposed as part of new landscaping works.*

*We agree that repurposing the original flagstone pavers as part of the proposed landscaping scheme will be a positive contribution to the balancing of the proposal's heritage impacts. Notes on HV02 and HV05 have been added to this effect. Refer to Figure 6 and 7 in the appendix.*

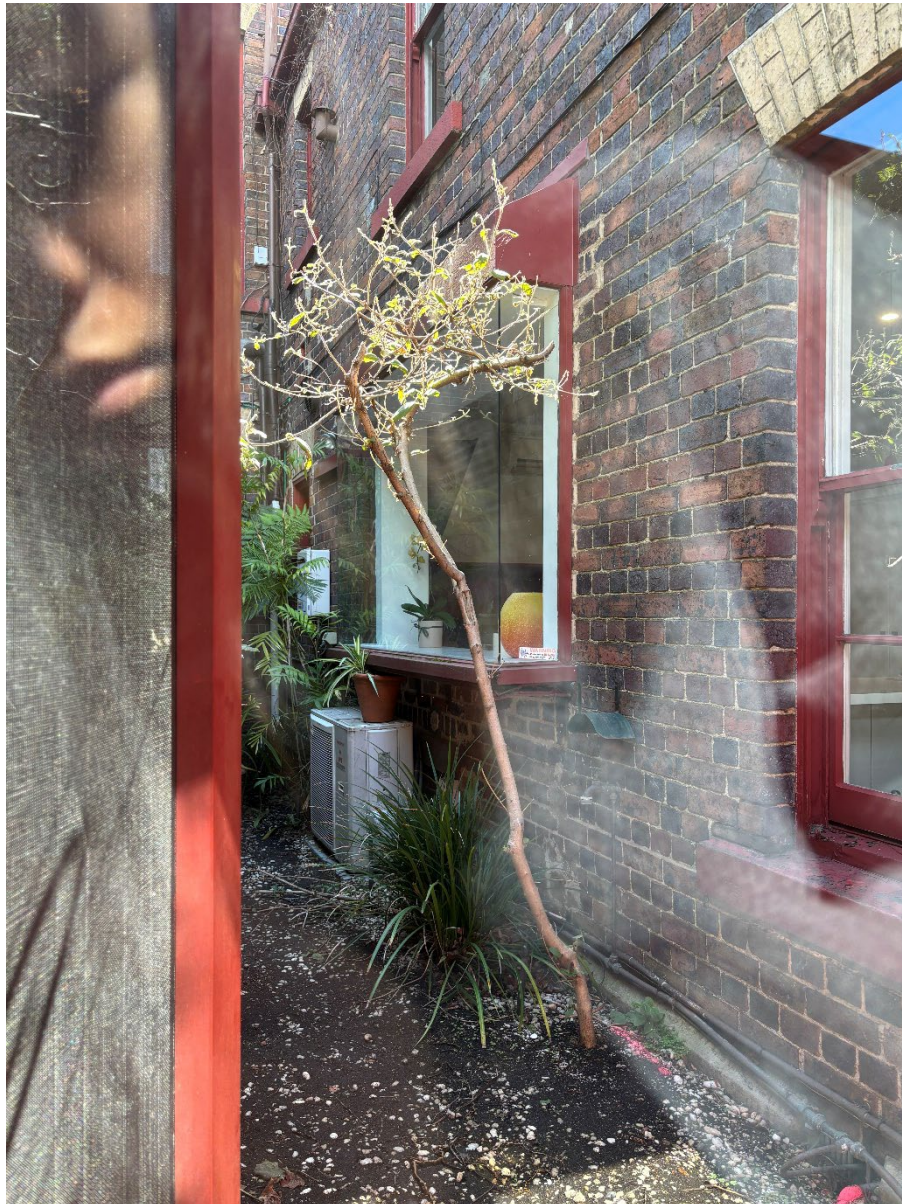
*Figure 8 – Existing lightcourt pictured above. The window on the right is proposed to be altered into a door. The existing sill and bricks under the window will be removed to do so.*
