# HERITAGE IMPACT STATEMENT

## LANDSCAPE RENEWAL

## ST MARYS ANGLICAN CHURCH NORTH MELBOURNE

August 2024

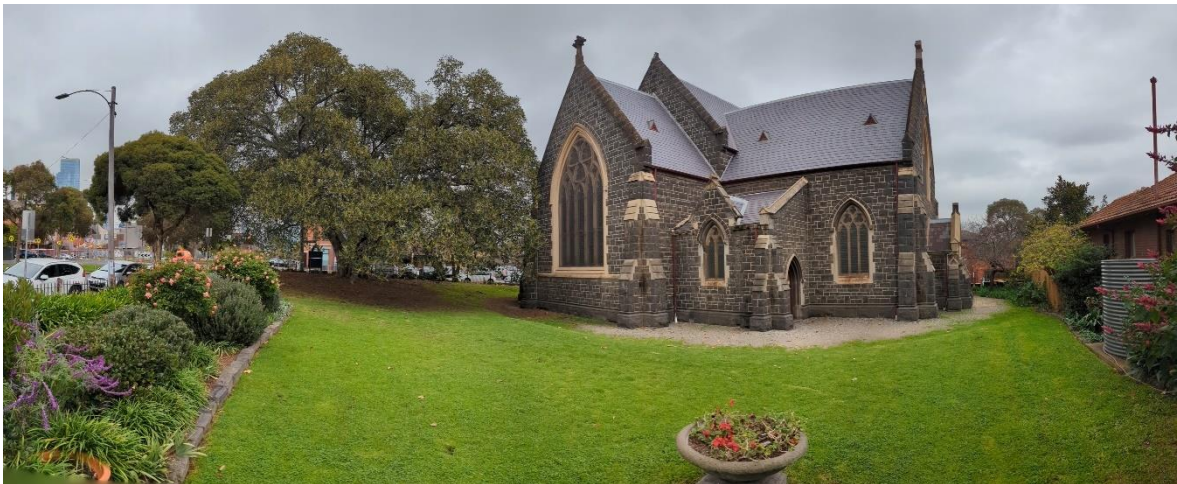
Figure 1: View looking southwest from the corner of the site (Howard St boundary) of the area of proposed works. The view is slightly distorted due to creation of panoramic view.

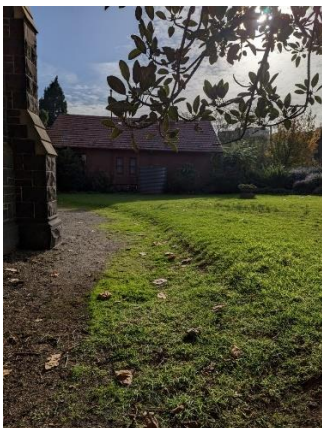
Figure 2: View north toward the neighbouring vicarage on Howard Street. A gravel 'skirt' next to the church building is being encroached by the adjacent lawn. Part of a garden bed on the Howard Street boundary is visible at right of frame. The canopy of an existing Moreton Bay Fig is visible at top of frame.

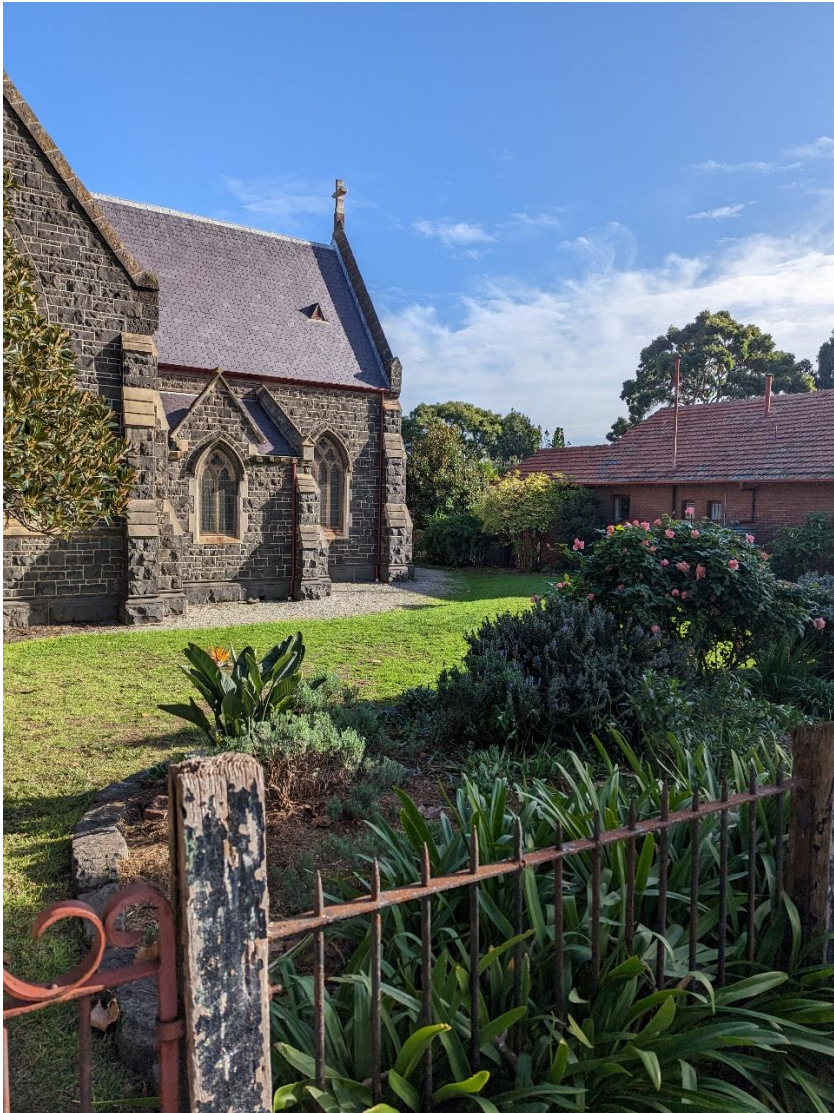
Figure 3: View north-west from a pedestrian gate on the Howard Street boundary. A shrub bed, edged with unmortared stone, runs along the boundary from the gate to the northern extent of the site.

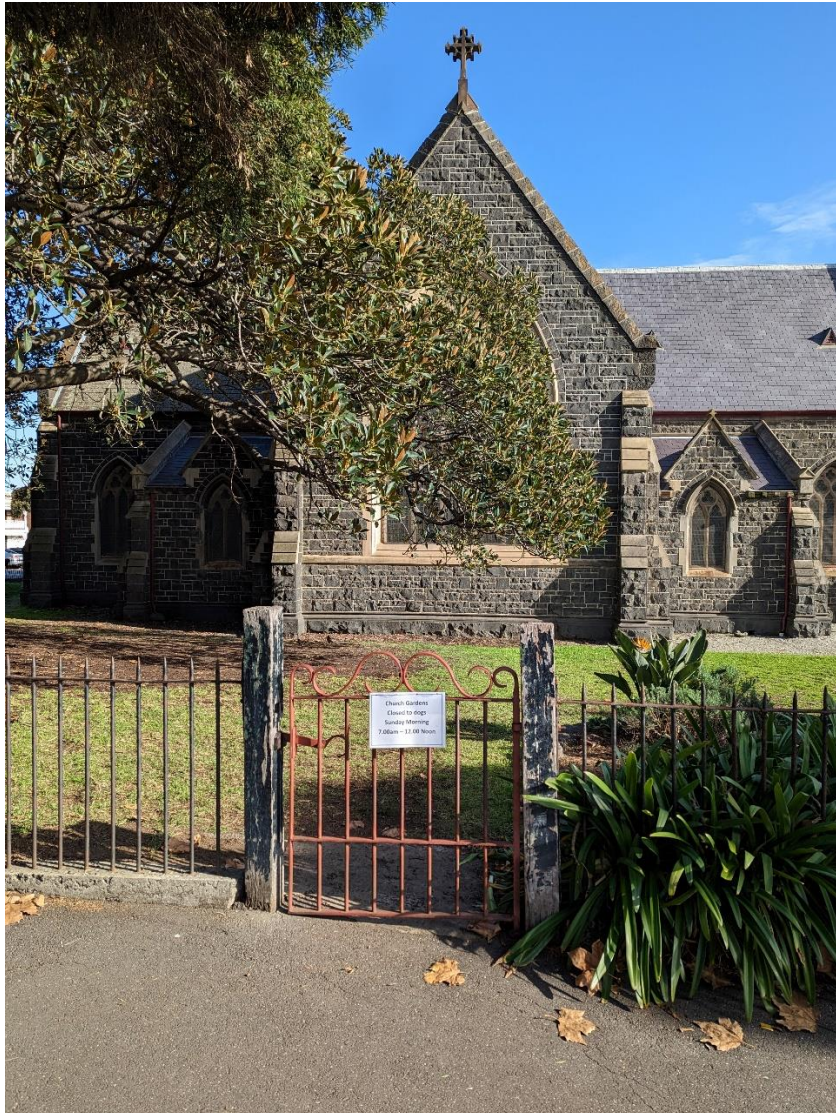
Figure 4: An historic iron fence, with timber posts, is present on the Howard Street boundary. A wrought iron pedestrian gate is slightly misaligned with the building façade.

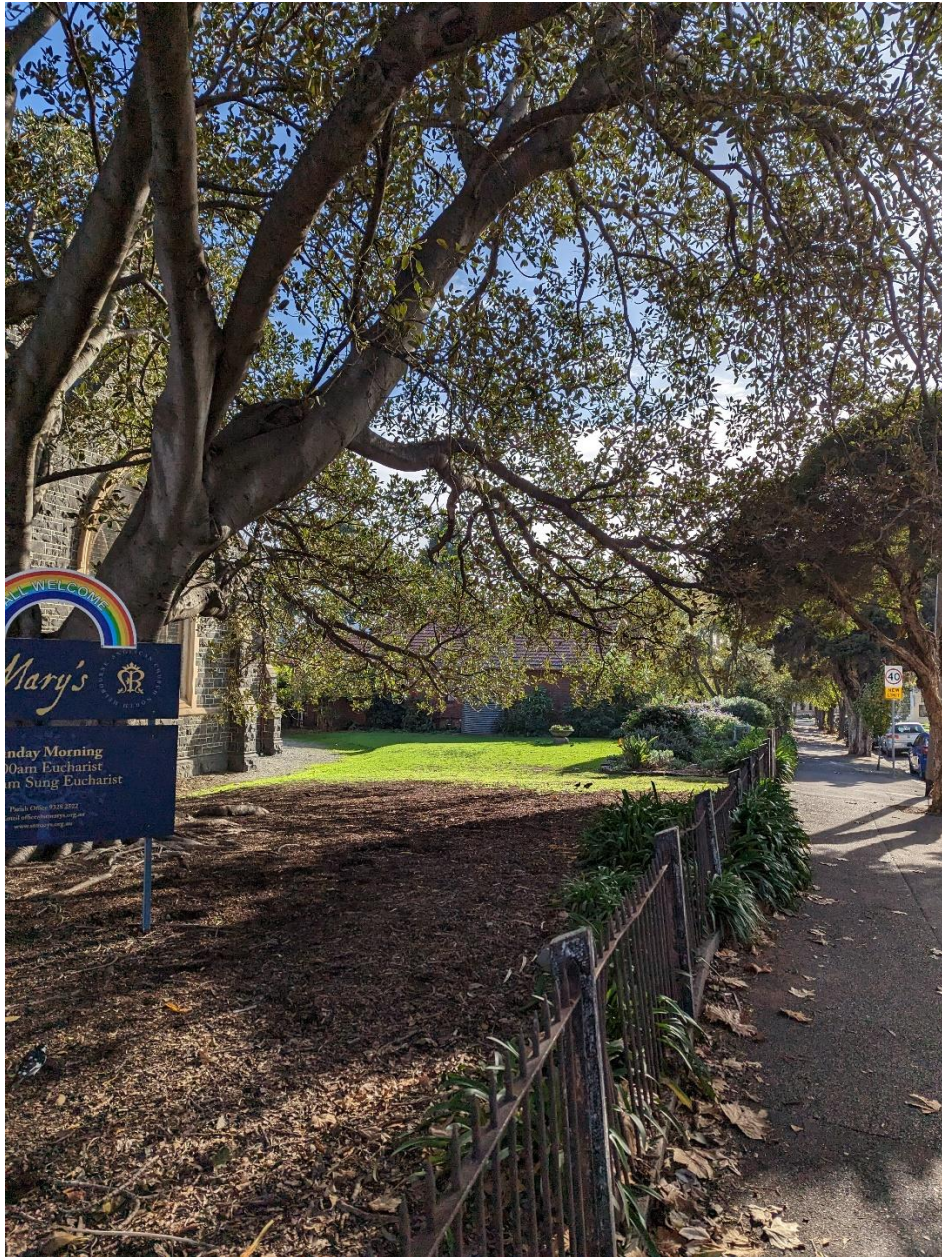
Figure 5: View along the Howard Street boundary of the site, from near the intersection with Queensberry Street. A large Moreton Bay Fig in the south-eastern corner of the site is to be retained.

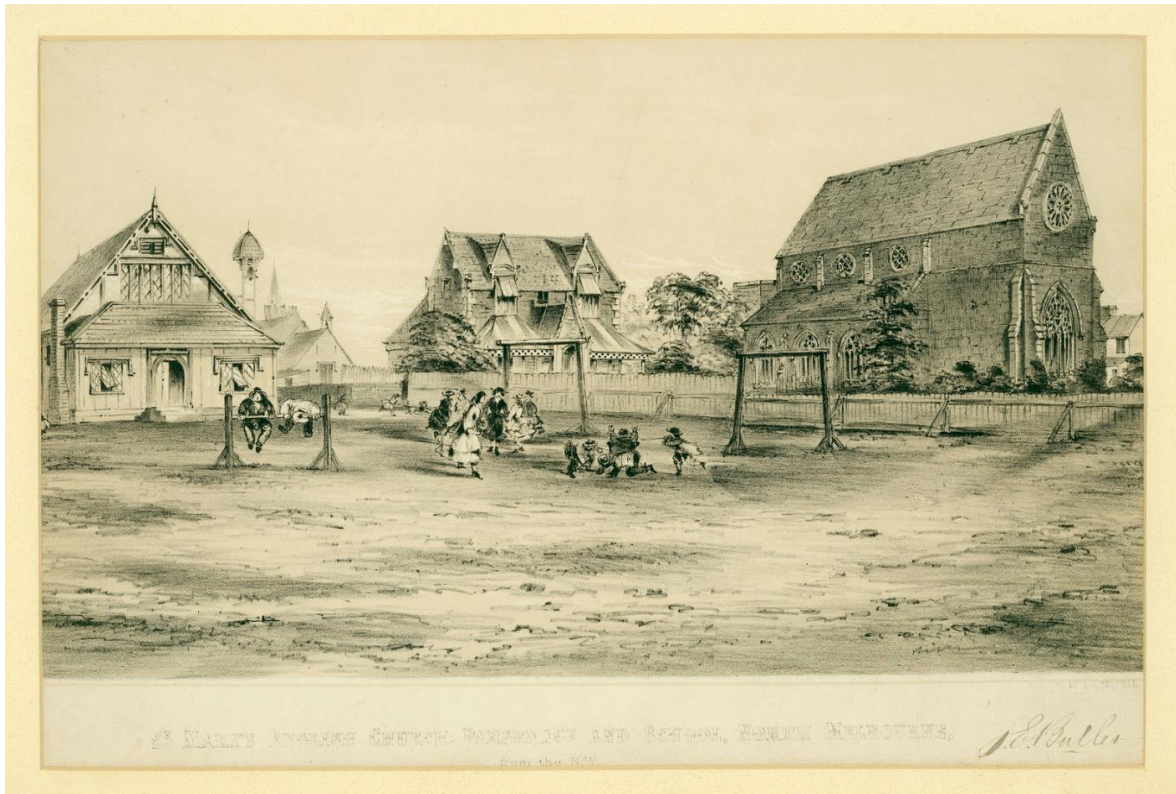
Figure 6: c.1862 drawing of St. Mary's English church, parsonage and school, North Melbourne by J.E. Butler. Source: State Library Victoria.

A c.1862 drawing of St. Mary's (Fig. 6) shows the adjacent St. Mary's schoolyard, separated from the church garden by a timber fence. An annotation below the drawing, "from the N.W." appears to be incorrect as the relative positions of the church, parsonage (vicarage) and school indicate a view from the southwest. The drawing shows shrub mass and a tree with the appearance of a conifer, perhaps a Deodar (*Cedrus deodara*), next to the western façade of the church. Given the construction years of the church (1858-1868) and the estimated date of the drawing, it is unlikely that a tree of the size shown in the drawing would have been present. It is also noted that drawings often do not accurately represent features present, particularly as regards landscape elements which may be added to provide a setting for the building and to complete the composition. The drawing can not be relied upon to provide information on the early elements of the churchyard.

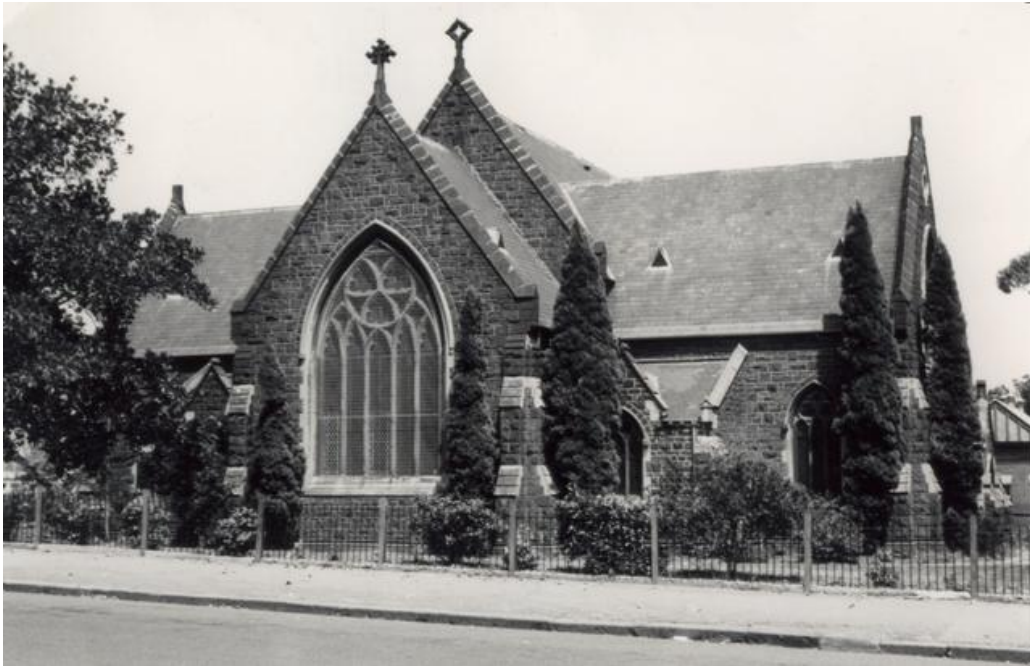
Figure 7: Undated (estimated c.1950s) view of the eastern façade of St Mary's. The most notable landscape element is the fastigiate conifers next to the building. Source: Picture Victoria.

A series of three photos sourced from Picture Victoria ([www.picturevictoria.vic.gov.au](http://www.picturevictoria.vic.gov.au)) which capture views of St. Mary's from different vantage points are undated, however an estimate of the age of a car in frame in one of the photos suggests the photos were taken c.1950s. The photo of this series showing the eastern façade of the church and the garden as viewed from Howard Street (Fig. 7) shows that fastigate conifers were present against the building façade, framing the stained-glass window of the eastern projection of the building, and emphasising the structure of the building.

The varied height of the conifers may indicate planting at different periods or may be the result of competition for water and nutrients with the Moreton Bay Fig, or some other localised site conditions. The Moreton Bay Fig (at left of frame) is of substantial size. Other planting in the eastern portion of the site consists of a few, regularly spaced shrubs and perhaps a small tree, adjacent to the eastern boundary fence. Little can be seen of surfaces next to the building, however at the bottom right of frame lawn and either gravel or paving may be present.

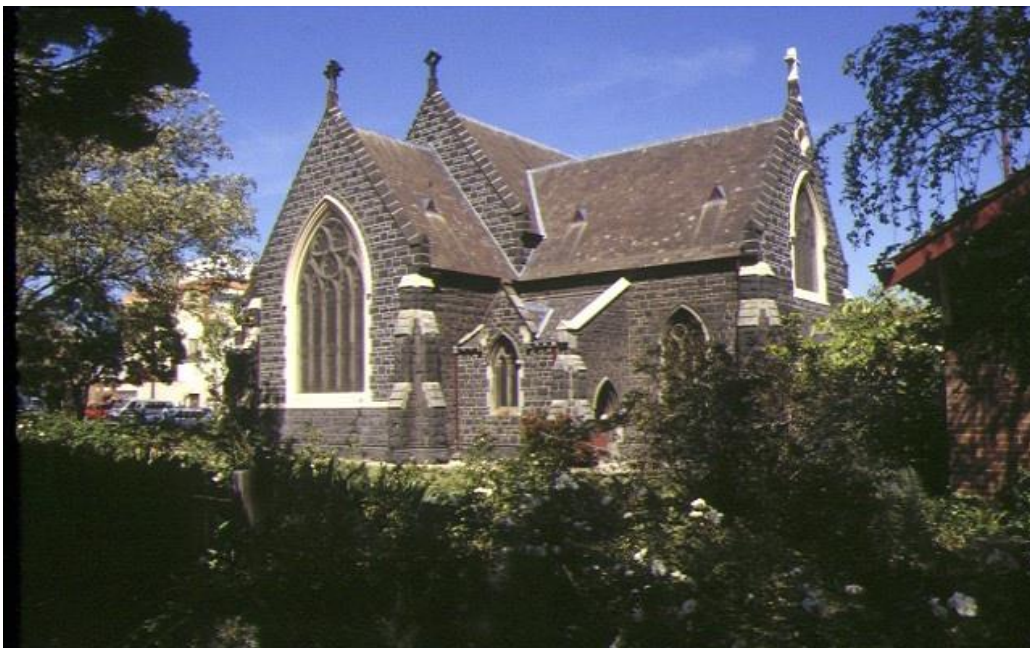
Figure 8: 1997 view of the eastern façade of St Mary's.

The period in which the conifers next to the church were removed is not known, however a 1997 photo (Fig. 8) shows they were not present. In a 2008 view (Fig. 9) the lawn and gravel apron next to the building are evident. A young tree or shrub adjacent to the building has since been removed.

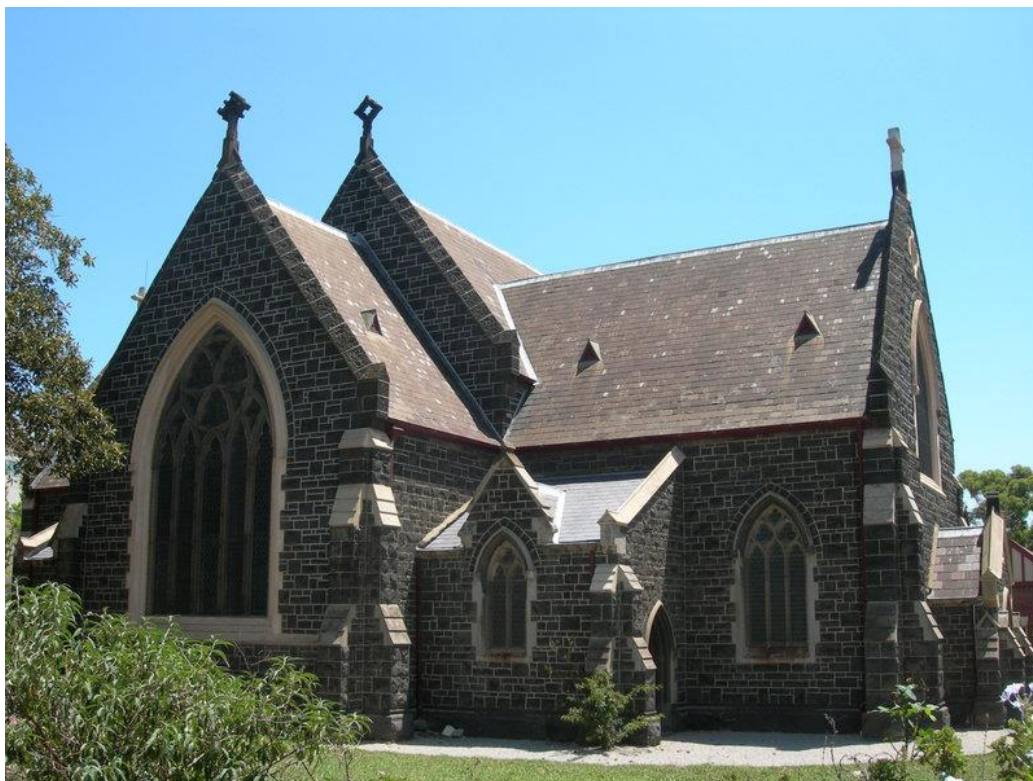
Figure 9: 2008 view of the eastern façade of St. Mary's.

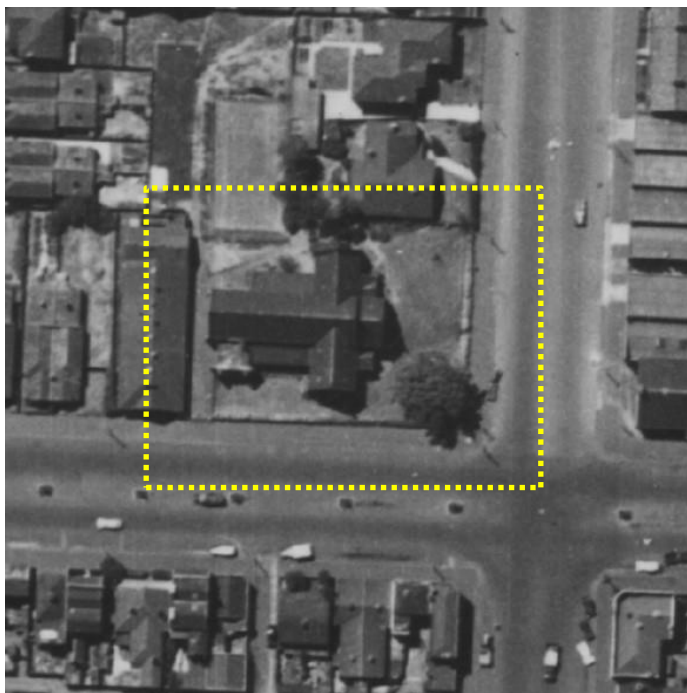
Figure 10: December 1945 aerial photograph, cropped to centralise the subject site (indicated in yellow). Melbourne and Metropolitan Area Project, Run 25, Frame 60107. Source: Landata ([www.landata.online](http://www.landata.online)).

The 1945 aerial (Fig. 10) shows an almost featureless garden east of the church, apart from the Moreton Bay Fig in the southeastern corner. A feature is visible in the lawn, toward the northern extent of the garden. This may be a planter urn with plinth, as is currently present at or near this location. While not discernible, it is possible that fastigate conifers are present next to the church building.

In the 1945 photo a path is visible at the northeastern corner of the building, linking the northern entrance and a minor entrance on the eastern side of the church building. A faint line, perhaps an informal foot path may be visible just north of the Moreton Bay Fig canopy, leading from the Howard Street boundary.

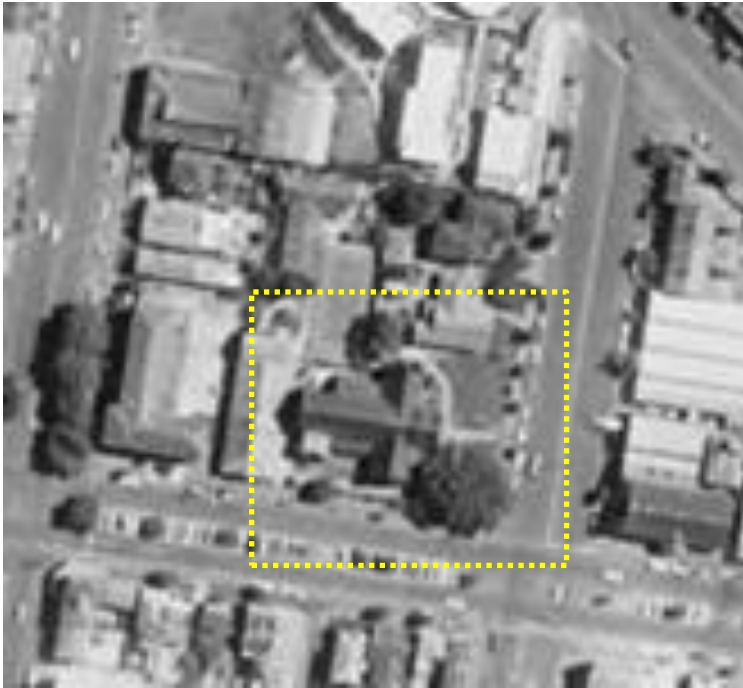
Figure 11: December 1979 aerial photograph, cropped to centralise the subject site (indicated in yellow). Heytesbury North Project, Run 9, Frame 189. Source: Landata ([www.landata.online](http://www.landata.online)).

A 1979 aerial (Fig. 11) clearly shows a path from the Howard Street pedestrian gate to the eastern façade of the church building, joining an area of regular width between the church building and the eastern lawn. Whether this area is gravelled or paved can't be determined from the photograph, however it appears to continue to the extent of both the southern and northern façades of the building.

While the addition of a hardscaped path from the Howard Street boundary gate to the gravel apron next to the church building will substantially alter the appearance of the eastern garden, historic aerial photographs (1979, Fig. 11 & 1982, Fig.12) show that a path previously existed in this location, albeit likely formed in gravel.

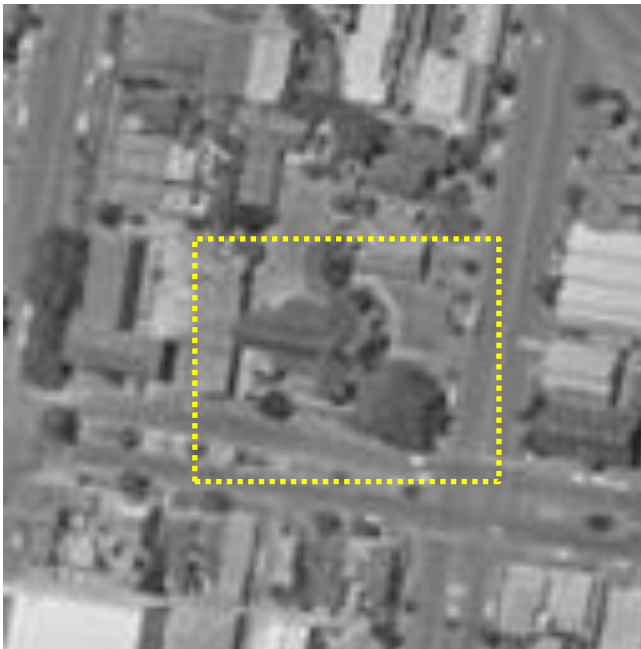
Figure 12: March 1982 aerial photograph, cropped to centralise the subject site (indicated in yellow). Heytesbury North Project, Run 4, Frame 229. Source: Landata ([www.landata.online](http://www.landata.online)).

The path from the eastern boundary pedestrian gate to the eastern façade of the church is also visible in the 1982 aerial photo (Fig. 12), however it appears less defined. This may be due to the relatively poor resolution of the photo or may indicate a gravel rather than paved surface. The current absence of a path in this location also suggests a gravelled surface. Very few other landscape features in the eastern garden appear to be present in 1982.

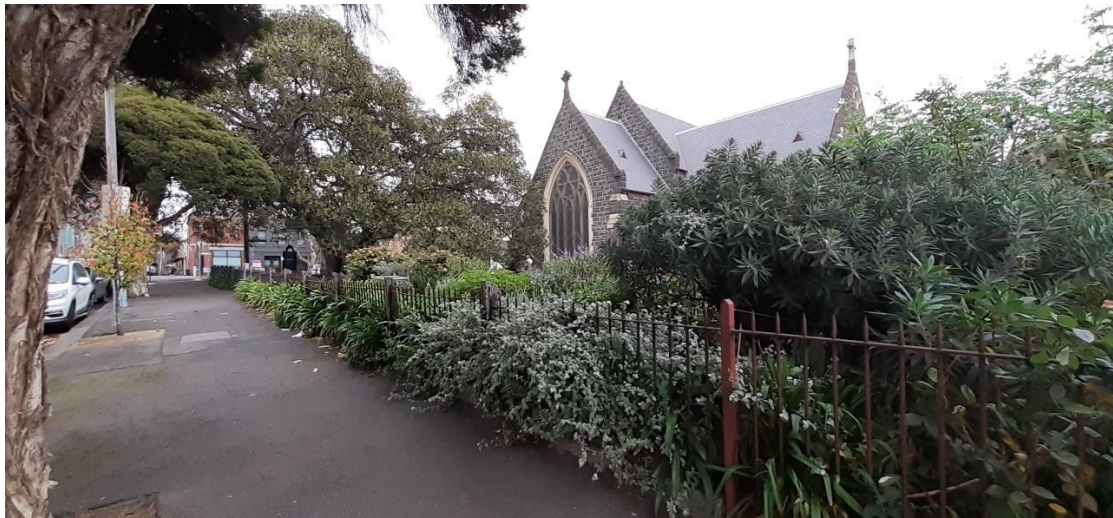
Figure 13: Views of the eastern garden are obscured by existing vegetation (which is to be retained) from the Howard Street footpath next to the northern portion of the garden.

An analysis of views into the site from the adjacent area (Figs. 13-18) found that ground level features are of limited visibility from the Howard Street footpath until a point just north of the pedestrian entry gate. Clear views are then obtained to the corner of the site, and from a portion of the Queensberry Street footpath.

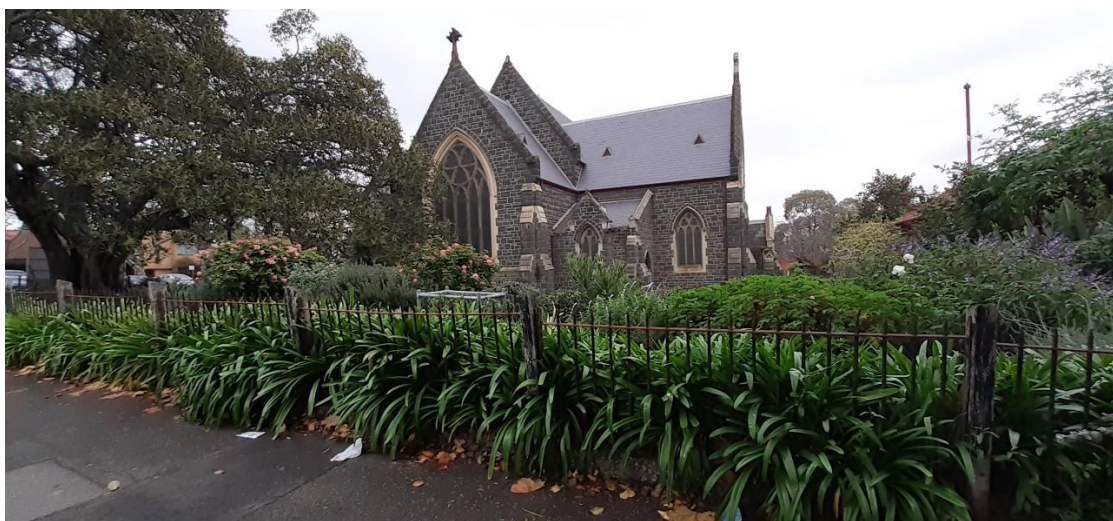
Figure 14: Views of the ground surface are limited by existing vegetation from the Howard Street footpath until the viewer is almost at the pedestrian gate.

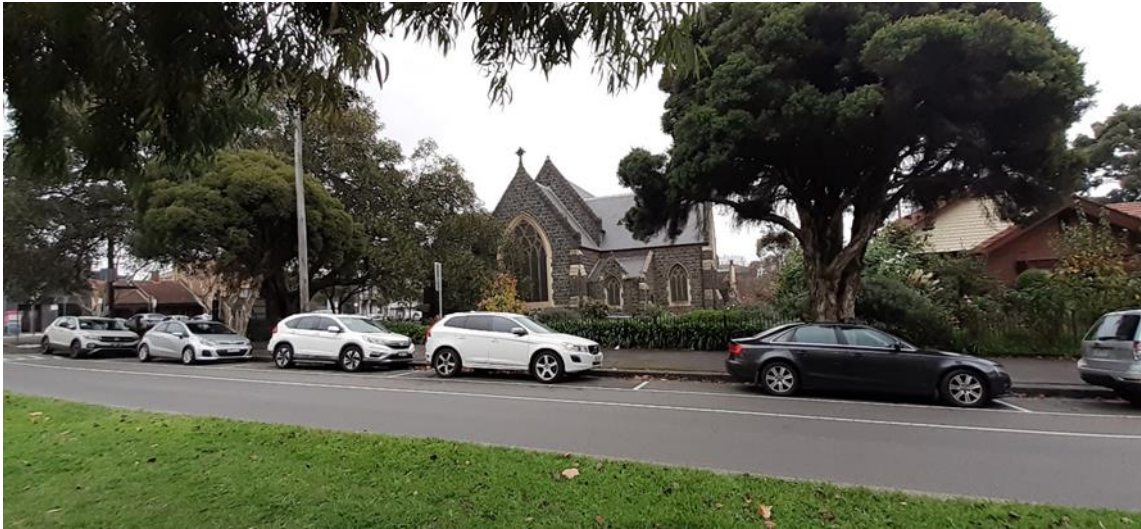
Figure 15: View from the Howard Street median strip approximately level with the northern boundary of the St. Mary's site. Views from the Howard Street median strip of the area of proposed works are obscured by boundary vegetation within the site.

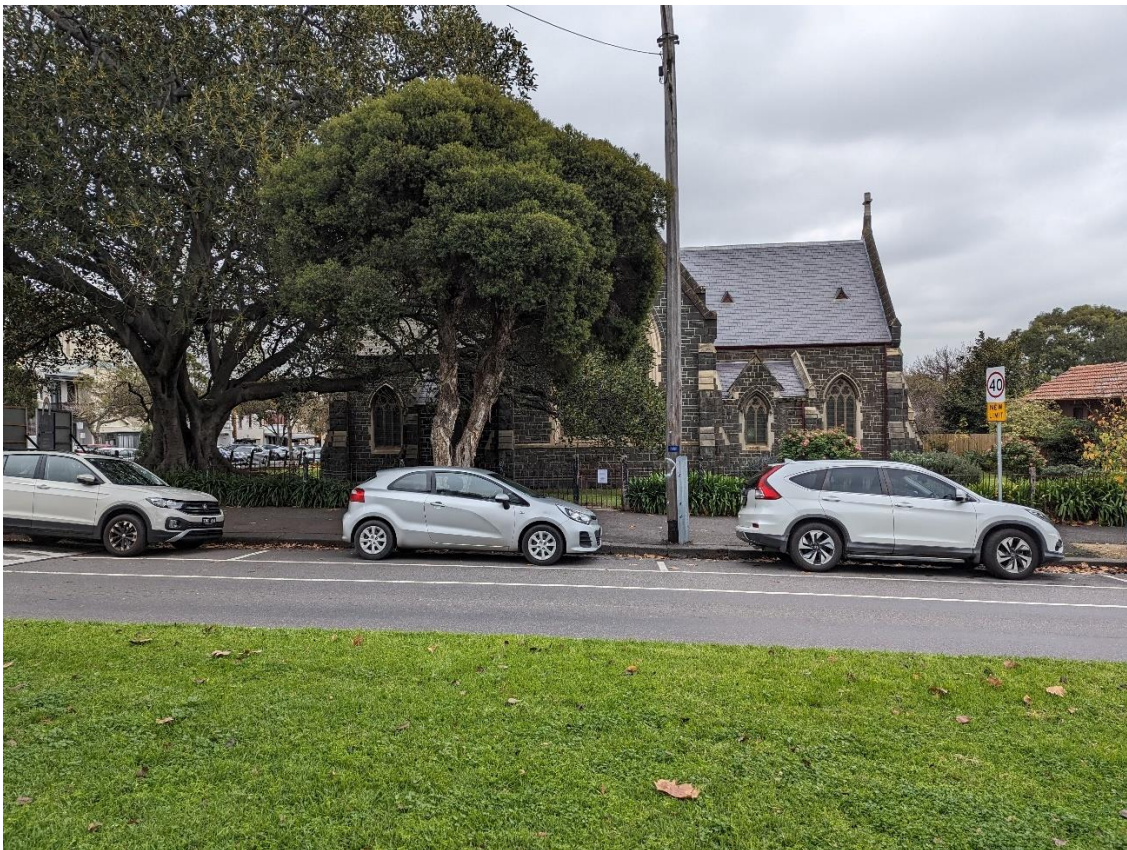
Figure 16: View from the Howard Street median strip, of the eastern façade of the church. Ground plane features within the church site are of limited visibility.

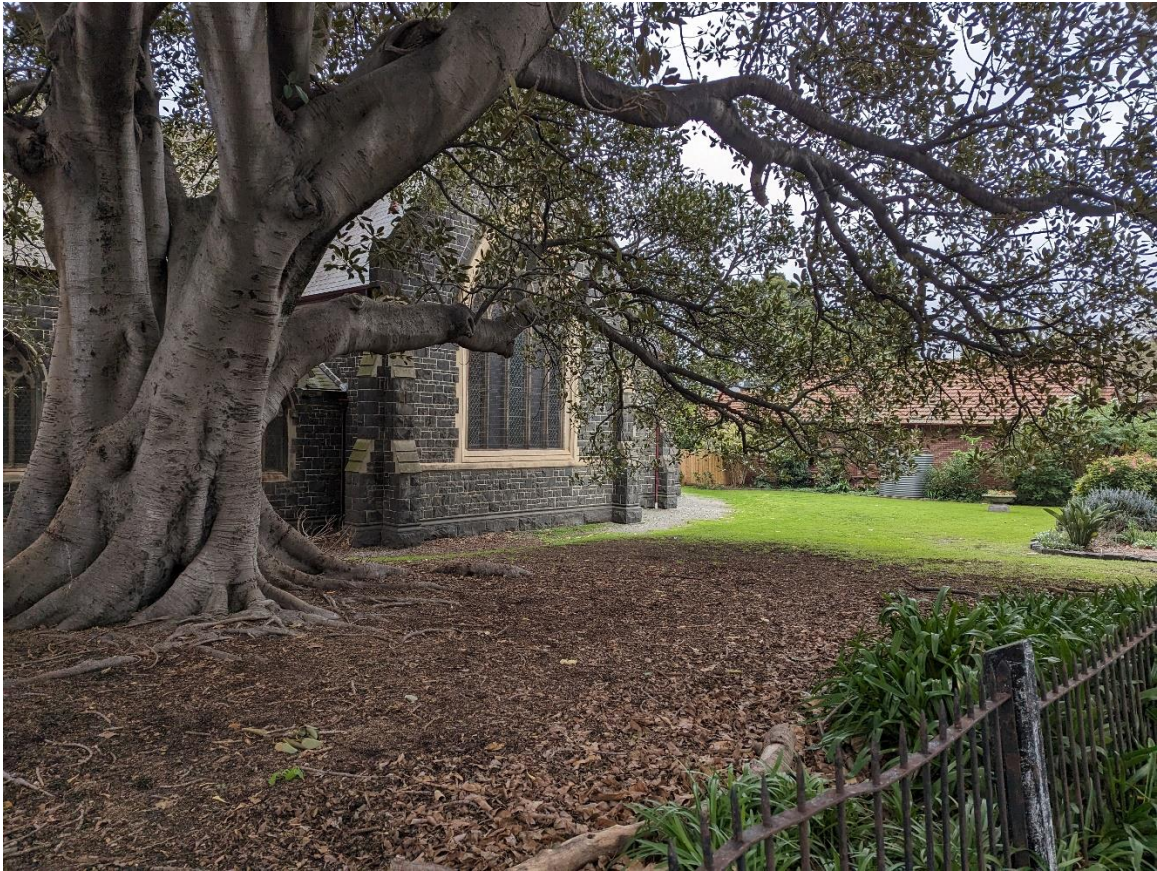
Figure 17: Open views are present from the pedestrian gate on Howard Street to the south-eastern corner of the site.

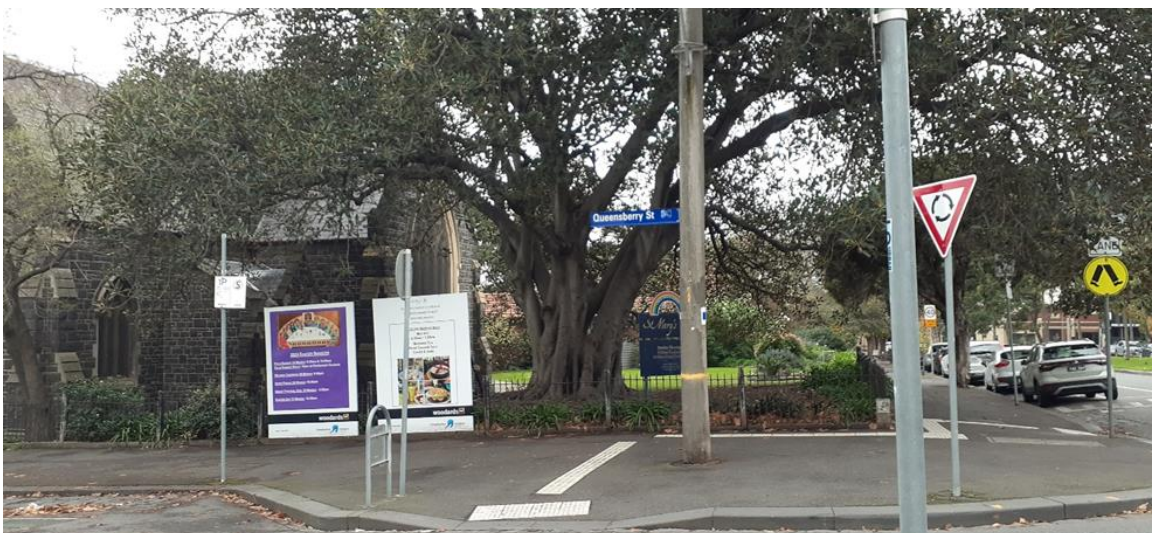
Figure 18: Views of the eastern garden are obtained from Queensberry Street near the south-eastern corner of the St. Mary's site.

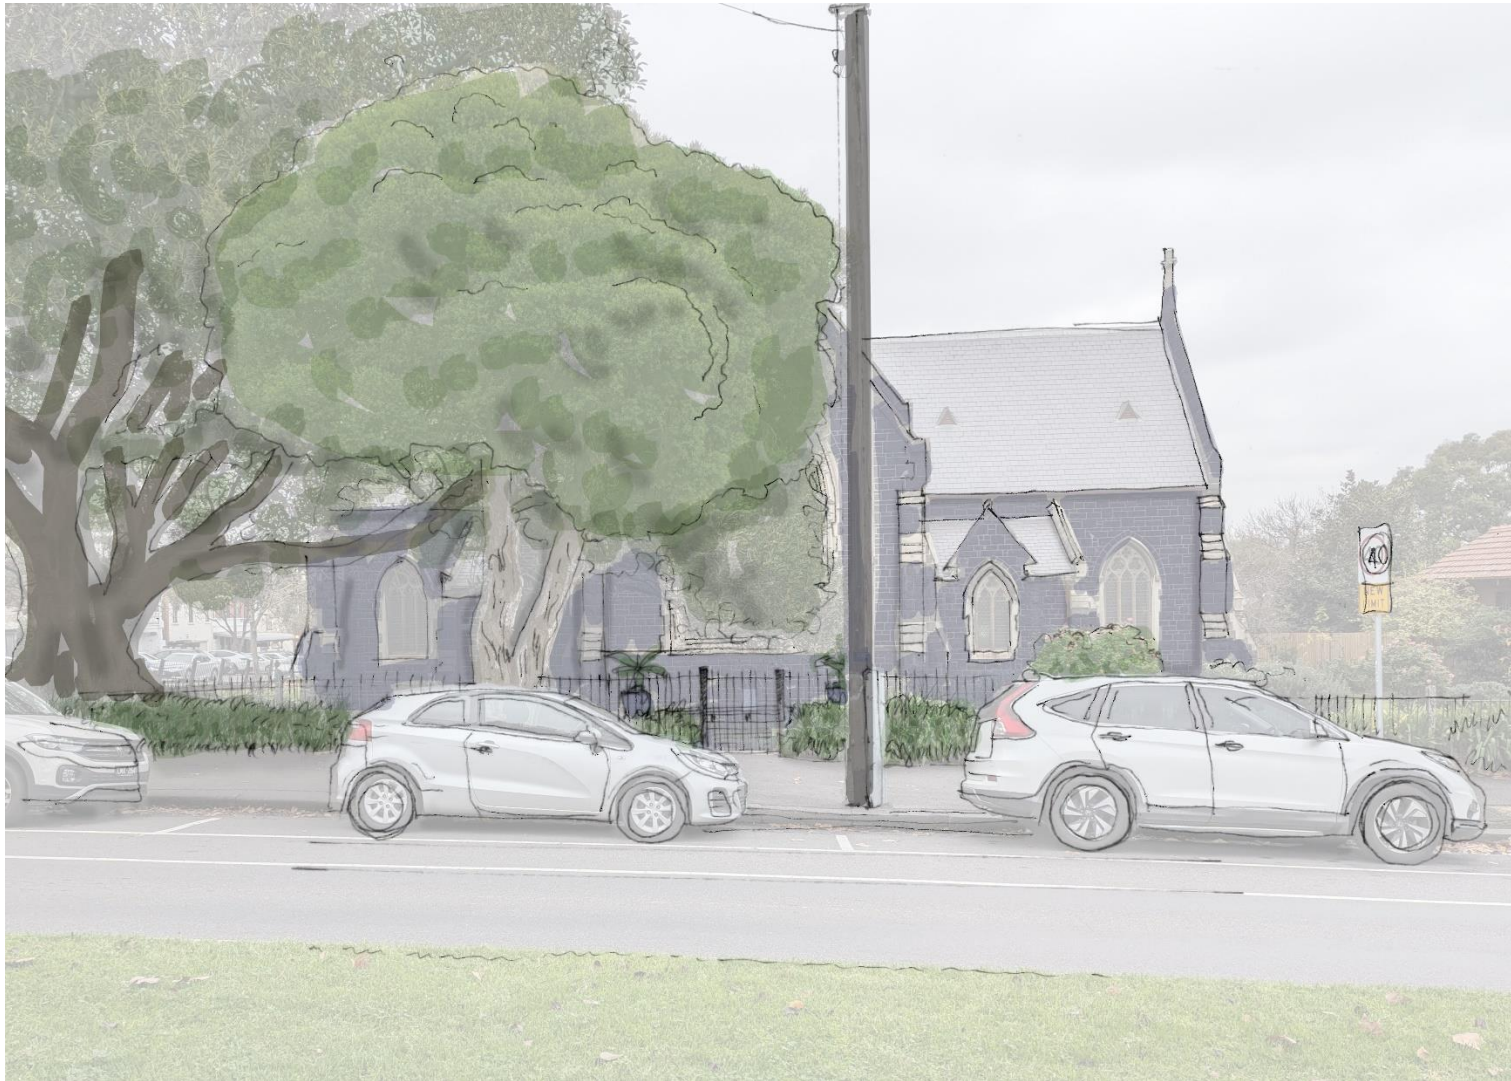
Figure 19: Drawing of the likely view of proposed works from the Howard Street central median strip.

An indication of the appearance of the proposed works from the Howard Street median strip and from within the eastern garden are provided as Figures 19 & 20.

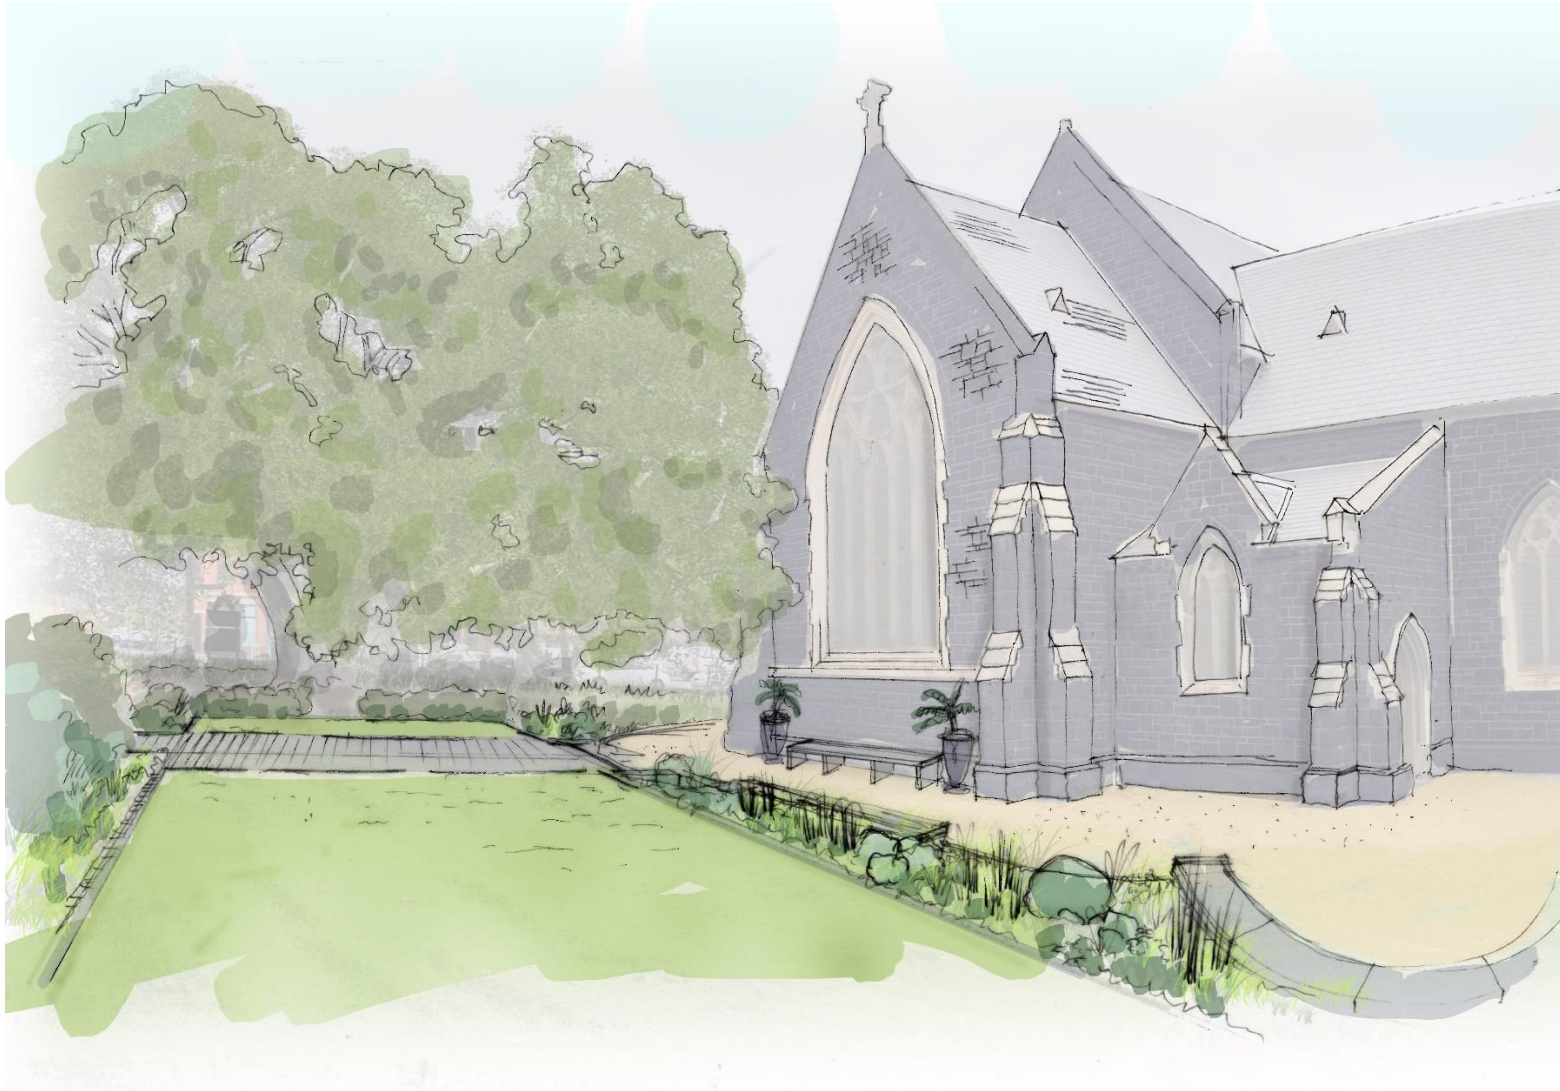
Figure 20: Drawing of the appearance of proposed works from within the eastern garden.

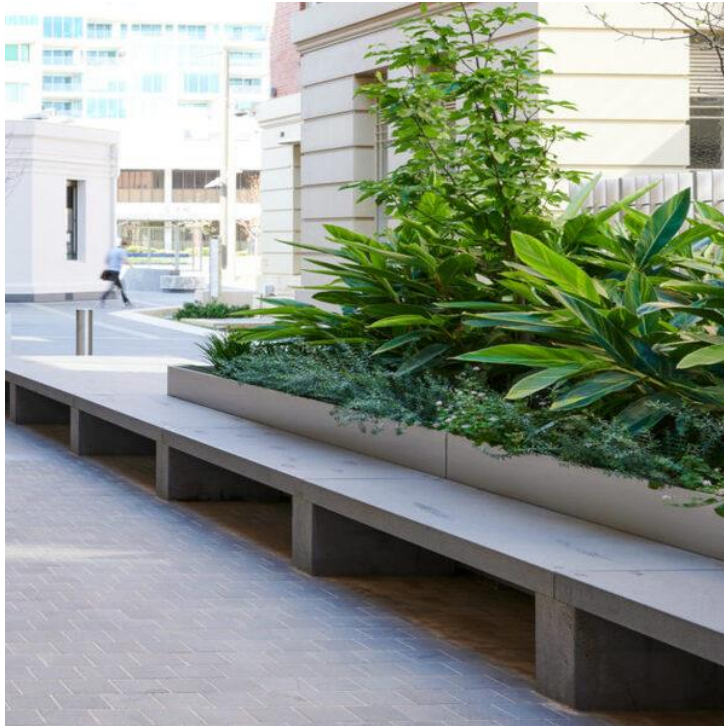
Figure 21: Example image of the bluestone bench seat proposed for adjacent to the eastern façade of St. Mary's.

The bench seat proposed for installation against the eastern façade of the church is of bluestone construction, with both the seat and supports of the minimum thickness required for structural stability. An example concept

image is provided as Figure 21. While the addition of a bench seat will alter the appearance of the church building, the visually minimal style of the proposed bench has been selected so that it does not detract from the appearance of the façade. The seat is also expected to visually blend with the bluestone plinth of the façade wall. The intended use of the seat, to provide an opportunity for viewing the eastern garden, and provision of amenity at times when the lawn is used for events, supports the social significance of St. Mary's church.
