Arborist Report for the Proposed Art Gallery building (café & loading bay) extension within the Benalla Botanical Gardens.

William Boag Architects have approached Council to conduct an Arborist report to assess the impact of the proposed Benalla Art gallery building extension. The existing conditions and proposed building extension is shown below.

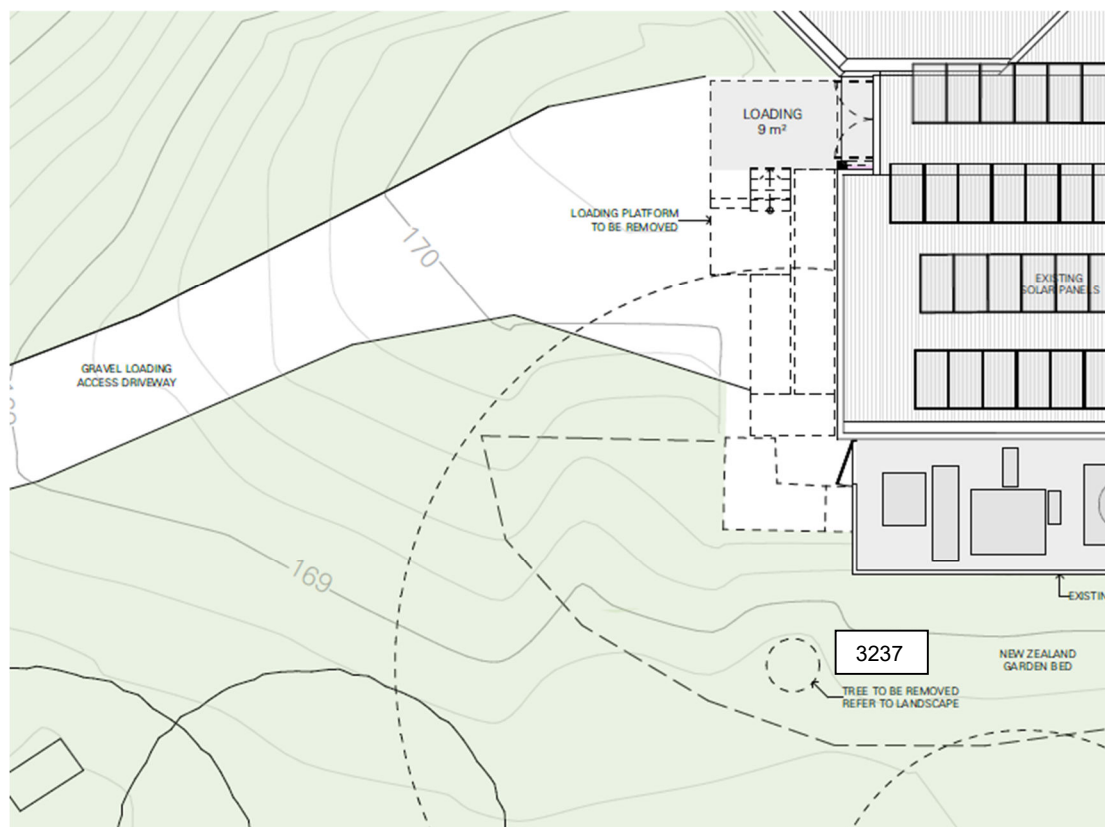
Image 2. Shows existing conditions and how Tree 3237 has encroached on the existing building.

- The building will see an encroachment of 60 % into the TPZ
- DBH 0.52 TPZ 6.24m SRZ 2.55
- Distance from building to centre of tree – 1.0m
- Major Incursion. Existing incursion due to poor placement of the tree (see below image).
- Recommendation: Tree removal.

- Remove tree 3237.
- Install garden beds to maximising plant health through mulching.
- Monitor the health of all trees.

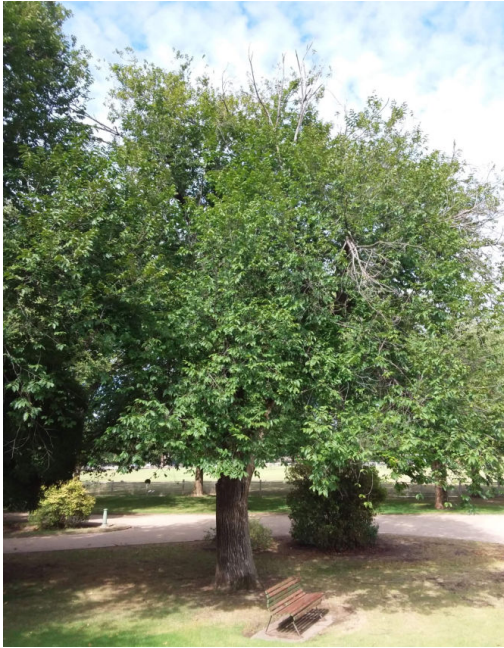
Tree Number : 3245

- The proposed building will see an encroachment of 0 into the TPZ
- DBH 0.52 TPZ 6.24m SRZ 2.67
- Distance from building to centre of tree 6.31
- NO Incursion

Health : Good

Structure : Good

Works_requ : Deadwood Removal

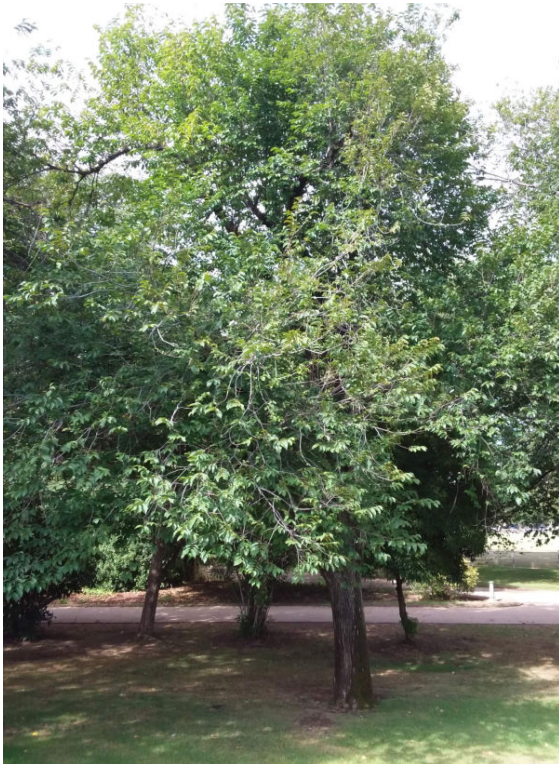
Tree Number : 3243

- The building will see an encroachment of 3.04% into the TPZ
- DBH 0.52 TPZ 6.24m SRZ 2.67
- Distance from building to centre of tree 5.373
- Minimal Incursion

Health : Good

Structure : Good

Works_requ : Deadwood Removal

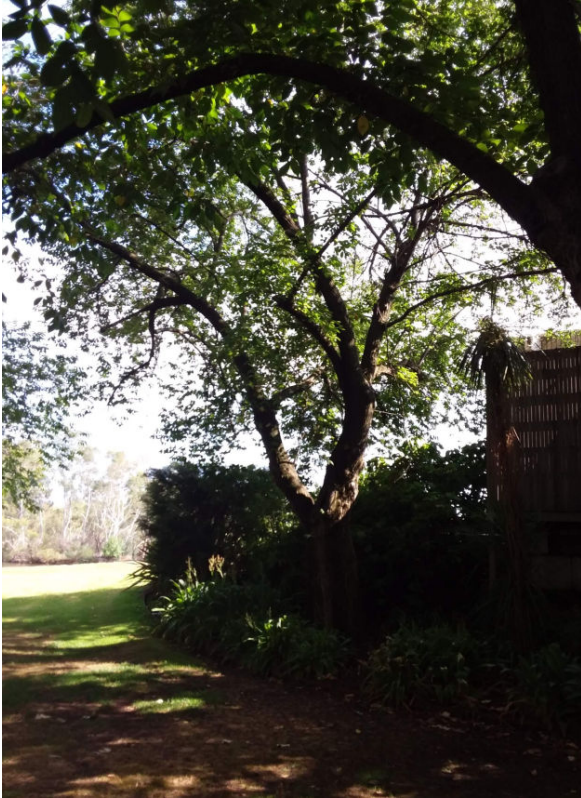
Tree Number : 3237

Health : Good

Structure : Good

Works_requ : Deadwood Removal

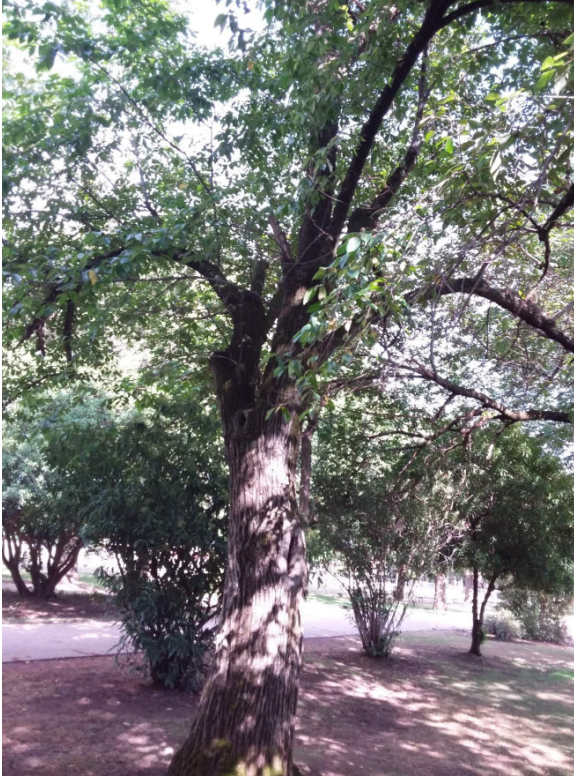
Tree Number : 3238

- The building will see an encroachment of 0 into the TPZ
- DBH 0.52 TPZ 6.24m SRZ 2.71m
- Distance from building to centre of tree 7.97m
- NO Incursion

Health : Good

Structure : Good

Works_requ : Deadwood Removal
