## Heritage Impact Statement

### Heritage Impact Statement for:

*57 Mostyn Street, Castlemaine VIC 3450*

*H0672*

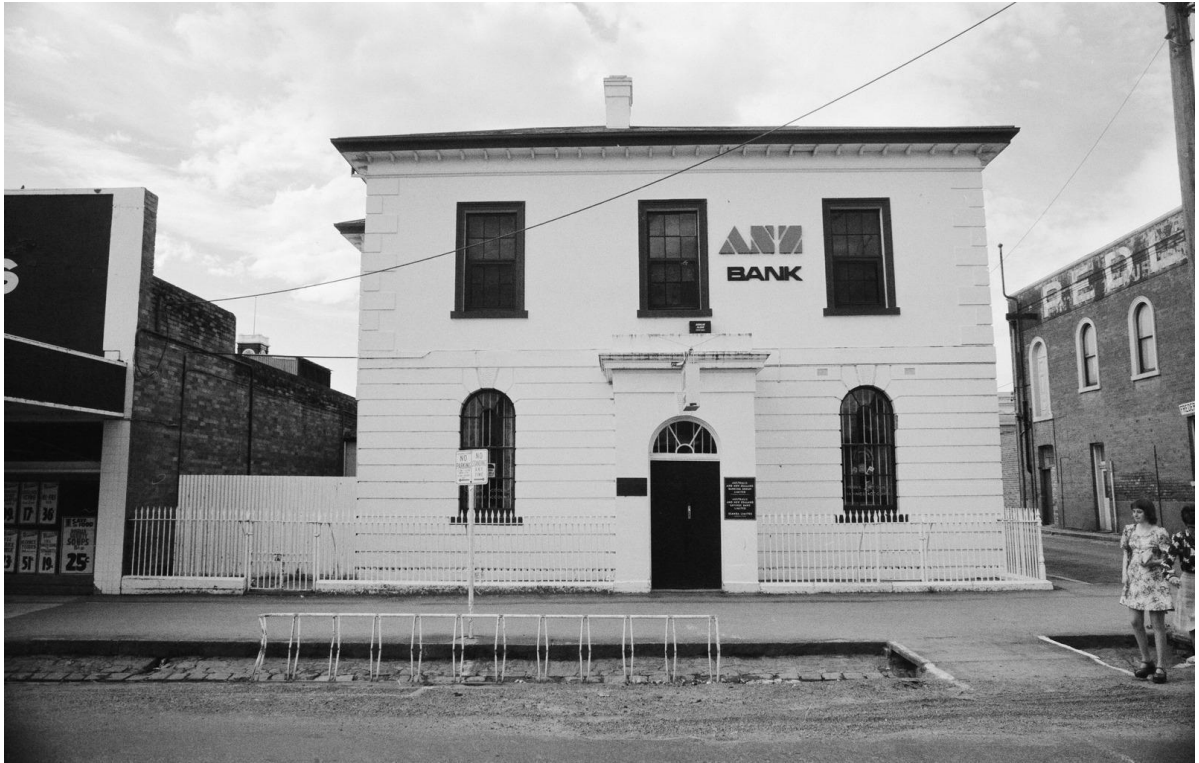
Image 1. ANZ Bank (photograph taken 1970)<sup>1</sup>

The owner wishes to reinstate a fence along the south west corner of the property, cordoning off the 'manager's residence garden' from the street. This will be the only private outdoor space for the residence. Ms Dernelley recommended the fence should appear 'domestic' in style, stating it should be made of timber, and that the fence should sit behind the quoining. Ms Dernelley had not seen the photograph of the original fence (Image 1 above) which does not sit behind the quoining.

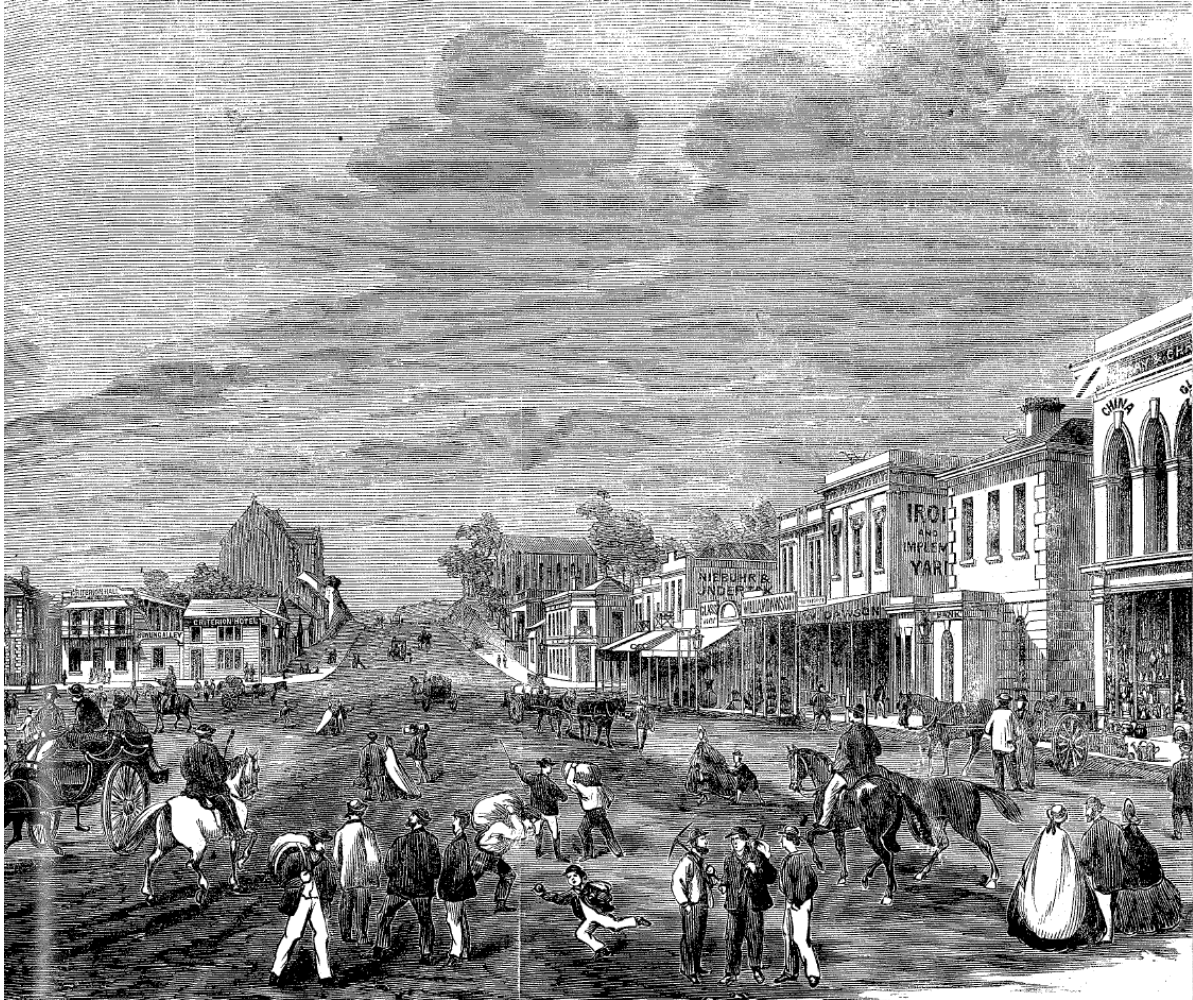
Image 3: Engraving of Mostyn Street showing the Bank of Australasia located on the far right<sup>7</sup>

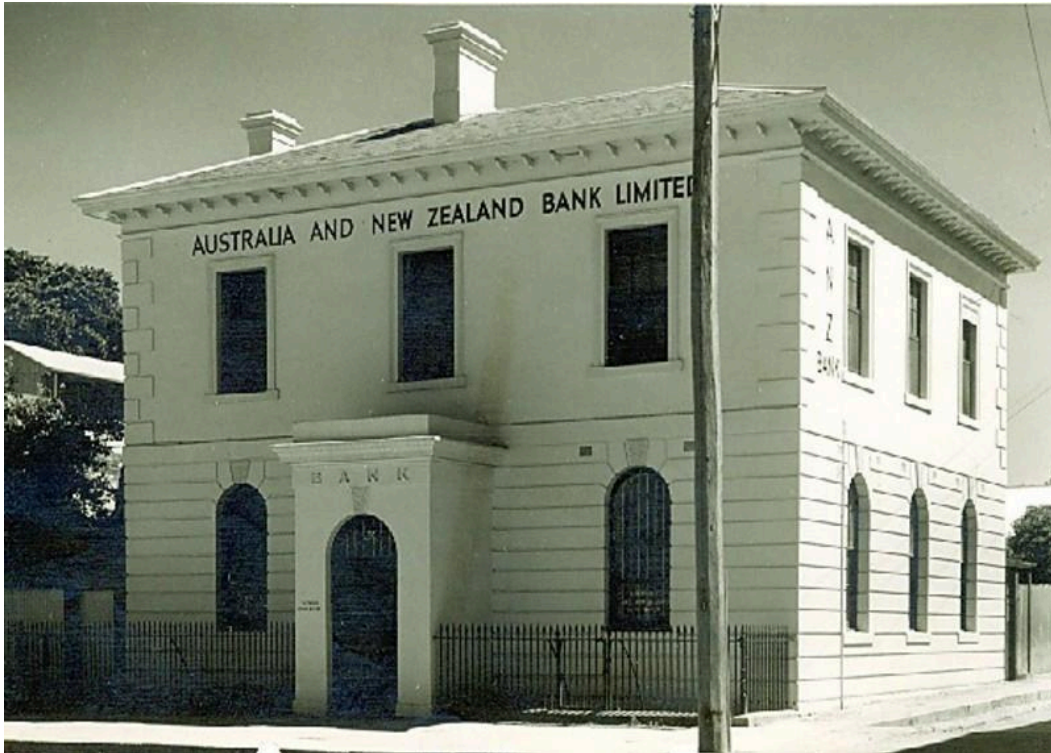
Image 5: photograph after 1951 (when the bank changed its name) and prior to the extension at the rear<sup>9</sup>

Original painted signs which are visible in early images, see *Image 5* above, have since been painted over but the client wishes to reconstruct “BANK” moulding that existed on the portico. This will improve the heritage significance of the site by highlighting the original condition of the building and also its original intended use.

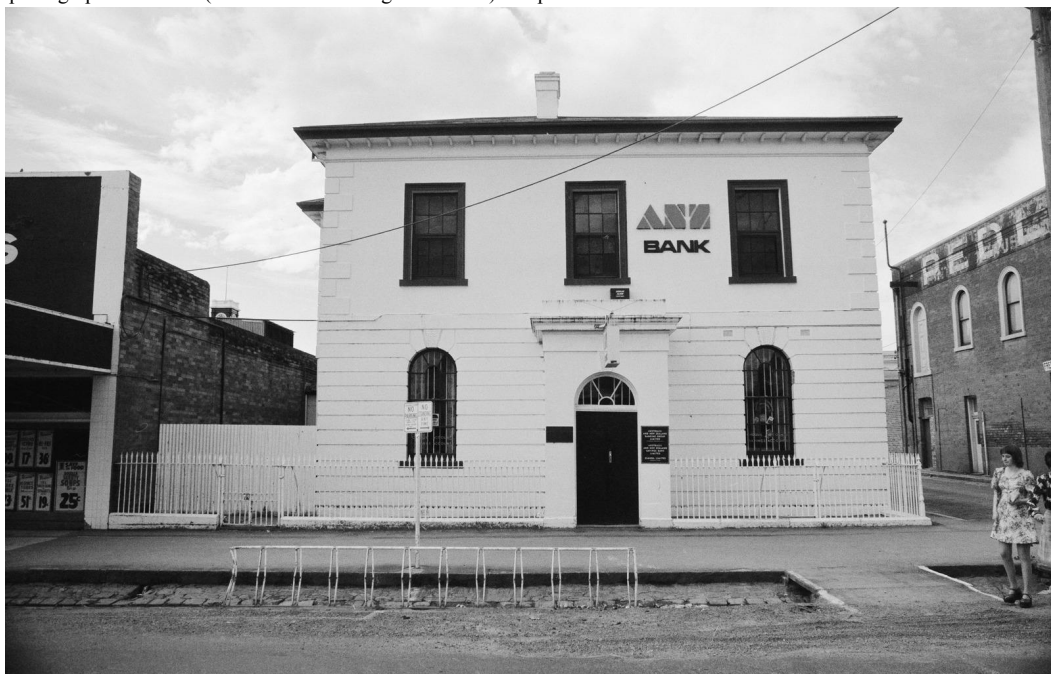
Image 6: ANZ Bank (photograph taken 1970)<sup>10</sup>

The symmetrical design includes a central arched portico connecting the setback building to the pavement. The arch contains a glazed fanlight and a double iron gate. The gates were introduced after 1971 – refer to image 6 above showing solid doors to the front portico. This may have coincided with the introduction of a threshold ramp.

(Note the absence of the tree and crossover in the second image. In the earlier image, the building does not appear to extend beyond the street sign). The photograph taken in 1951 (Image 5) also confirms the extension occurred in the second half of the twentieth century.

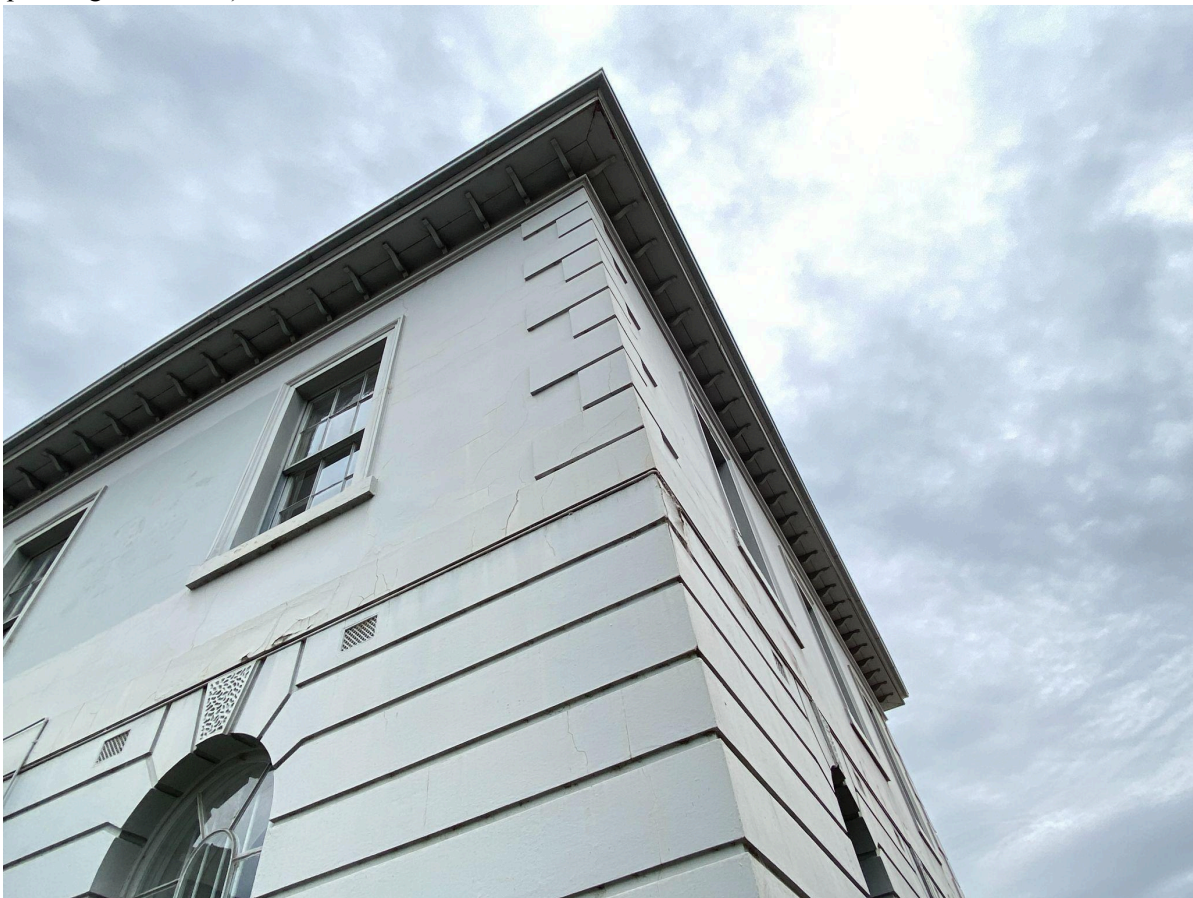
The rendered walls are finished with smooth rustication to the ground floor, and a smooth face with quoining to the first).

Image 7: photo of building corner showing the quoining, the eave and the rusticated facade details<sup>11</sup>

A hip and valley slate roof<sup>12</sup> crowns the building and includes an eave, which is unusual for a building of this style at the time<sup>13</sup> (typically the roof would be concealed behind a parapet wall).

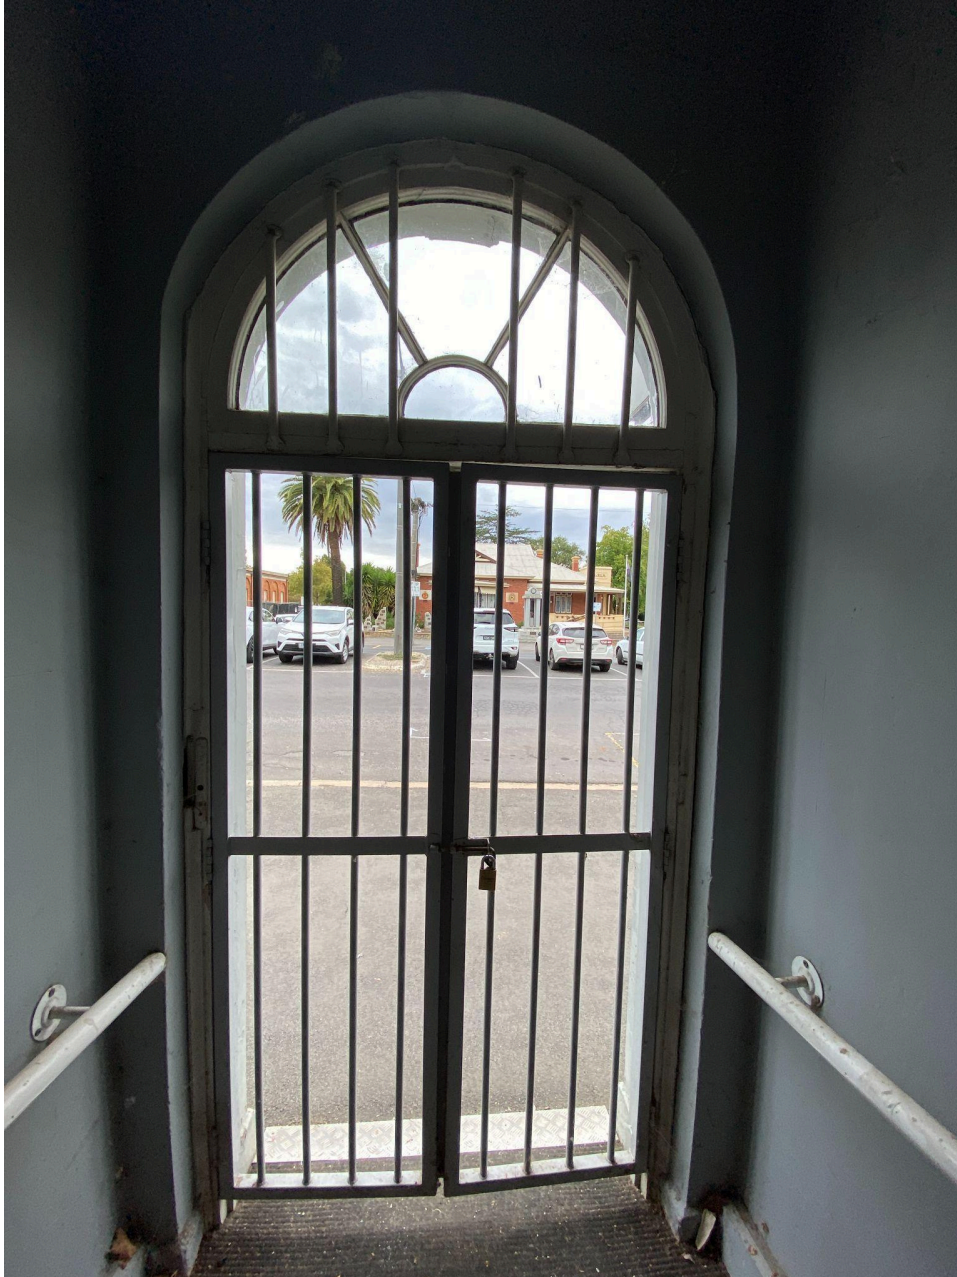
Image 8: photo within the portico showing the iron gate and fanlight<sup>14</sup>

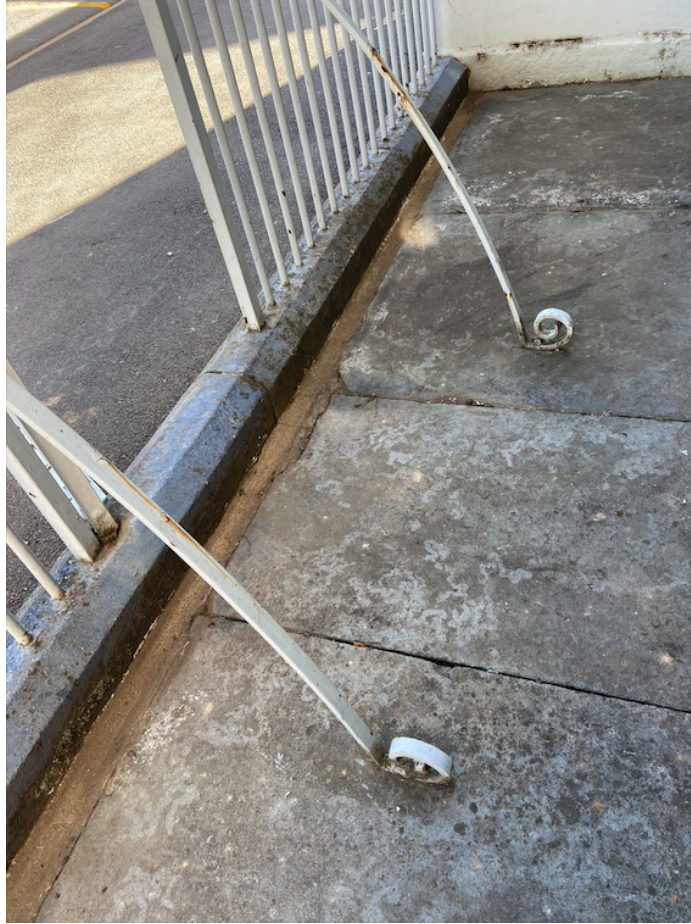
The building is made further imposing with a tall iron fence set into a raised bluestone plinth along the Mostyn street curtilage. The ground beyond is sealed off with locally sourced large grey slate flagging.

Image 9: photo of the slate and iron details<sup>15</sup>

- If possible to strip without causing degradation to bluestone or surrounding surfaces, strip paint from bluestone fence plinth.
- Repair/ replace and or re-level broken slate flagging.

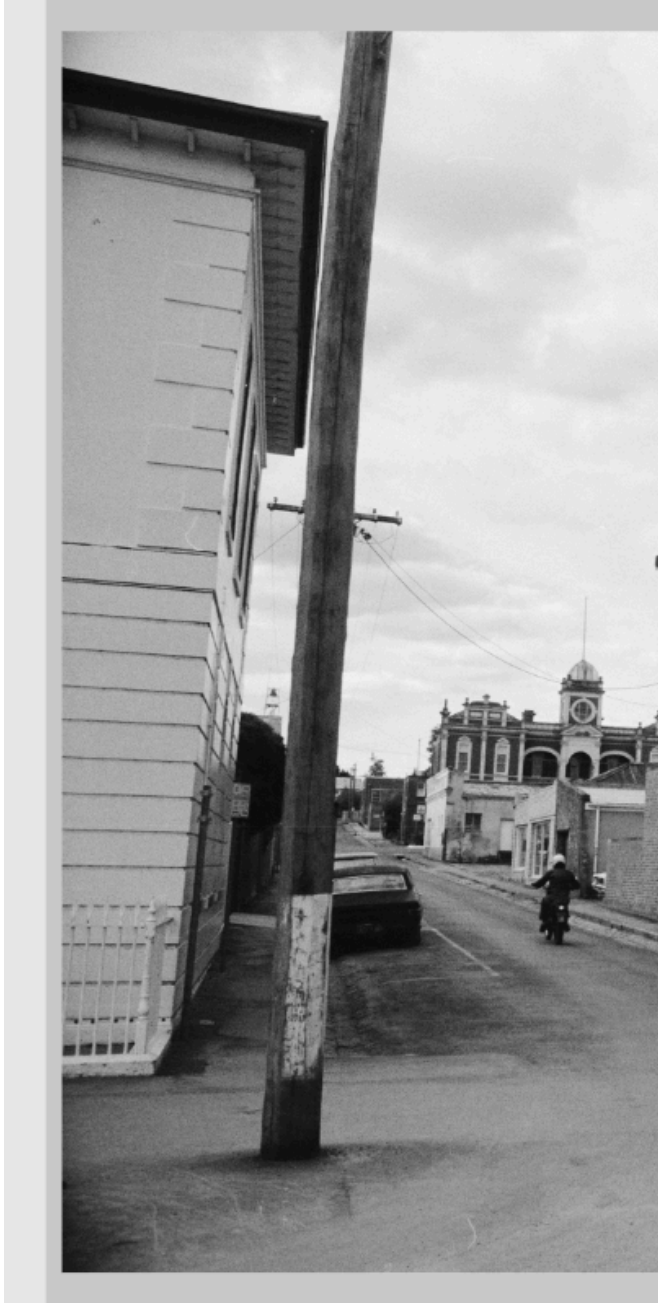
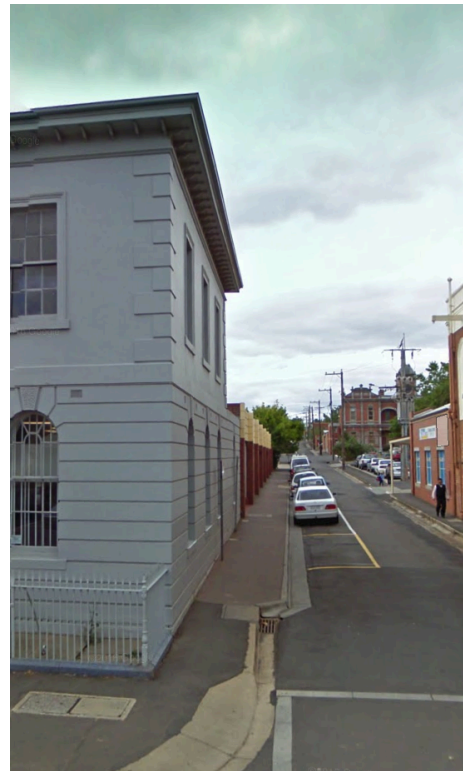
The rear of the building was extended on the ground level. This was built in the matching style, yet with a flat roof built behind a parapet wall. No record is found of when this was constructed, however, this appears to have occurred after 1970:

Images 10 & 11: (Left: Corner of Mostyn and Frederick streets facing North-East, photographed 1970<sup>16</sup>. Right: same view, photographed 2010<sup>17</sup>)

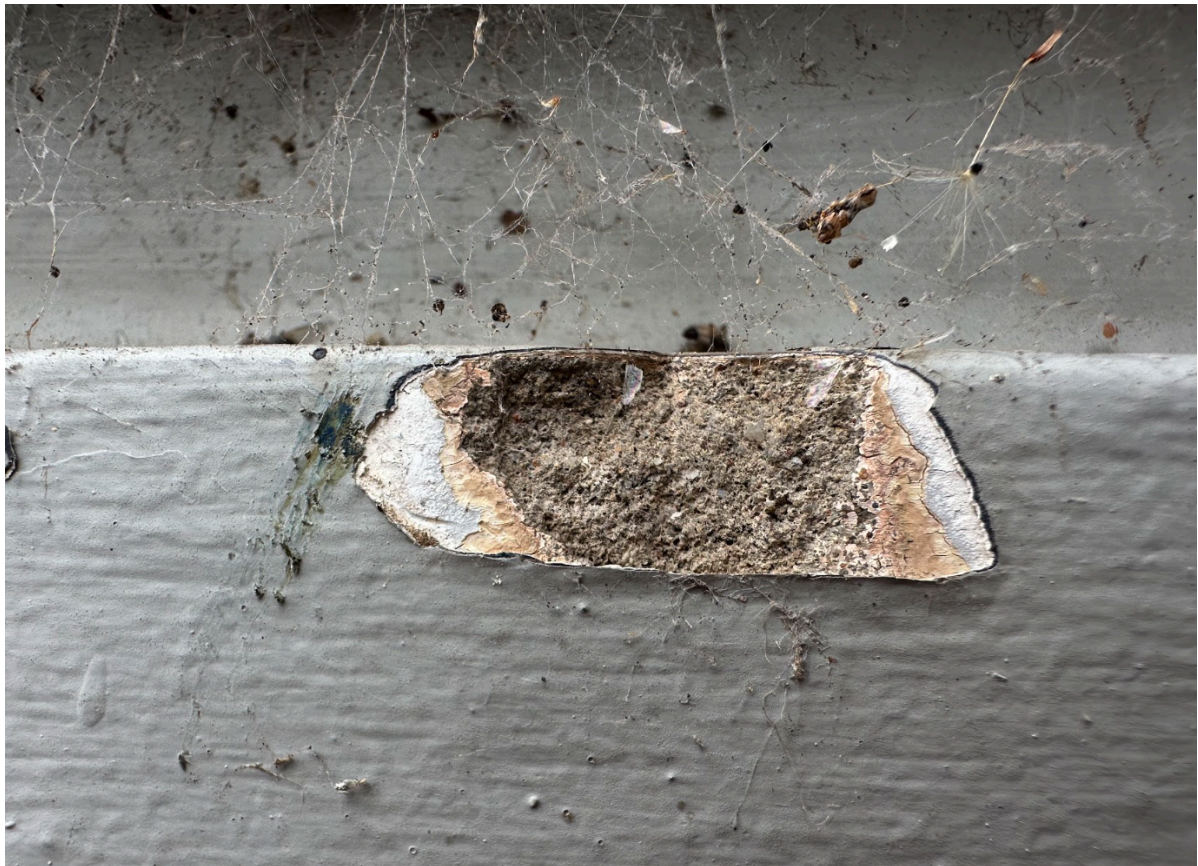
Externally, the building has been repainted several times. Most recently, a light grey, prior to that, a cobalt blue, consistent with the ANZ brand colour, and prior to that, various shades of white/ light grey. The earliest colour cannot be confirmed since oil mediums used in earlier paint have a tendency to yellow over time. however, the paint scrapings (image 12) suggest the building was painted in a light cream, which is consistent with render paint colours during the early to mid-Victorian periods.

Image 12: paint scrapings<sup>18</sup>

All images indicate that at any time, the entire building was painted in a monochrome palette.

- Redirect first floor roof plumbing to LPOD and away from ~1970’s roof.
- Repair loose render throughout and repaint (in a monochrome light grey colour)

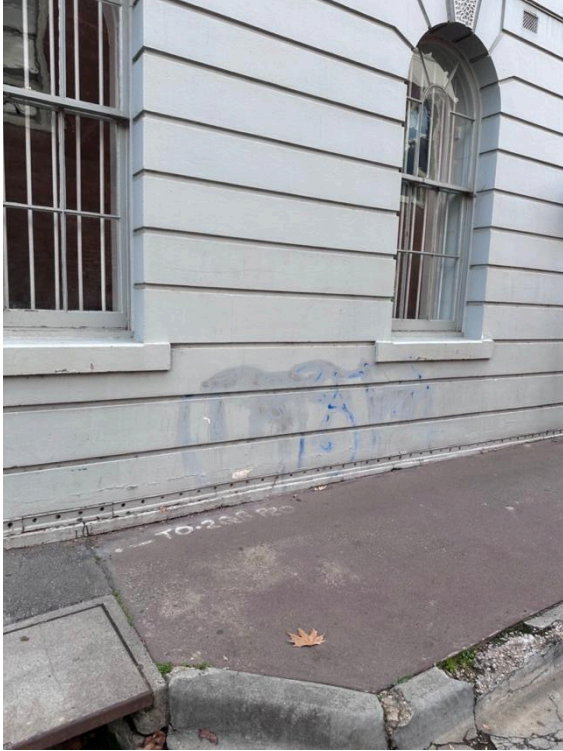
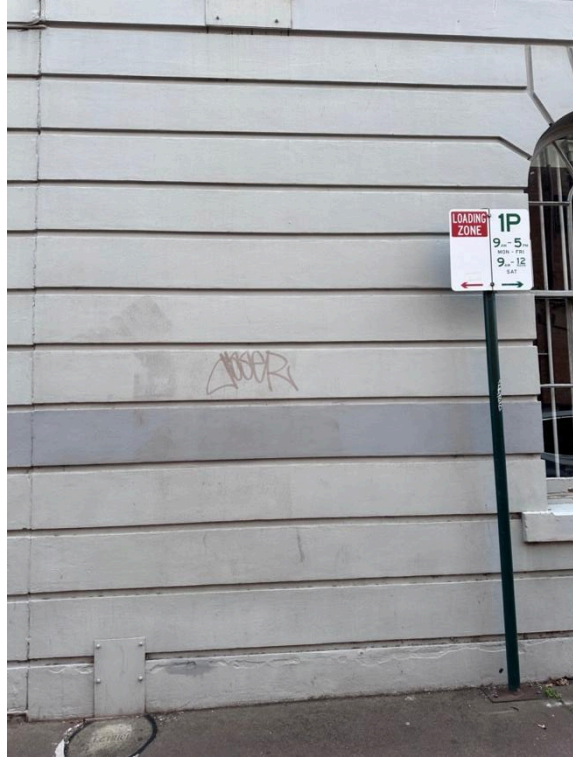
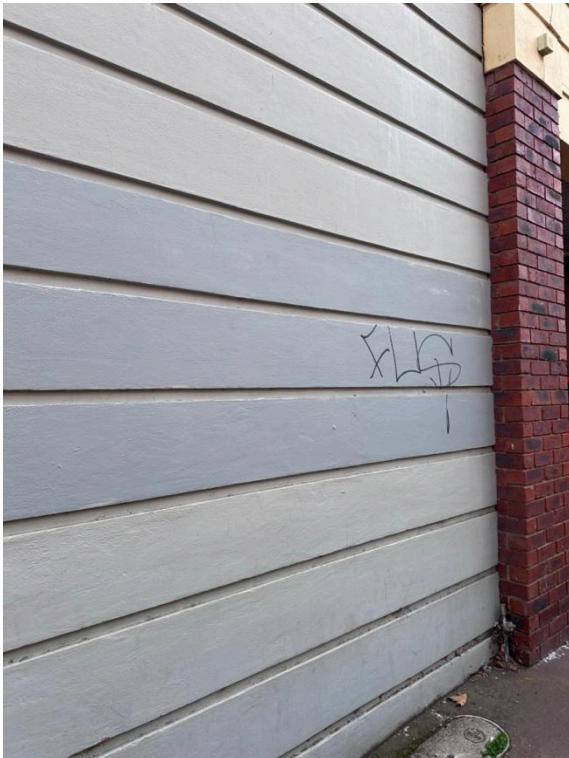
Due to the nature of the smooth light coloured render and the proximity to public access, the elevation along Frederick street is a constant target for graffiti artists. Graffiti alters the appearance of the heritage place, compromising its historical and aesthetic value. This also poses an ongoing maintenance burden, adding to the maintenance costs as well as exposing the rendered surface to degradation and damage as a result of high pressure and toxic sprays.

Images 13-15: graffiti on Frederick street elevation<sup>19</sup>

- Apply a clear protective coat to the Frederick Street ground floor elevation, to protect the wall from graffiti.
- Internally introduce a new partition wall between the ‘shop’ and the manager’s residence on the ground floor, effectively partitioning off the later rear extension from the original bank lobby.
- Other necessary internal alterations to appropriate the place to the abovementioned multiple uses including a manager’s residence, a retail premises located in the original bank lobby and a commercial tenancy on the first floor.

The application of an anti-graffiti coating to the Frederick street elevation, while noticeable, will protect the building from further damage as well as presenting the owner with an economic solution to the ongoing preservation and maintenance of the wall.

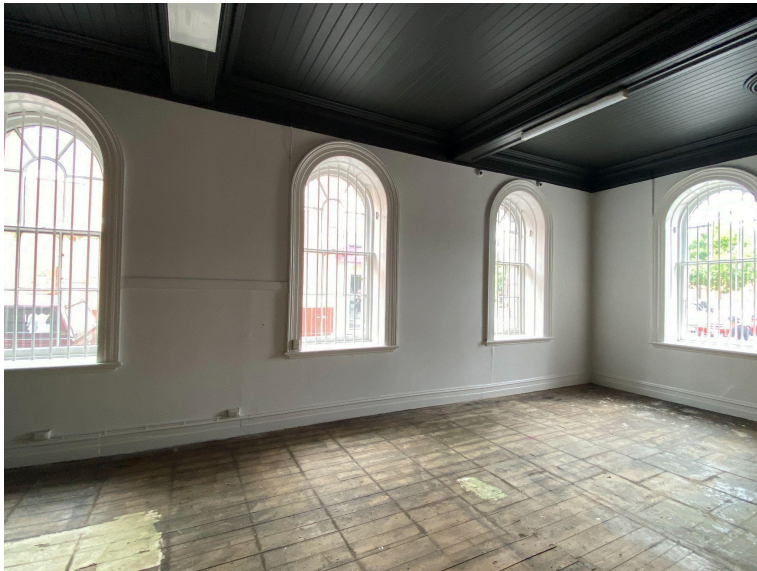
Image 16<sup>20</sup>

Timber framed windows; some glazing panels have been replaced with plate glass.

<sup>20</sup> Wexhaus, 2024, main bank lobby view of arched windows facing south east corner

- If budget permits, restore windows that have been painted shut. This may include replacing glass with higher thermally performing glass. Externally, the windows will look identical.

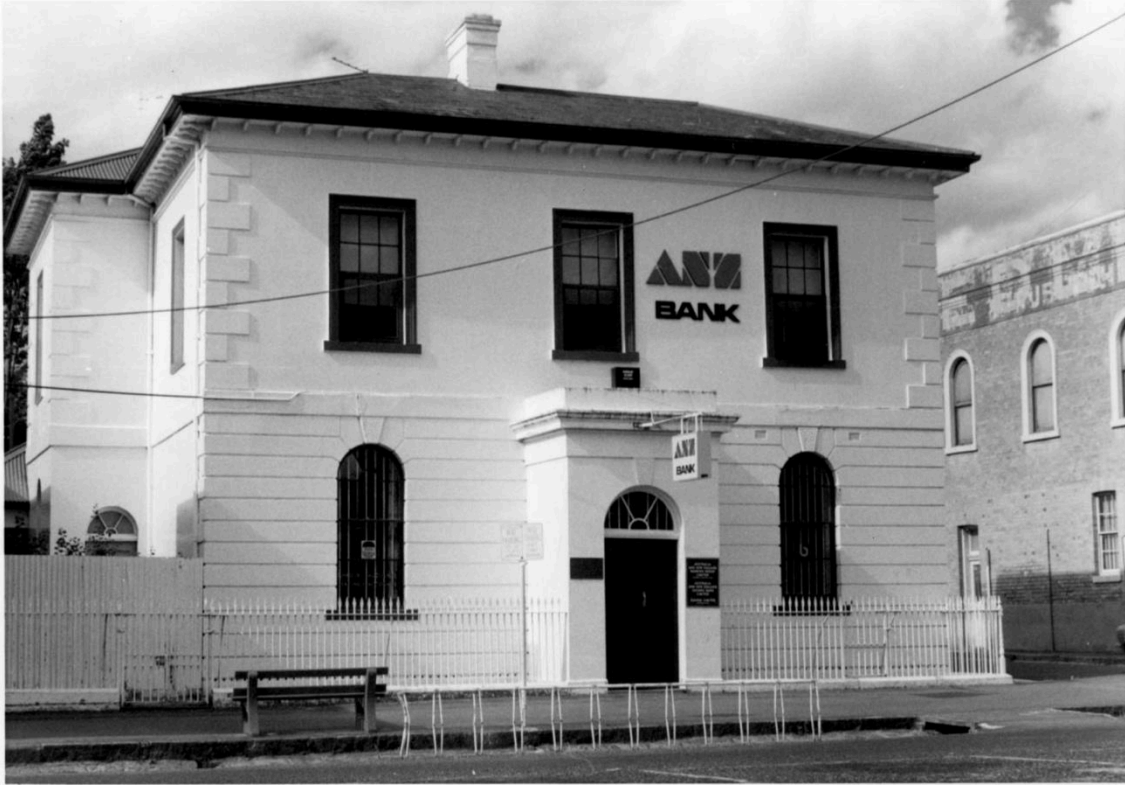
Image 18 below (as well as others) shows the past fence (now removed):

- 2m back from the Mostyn street boundary – in line with the face of the front facade
- Solid – corrugated iron
- Painted to match the building wall colour
- Approximately 2m tall (~6.25 rustication courses at 330mm for each course including the shadowline groove)

Image 18 ANZ Bank (photograph taken 1968-76)<sup>22</sup>

The proposed is to construct a new fence at the same setback and height as the original, also in a solid metal. To appear new, in lieu of painting to match, the proposed fence is to be clad in raw steel panels, which will disguise the gate -this achieves a similar effect to the original, while remaining neutral in effect and commercial in appearance. A timber fence in this application would appear too domestic in character and subsequently clash with the otherwise commercial style of the building that is part of its heritage significance and sought to be retained (particularly along the front curtilage of the building).

Finally, to avoid unwanted degradation of the original façade fabric, the proposed fence will be constructed independently of the building, supported by independent posts and footings that will not be tied in to either adjacent wall.
