# Ovoid Sewer Aqueduct over Barwon River: proposed demolition

## HERITAGE IMPACT STATEMENT

140 Tanner Street Breakwater and  
91-97 Tannery Road Charlemont 3217

August 2025

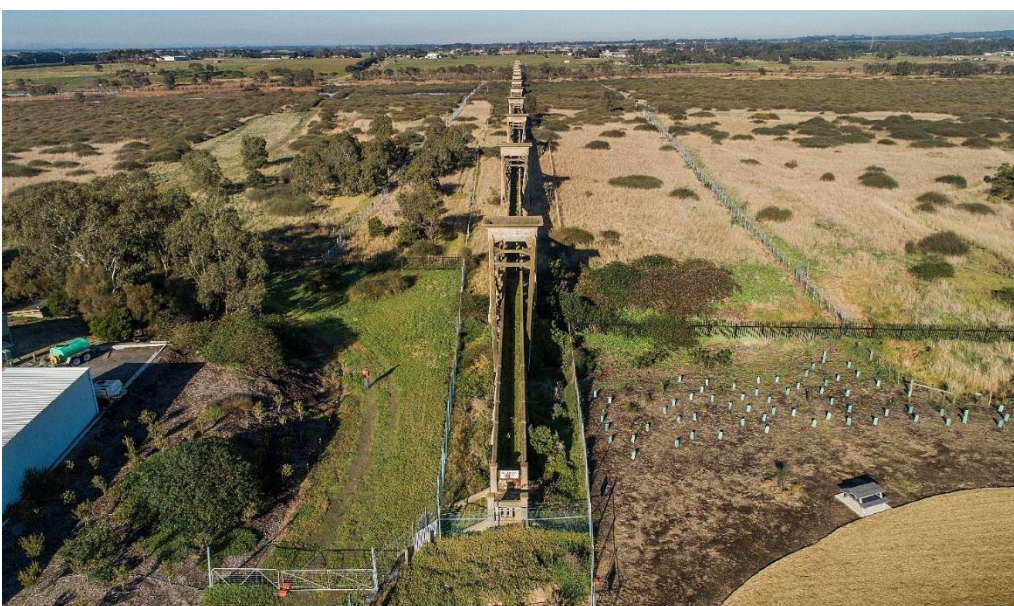
Figure 4 Oblique aerial view looking directly south along the length of Aqueduct from Truss #1  
Source: Courtesy Barwon Water

The Aqueduct is a 756-metre, multi-span bridge constructed of reinforced concrete using experimental methods. Erected between 1912 and 1915, the Aqueduct contains 14 symmetrical truss spans (Figure 3 to Figure 6) in a balanced cantilever arrangement to carry the Geelong Outfall Sewer ovoid pipe across the river and floodplain at Breakwater.

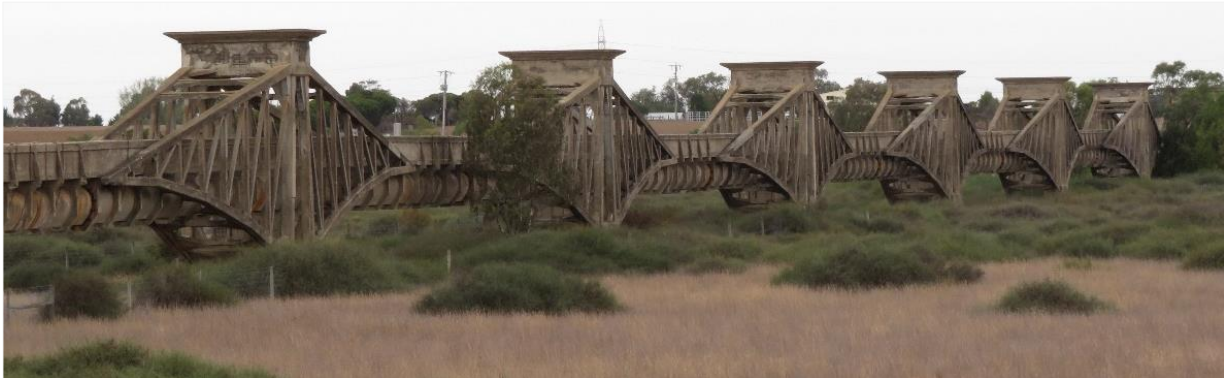
Figure 5 View to the Ovoid Sewer Aqueduct from Kadak Place, Breakwater  
Source: Lovell Chen archives, photographed 2019

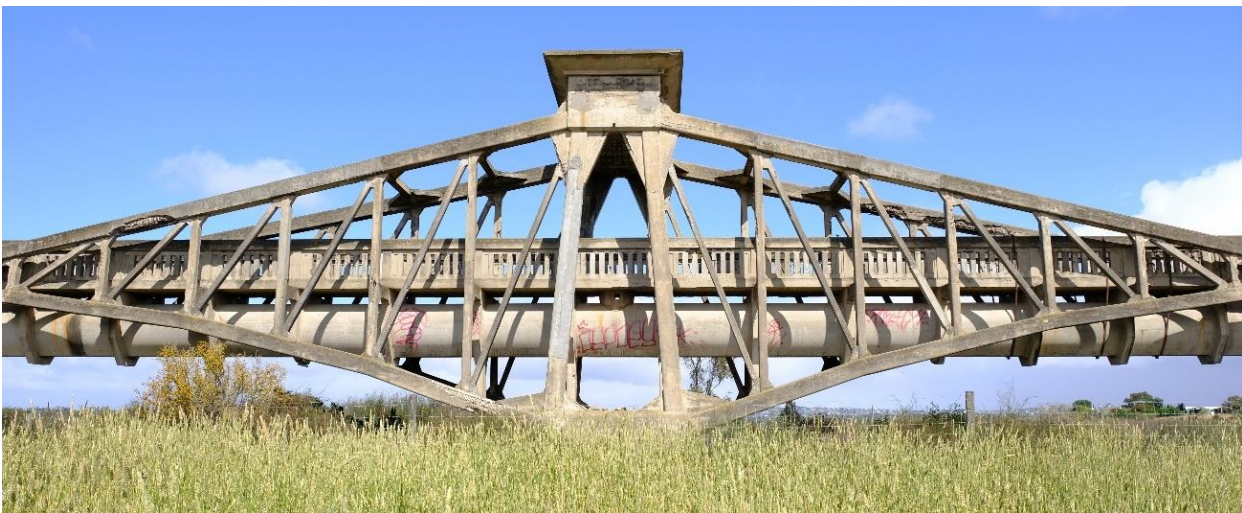
Figure 6 Typical pier and truss span; upper chord and diagonal web members are held in tension, while the lower chord and vertical web members are subject to compression forces  
Source: Lovell Chen archives, photographed 2019

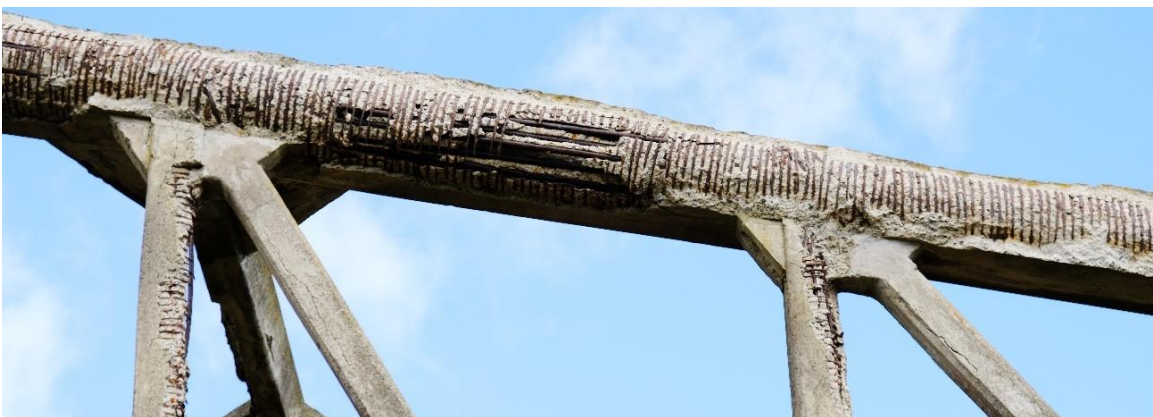
Figure 7 Example of advanced degradation of an upper chord and adjoining vertical members and crossbeam  
Source: Lovell Chen archives, photographed 2019

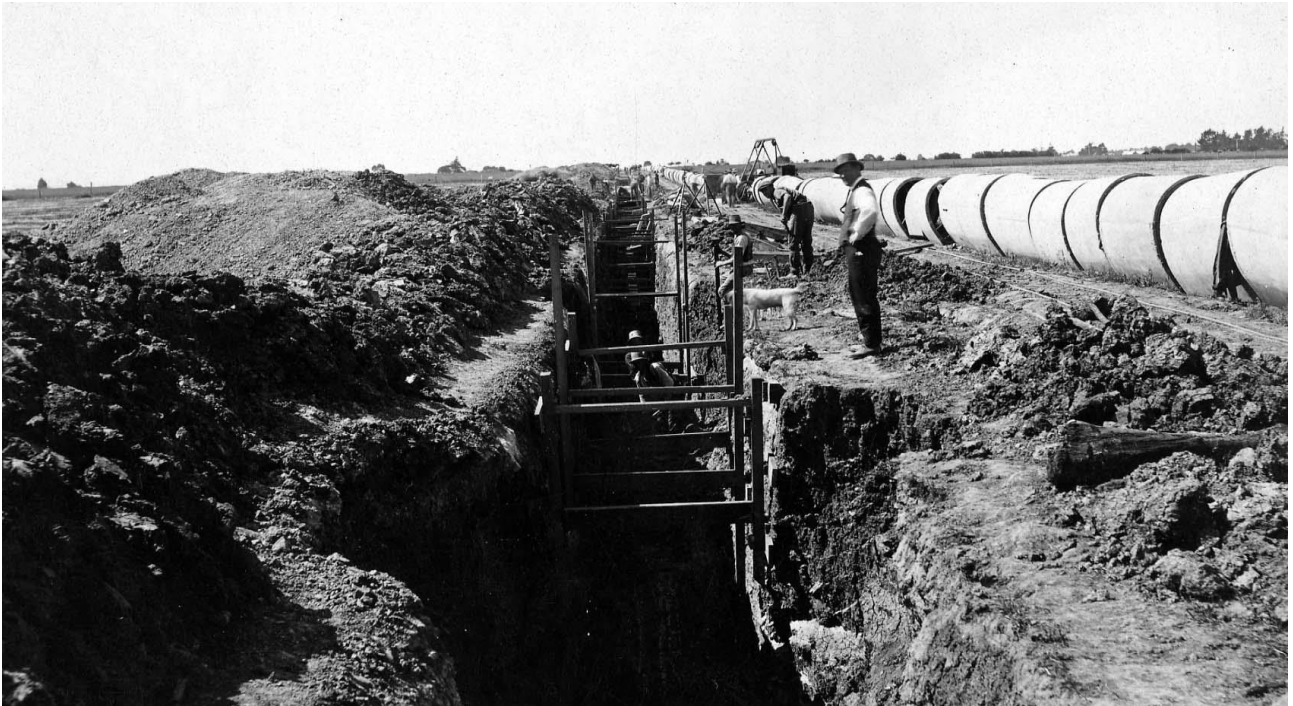
Figure 8 Trenching for the installation of the Geelong Outfall Sewer, c. 1912-1914, with ovoid sewer pipe manufactured by Stone & Siddeley lined up alongside the trench for installation  
Source: Barwon Water archives

Stone & Siddeley had by this time won several of the Trust's contracts to supply and install concrete sewer pipe along the route of the outfall sewer (Figure 8) and in June 1912 had opened a temporary factory at Marshall and a construction tramway to deliver precast pipe along the length of the sewer trenching works. Methods developed by Stone & Siddeley at the pipe factory were at least as innovative as their adventurous design for the Aqueduct; the factory was widely lauded by the press and the process successfully patented in Australia and the United States. In early 1913 the factory produced precast concrete piles (Figure 9) which would be driven into the bedrock below the floodplain at Breakwater to anchor the central piers of the Aqueduct's fourteen cantilevered trusses.

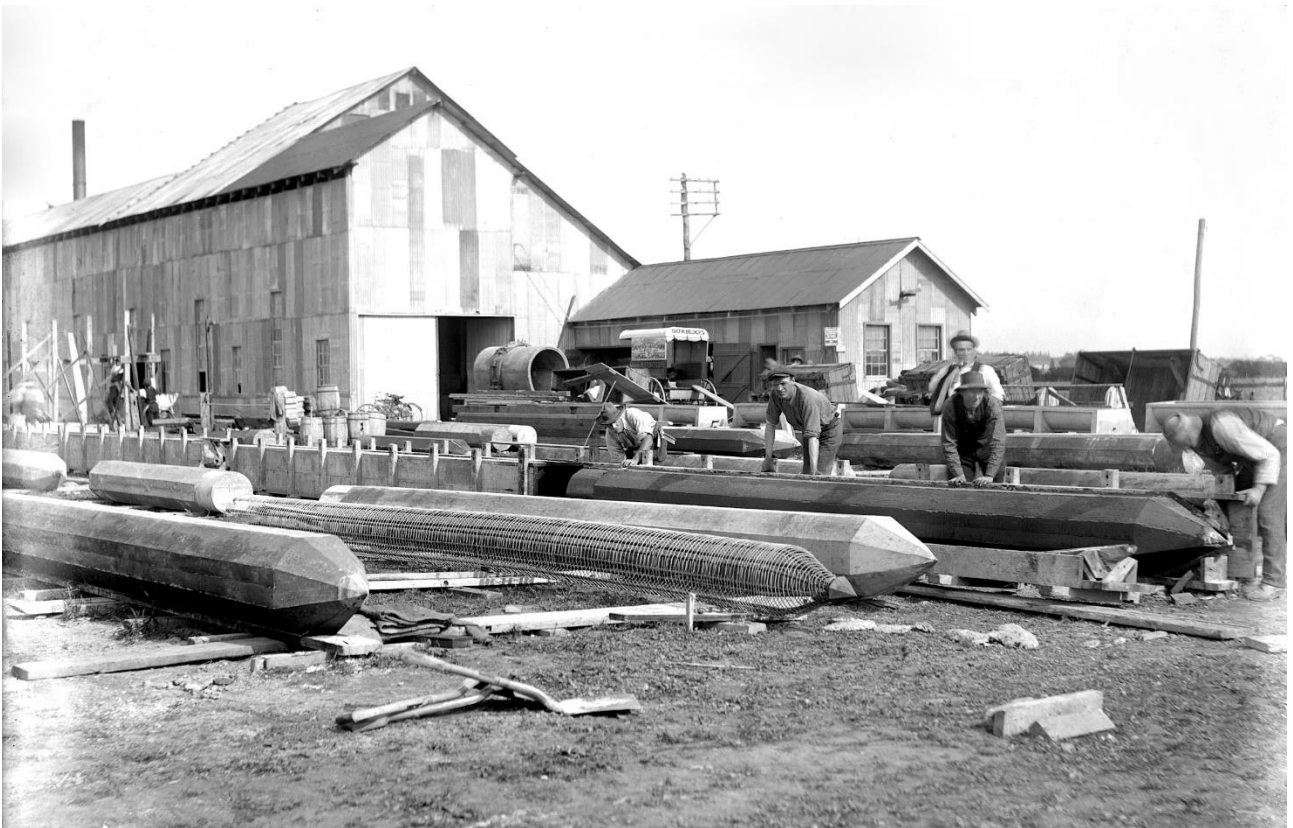
Figure 9 Manufacturing of Aqueduct's precast concrete piles at Stone & Siddeley's Marshall Pipe Factory, 1913  
Source: Barwon Water archives

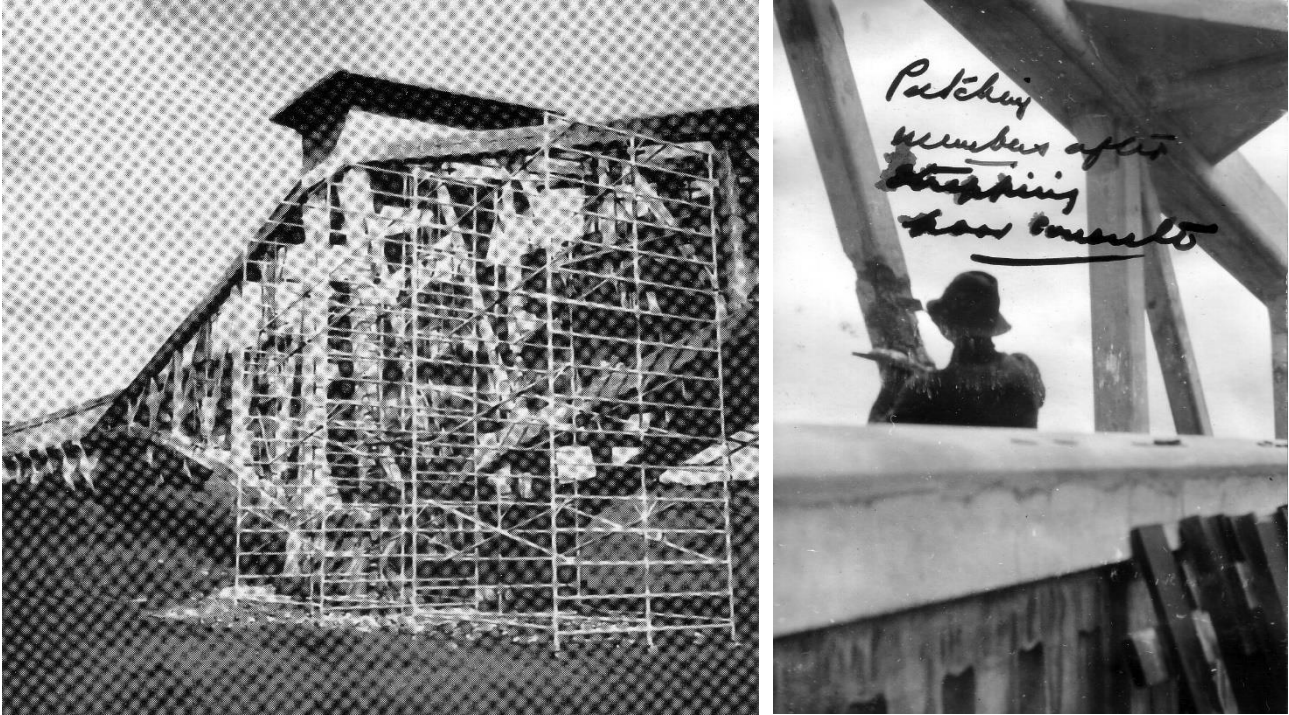
Figure 12 Historical photographs of concrete repair works, possibly those specified by E.G. Stone in 1924  
Source: Barwon Water archives

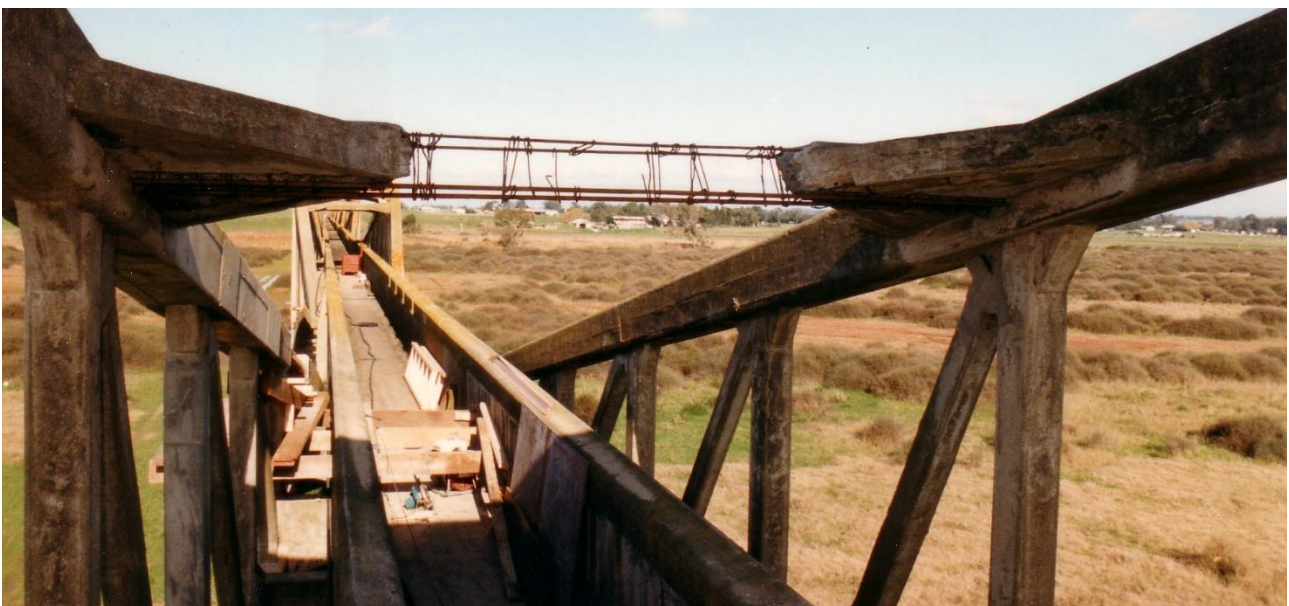
Figure 13 Recasting of a truss cross-brace beam while the structure remained in service, likely c. 1984; freshly repaired or recast sections are also seen just behind it on the truss top chord and vertical member at left  
Source: Barwon Water archives

Those running repairs are known to have continued. The Register of the National Estate entry included in the Australian Heritage Database notes that shotcrete repairs were undertaken in 1977, 1979 and 1980. Further works in 1984 (Figure 13) included concrete stripping, reinforcement and recasting of sections of top and bottom chords on six of the trusses, recasting or patch repairs to vertical and diagonal web members and pier legs, and repairs to pipe supporting beams, handrails and gussets, at a cost of around \$500,000 in today’s dollars.<sup>25</sup>

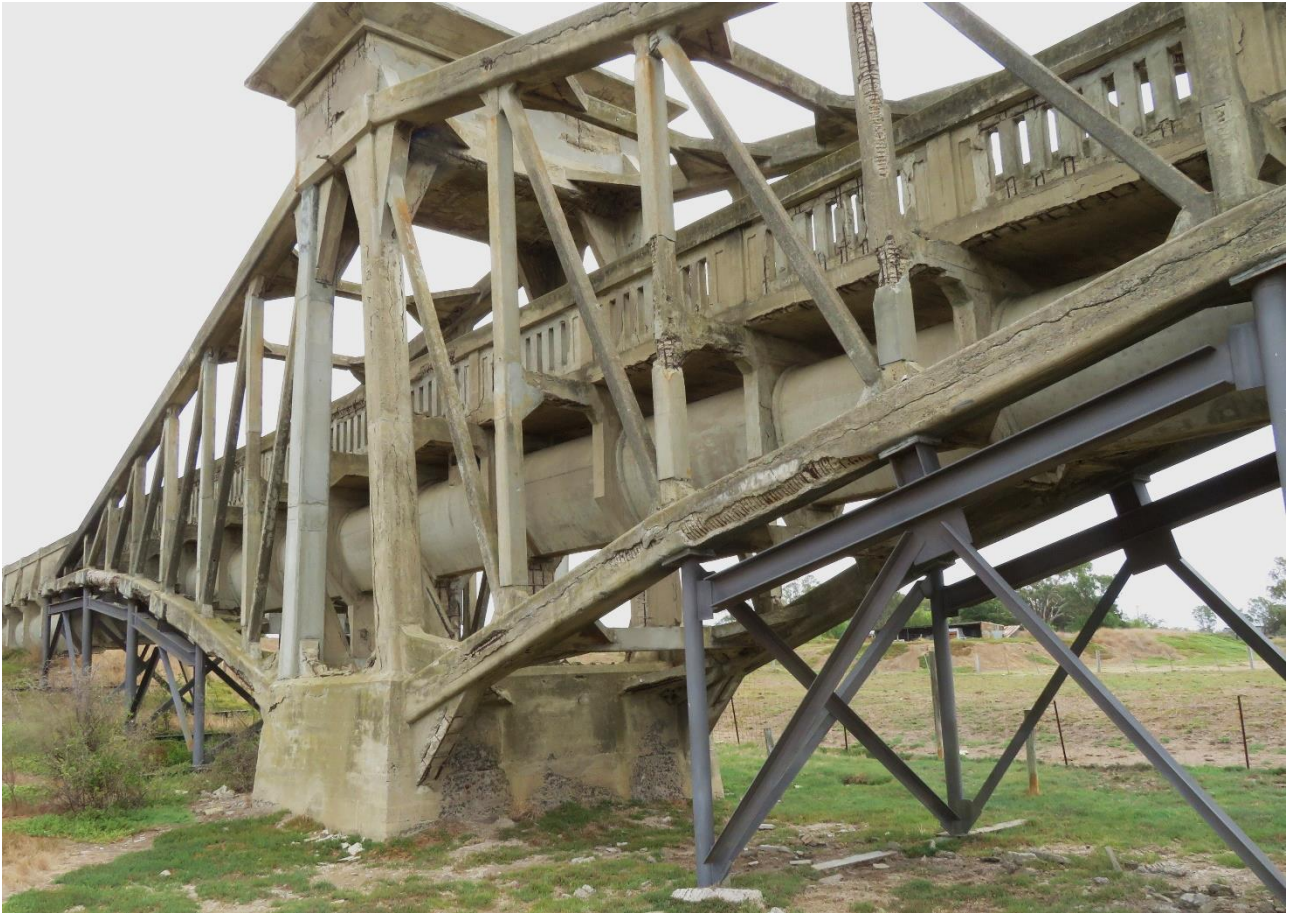
Figure 14 Truss 14 (south end of Aqueduct) with permanent propping installed c. 1991, exposed steel reinforcement, cracks, repaired and recast pier leg and web members, failed patch repairs  
Source: Lovell Chen archives (photographed 2019)

Urgent works to prop Truss no. 14 were undertaken in c. 1991-1992 (Figure 14). This likely averted a partial or complete collapse that would have been triggered by failure of that truss's bottom chords, where deflection and failure of the reinforcing structure remains visible today (Figure 15). Even after installation of the propping, the Contractor at the time was said to have identified the continuing safety risks posed by the failing truss and that further temporary supports and scaffolding would be required to make the truss safe for any subsequent repairs.<sup>32</sup>

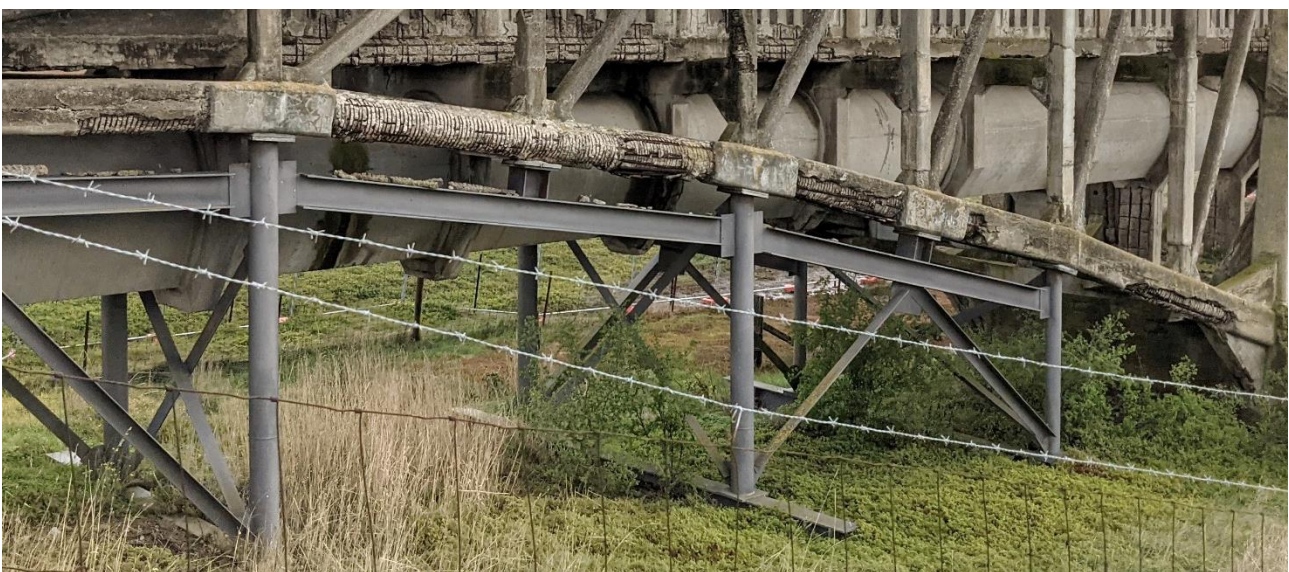
Figure 15 Detail of propped Bottom Chord on Truss 14 with exposed and buckled steel rods, apparent deflections and extensive concrete spalls accumulated on top of the c. 1991 steel props  
Source: Lovell Chen archives (photographed 2021)

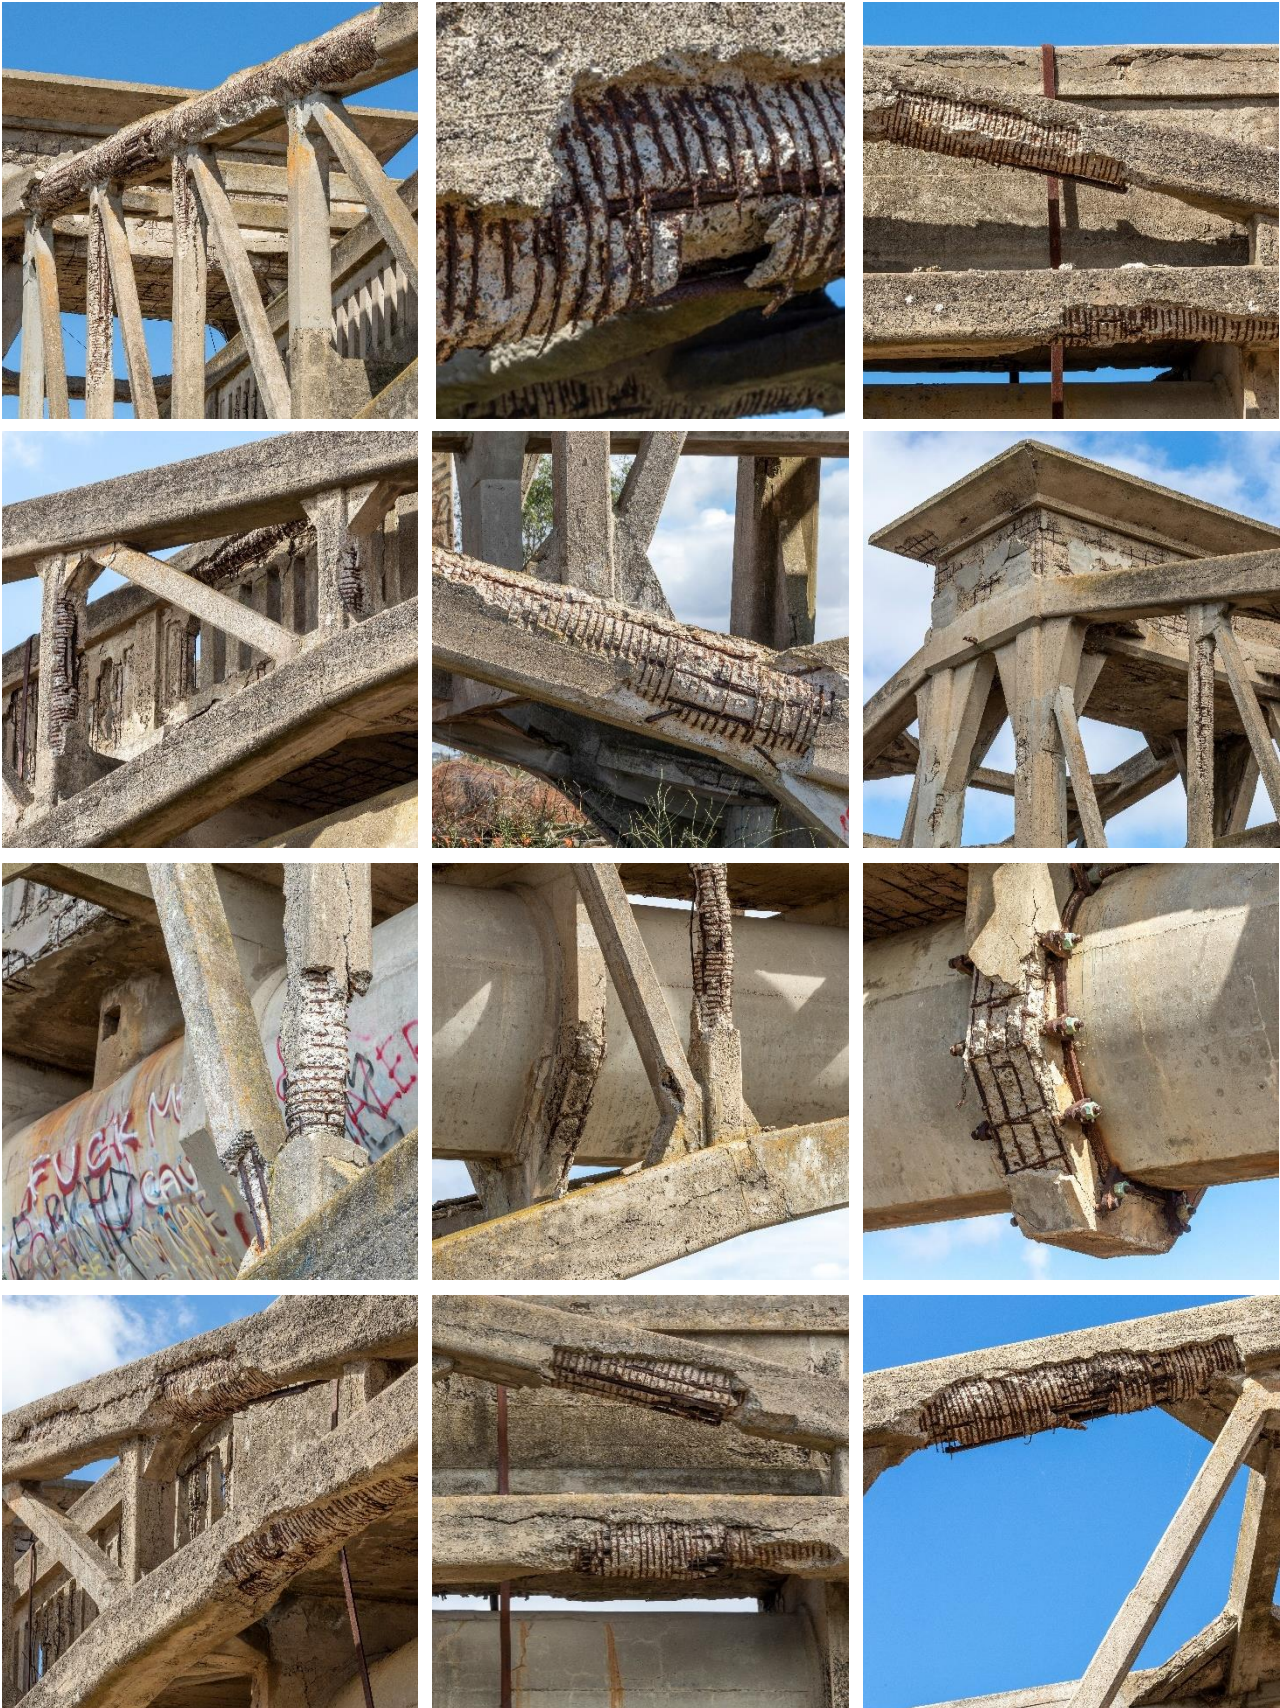
Figure 16      Example deterioration of the concrete cover and underlying steel reinforcement across the Aqueduct  
 Source: Glasshouse Creative Media (2022), courtesy Barwon Water

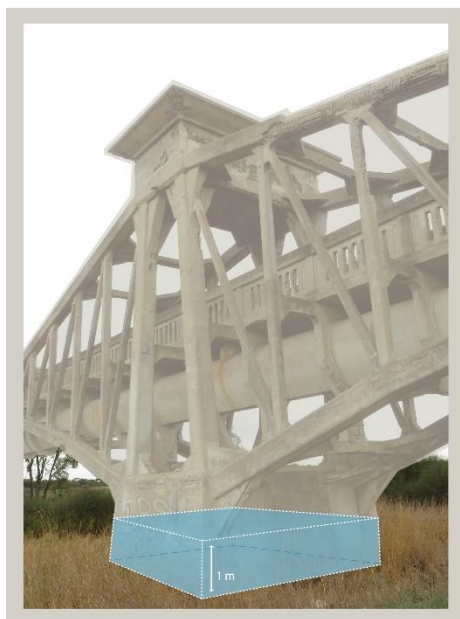
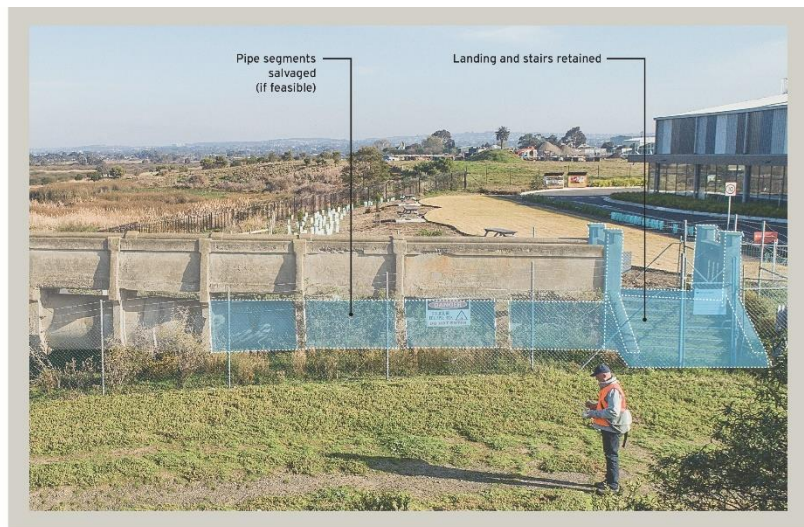
Retention of Pier Bases

Sewer Landings retained at north and south ends of structure

Figure 22 Detail of retained footprint elements for activation in the proposed Heritage Interpretation Strategy  
Source: Aqueduct Heritage Interpretation Strategy (Lovell Chen, August 2025)

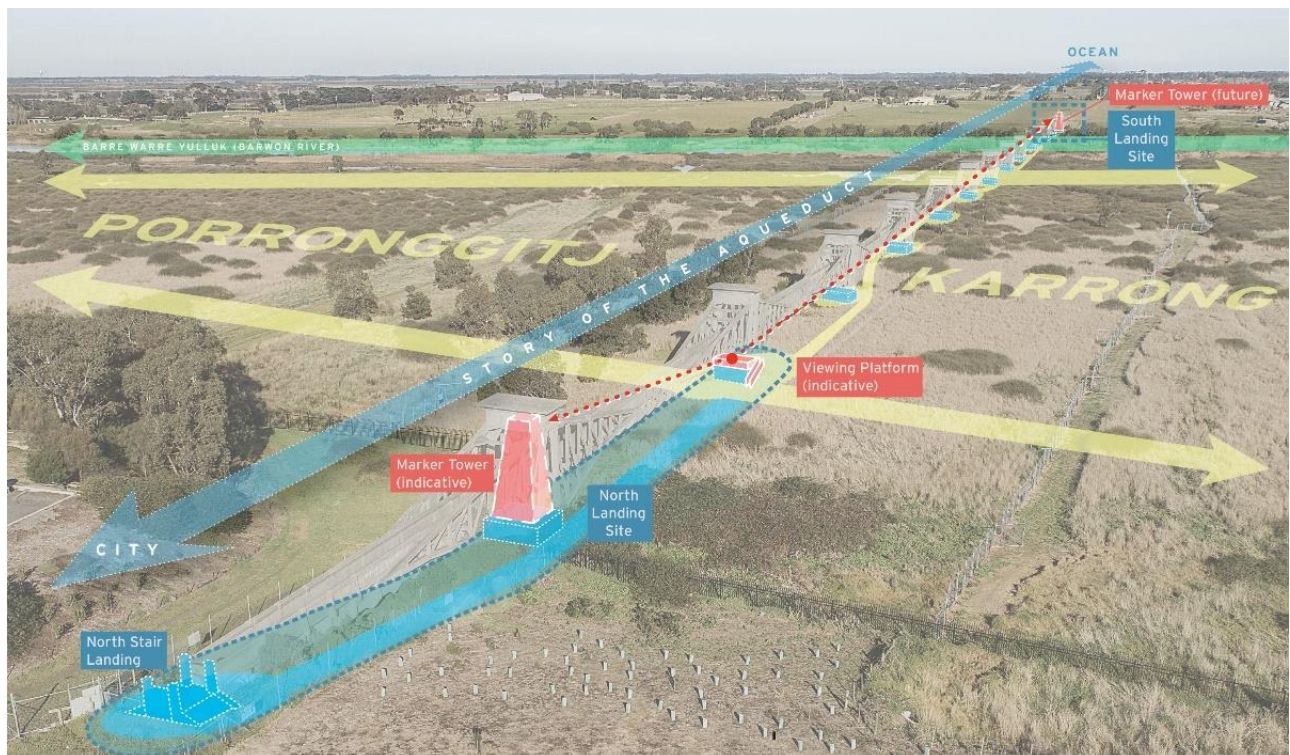
Figure 23 Concept illustration showing the spatial and storytelling relationship between the North Landing site, pier bases and (future) South Landing developments, within the context of the Outfall Sewer and Porronggitj Karrong  
Source: Aqueduct Heritage Interpretation Strategy (Lovell Chen, August 2025)
