Engineering peer review report

Barwon Ovoid Sewer Aqueduct

March 2025
Revision 4

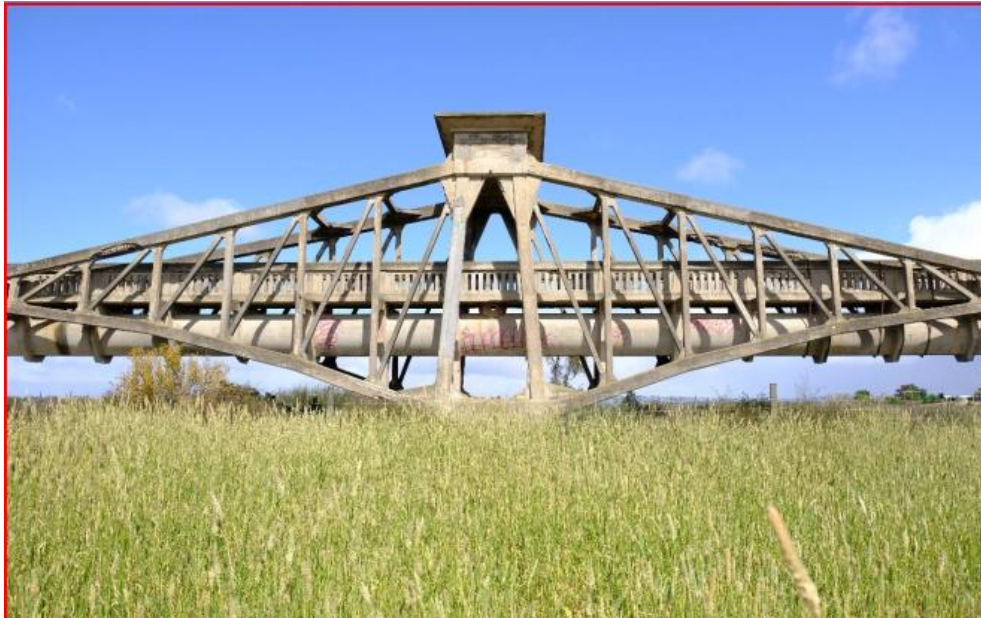
Image of a typical balanced cantilever truss and pier arrangement. Note that the top chord and diagonal members are in tension whilst the bottom chord and verticals are in compression

The Aqueduct truss system (example above) contains more than 896 discrete concrete elements (64 main truss elements at each of the 14 piers, with additional lateral elements). These elements were poured in-situ using the Considère system of steel reinforcement and serve in concert to carry the loading of the structure. Many of the truss elements are narrow, with a very thin concrete cover (often less than 60 mm).

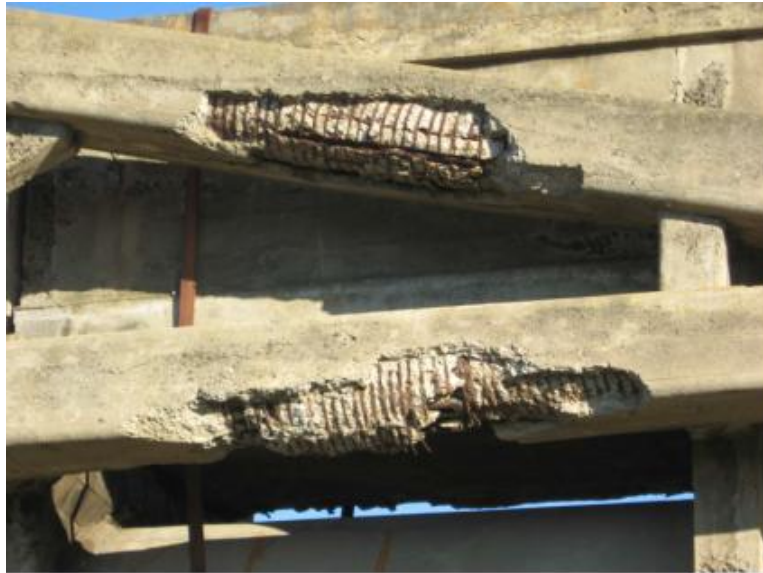
Extracted from GHD Report May 2017

This report elaborates on MacLeod's work to include the preliminary designs for alternative truss and catenary options for the support of the trusses and walkway spans, shown below, in conjunction with a potential solution for safe land access under the structure via a culvert. The GHD analysis identified the possibility of a sudden non ductile major collapse following the failure of a critical tension member in the existing concrete trusses. This could occur if the reinforcement corrodes to the point that it cannot carry the imposed loads. There is evidence that this form of corrosion is well advanced in a number of locations. See photos below from the GHD and Arup assessments. We also witnessed several heavily corroded tension members when we inspected the site.

Photograph showing Spalled Concrete and Corroded Reinforcement to Truss Bottom Chord (Compression Member) and Truss Top Chord (Tension Member)

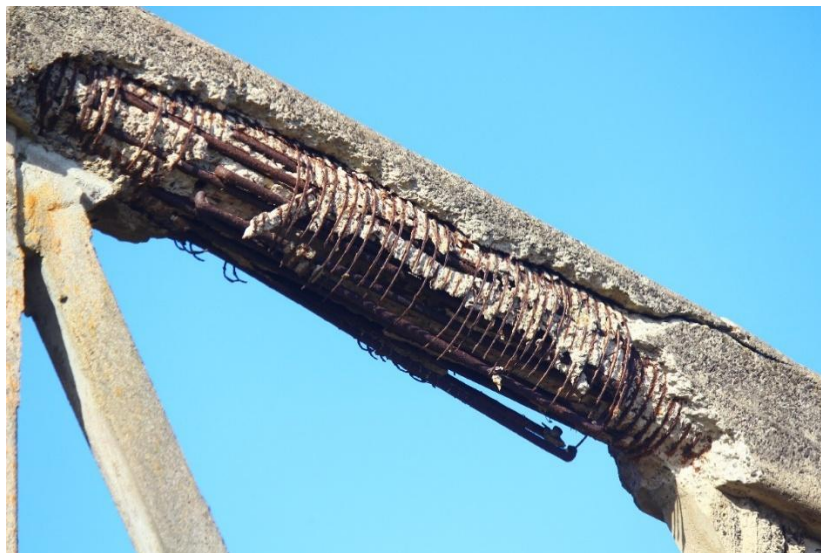
Chord tension member with considerable spalling and corrosion of primary tension reinforcement. Note dislodged main bar. Extracted from Arup Condition Report August 2024.

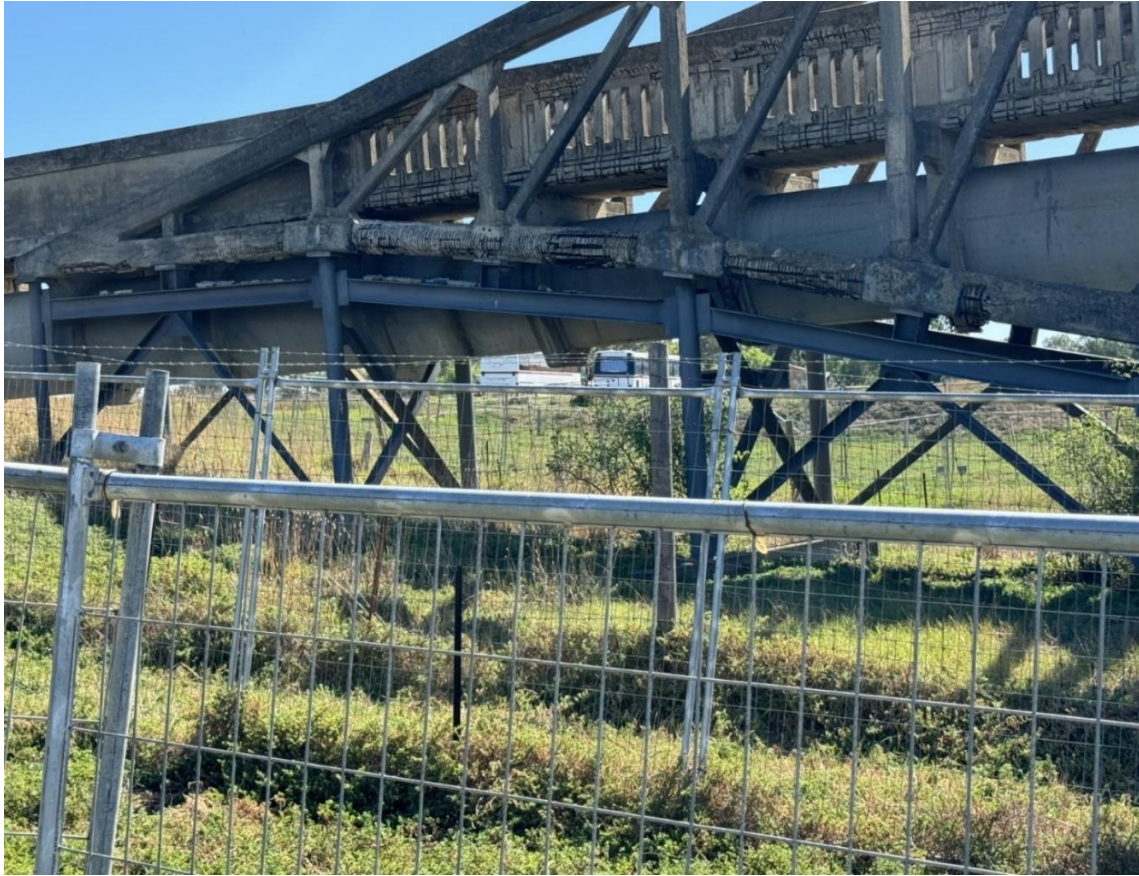
This is evidenced by our observation that the propping that already exists (refer images below) under the Southernmost spans shows signs of corrosion and notably the tops of the beams are holding many significant pieces of spalled concrete. We note the date on the drawing is October 1989 and understand the propping was likely installed in 1991. Planned further works were halted when the contractor withdrew due to safety concerns.

The image below taken during our site visit shows that it continues to do what it was designed for albeit it is showing signs of corrosion. Repainting or otherwise protecting the steelwork would not be easy to undertake safely given the advanced deterioration and spalling concrete.

**Image Showing Spalling and Concrete Pieces on top of Steelwork
Propping Southern Spans**

Safe work methods to maintain the steelwork would be challenging and without repainting the steel will also become compromised in time.
