## DA106 KARDINIA HOUSE EXISTING LAYOUT - GROUND FLOOR

13280 | RIVERVIEW | 1 RIVERVIEW TERRACE, BELMONT 3216

RFI Item 8: Sequence plans showing the sequence of alterations and additions, identifying significant and non significant fabric and dates of construction.

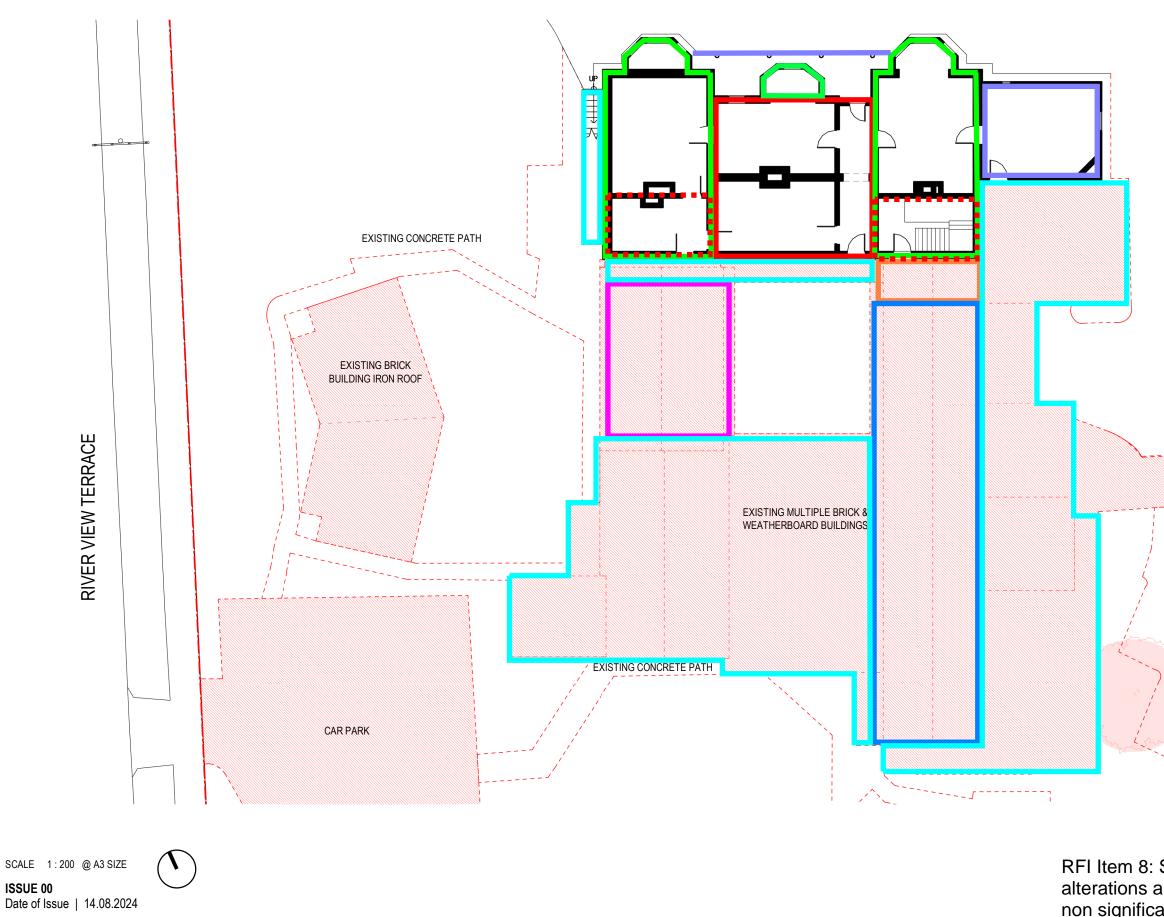
::::	1846-1855 - PRIMARY SIGNFICANCE Likely original part of stone house, altered 1860s. South-west room internally is NO SIGNFICANCE
	1846-1855 - PRIMARY SIGNIFICANCE Original hipped-roof stone house, added to in 1860s
	1860s - PRIMARY SIGNIFICANCE Attic gable wings and bay windows added (single storey)
	1880s - SIGNFICANT Cast iron verandah is PRIMARY SIGNFICANCE. East wing is SECONDARY SIGNIFICANCE
	c1915 - NO SIGNIFICANCE Timber outbuilding, heavily altered with only the roof structure remaining.
	c1920s - NO SIGNIFICANCE heavily altered outbuilding
	c1950s - NO SIGNIFICANCE Double storey addition, connected at first floor.
	c1960s - NO SIGNIFICANCE Post-war additions and accretions

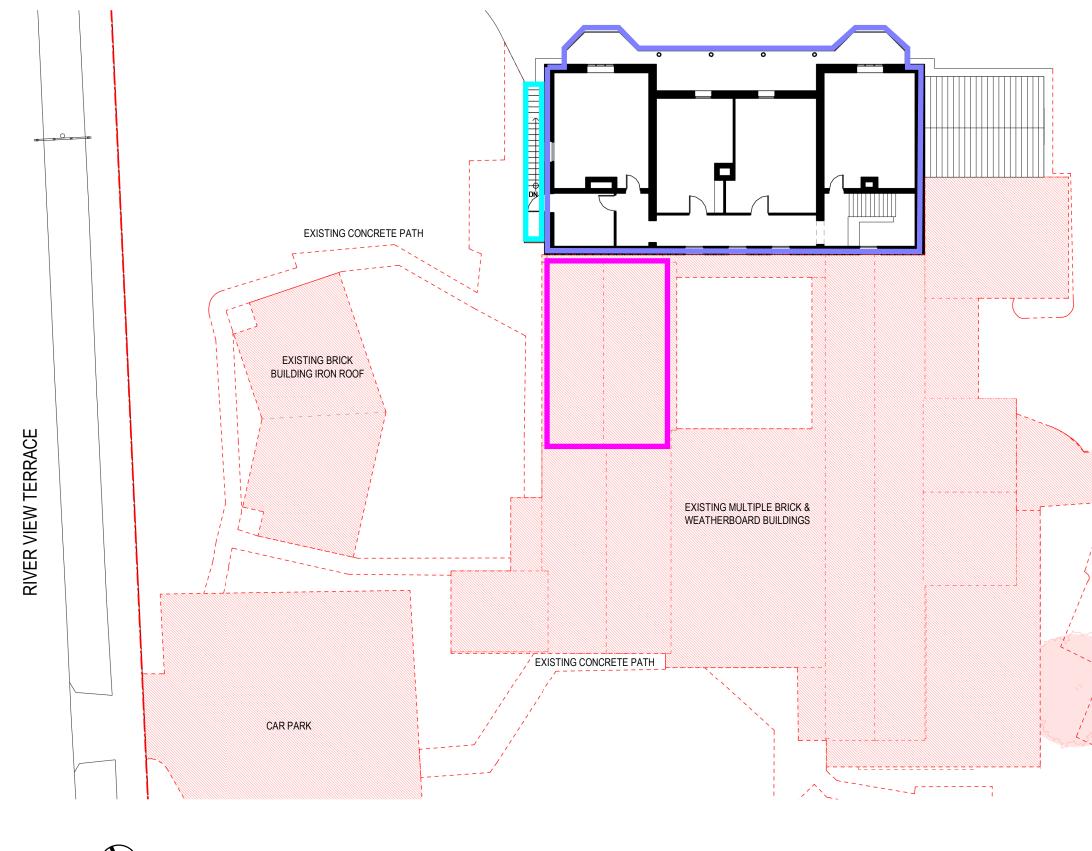
## DA107 KARDINIA HOUSE EXISTING LAYOUT - FIRST FLOOR

1880s - PRIMARY SIGNIFICANCE Additions including second storey, cast iron balcony

c1950s - NO SIGNIFICANCE Two storey addition, connected at this level

Post-war - NO SIGNIFICANCE Fire escape stair
