**VHR H0626**  
**Former Bryant & May Industrial Complex**  
**Administration Building (Building E)**  
560 Church Street, Cremorne

## **Heritage Impact Statement**

For Pitch Golf Pty Ltd  
**1 July 2026**

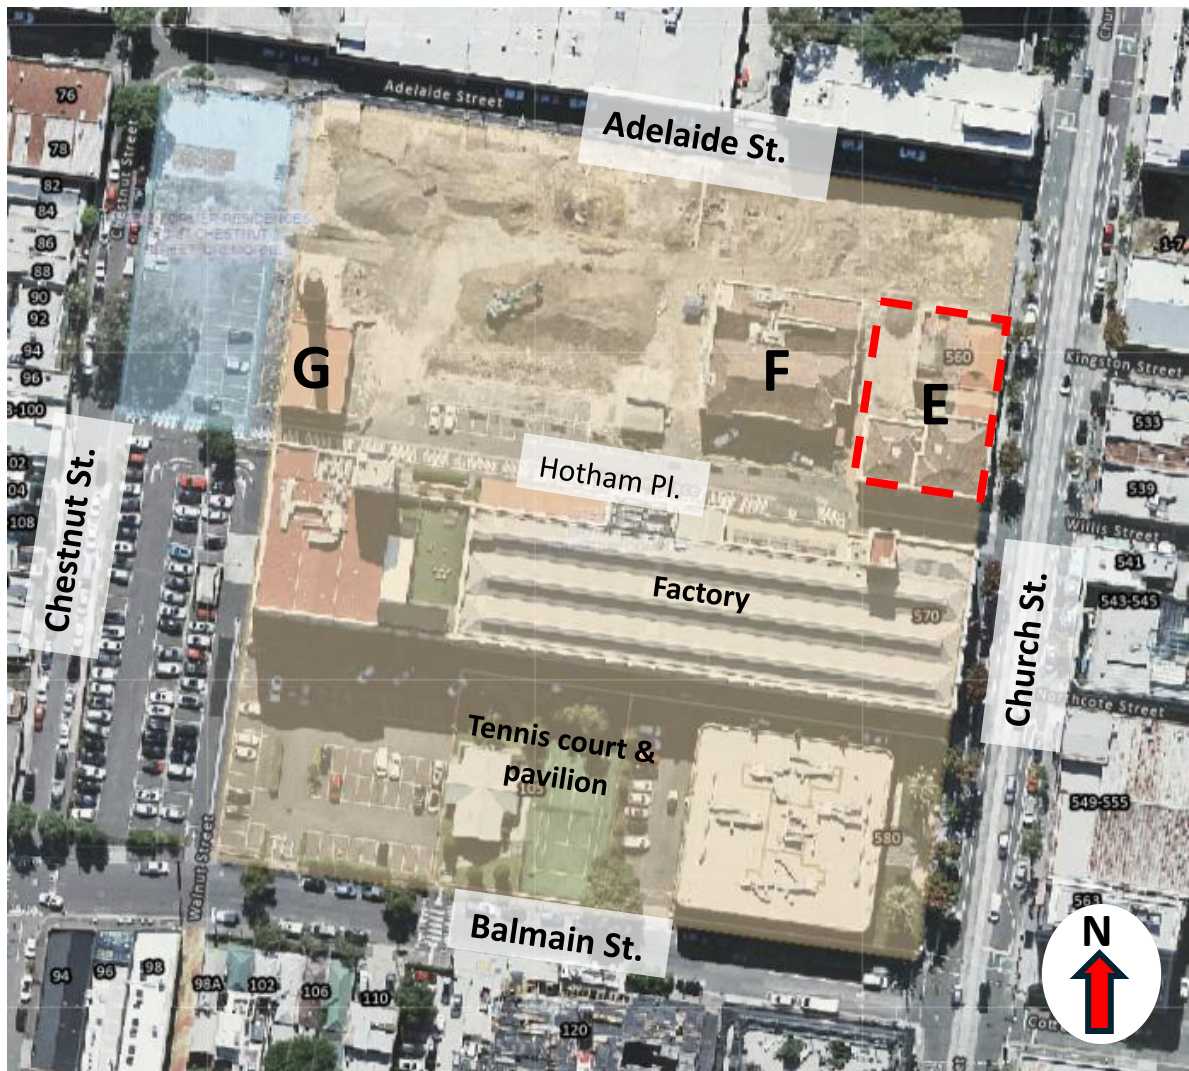
Figure 1: Aerial image showing extent of registration (yellow fill); and location of subject site (Administration Building - building E), Brymay Hall and Dining Hall (building F) and Boiler House and chimney (building G) in relation to the southern portion of the complex. Source: VicPlan, 2026.

The proposed works are limited to the **interior** of the former Administration Building (building E), as outlined in Figure 1 and Figure 2.

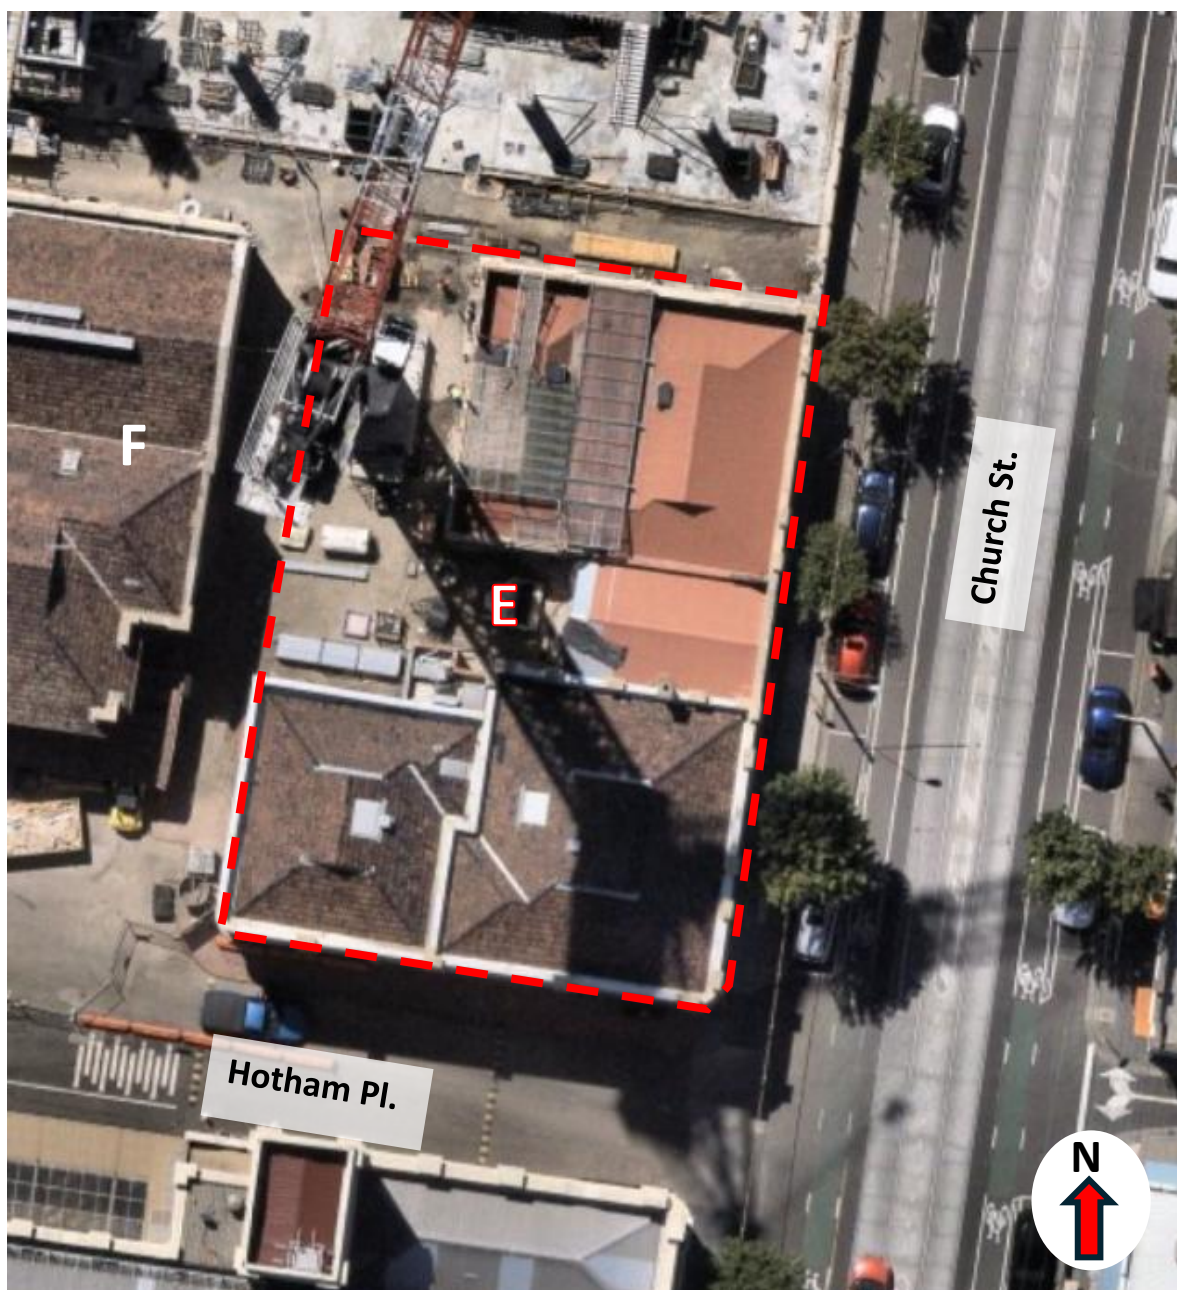
Figure 2: Aerial image of the former Administration Building (subject site) taken on 14 February 2026.  
Source: NearMap 2026.

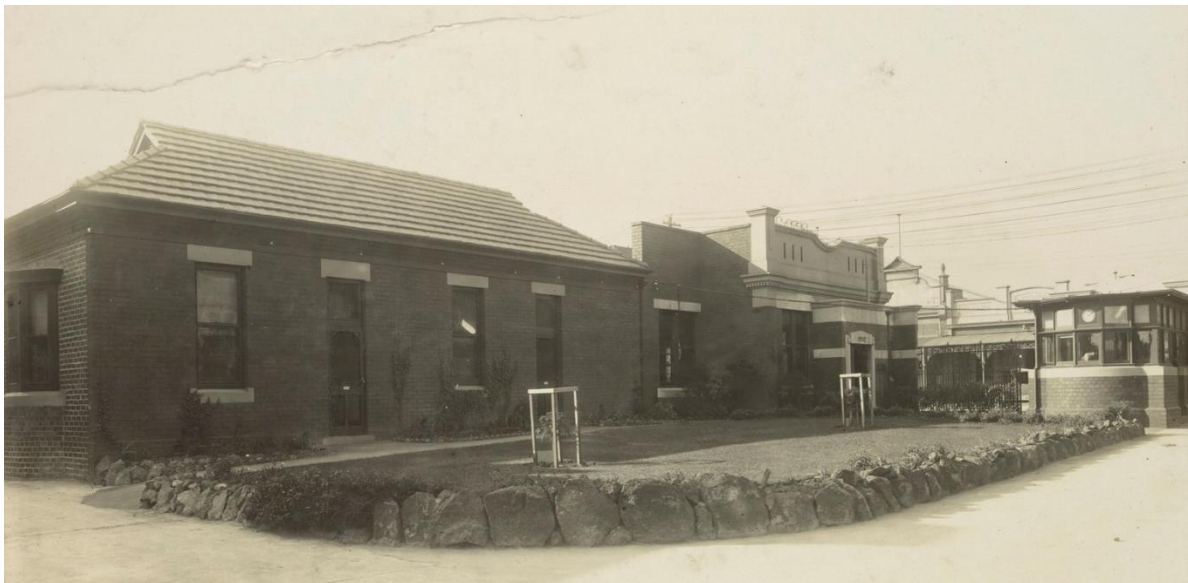
Figure 10: Southern elevation of the Administration Building, showing extended dining room, new parapet between buildings, new entry porch to south east, partial removal of the brick wall at the factory entrance, and the kiosk along Church Street. Source: *Looking Towards Church Street Entrance*, c1920-6, SLV, H92.401/10.

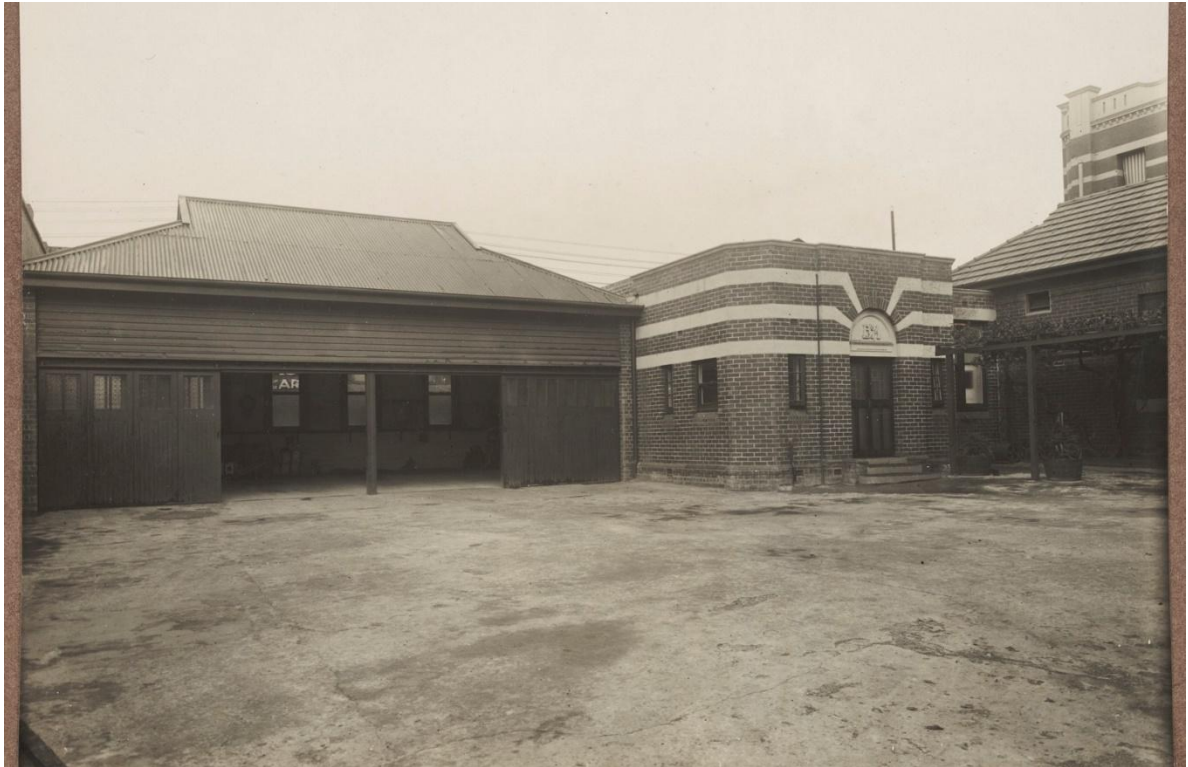
Figure 11: Image showing the west elevation of the Administration Building, as it appeared in the early to mid- 1920s, with the courtyard, boardroom, and garage shown.  
Source: Exterior View Showing Courtyard Behind Church Street Facade, 1920-6, SLV, H92.401/9

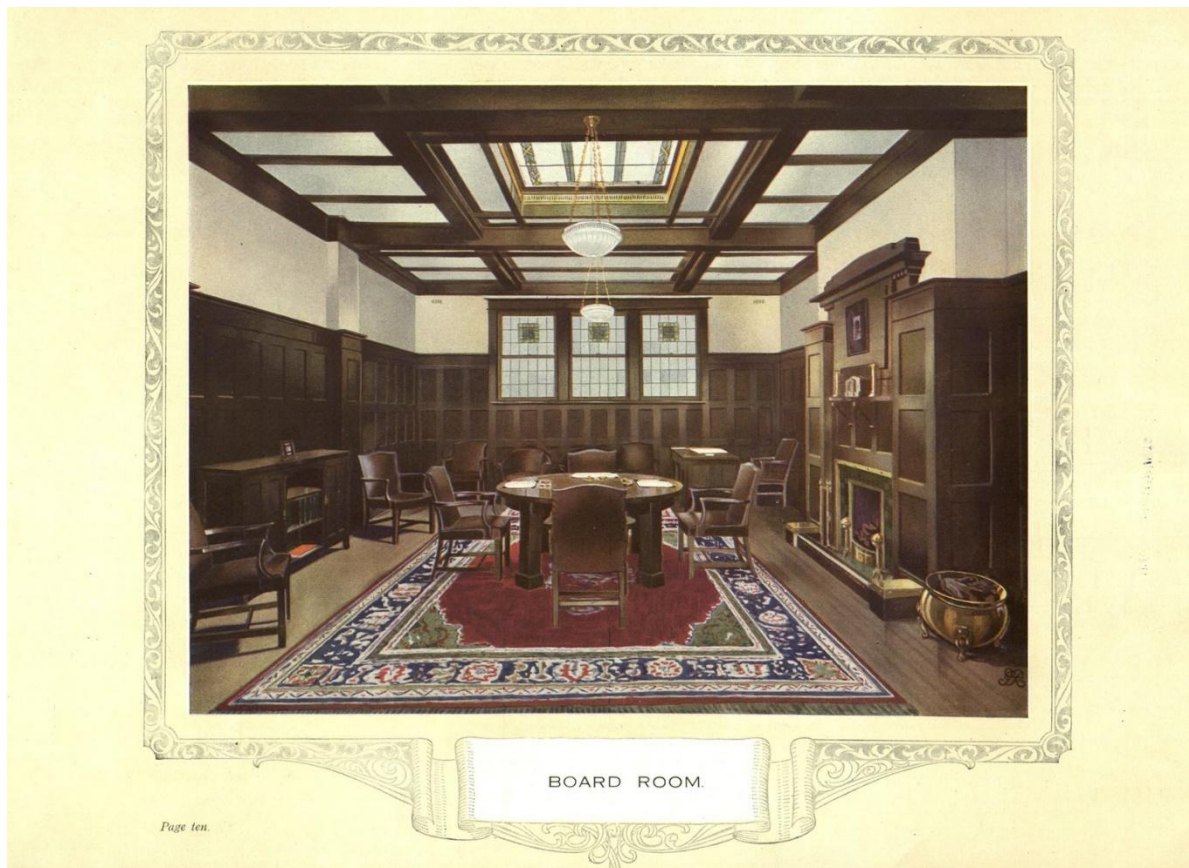
Figure 13: Drawing of the new boardroom, which adjoined the offices.  
Source: *The Matchmakers: A Story of Real Life*, Bryant & May, 1925, SLV, 662.5 B84M.

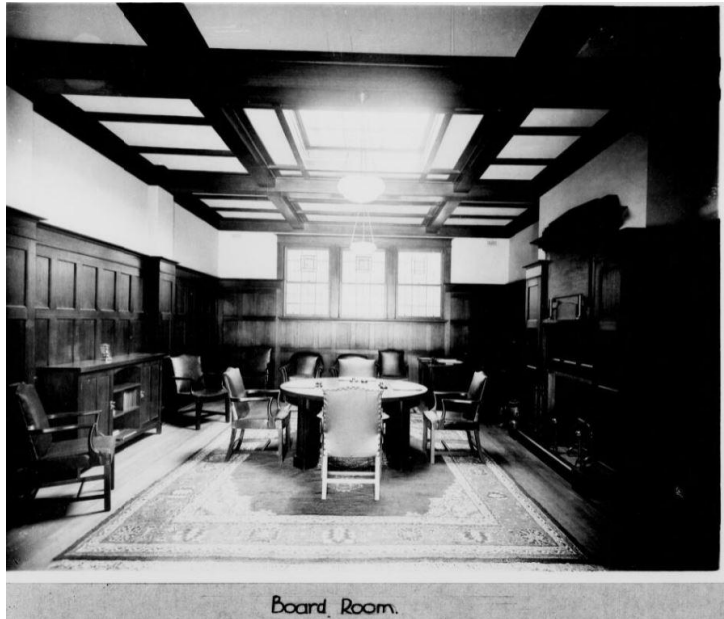
Figure 15 (left): Photograph of the boardroom, taken in the 1920s. Note smaller, leadlight sash windows to street front. Source: Australia: Various Photographs of Empire Works, Showing Workers, Processes, Facilities, 1920s, NLA, D/B/BRY/3/2.

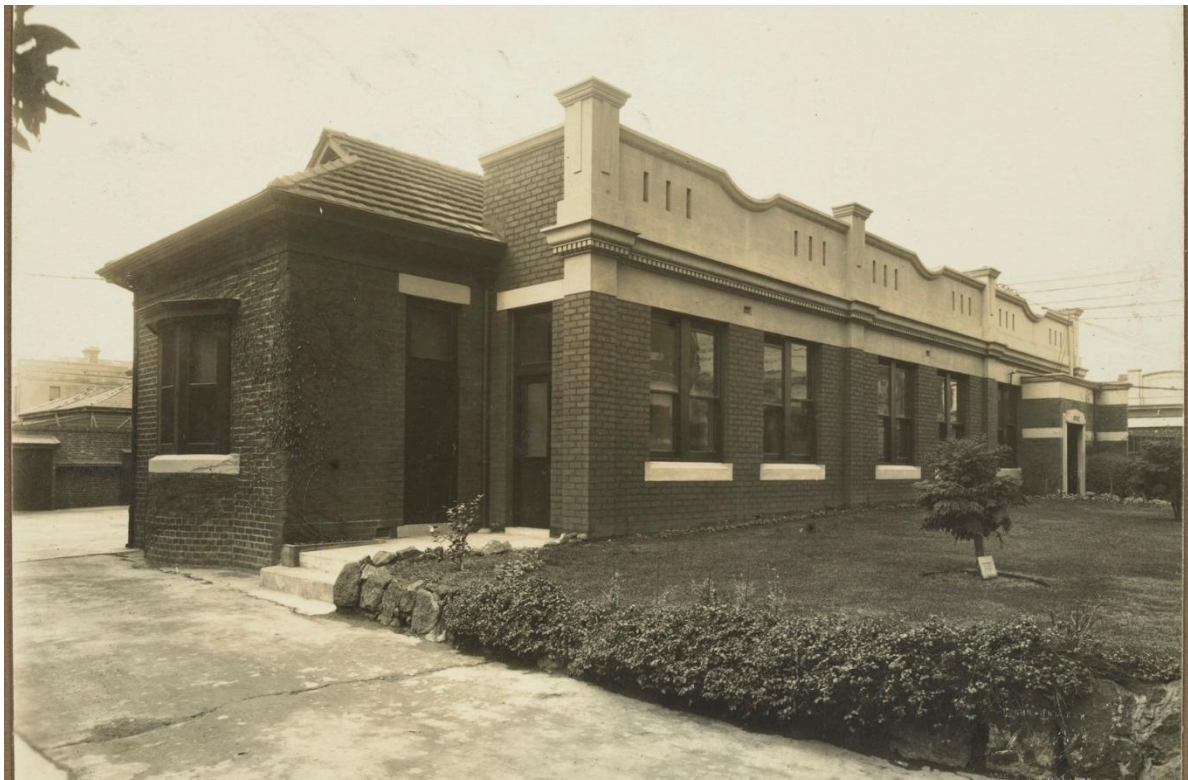
Figure 16: Administration Building after southern façade was extended further south. Source: Building and Garden at Factory, Possibly Bryant & May, c1910-32, SLV, H92.401/339.

Further works occurred to the Administration Building in the mid to late 1920s when part of the southern façade was extended forward and built to resemble the Church Street façade (shown in Figure 16 and Figure 17). It was possibly at this time, or earlier, that an additional room was added to the centre north of the Administration Building (shown as Room 8 on the application drawings and partially depicted to the left in Figure 22).

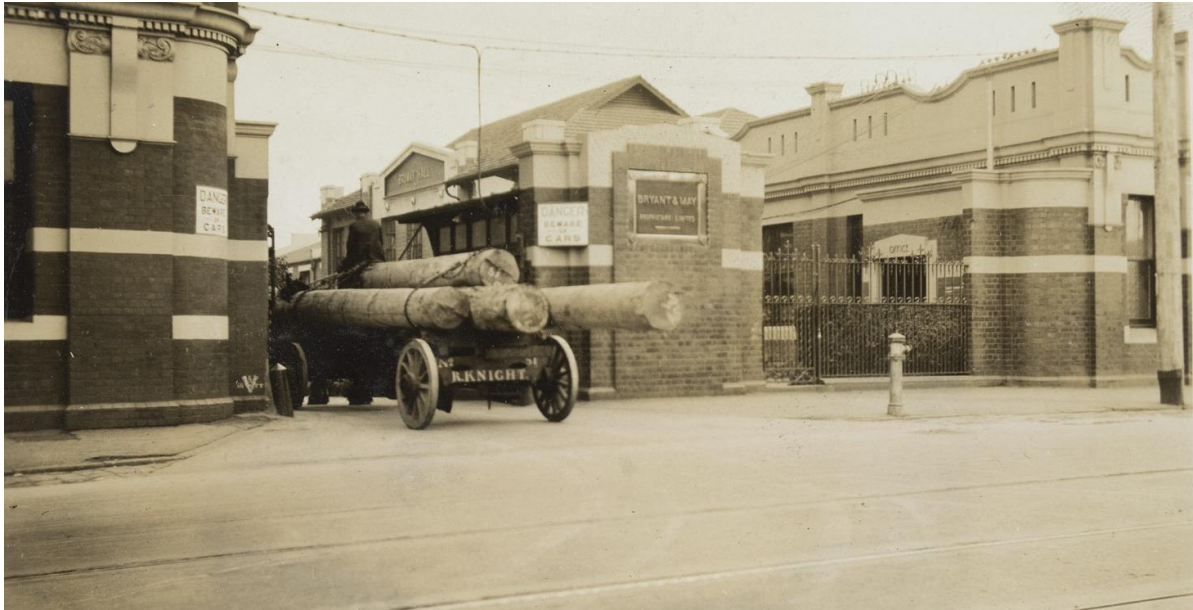
Figure 17: Image of the entrance to Church Street, showing portions of the south and east elevation of the Administration Building after the façade was extended along the former dining room.  
Source: Two Horses Pulling Wagon Load Of Logs into Bryant & May Richmond Picture, 1920s, SLV, H92.401/421.

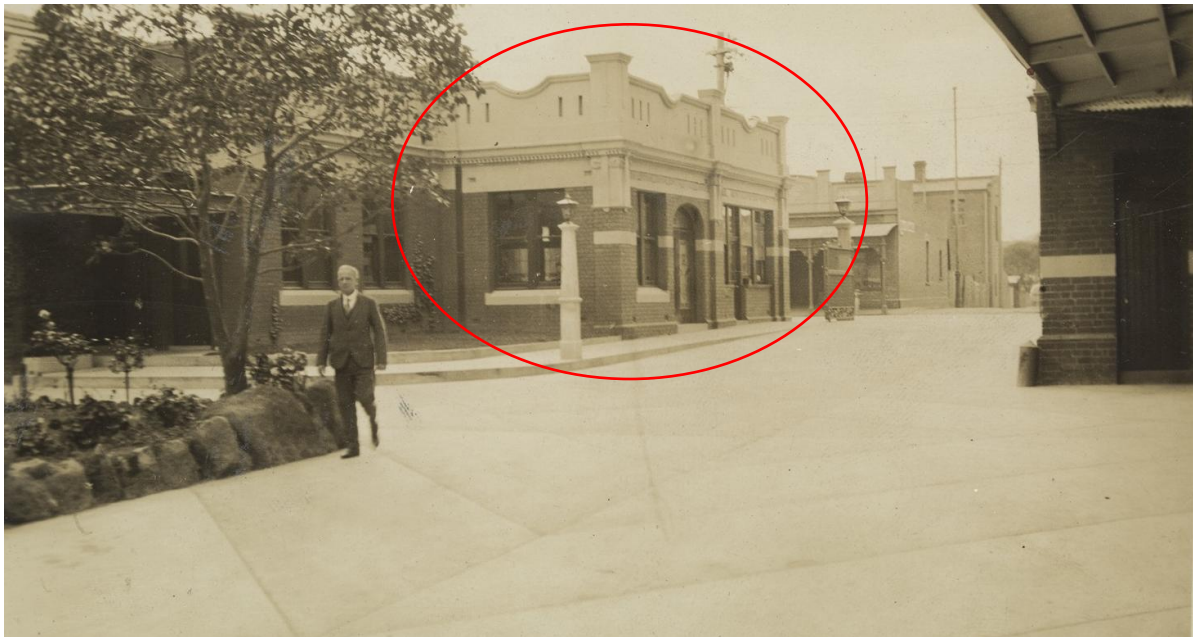
Figure 18: Image of the entrance and south side of the office buildings, showing further changes to this façade. The south façade appears to have been extended further across the site entrance (circled red).  
Source: Inside Grounds of Bryant & May Factory, Richmond, Nov 1928, SLV, H92.401/433.

| DATE | BROADER SITE DEVELOPMENT / EVENT | SUBJECT SITE DEVELOPMENT |
|---|---|---|
| | Image of southern façade of Administration Building taken in 1928. See Figure 18. | By this time southern façade of Administration Building is significantly redesigned. Façade in the two easternmost bays is extended south (again), and arched entrance extant today is visible. Garden south of Administration Building replaced with concrete roads. Wall between Administration Building and factory demolished and replaced with entrance gates. See also Figure 19. |

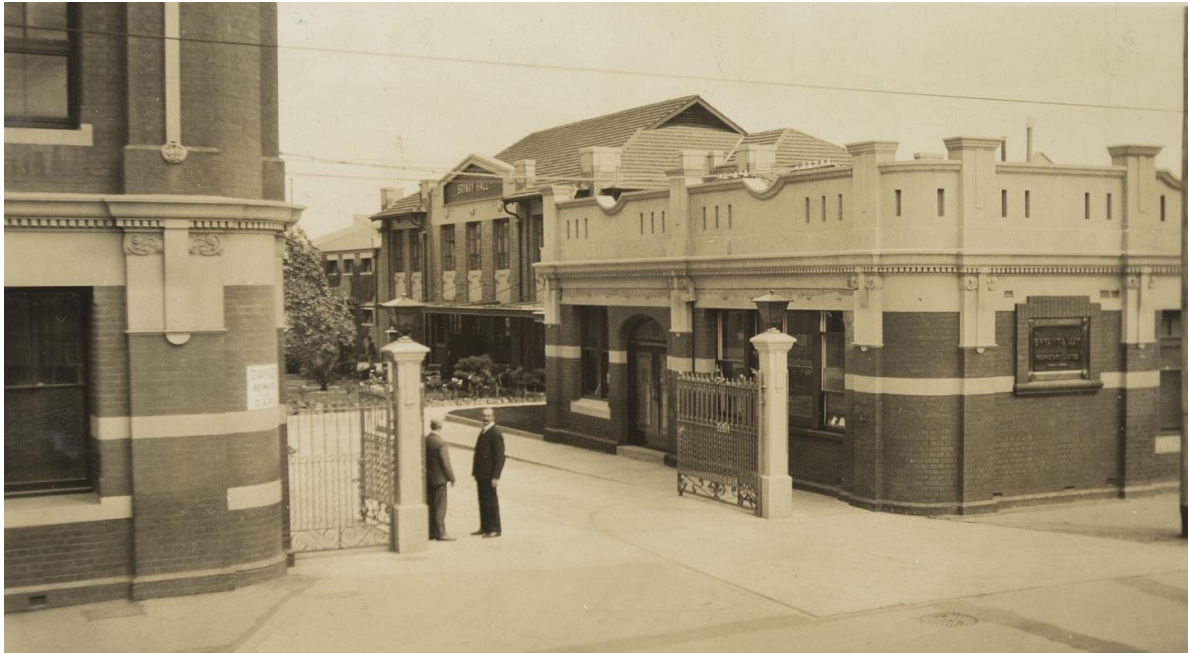
Figure 19: Image showing portions of the south and east facades of the offices (pictured right of image), with the south façade further extended and changes shown to the east façade, including the relocation of the plaque.  
Source: *Looking Through Gates at Bryant & May, Richmond, to Brymay Hall, 1928*, SLV, H92.401/435.

By 1928, further works had occurred to the subject building when the southeastern portion of the southern façade was again extended forward (see Figure 18 and Figure 19). Between the late 1920s and the early 1930s, a gabled addition was constructed to the garage.

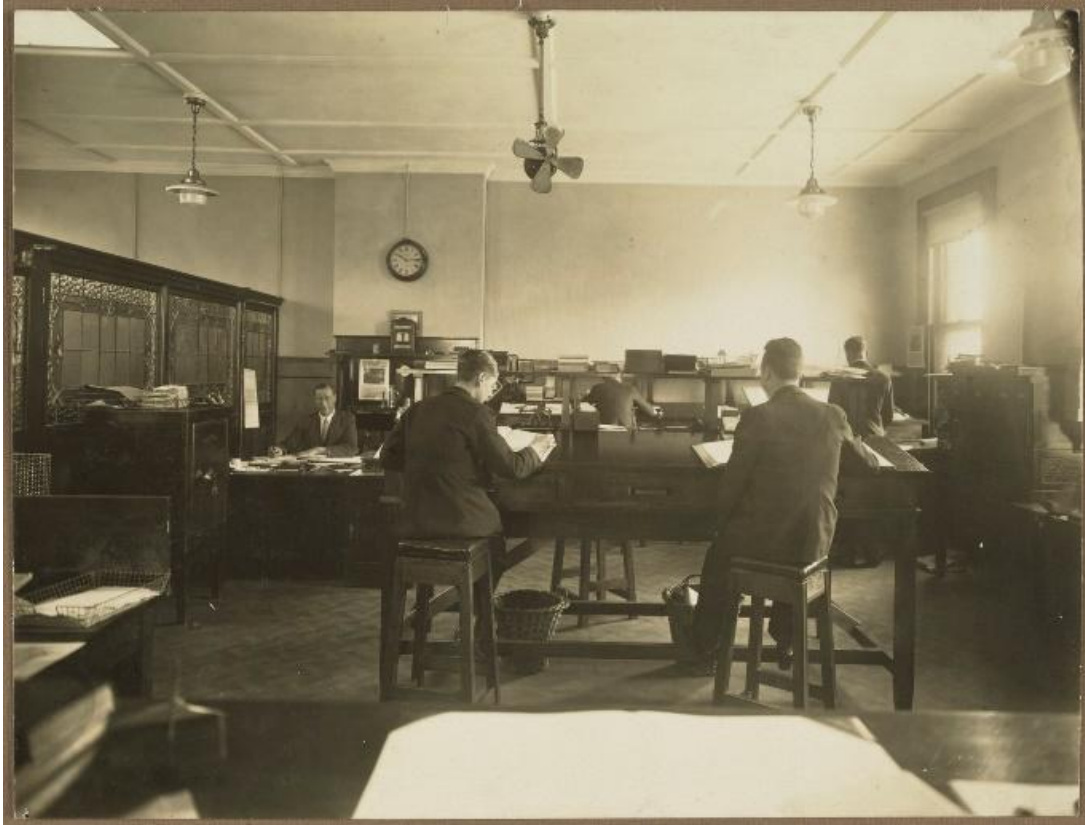
*Figure 20: Image of an office area at Bryant & May, likely taken c.1927 looking north in Room 10 as shown on application drawings. Source: Men at Work in Office Area of Factory, Probably Bryant & May, c1927, SLV, H92.401/342.*

Available images depict parts of the Administration Building internally during the 1920s (see Figure 20, Figure 21 and Figure 22). The images refer to 'offices at the Bryant & May factory'; the double-hung sash windows evident in the images suggest that they were taken of the interior of the subject building. The images show rooms with panelled ceilings, dados to the walls, decorative timber partitions with leadlight glazing (some half height), high timber skirtings, and herringbone pattern flooring (likely linoleum on top of the specified hardwood).

1. running north-south from the rear of the boardroom (identified by chimney, see Figure 20); and
2. running east-west at the entrance lobby (identified by double timber doors beyond) - forming the southern wall of offices (see Figure 21).

When compared and analysed against the phases of development map, Figure 22 seems to depict a third decoratively glazed partition wall that ran parallel to the one depicted in Figure 20, creating a corridor to the boardroom. It would, however, be unusual that this third partition isn't mentioned in the 1922 specification or photographed in the series with the other images.

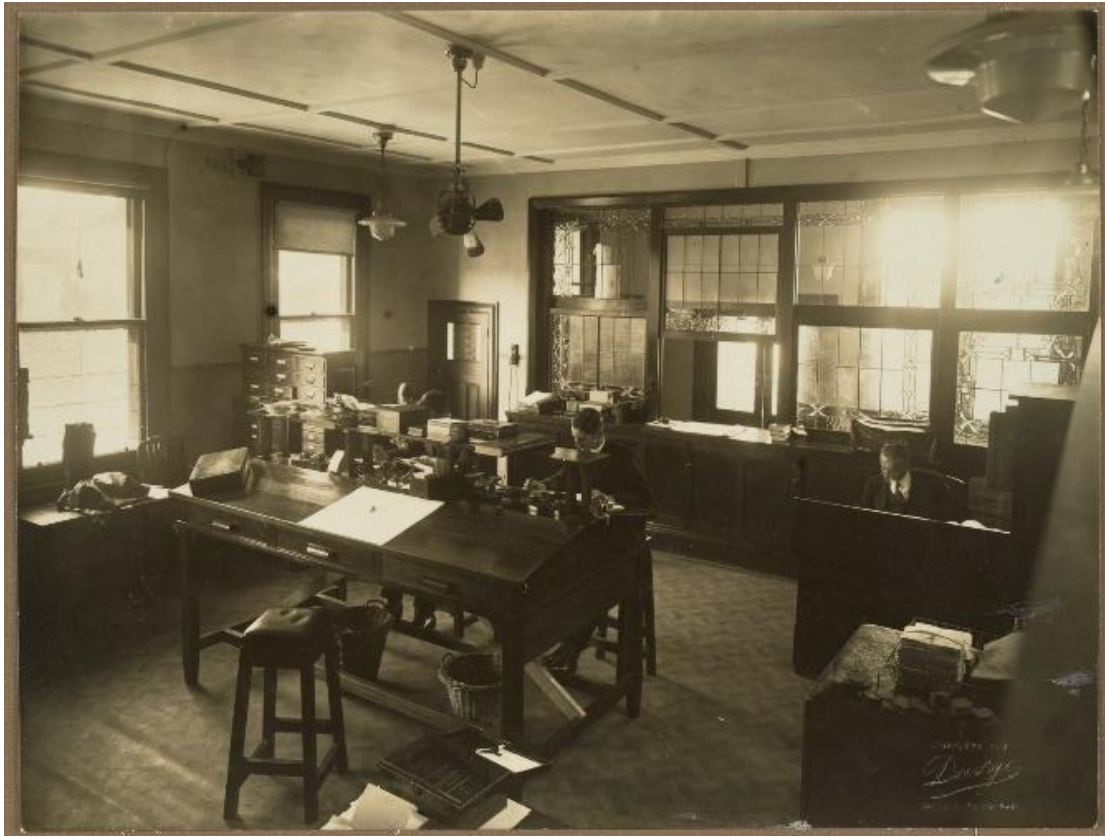
Figure 21: Image of an office area at Bryant & May, likely taken c.1927 looking southeast in Room 10 as shown on application drawings. Source: *Men at Work in Office Area of Factory, Probably Bryant & May, c1927*, SLV, H92.401/343.

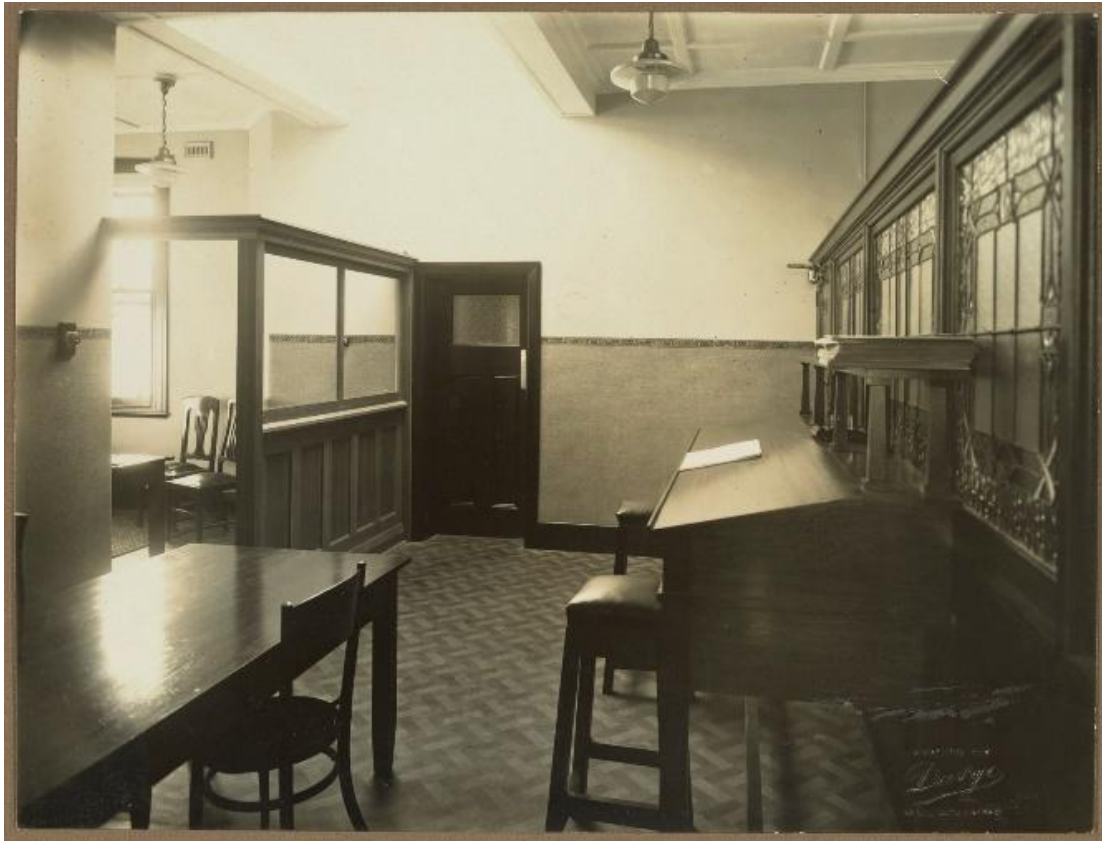
Figure 22: Image of an office area at Bryant & May, likely taken c.1927 looking northwest in Room 9 as shown on application drawings. Source: Office Area of Factory, Probably Bryant & May, Algernon Darge, 1920-30, SLV, H92.401/345.

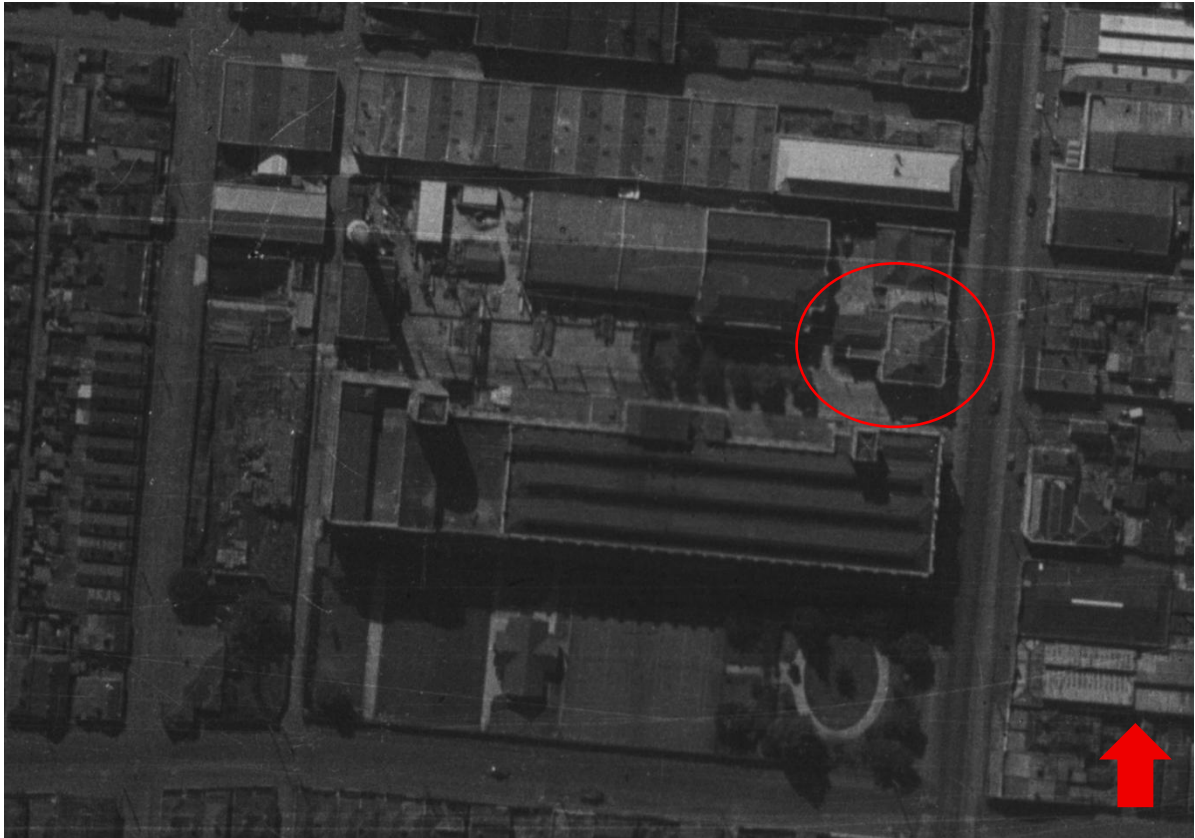
*Figure 23: 1942 aerial of the Bryant & May factory, with the Administration Building circled red. Note that a first storey was added to the south-easternmost corner of the building, with a gambrel roof constructed.*  
Source: Run 16, Frame 72351, Geoscience.

A second storey was added to the office block in the 1930s or early 1940s, appearing on an aerial from 1942 (Figure 23); previous histories compiled on the factory noted that this storey was added in 1934 and was designed by Arthur and Hugh Peck.<sup>19</sup> Initially, the first storey was added to only the southeastern corner of the building.

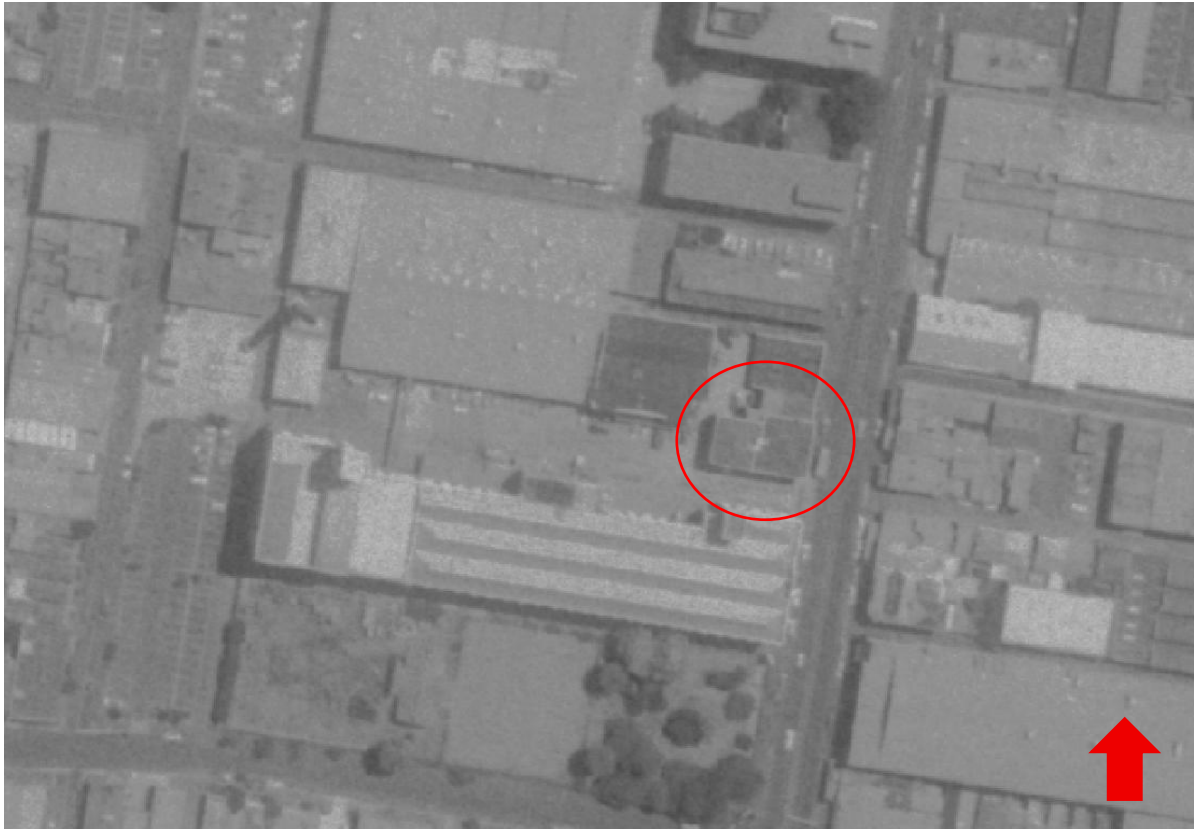
*Figure 25: January 1983 aerial of the Bryant & May Match Factory, with the Administration Building circled red. Note that the ground floor and the first floor have been extended to the western portion (originally the dining room). Source: Run Unknown, Frame 791, Geoscience.*

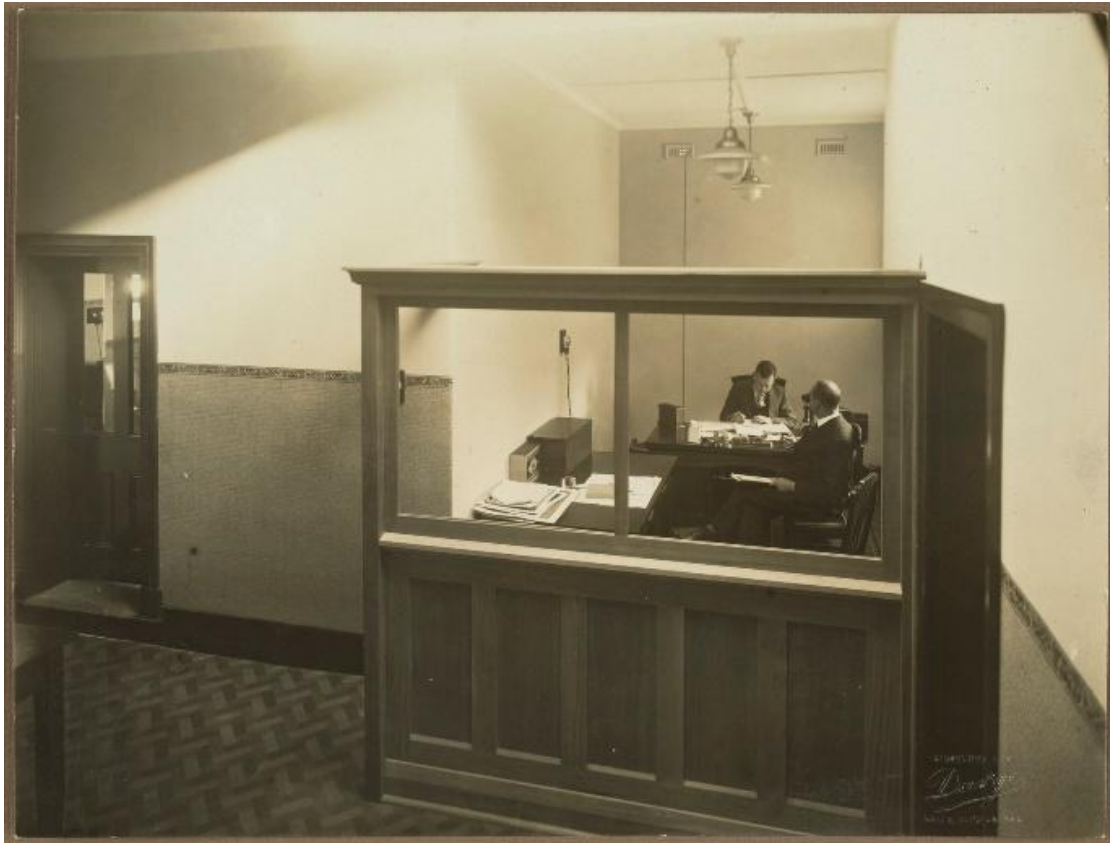
Figure 27: Image of an office area at Bryant & May, likely taken c.1935 on level 1 looking west from room 17 on the application documents, prior to the c.1942-1950 extension.  
Source: Office Area of Factory, Probably Bryant & May, 1920-30, SLV, Algernon Darge, H92.401/344.

Only one image was found that may depict an office space on level 1 of the Administration Building. Figure 27 shows a hallway and office entrance, possibly at the southwest of level 1, prior to the 1942-1950 extension. The image shows external wall vents at the rear, and a sash window on the left wall inside the office (also to the left). The depth of the wall and location of the door align with the footprint of room 18 on the application documents - though it is noted that the depth of the wall in the image is substantial, unlike the wall extant on site. It is also noted that the ceiling moulds are flatter, and the timber door is low waisted with clear glazing, which differs from those in previous images of office spaces, indicating this area was constructed at a different time than the areas in previous photographs.

The image in Figure 27 suggests that when constructed, the upper level adopted a similar design aesthetic to the ground floor: parquet patterned linoleum floors, tall timber skirtings, paper wall dados with borders and white paint above, timber or mould strapped ceilings with small cornices and pendant lights throughout.

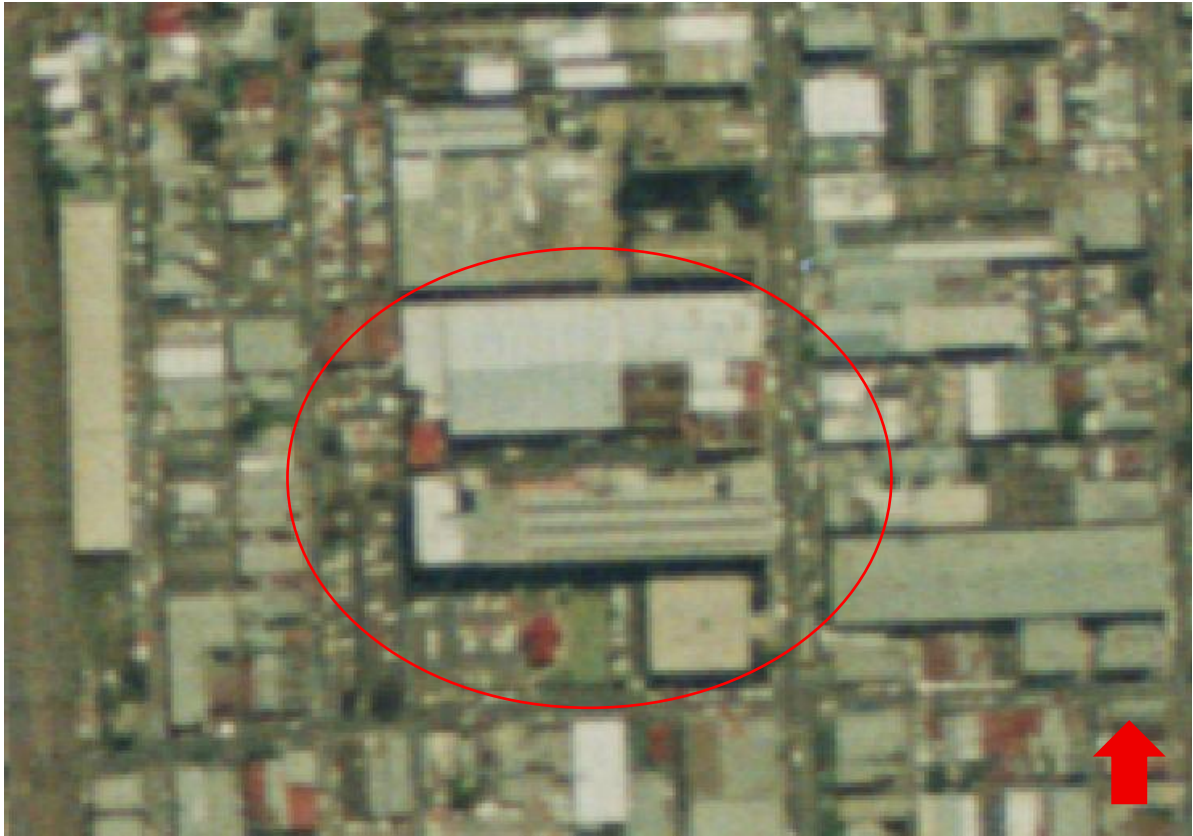
*Figure 30: October 1992 aerial of the Bryant & May Match Factory, circled red. Note that the courtyard to the west of the garage was built over, including the area to the immediate north of the offices. Source: Run 2, Frame 449, Geoscience.*

Over the mid to late 1980s, a large double storey showroom was constructed over the courtyard to the north and west of the garage, appearing in a 1992 aerial with a corrugated metal roof (see Figure 30). The same aerial image appears to show a small double storey addition to the northwest façade of the Administration Building (facing the utility yard). Around this time, the roof cladding to the garage and boardroom was replaced. In 1989, the Richmond and Clock Tower buildings were refurbished, likely for the reuse of the site.<sup>21</sup> Also in the late 1980s, the subject building was renovated and altered for use as a showroom and office for Porsche and Audi, who moved to the site in 1989, and which likely involved exterior and interior alterations, including the widening of openings to the front (east) façade as it faces Church Street (see Figure 31).<sup>22</sup>

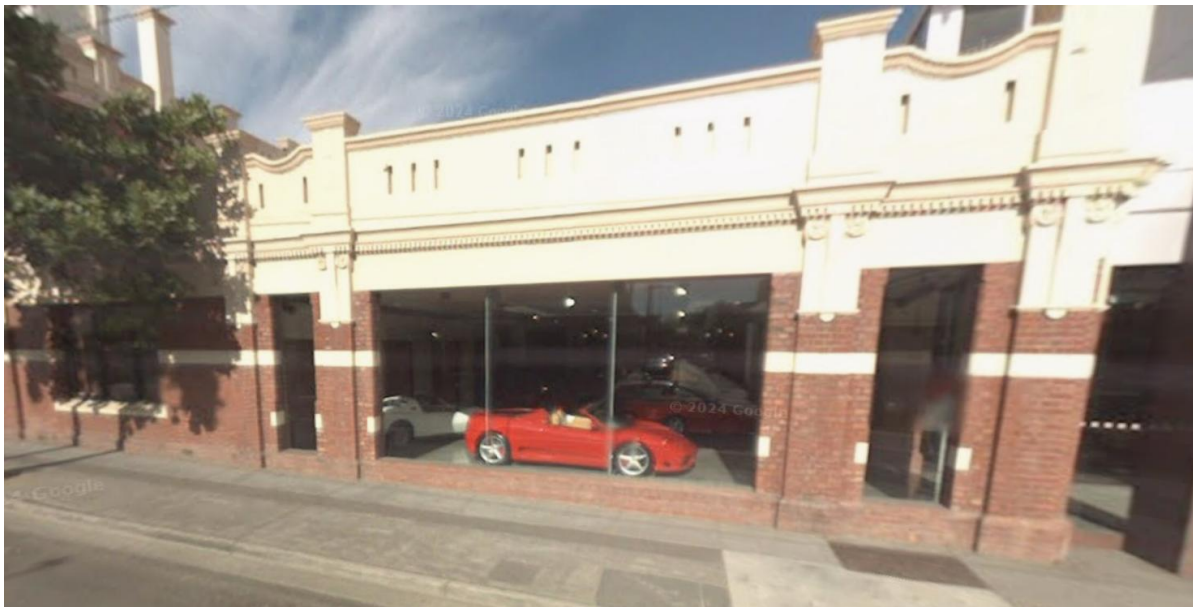
*Figure 31: Image of the east (front) façade of the subject building, taken in December 2007, with the alterations to the opening shown. Source: Google Street View.*

| DATE | BROADER SITE DEVELOPMENT / EVENT | SUBJECT SITE DEVELOPMENT |
|---|---|---|
| Late 1980s-early 1990's | Porsche and Audi, move to subject site in 1989.<br><br>Aerial images of subject site captured in 1992. | Small extension to central north-west of the first floor, and a large new showroom constructed to the northwest by 1992.<br><br>Roof cladding to the garage and boardroom replaced.<br><br>Part of subject site renovated and altered for use as a showroom and office for Porsche and Audi, which likely involved exterior and interior alterations, including the widening of openings to the front (east) façade (see Figure 31). |

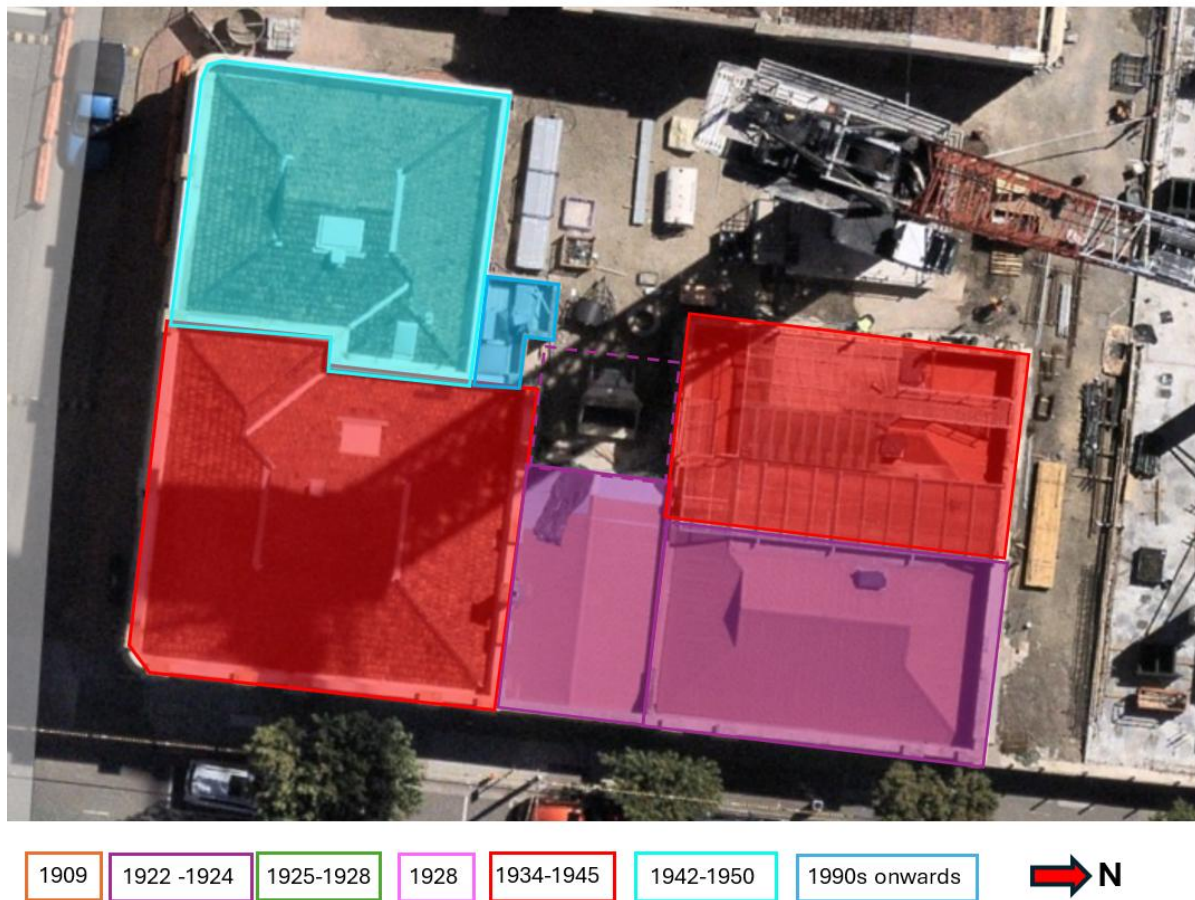
Figure 36: Phases of development at the former Administration Building - 2026 aerial image.  
Source: NearMap with RRCD overlays.

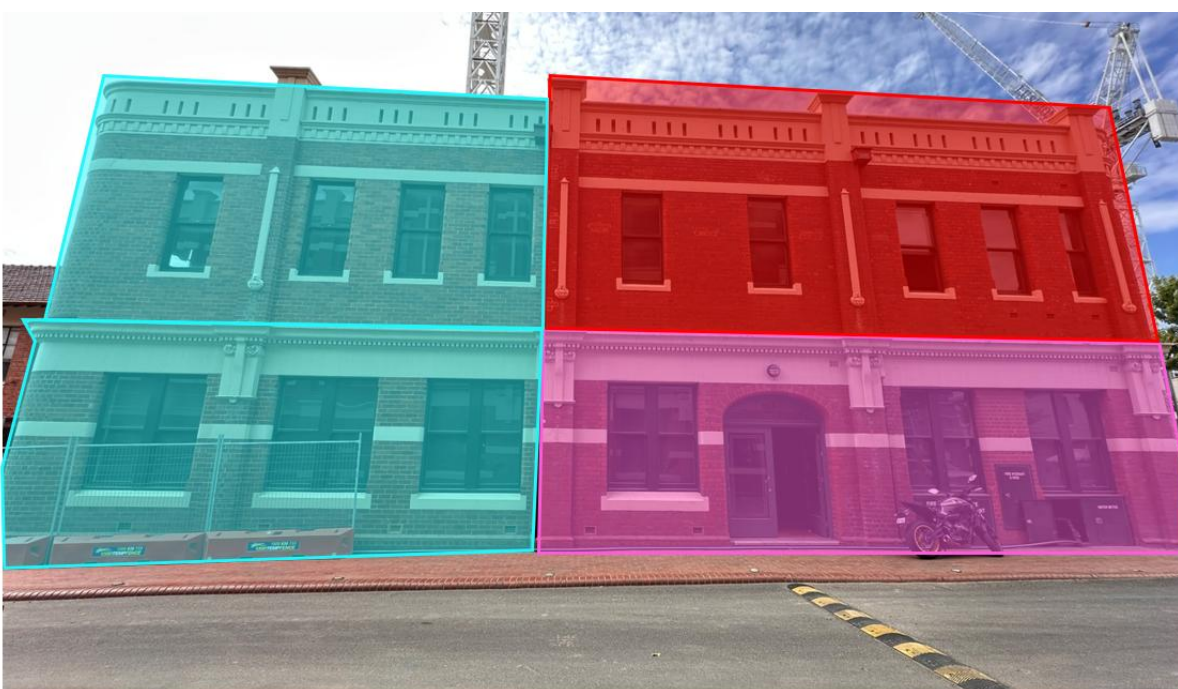
Figure 38: Phases of development at the former Administration Building - Southern (Hotham Place) elevation.

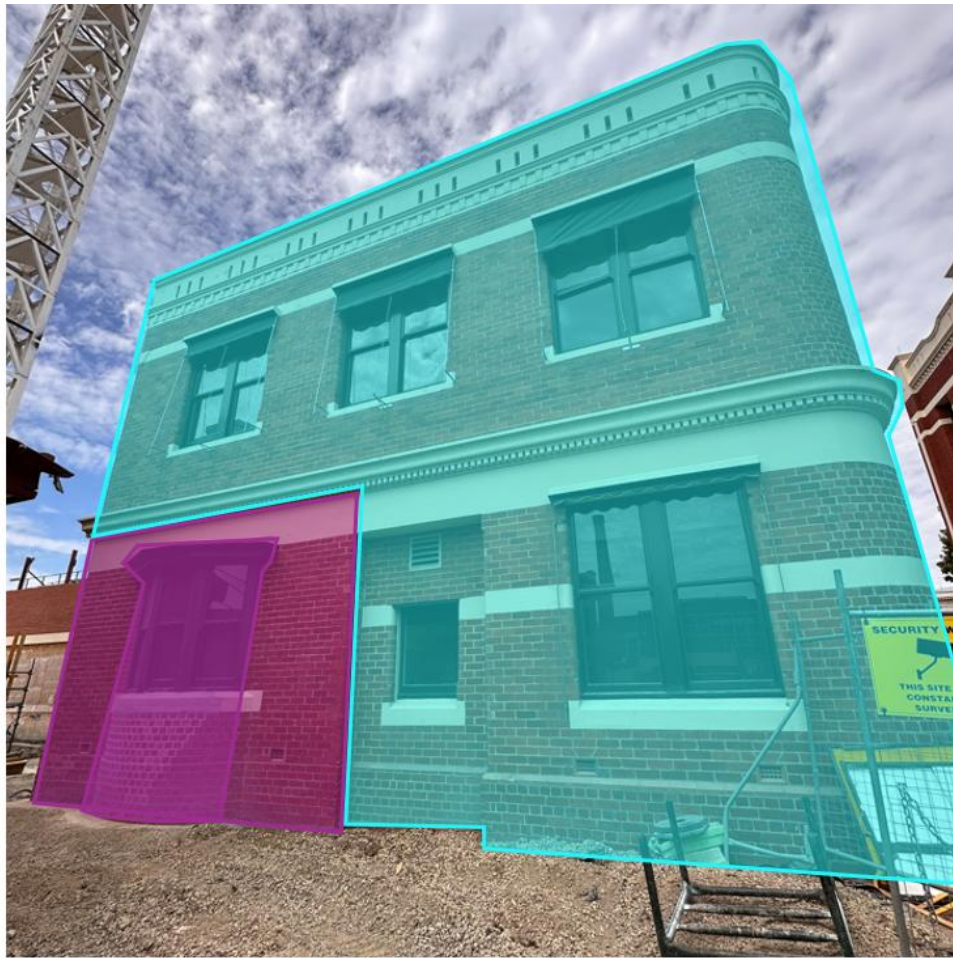
Figure 39: Phases of development at the former Administration Building - Western elevation.
