**VHR H0626**  
**Former Bryant & May Industrial Complex**  
**Administration Building (Building E)**  
560 Church Street, Cremorne

## **Heritage Impact Statement**

For Pitch Golf Pty Ltd  
**1 July 2026**

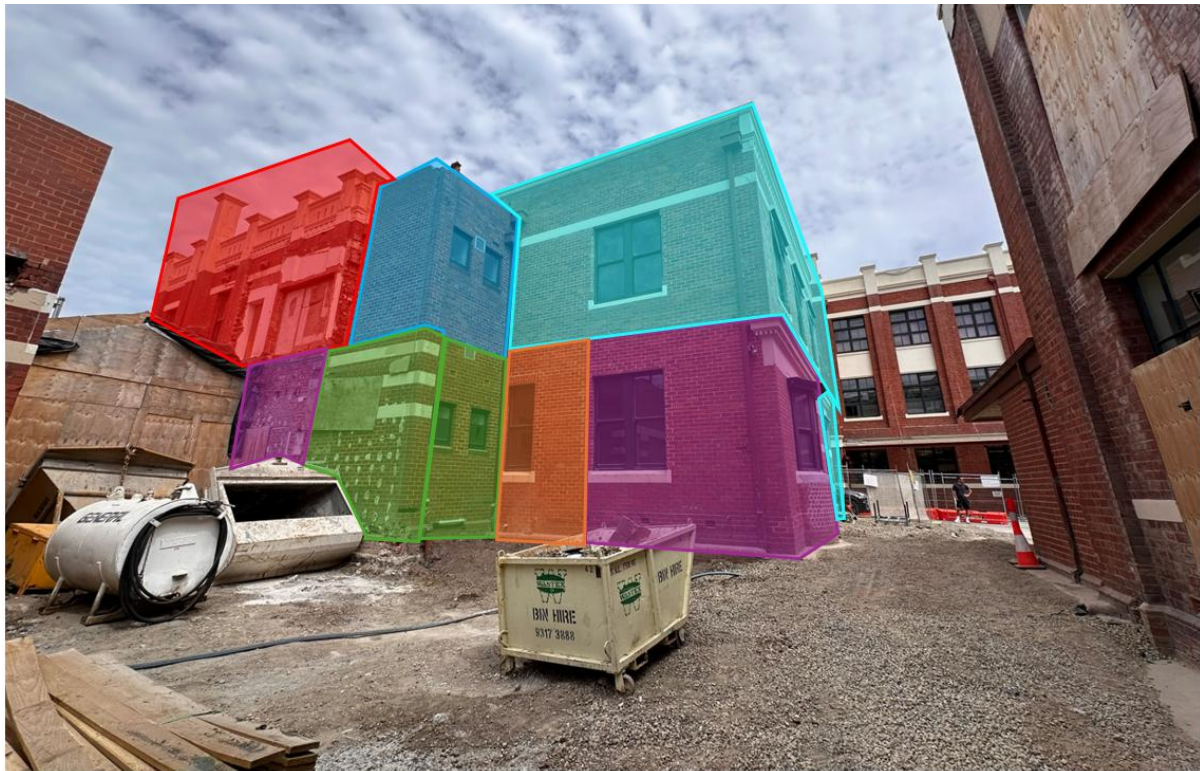
Figure 40: Phases of development at the former Administration Building - Northern elevation of offices and former dining room. Partially demolished boardroom to left of image with garage beyond.

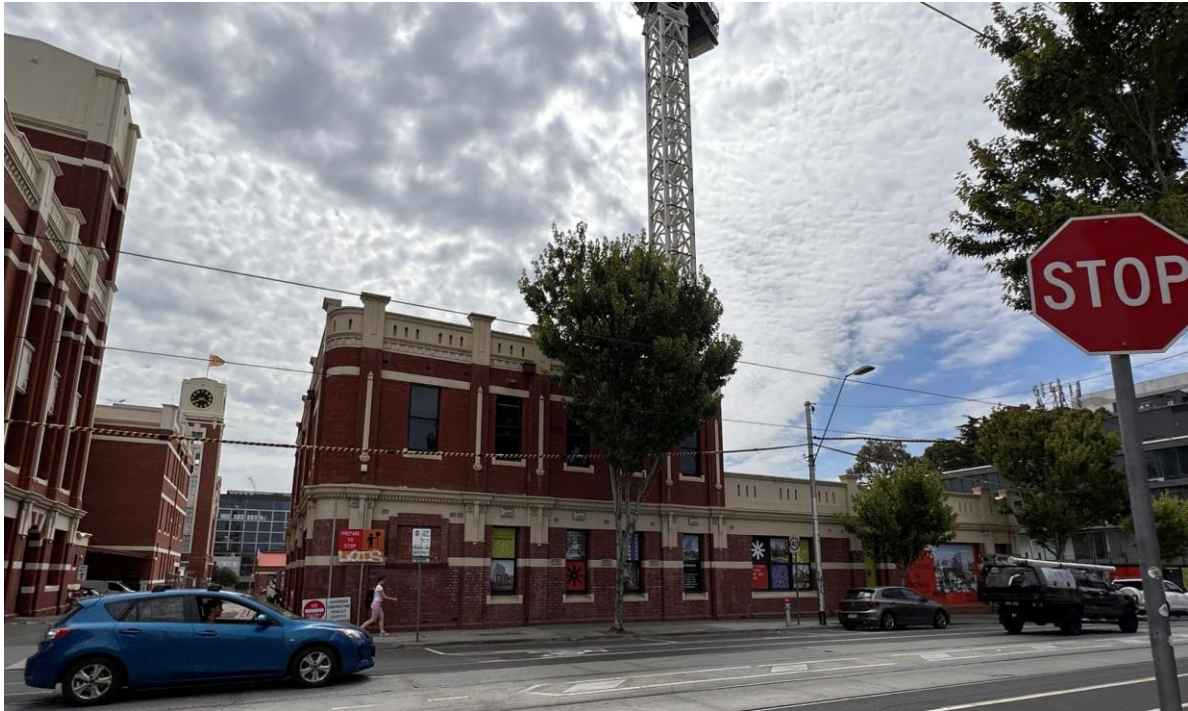
Figure 41: Church Street (eastern) façade of Administration Building showing double storey offices to left, single storey boardroom in centre and garage to the right.

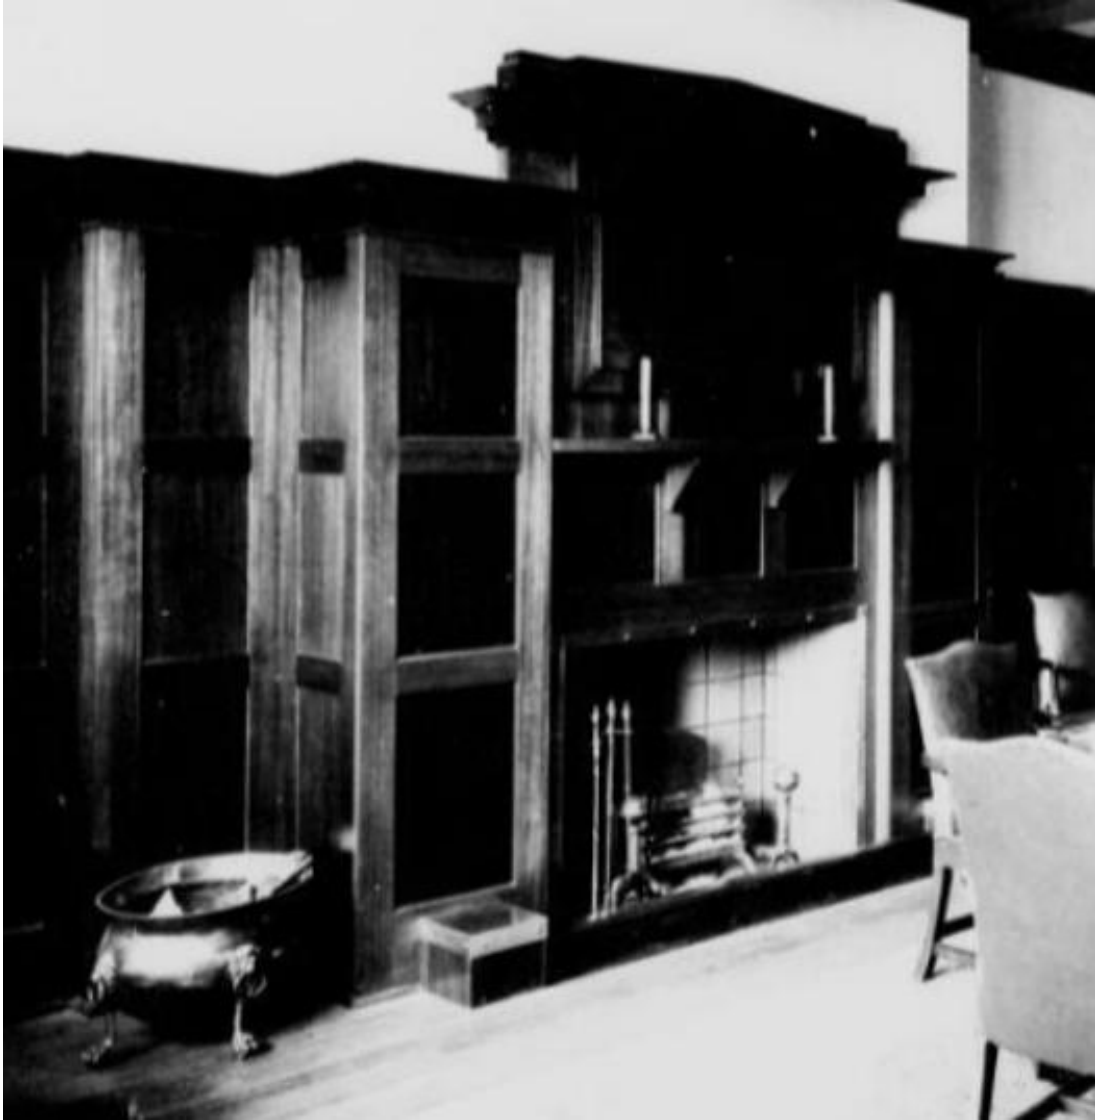
*Figure 48: Extract from photograph showing fireplace in boardroom c. 1924. (Source: Australia: Various Photographs of Empire Works, Showing Workers, Processes, Facilities, 1920s, NLA, D/B/BRY/3/2)*

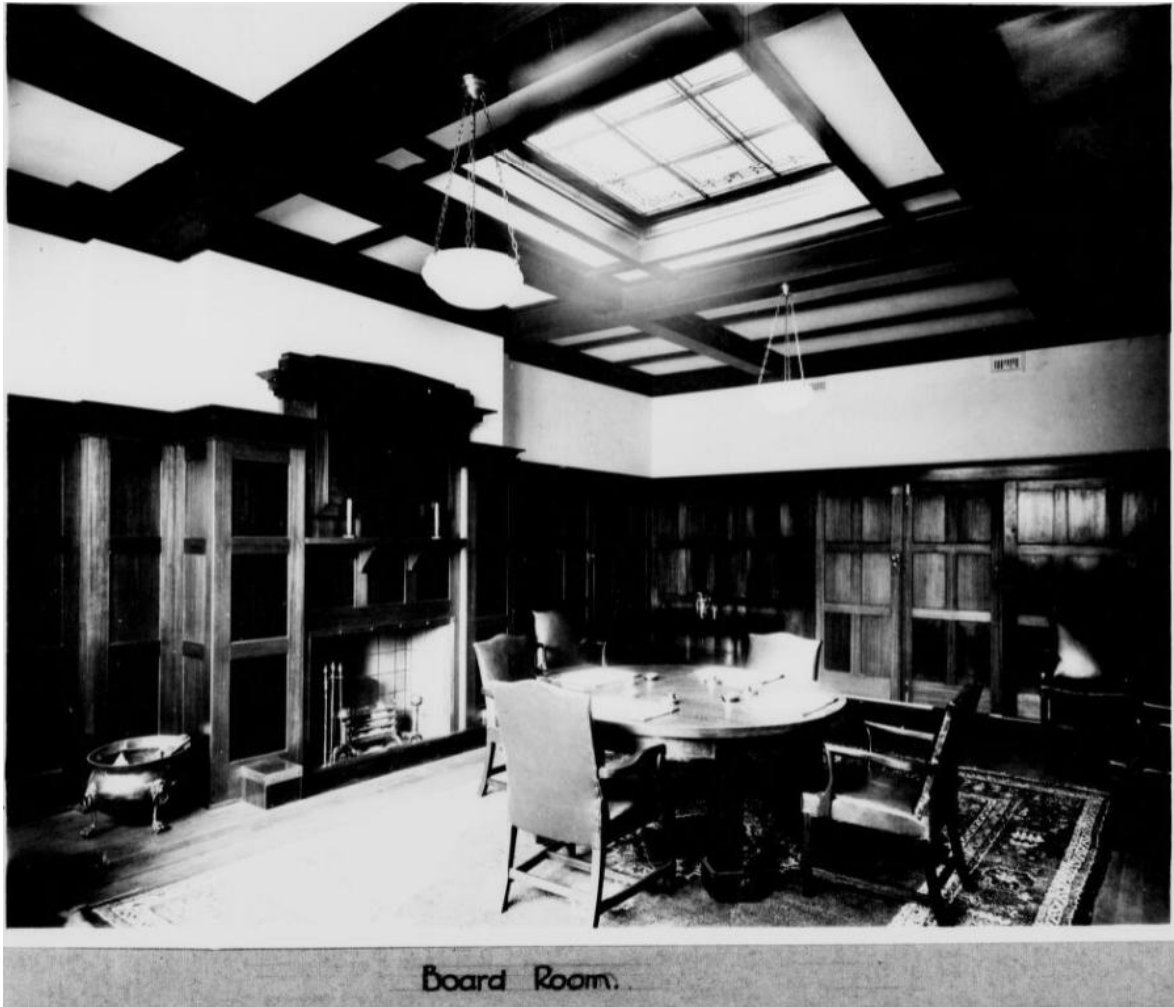
Figure 49: Photograph of the boardroom, taken in the 1920s. (Source: Australia: Various Photographs of Empire Works, Showing Workers, Processes, Facilities, 1920s, NLA, D/B/BRY/3/2)

Wall panelling in board-room and lobby 2 to be 1" framed seasoned Tasmanian Hardwood. Finish at top with ½" necking bead and 3" x 1" capping and bead under. New door between General Office and boardroom to be 6'10" x 2'10" Tasmanian Hardwood to match panelling and fitted with furniture.

Cover boardroom and lobby 2 floors with 4" x 7/8" T. & G. Crown brand Tasmanian Hardwood traversed and sanded smooth stained an oiled 1 coat and wax polished.

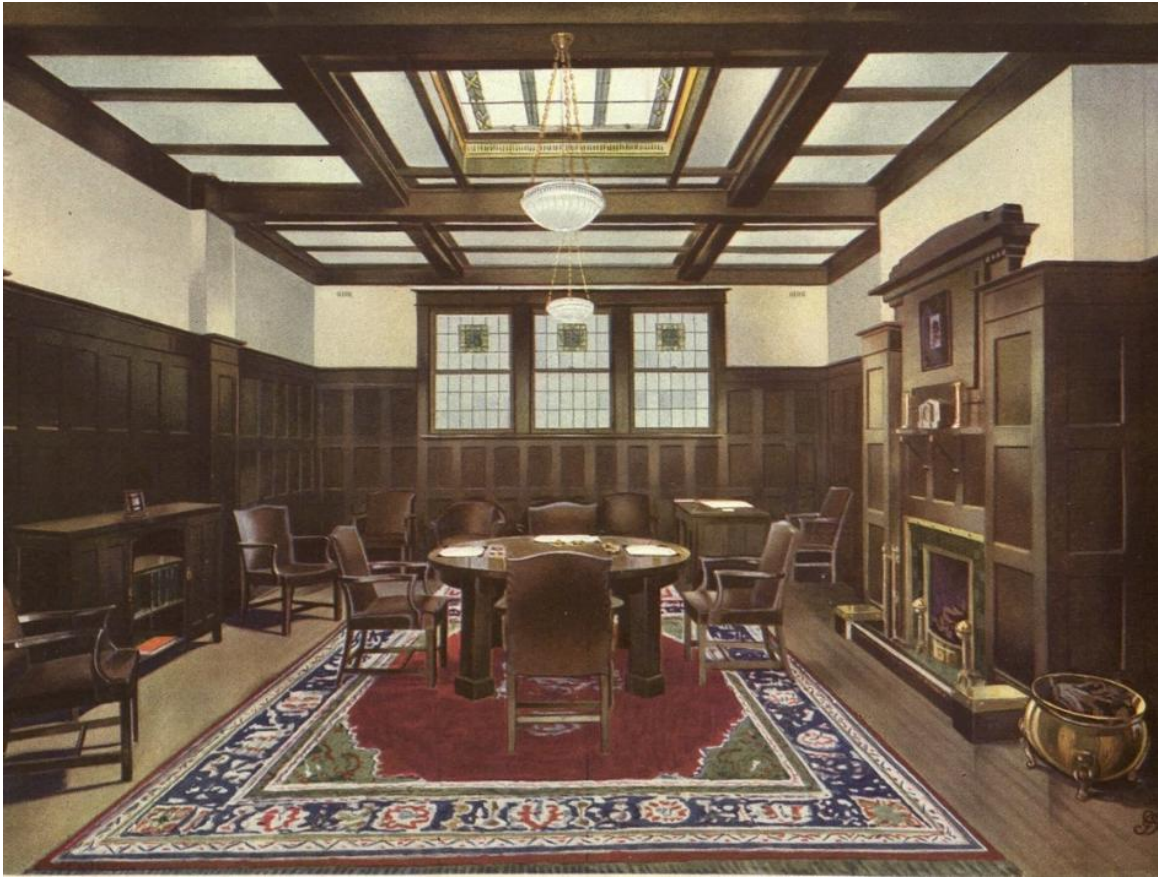
Figure 50: Drawing of the new boardroom, which adjoined the offices. (Source: *The Matchmakers: A Story of Real Life*, Bryant & May, 1925, SLV, 662.5 B84M)

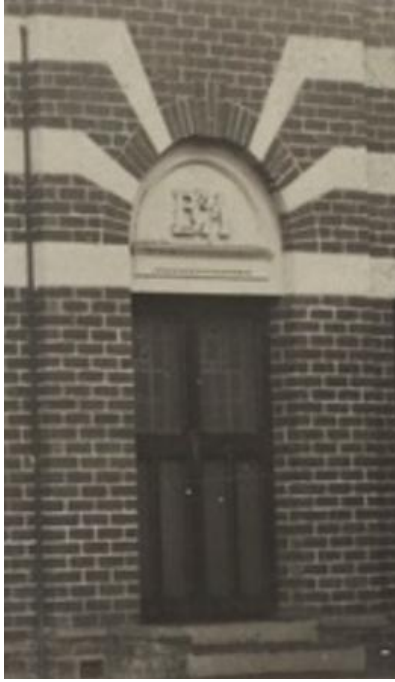
*Figure 51 (Left): extract from photograph showing external door to Lobby2. Source: Exterior View Showing Courtyard Behind Church Street Facade, 1920-6, SLV, H92.401/9)*

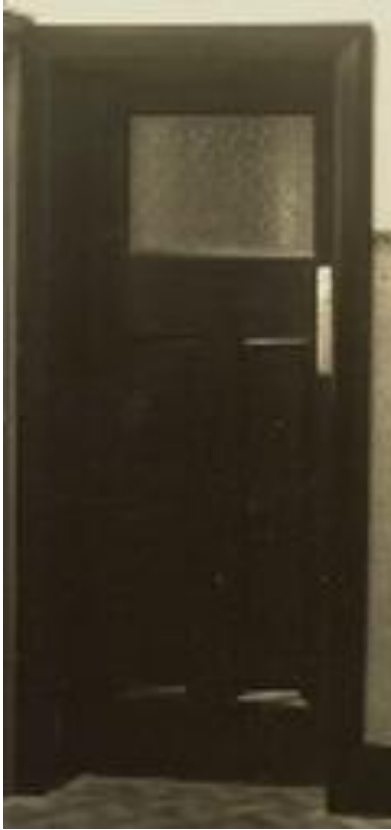
*Figure 52: Extract from photograph (likely in the office) showing same details as specified Lobby 1 door. Source: Office Area of Factory, Probably Bryant & May, Algernon Darge, 1920-30, SLV, H92.401/345.*

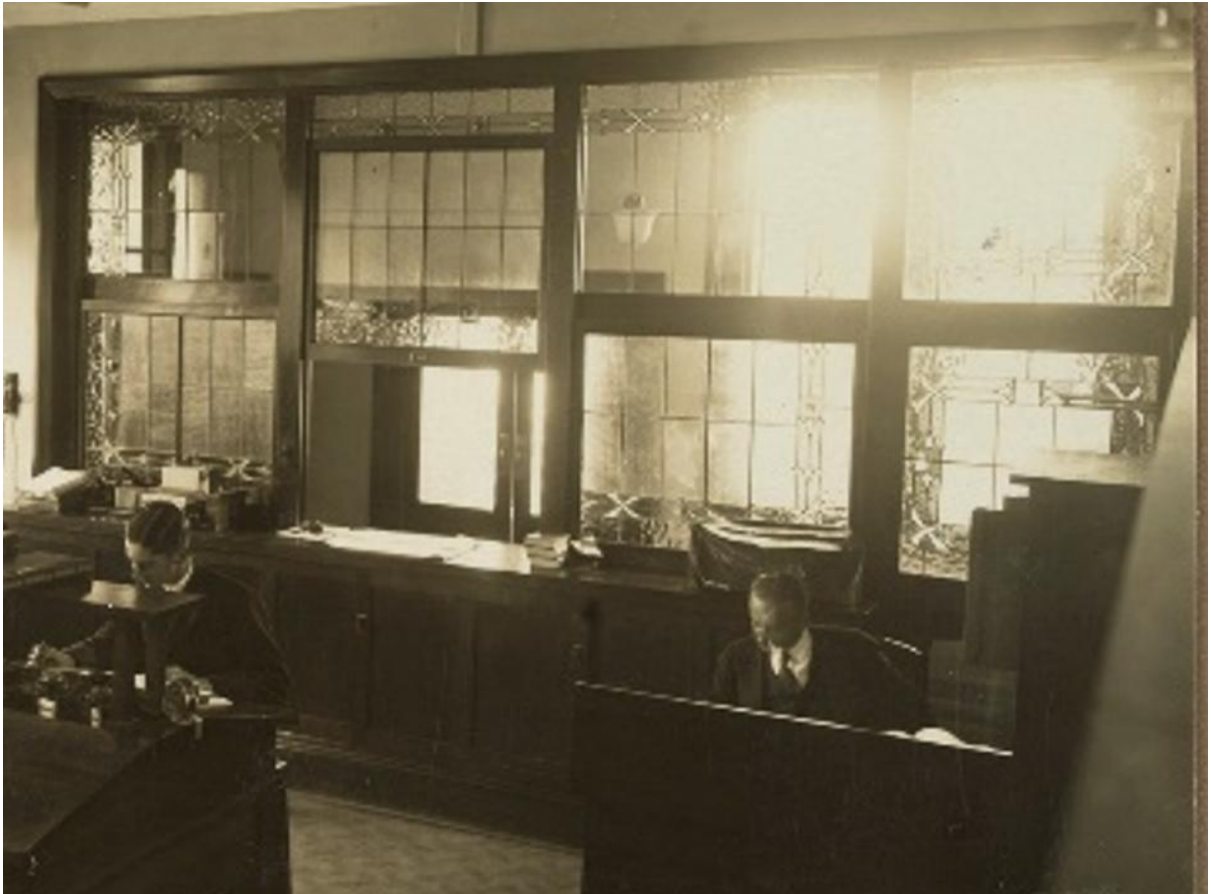
*Figure 53: Extract from image of the office area showing partition at entrance lobby c.1927. (Source: Men at Work in Office Area of Factory, Probably Bryant & May, c1927, SLV, H92.401/343)*

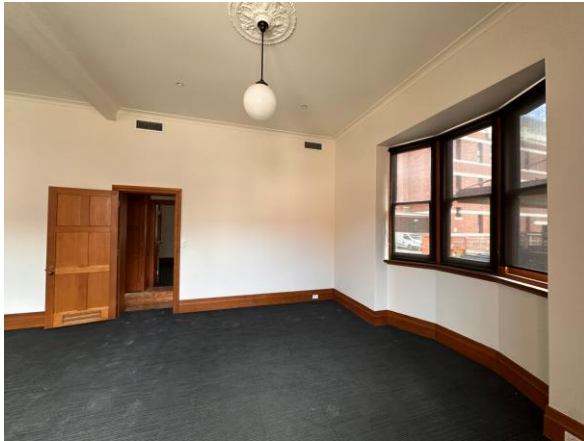
*Figure 81: Room 5 - former dining room extension (1922-1924) - looking southwest.*

Whilst partial removal of original and early fabric is not ideal, the existing fabric is utilitarian having contemporary plaster and timber finishes. Importantly, the original wall alignment would be retained and remain interpretable above the door openings.

Accordingly, the impact of the proposed removal of original and early fabric is very low and is not considered harmful to the historical, architectural or social significance of the place.

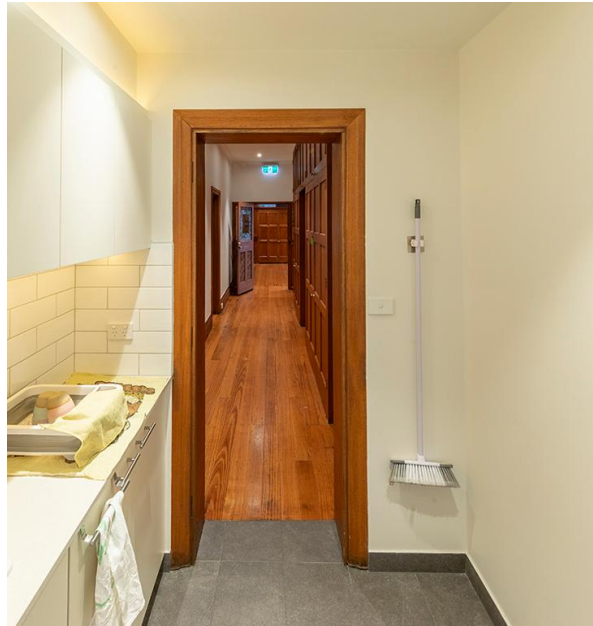
*Figure 82: Room 4 - looking east towards c.1925-1928 wall. Source: Alfasi Property Group, photographic survey for P37853, 2024.*

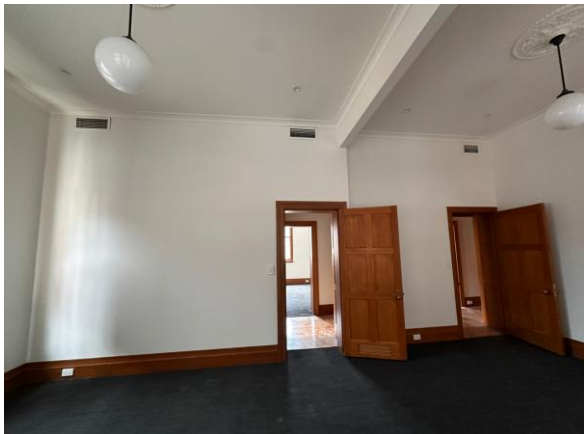
*Figure 83: Room 3 - c.1942-1950 office addition - looking north.*

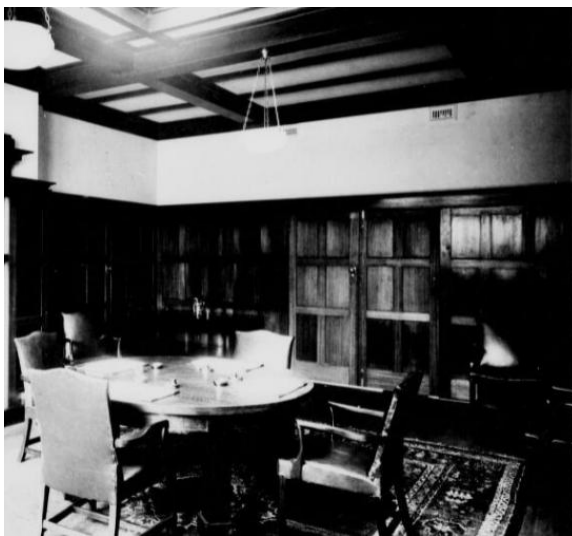
Figure 84: Photograph of the boardroom, taken in the 1920s, showing original western wall. Source: Australia: Various Photographs of Empire Works, Showing Workers, Processes, Facilities, 1920s, NLA, D/B/BRY/3/2.

The proposal seeks to relocate 6-panelled timber doors from rooms 3 and 5 on the ground level. Unless the ED is aware of original boardroom doors having been securely stored, it is recommended that the doors from rooms 3 and 5 be relocated to the western wall of the proposed members lounge, as they are closer in design to the original doors than the glazed ones extant in the decorative partition wall.

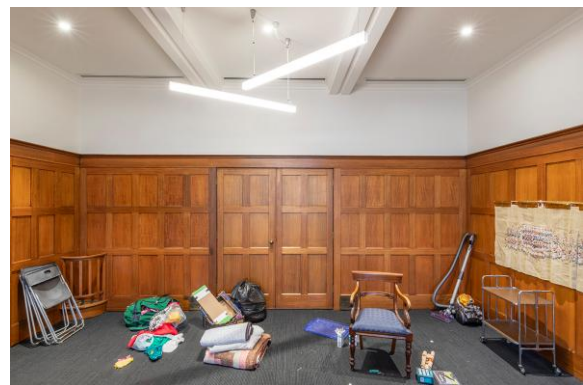
Figure 85: Western wall of former Boardroom in 2024. Source: Alfasi Property Group, photographic survey for P37853, 2024.

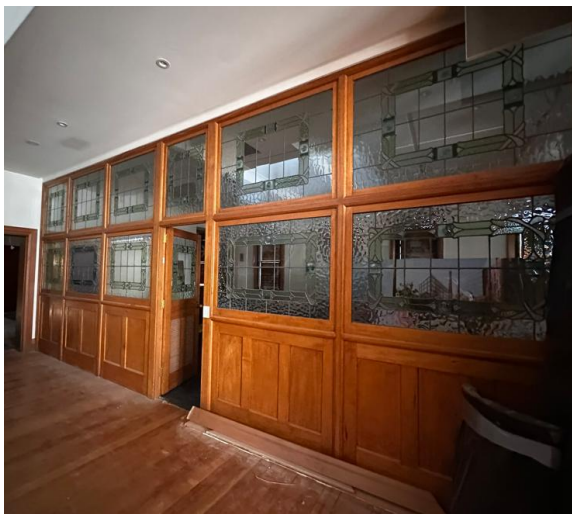
Figure 86: Decorative partition walls as extant.

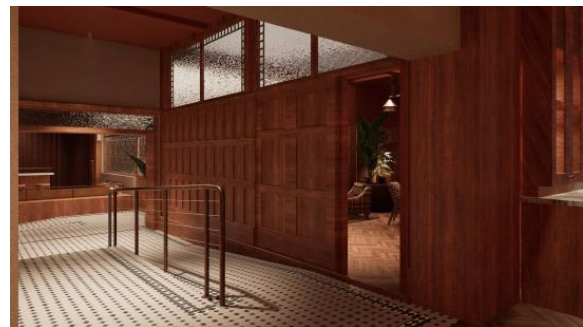
Figure 87: Extract from application documents showing proposed reinstated western wall of former boardroom.

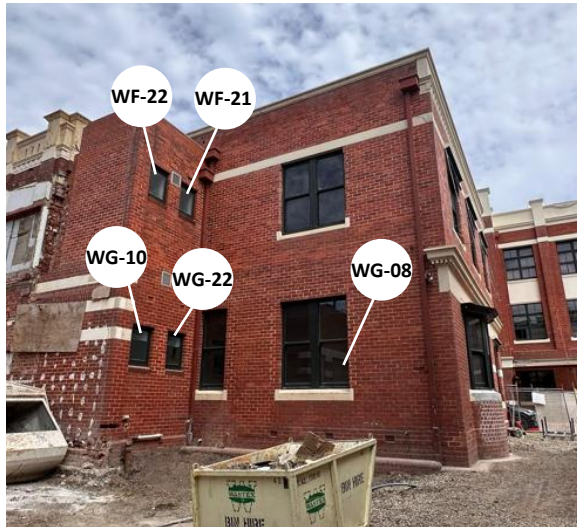
Figure 88: Subject site as seen from the northwest showing affected windows. Note that existing window between WG-22 and WG-08 has been approved under previous permit for conversion into door.

All proposed bathroom and kitchen windows (WG-04, WG-05, WG-07, WG-08, WG-09 and WG-10 on the ground floor; and WF-21 and WF-22 on the first floor) will receive a removable opaque privacy film. The biggest impact would be to windows WG-04, WG-05 and WG-07 which are public realm (south and west) facing windows. However, the opaque film will not have any more visual impact than internal window furnishing. As per existing conditions, the reflective glass in these windows will simply

Whilst an internal wall is proposed across half of WG-08, and across both WG-09 and WG-10, these windows face out to a utility / bin storage area. The wall in front of WG-09 and WG-10 is also an existing condition.

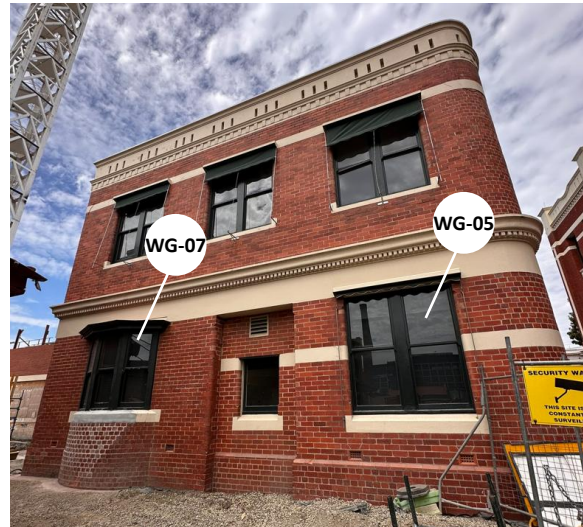
Figure 89: Subject site as seen from the west showing affected windows.

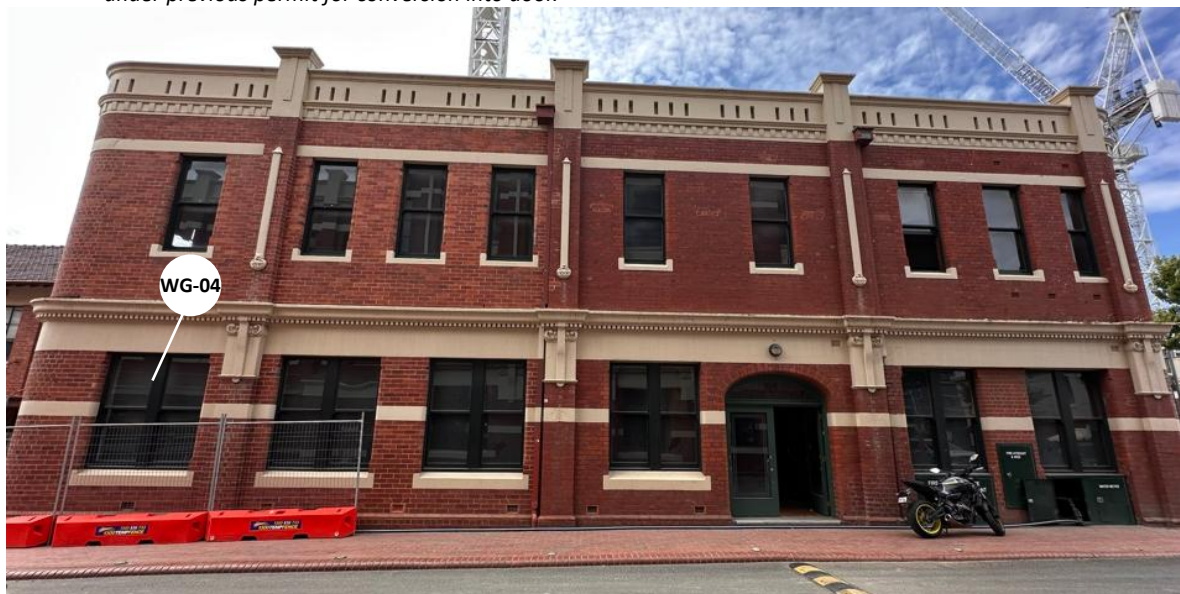
Figure 90: Subject site as seen from the south showing affected window.
