## Former Royal Mint – Letter of Archaeological Advice

This letter constitutes the preliminary archaeological advice for The Former Royal Mint (H0770) and Royal Mint (H7822-0132) ahead of Hellenic Museum Pavillion works at 280-318 William Street, Melbourne. The proposed works comprise the replacement of the current concrete slab with a similar slab incorporating cantilevered edges. It is anticipated that the works will require the removal of 200mm of ground disturbance.

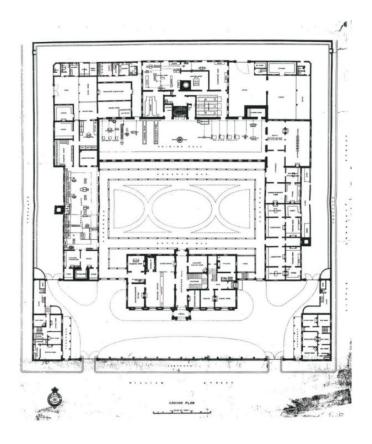
Figure 1: 1870 J. J. Clark Architectural Plan showing the central courtyard within the quadrangle. Source: Public Works Department Archives. held by the former Department of Infrastructure Records Office, cited in HLCD, 1999: Appendix 2, figure 13

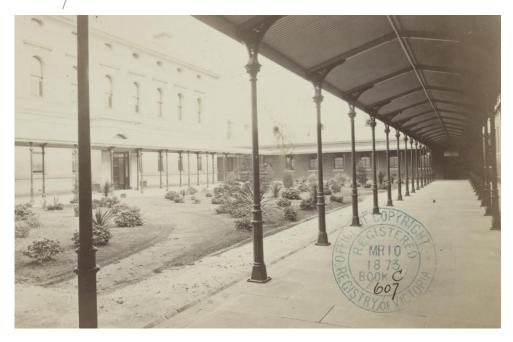
Figure 2:1873 C. Nettleton Photograph, 'Quadrangle looking North West of Royal Mint". Source: SLV

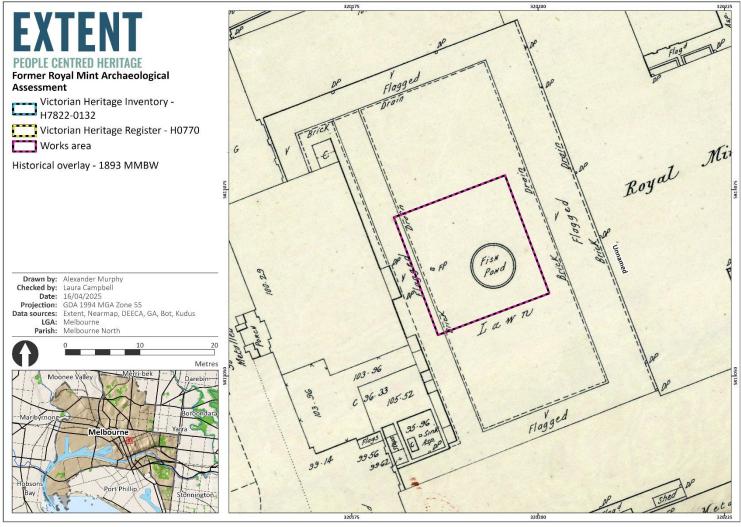
Figure 8: Historical Overlay showing works area in red and the 1885 Melbourne Metropolitan Board of works Plan.

During the construction of the M pavilion in 2015 a fountain/ fishpond feature was unearthed and recorded by AHMS archaeologist, Adrian Burrows (AHMS 2015, p. 1). The location of the feature was "further north of that shown on the MMBW plan, centred on the rear exit of the former Mint administration building, whereas that shown on the MMBW plan was noticeably 2-3 metres off-centre to the south." (AHMS 2015, p. 2). The distance between the fishpond and the rear exit of the former Mint administration building was noted to correlate precisely at 8 metres. Figure 8 shows an overlay of the MMBW plan and the works area supporting this assessment.

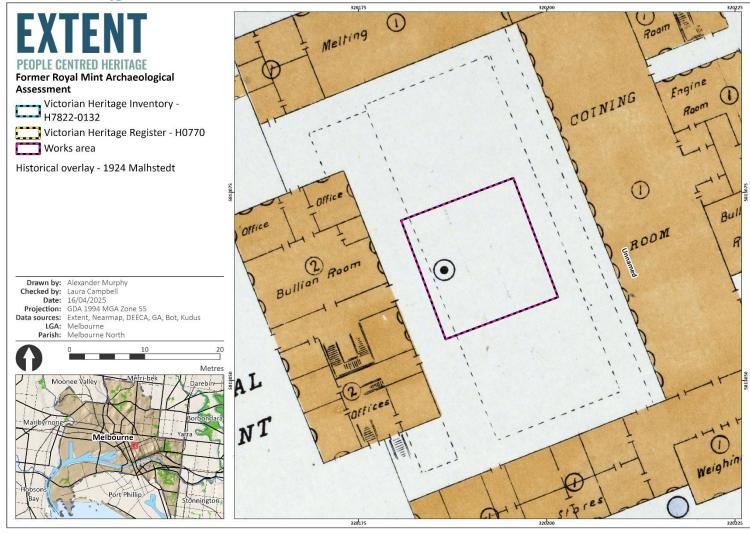
Figure 9: Historical Overlay showing works area in red and 1924 Mahlstedt Fire Insurance Plan:

Exhibition Building. Figure 9 shows that the pond feature is aligned with the rear threshold indicating that the structure and central courtyard gardens underwent a number of changes throughout the late nineteenth and early twentieth century.

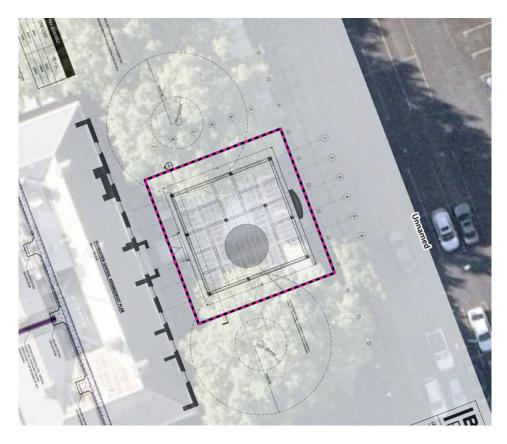
Figure 10: Overlay of works area with current ground layout. The pond feature is shown in dark grey.

It is anticipated that 200mm of fill will need to be removed in the area of the slab measuring approximately 10m by 10m, likely through mechanical excavation. The new ground slab configuration is anticipated to be N12-200 top and bottom, both directions on 0.2mm polythene membrane over 50mm sand bed and utilise the foundation trenches and piles associated with the old pavilion structure. A Geotechnical Consultant may be required to conduct a foundation investigation to ascertain depth and condition.
