Heritage Impact Statement for: **St Kilians Catholic Church Complex** **173 McCrae Street and 2 Havelock Street, Bendigo**

This Heritage Impact Statement forms part of a permit application for:

Partial demolition of existing buildings, structures and landscaping and works associated with the extension and modification of the adjoining school playground.

16 February 2025

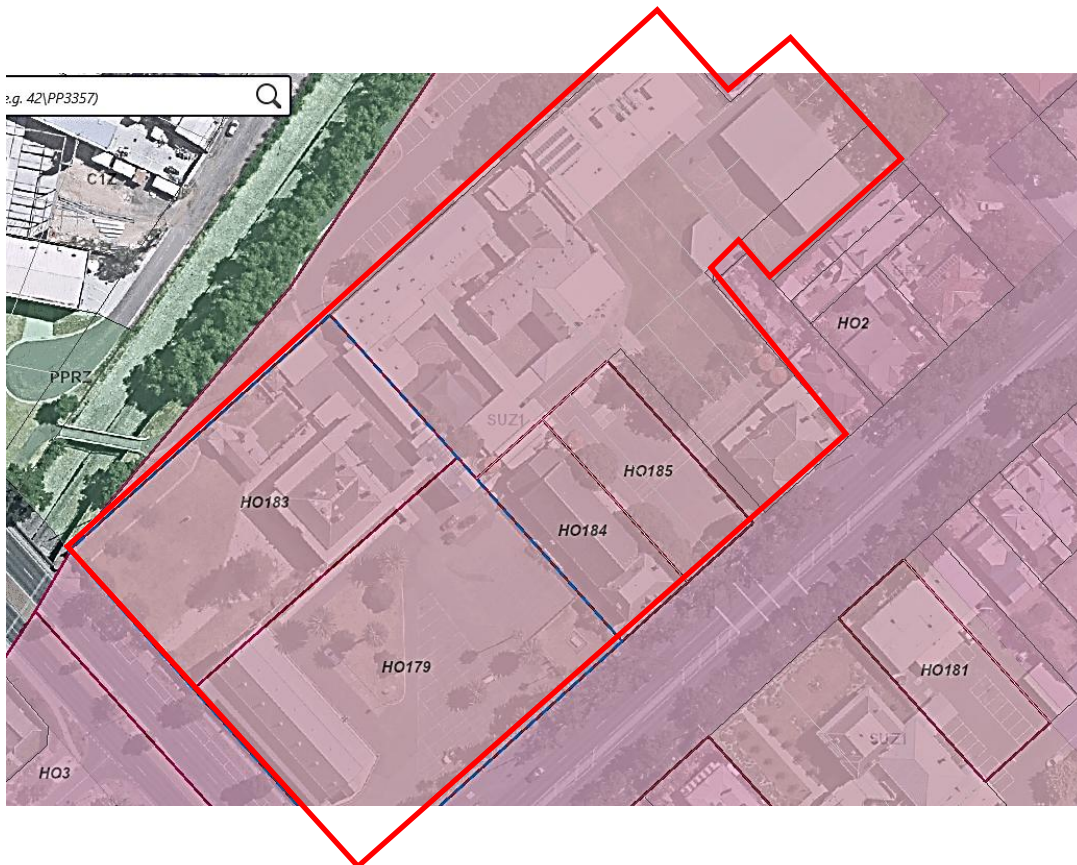
Image 1: Site plan showing the various heritage overlays that apply to the St Kilian's Catholic Church Complex which is outlined in red.

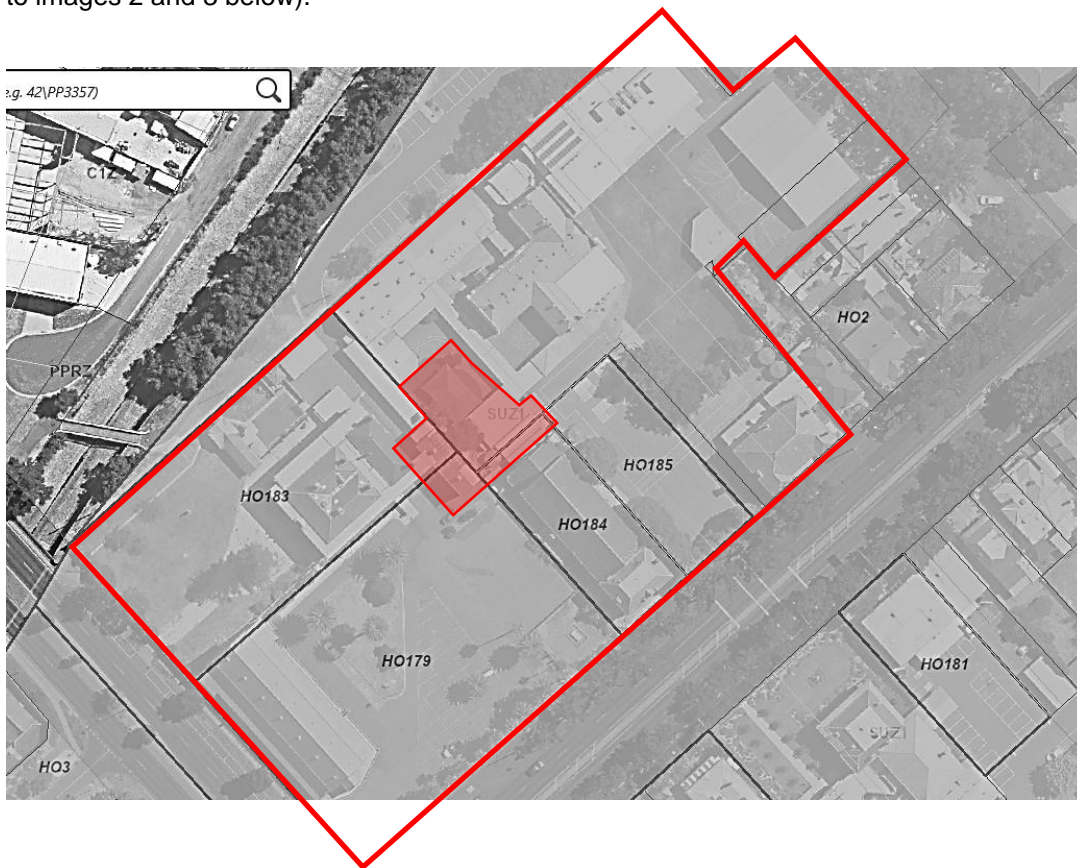
Image 2: Area of land associated with the proposed works shown shaded in red above

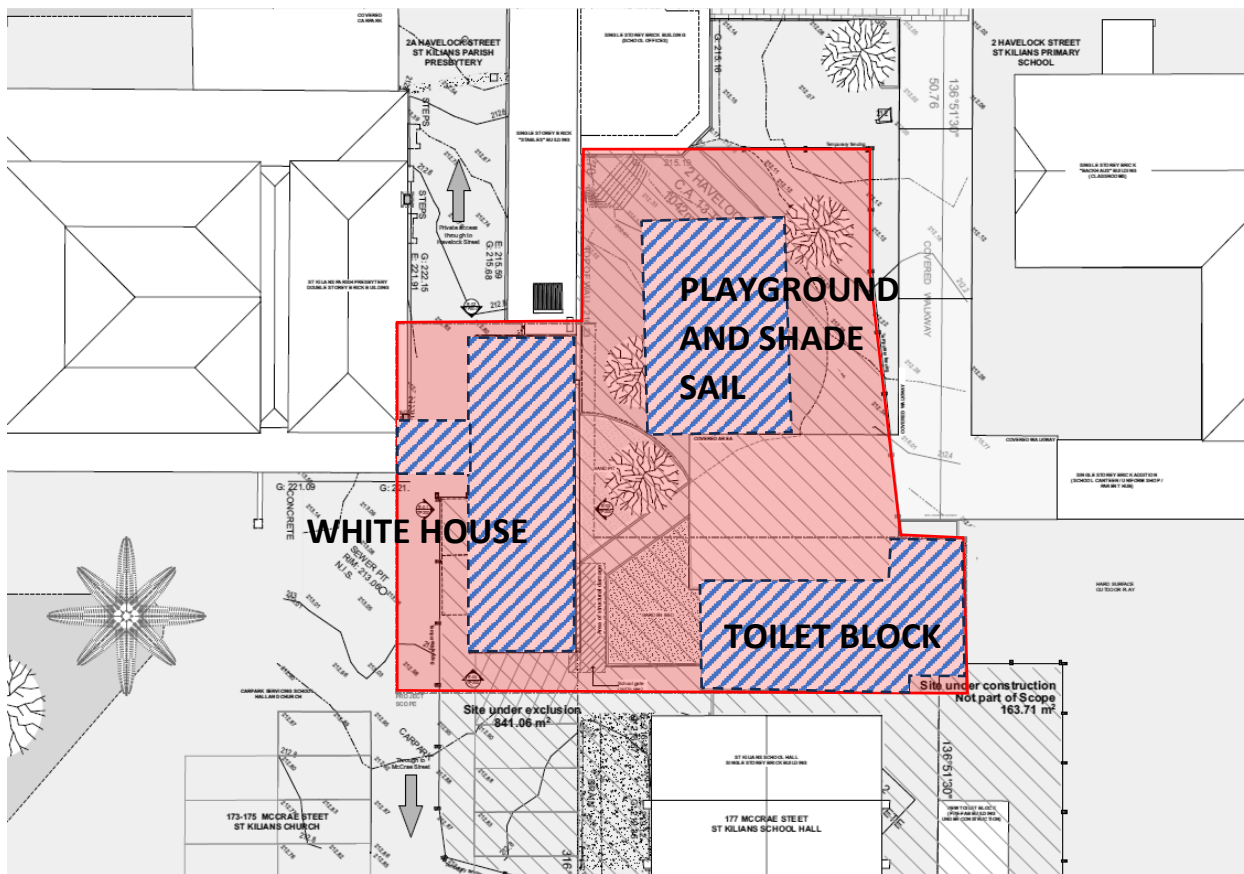
Image 3: Detail of area affected by the proposed works shown in red above. Buildings/structures to be demolished hatched in blue.

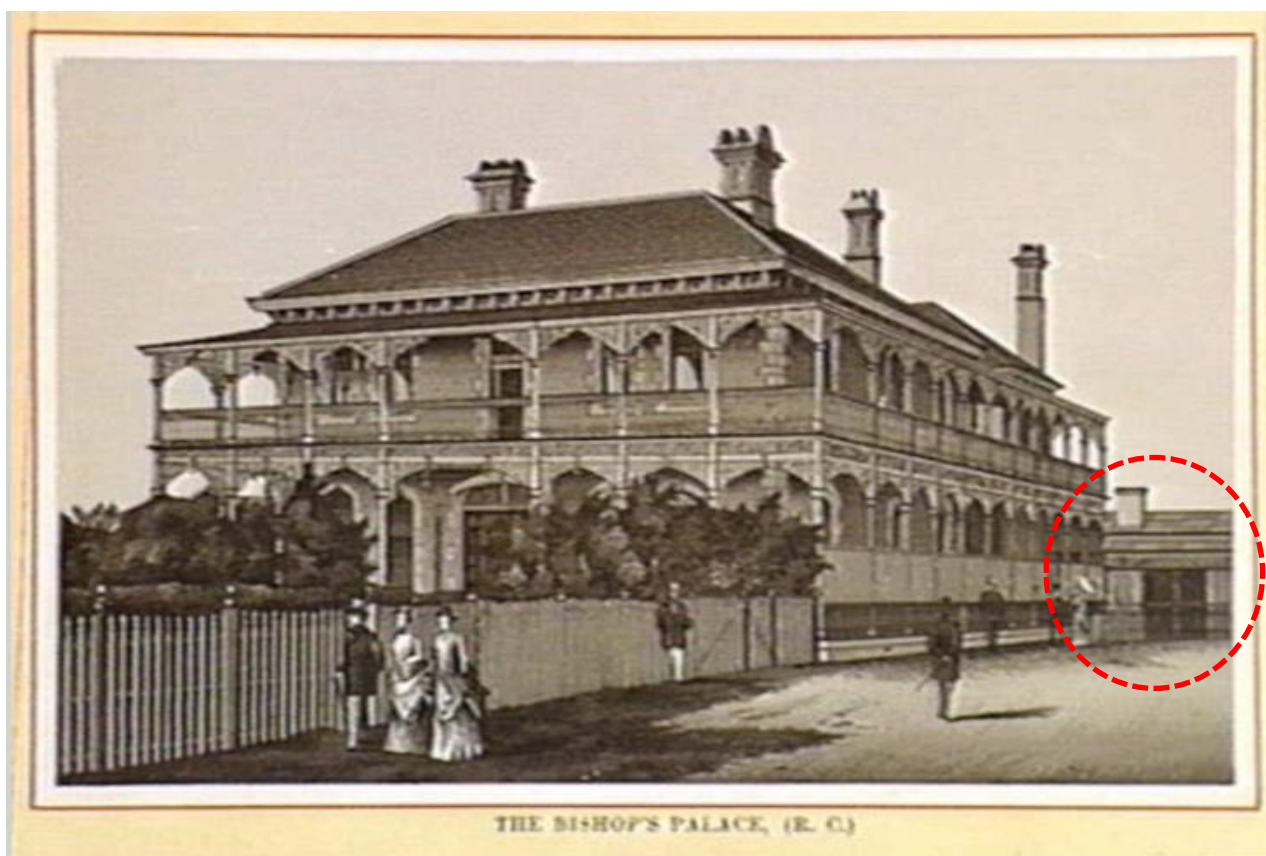
THE BISHOP'S PALACE, (R.C.) [BENDIGO] [picture]. (1881). [<http://handle.slv.vic.gov.au/10381/4268818>]

The image above shows a single-storey building at the rear of the main building (shown circled in red above). This is not the same building that currently exists in this location.

The earliest known reference to the building known as "The Bishop's Palace" (also HO183 - 173 McCrae Street, Bendigo, St Kilian's Hall) is from an album of lithographs based on photographs, dated 1881. The photo shows a well-established two-storey Victorian style building with a decorative iron verandah and balcony and a mature front garden. A single-storey building is shown at the rear of the main building however this is not the same building that currently exists in this location.

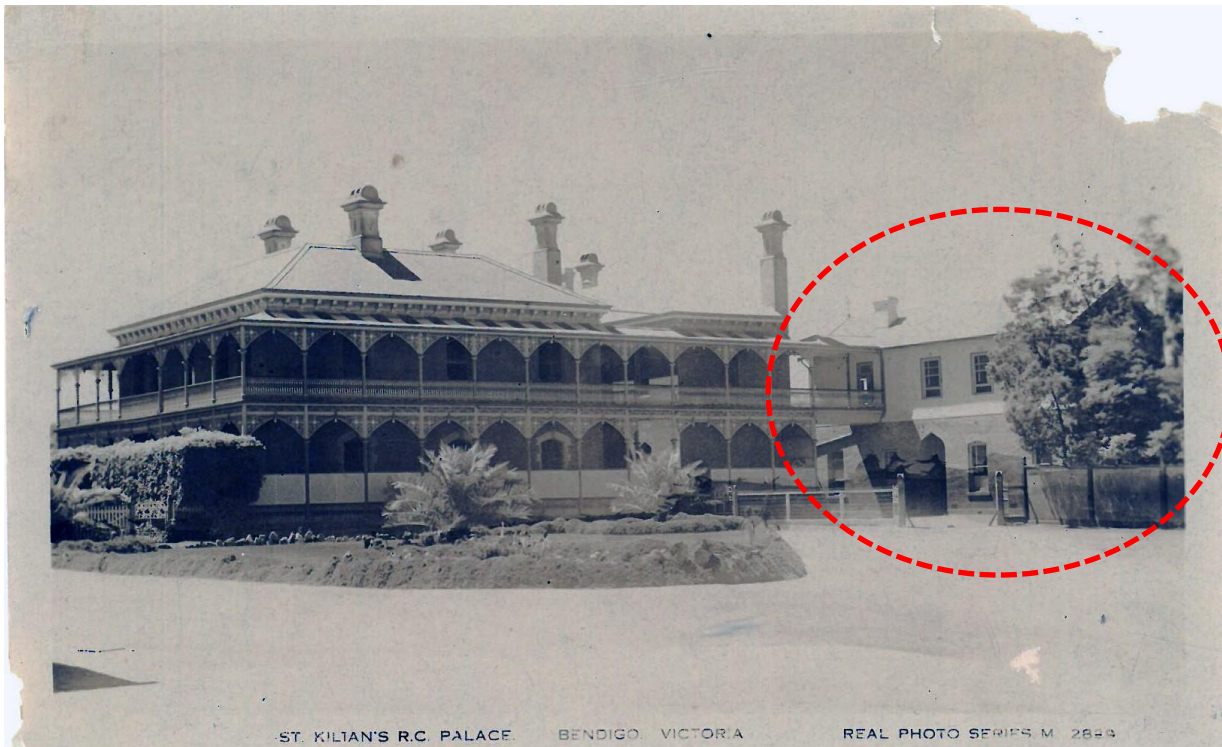
It is estimated that the image above was taken c.1913-1927. The building circled in this photograph is the same as the subject building.

The original purpose of this building is unknown however it is clearly associated with the presbytery building not the actual church itself. In recent times it is believed to have been used as shared accommodation for visiting seminarians.

The White House first appears as a two-storey building in a photograph taken c.1913-1927 although it appears to have been a modification of the earlier building. The original purpose of this building is unknown however the pedestrian link to the main building at the first floor level clearly confirms that its use was associated with the main building.

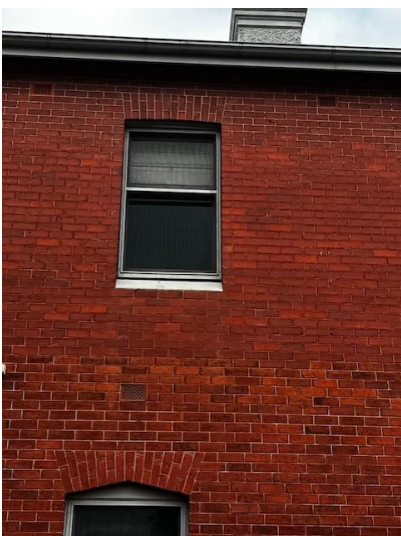
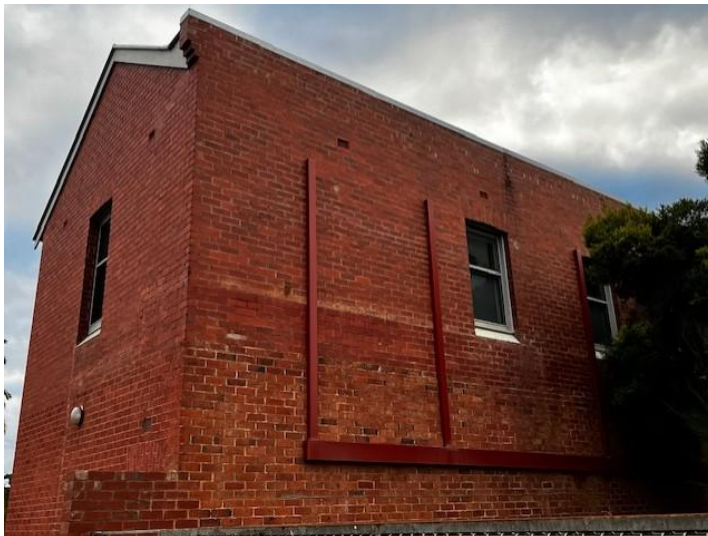
The ground floor level and the upper floor level are constructed of slightly different coloured bricks. The images below show that while the difference in bricks is subtle at the front (southwest elevation), it is more prominent at the rear facing the school.

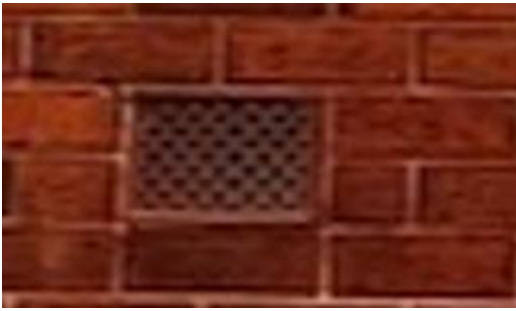
The air vents fitted to the ground floor level are cast iron (see below), which are Victorian in style. These indicate a construction date prior to 1900.

The use of two different air vents in a single elevation is clear evidence that the ground level and the upper floor level of this building were built at different times.

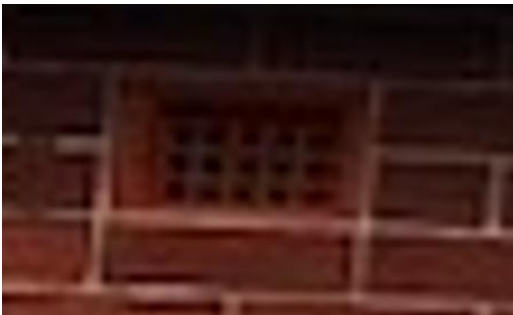
The air vents to the upper floor level are terracotta. These indicate a construction date from the 1920s.

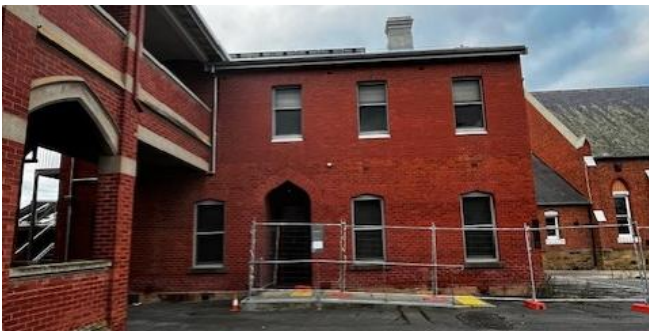
The ground floor level window and door openings are different. Those at the ground level have pointed arches that match the openings of the main presbytery building. The shape of these openings is indicative of the work of W.C. Vahland, who was identified as the architect in the tender posted in 1891.

The upper-level openings are slightly arched. This confirms that the top and lower floor levels were most likely not built at the same time.

Both the upper and lower floor levels have double-hung timber framed windows that match. These frames were most likely all installed at the same time, but on the basis that the ground floor level is believed to be earlier, it is likely that the existing window frames at the ground level, have been replaced. It is indeed possible that all the timber window frames have been completely replaced at some time.

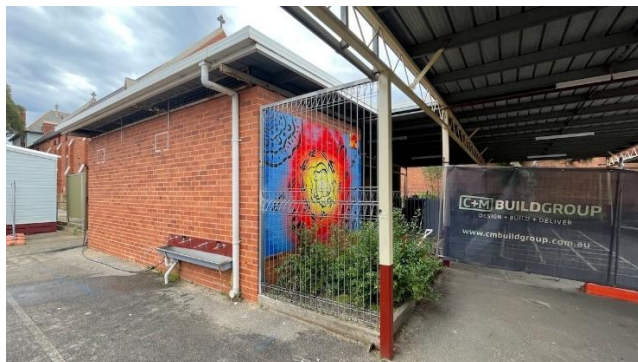
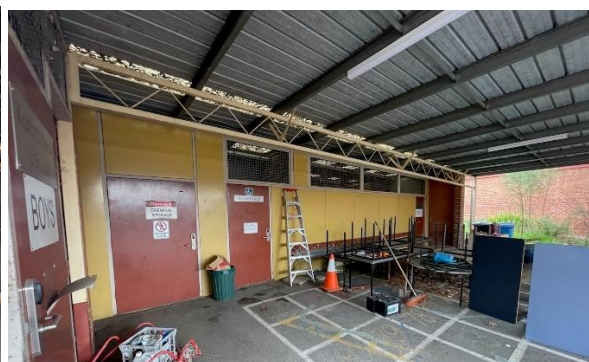
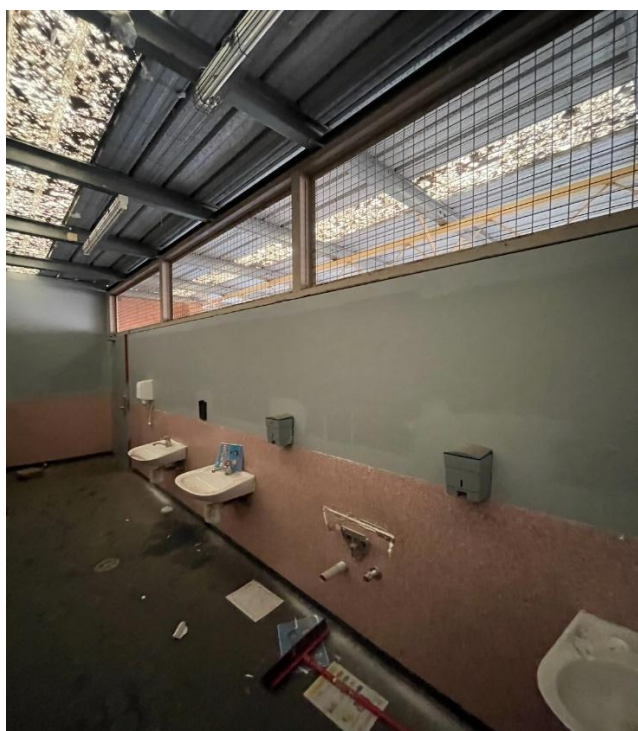
The existing toilet block is of no heritage value. It is a rudimentary brick structure with a flat roof that was probably constructed c.1970s/80s. A large flat roofed area is attached to the north side of the toilet block to provide under cover area to the playground.

The toilet block has been deemed unfit for use and has been partially dismantled for some time.

It is considered that the toilet block and the playground make no contribution to the significance of St Kilians Hall (HO184) or the broader Baxter Street heritage precinct (HO2).

The demolition of these non-contributory elements will have no impact on the significance, character or appearance of St Kilians Hall (HO184) or the broader Baxter Street heritage precinct (HO2) as neither of these elements are visible from the principal street frontage of the site in McCrae Street.

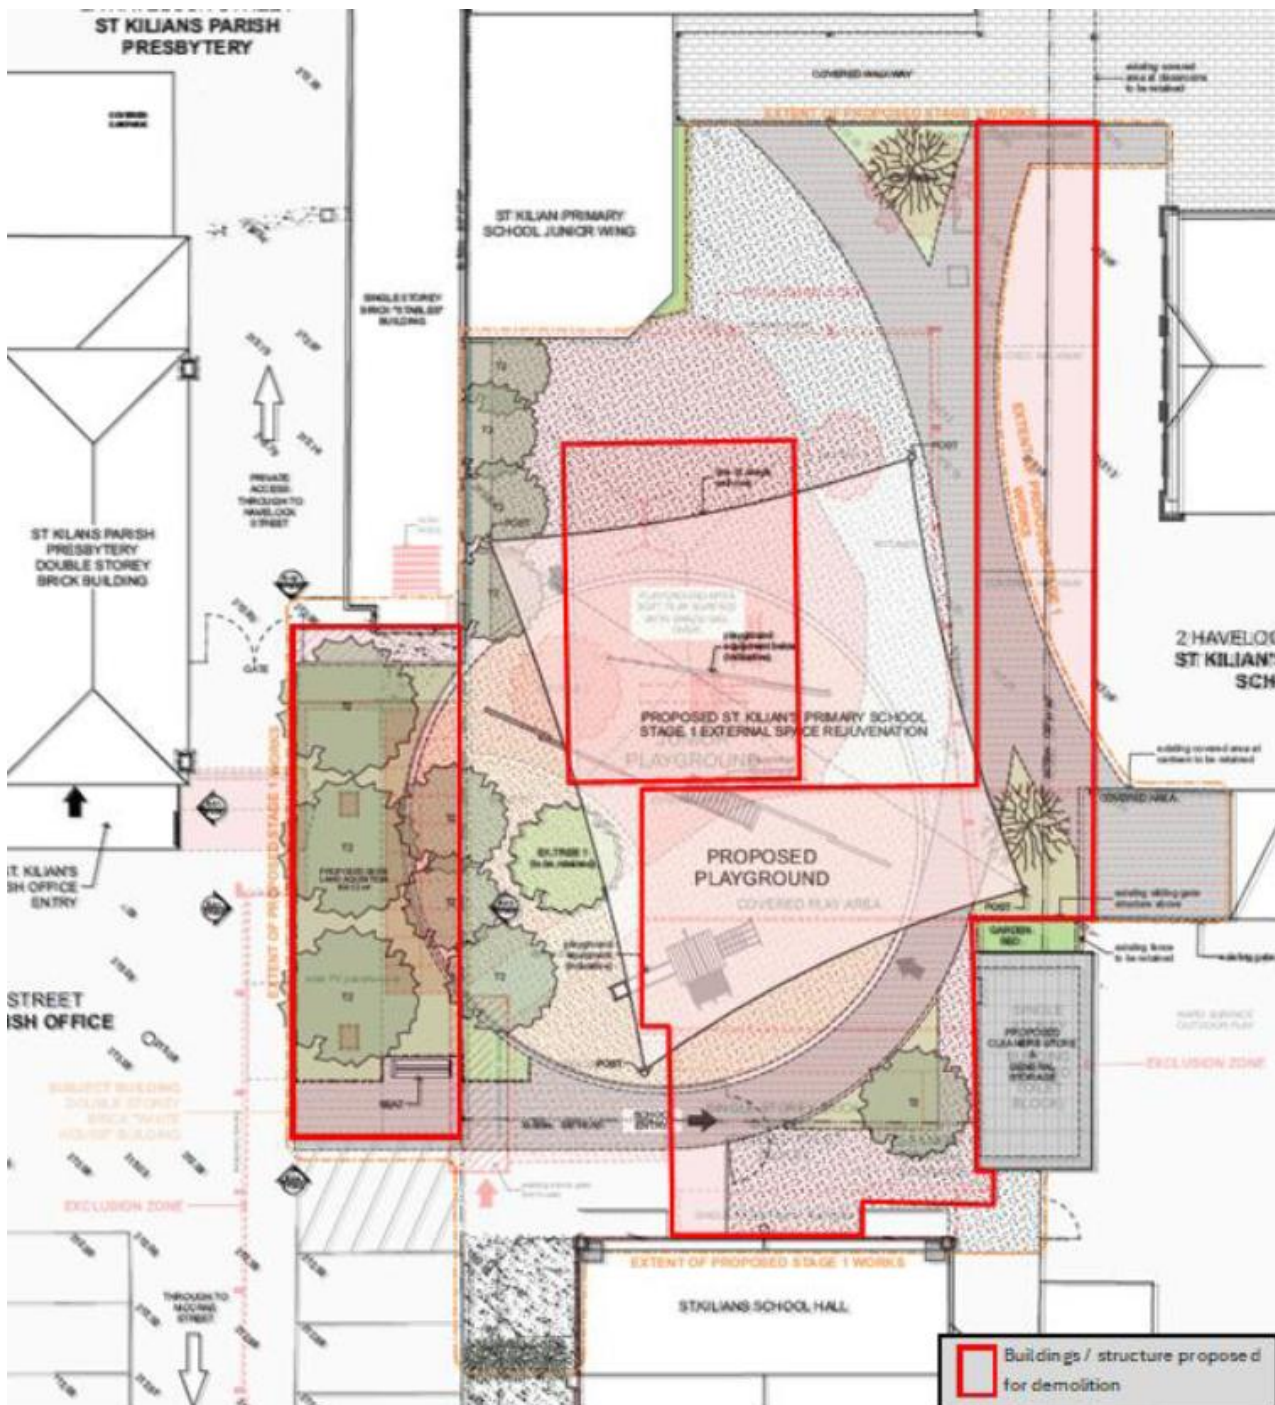
Image 4: Extract from proposed redevelopment and extension of the school playground area.

Following the demolition of the White House, the associated stairs and covered walkway linking it to the Parish Presbytery building, the subject land will be amalgamated with the adjacent school playground area. Redevelopment and extension of the existing school playground will be in accordance with the plan shown below (refer to image 4).

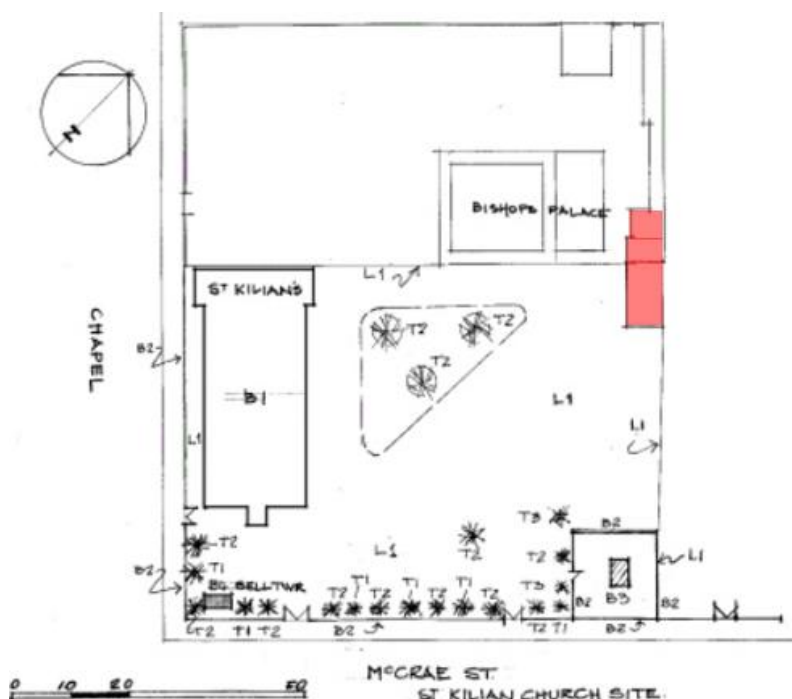
Image 6: Diagram 600048 showing the extent of land and various elements included on the Victorian Heritage Register. Subject building is highlighted in red. It is not identified as a building of heritage interest.

The White House is directly associated with the St Kilian's presbytery, identified in Image 6 above as the Bishop's Palace which is within both HO2 and more specifically HO183 of the Greater Bendigo Planning Scheme. The land associated with St Kilian's presbytery is not included on the Victorian Heritage Register.

Part of the White House extends onto the land associated with the adjacent St Kilian's church which is included on the Victorian Heritage Register (No H1341 - St Kilian's Catholic Church). The White House is not identified as a significant building. It is therefore considered that it does not contribute to the significance of the church itself.

As the White House is considered a non-contributory building, the demolition of this building will have **no effect** on the cultural heritage significance of the registered place (St Kilian's Catholic Church) if the proposal were to be approved [s101(2)(a)].
