GEOTECHNICAL INVESTIGATION REPORT

PROPOSED STUDENT ACCOMMODATION DEVELOPMENT

253-259 BRUNSWICK ROAD

JOB NO: 8257-2-R

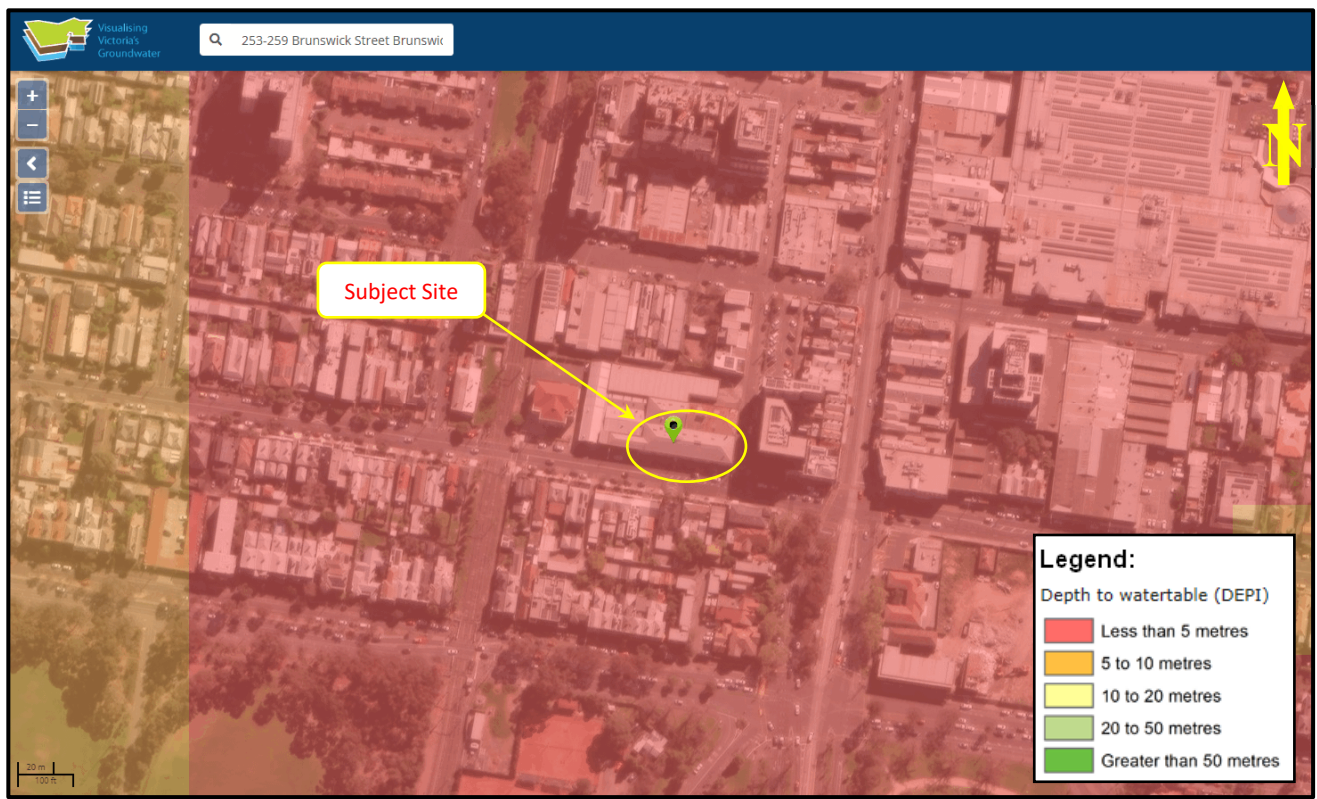
FIGURE 1.5.1: Screenshot from the Visualising Victoria's Groundwater Website

Reference to Visualising Victoria's Groundwater website (www.vvg.org.au) indicates the depth of the ground water table to be less than 5 metres below the ground surface at the subject site.

A screenshot of the plan extracted from the Visualising Victoria's Groundwater website superimposed over an ESRI image of the subject site and immediate surrounds, showing the estimated depth of the ground water table, is provided in Figure 1.5.1.

In considering the ground water information provided on the Visualising Victoria's Groundwater website, it must be noted that the ground water depths are very approximate only.

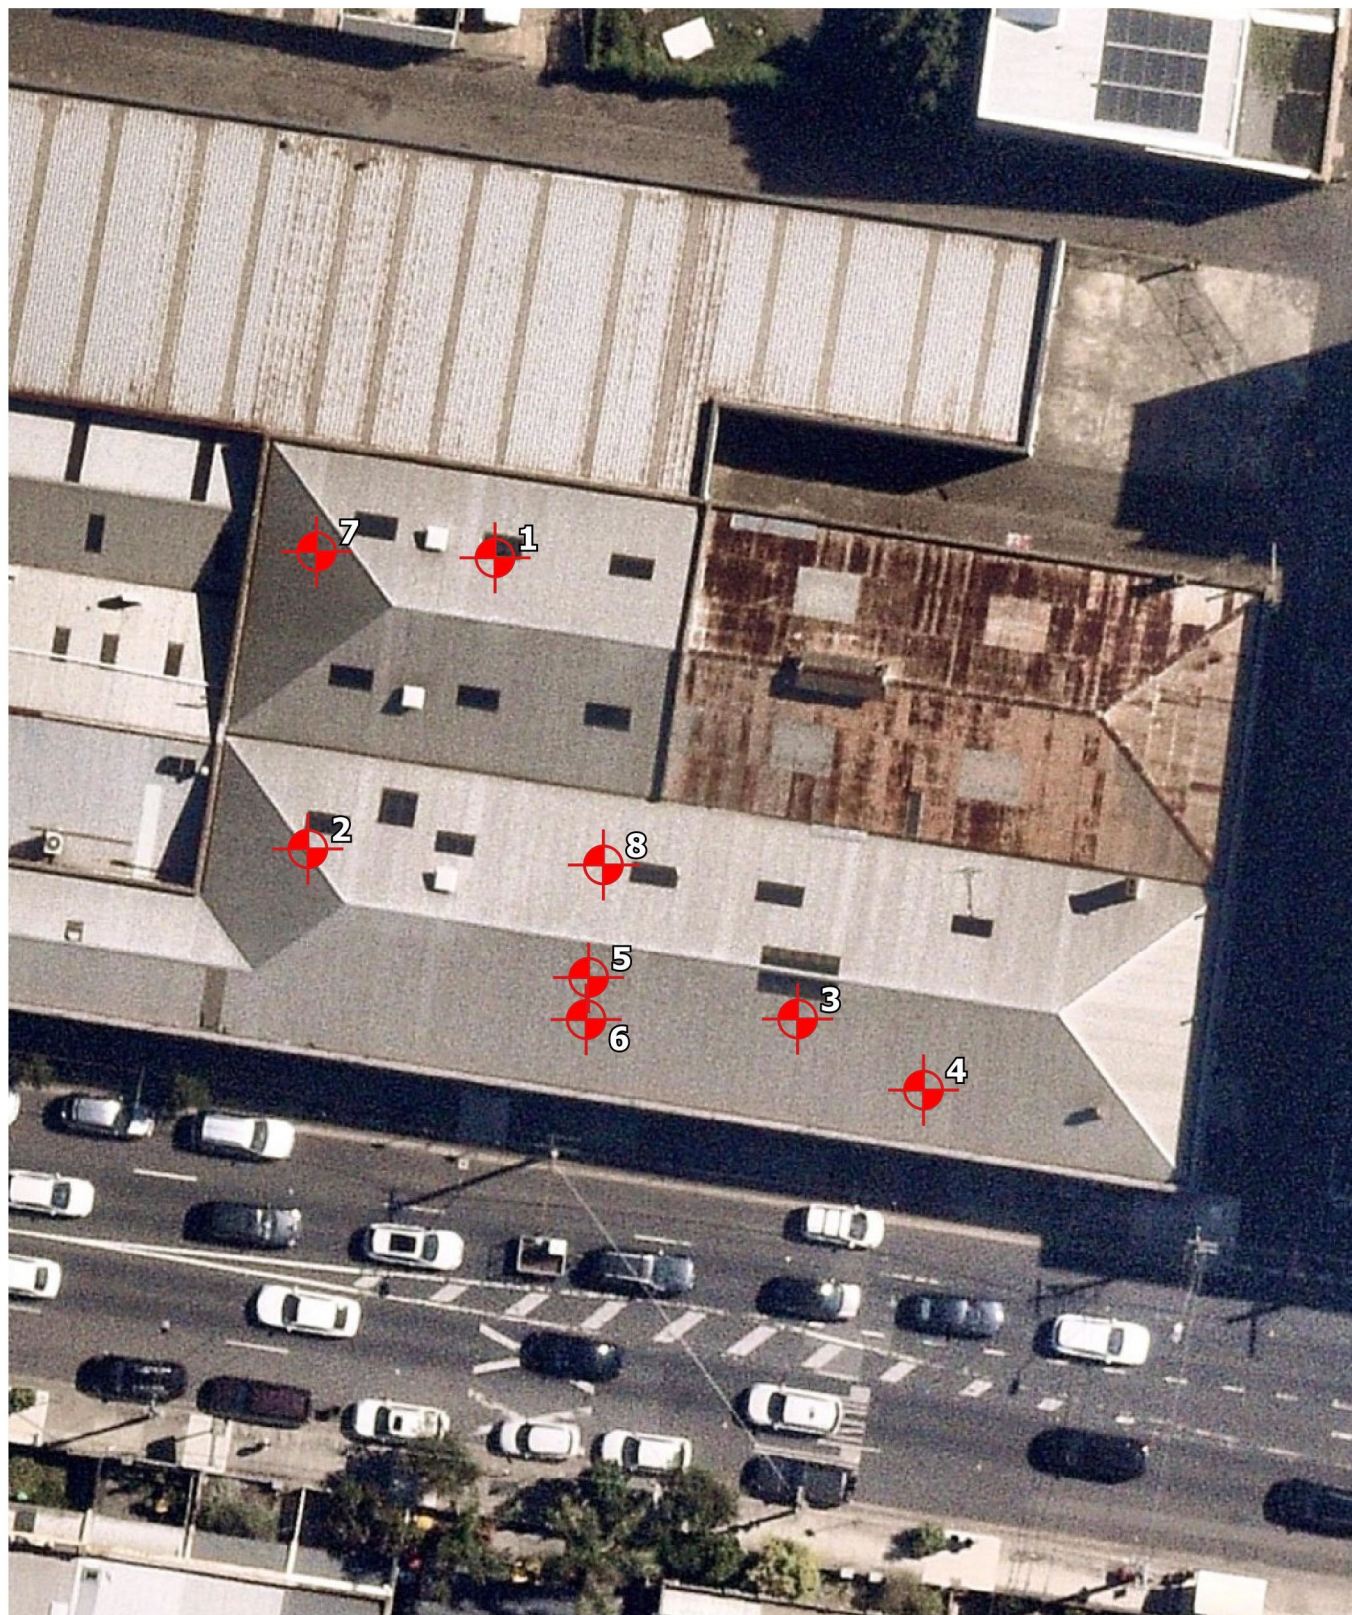
TEST LOCATION PLAN

The details of the boreholes drilled at the subject site are provided in Table 2.1.1.1. The approximate locations of the boreholes are indicated in the attached Figure 1.

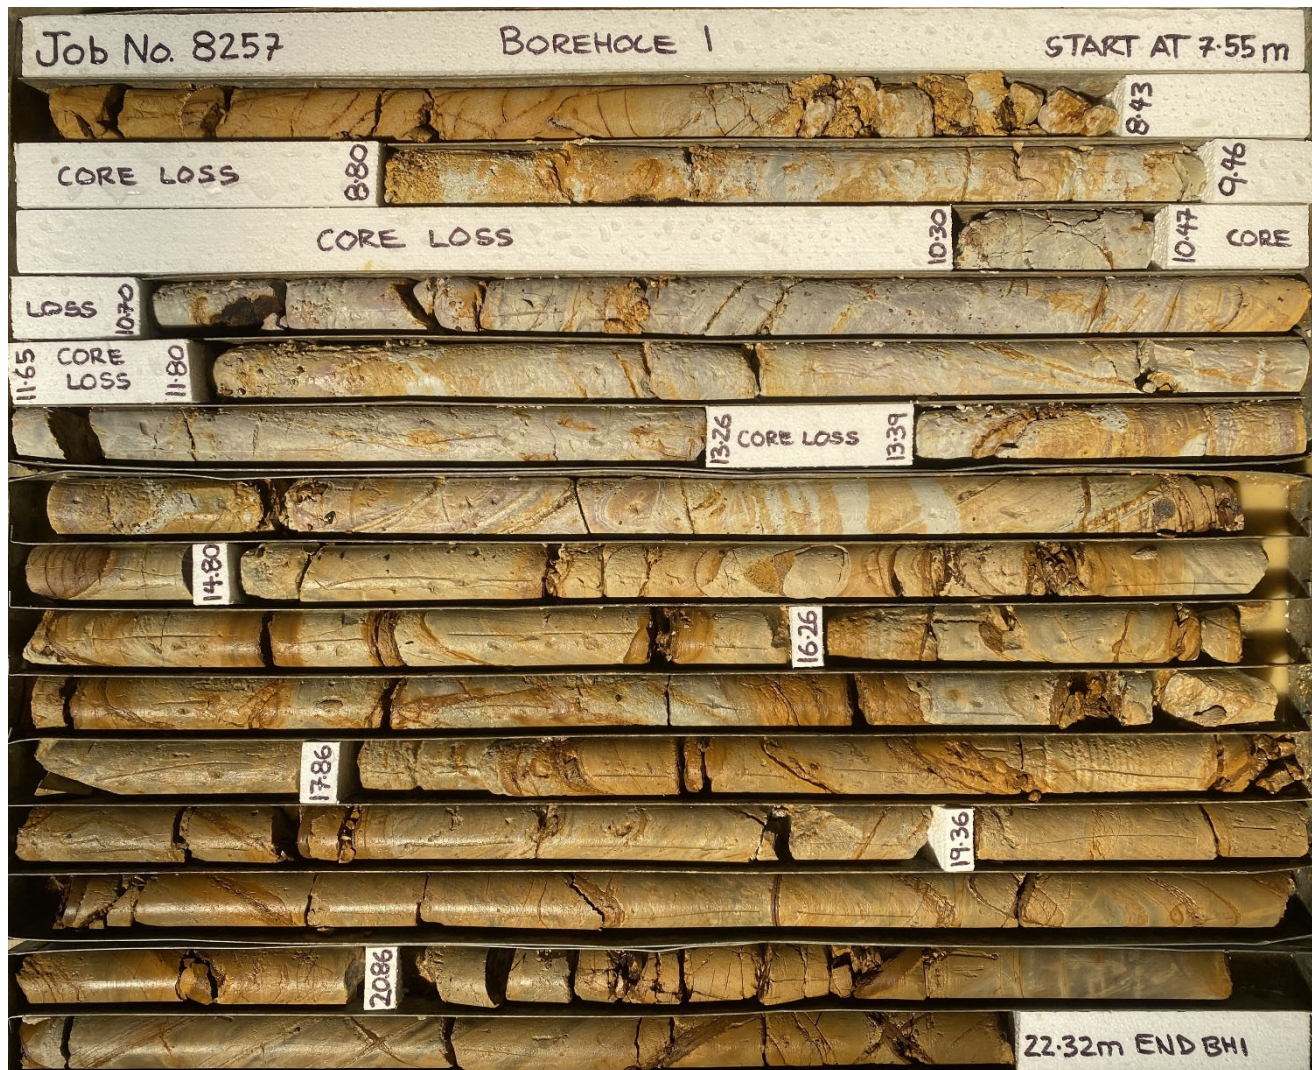
Figure 1

Photograph of Core Recovered from Borehole 1

Photographs of the rock core recovered from the boreholes are provided in Appendix D.

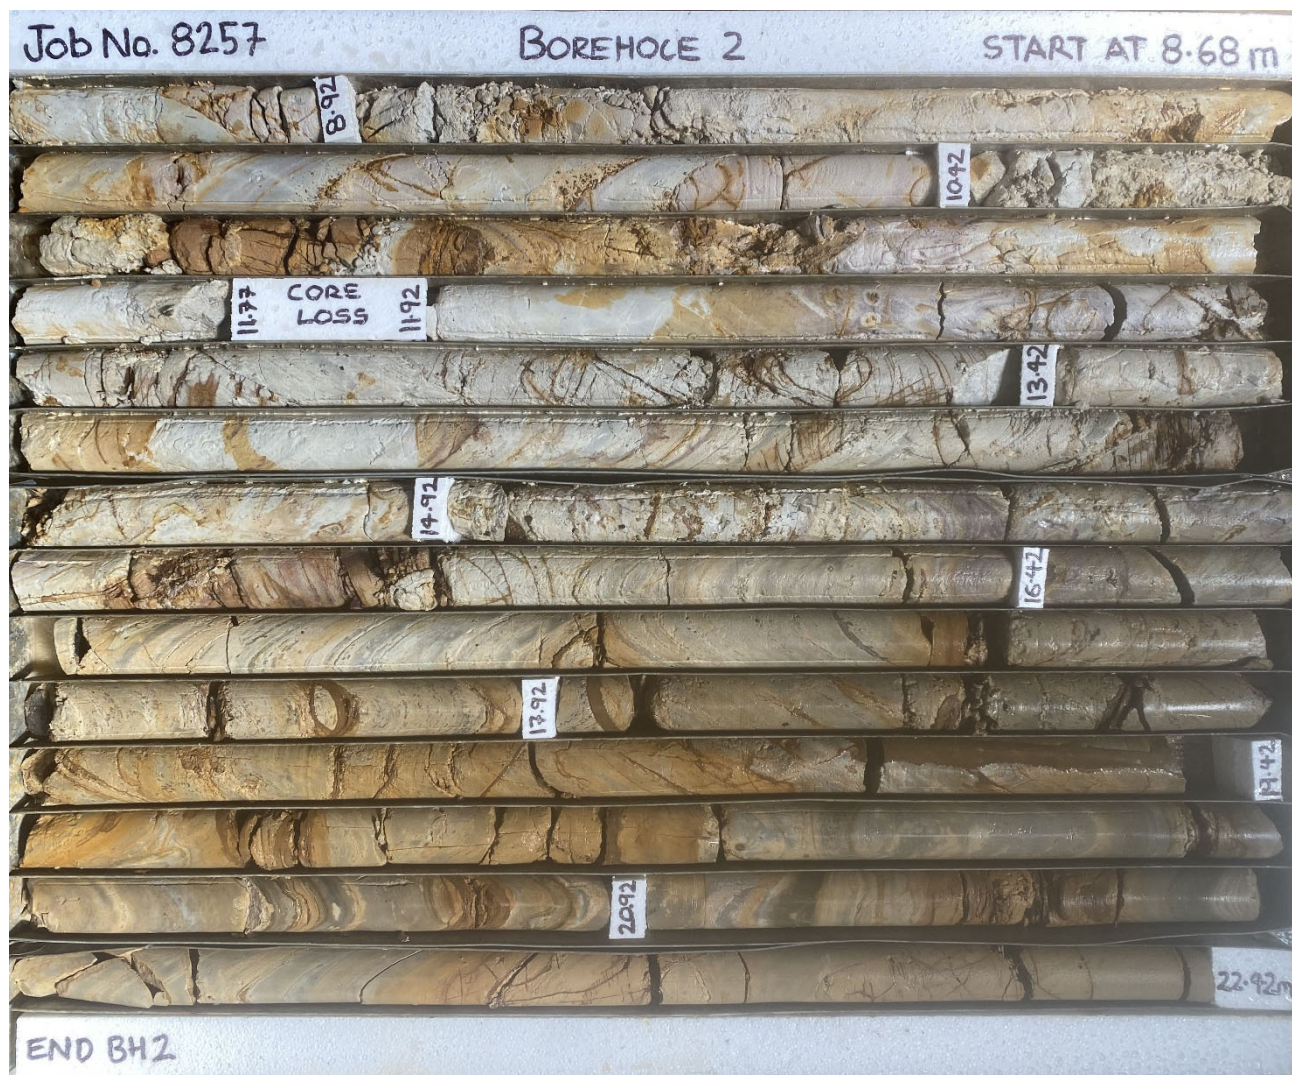
Figure 2

Photograph of Core Recovered from Borehole 2

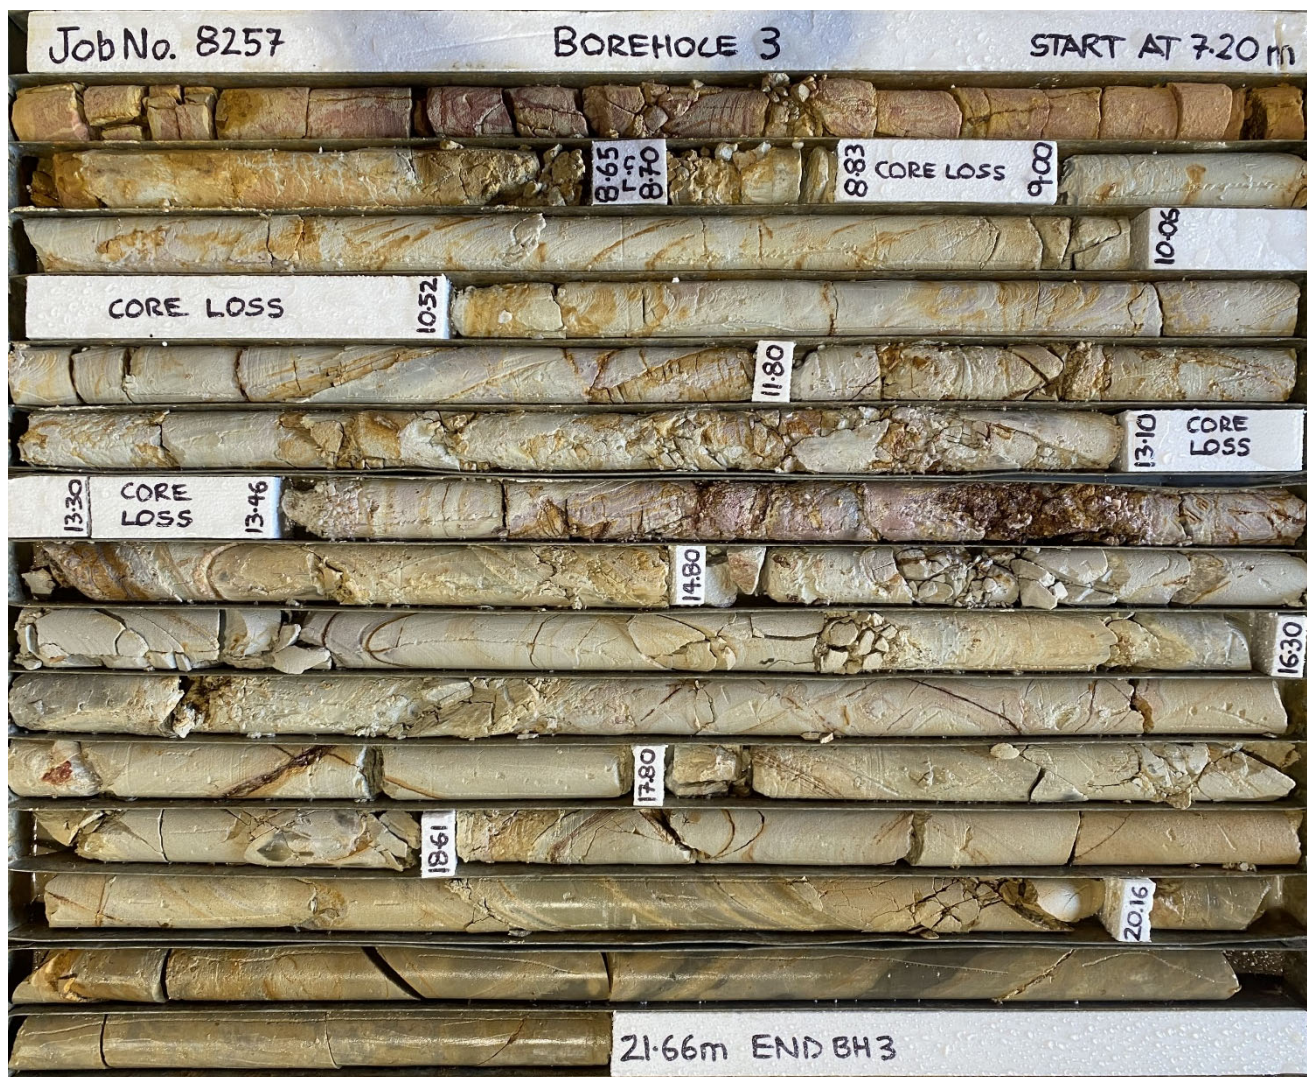
Figure 3

Photograph of Core Recovered from Borehole 3
