## CONSERVATION STRATEGY for the

### **Traill Fountain, Geelong Botanic Gardens** **H2095 Eastern Park and Geelong Botanic Gardens [S2 Traill Fountain]**

**Date:** 10 June 2026 (updated 22 July 2026)

**Prepared by:** Janet Beeston

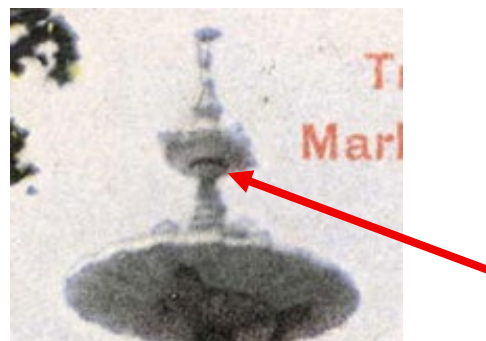
*figure 5 – detail of top of Traill fountain from 1906 postcard (SLV H96.90/53) – red arrow indicates current top of the fountain, section above is missing.*

It is assumed that various works have been undertaken to the Traill fountain since its relocation to the Botanic Gardens 114 years ago, although details are not known. At some stage, the very top section of the fountain (square plate or bowl with moulded shaft above) was removed as can be seen comparing the existing fountain top and the image when the fountain was in Market Square in figures 4 and 5 below.

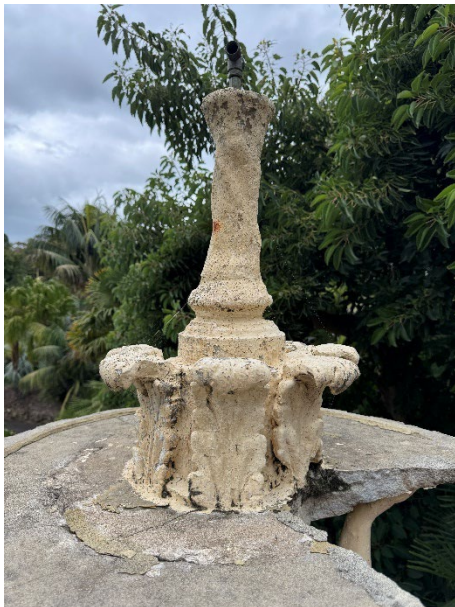
The fabrication (or perhaps previous dismantling points) of the two main dishes of the fountain can be clearly seen on the top of each dish and in section of the smaller dish where a piece has fallen off.

*figure 6 – smaller dish of fountain (2026)  
note the circle line of infill cement*

Top piece of the fountain. Chip out the ring of infill cement in the top of the dish and cut through the shaft below the dish top line.

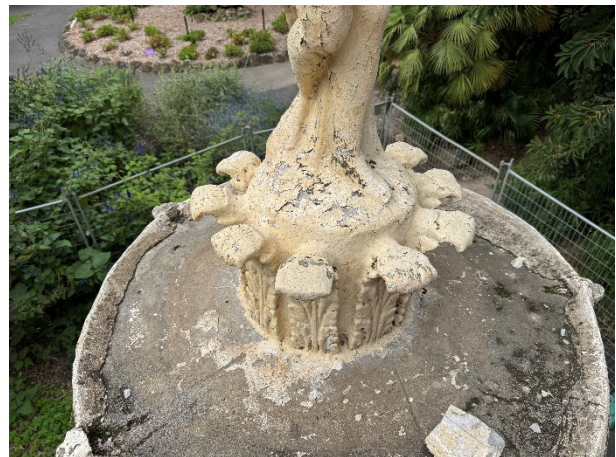
*figure 7 – larger dish of the fountain (2026)  
note the similar circle of infill cement*

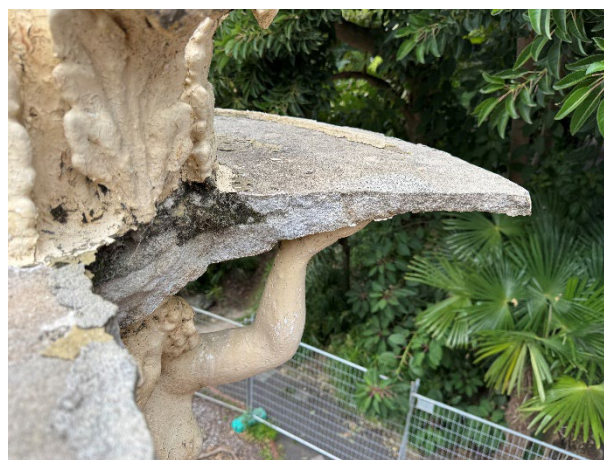
*figure 8 – smaller dish section (2026)  
note the infill cement*

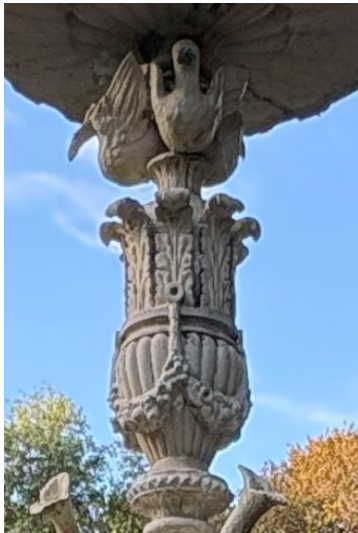
Below the larger (lower) dish are the birds sitting atop a ring of acanthus leaves below which is the ornate fluted urn. The birds are in poor condition but are protected by the dish above. The base of the urn sits on a wider decorative moulding below which is a simple circular ring. Given the simple moulding of the circular ring, it is potentially a logical point at which to cut through the shaft for the dismantling.

*figure 9 – elaborate fluted urn with acanthus leaves and birds above (2026)*

This section includes the large dish at the top protecting the birds below. The cut line will be below the fluted urn under one of the simple band mouldings.

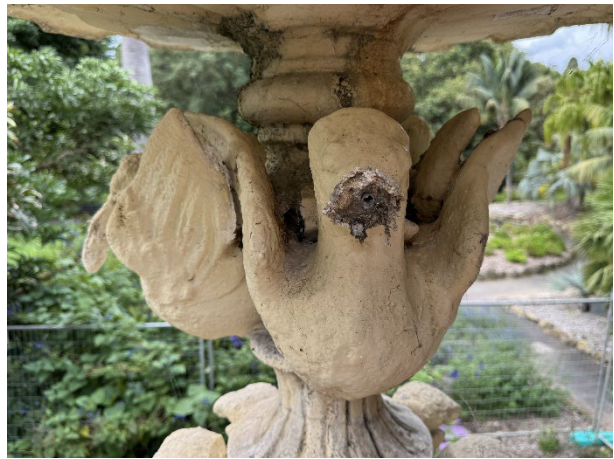
*figure 10 – detail of one of the birds with the beak missing but the water pipe extant (2026)*

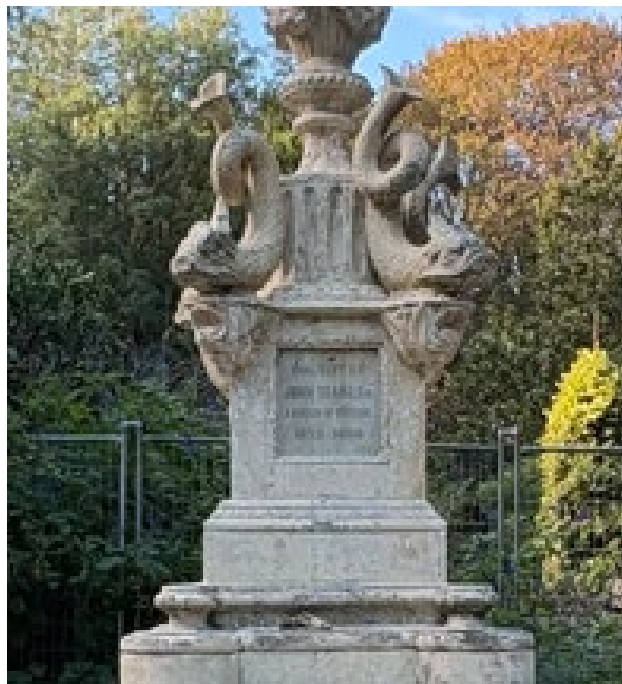
The next section below the urn widens out with a fish on each corner of the plinth below. The tails of the fish are curled around and fan out at the top like a trumpet. The shaft on which the fish lean appears to be solid.

*figure 11 – trumpet tailed fish on each corner of pedestal (2026)*

A shorter section that is anticipated to be solid and heavy. Fish tails will be vulnerable and will need care. Again the cut will be at a junction below a simple moulding to enable a smooth connection when reconstructed.

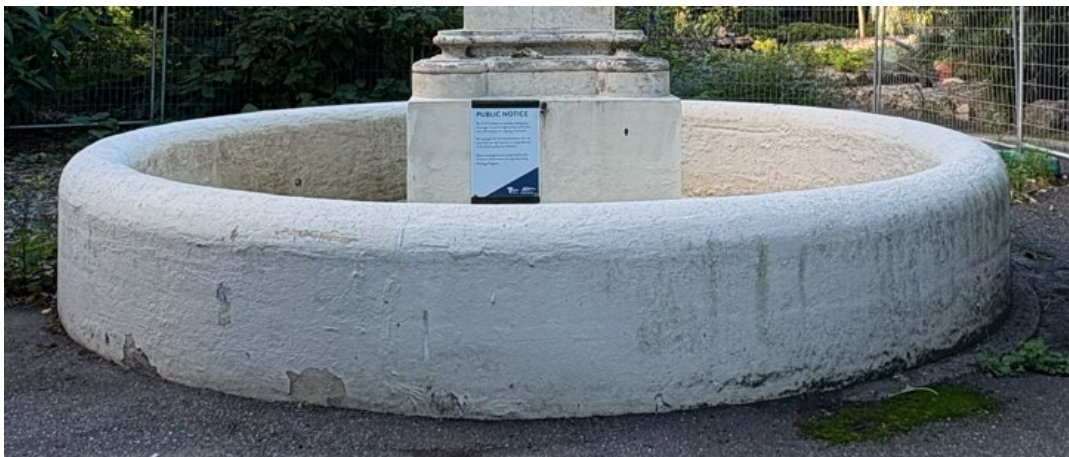
The lower of the two sections of pedestal is an unadorned square section, 900mm high constructed of rendered brickwork. It is probable that this base was newly constructed in the gardens when the fountain was relocated from Market Square, rather than the original base having been moved. Similarly, the walls of the surrounding pond are of the same construction and although it appears to be visually similar to the pond when the fountain was in Market Square, it is more likely that a new pond was constructed when the fountain was moved.

*figure 12 – lower rendered brickwork section of pedestal and pond wall (2026)*

This section of the pedestal is rendered brickwork. It is unadorned and may have been constructed as a new plinth when the fountain was relocated. This section could be dismantled and the bricks retained.

The pond walls and base are like Section 6 thought to be a new construction at the time the fountain was relocated to the current site in 1912. The assumed rendered brick walls (it may be concrete) should be demolished and the bricks retained for use when the fountain is reinstated following conservation works.

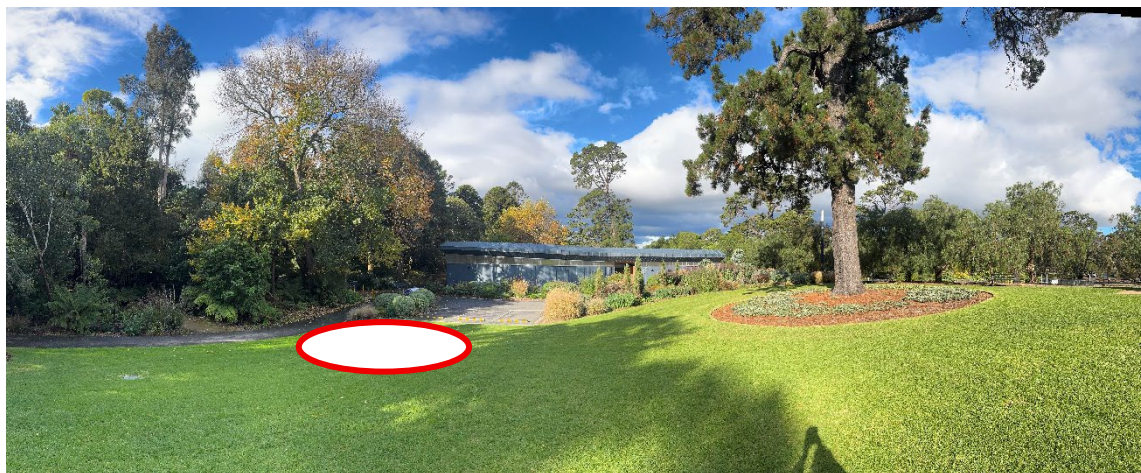
*figure 14 – view from the west of the proposed new location (white circle with red border) for the Traill Fountain when reinstated following restoration works. Note carpark and information centre behind the proposed new location for the Traill Fountain.*

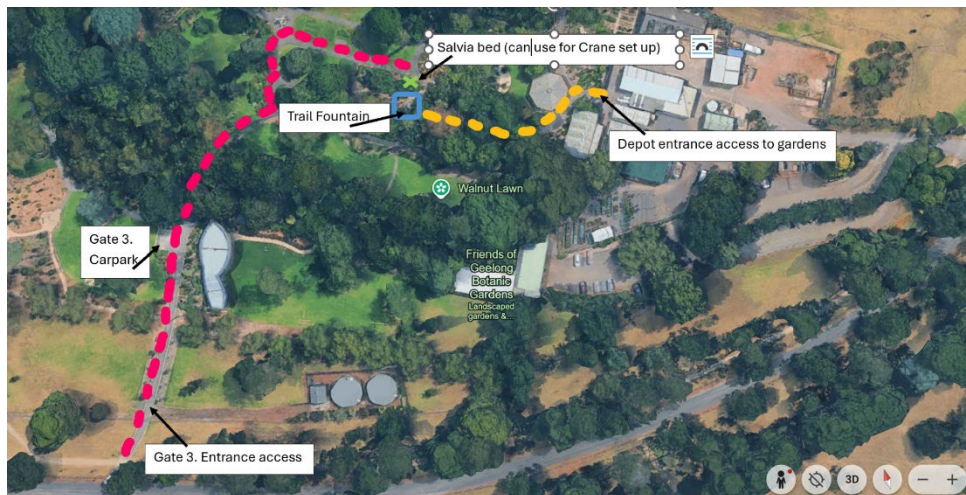
*Access to Traill Fountain map (Geelong Botanic Gardens 2026)*

Geelong Botanic Gardens staff have provided the above map indicating access points to the fountain and recommended location for crane set up during the dismantling procedure.

The yellow dashed line indicates pathway access to the fountain from the depot entrance. This may be used for machinery access (crane, boom lift etc) or vehicle (maximum size is a ute).

The red dashed line indicates road and pathway access to the fountain from Gate 3 off Eastern Park Circuit. Gate 3 entrance is wide enough for truck access however there is no turn around circle and therefore a truck would need to reverse in to the Gate 3 carpark location from Gate 3 entrance.

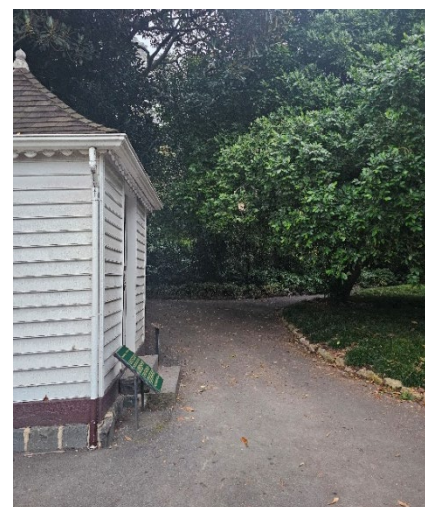
For access on this path, machinery and vehicles would need to be reversed from the depot entrance to the fountain with the smallest part of the pathway being 2.5m wide between the old Customs House and the garden edging. The height clearance along this path is approximately 3.5m.

*2.5m min width of path between old Customs House and the garden edging (Geelong Botanic Gardens 2026)*

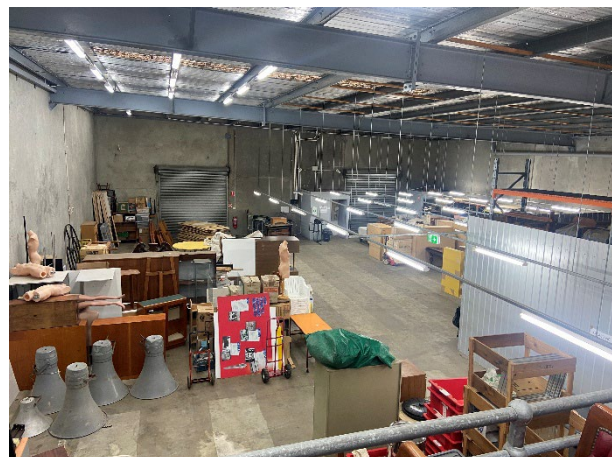
*View of interior of shed for temporary storage of Traill fountain sections and salvaged bricks on pallets. Note this is not a recent photograph and there is less items currently stored in the shed.*

The salvaged bricks (from pond wall and base of plinth) and the individual sections of the dismantled pressed cement fountain will be placed in storage in this building on pallets.
