ARBORICULTURAL INSPECTION REPORT

REDWOOD FOREST: VISITOR FACILITIES IMPROVEMENTS

VERSION 3 (UPDATED 14/3/2024)

Prepared by Stephen Fitzgerald
for:
Parks Victoria

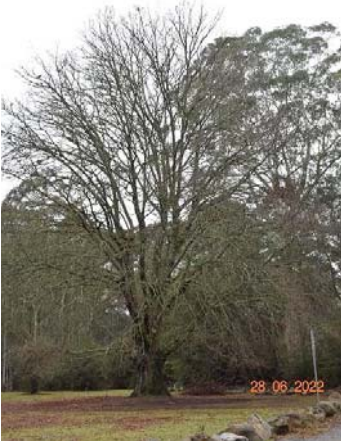
Photo 1: Tree 1 (photo C&R Ryder Consulting P/L)

TREE #	SPECIES / COMMON NAME	IMPACT OUTCOME	DBH ¹	HEIGHT x Width	HEALTH STRUCTURE	DEFECTS/ CONDITIONS ²	ACTIONS ³	RETENTION VALUE	TPZ ⁴ Encroach.	SRZ ⁵ Encroached?	ORIGIN	LIFE Exp. ⁶	COMMENTS
1	<i>Quercus robur</i> English Oak	Retained	192cm	31 x 20m	Good Fair	large failure on NW side (fungal fruiting body Arb)	Further investigation of decay in stem (see photo)	Very High	15m	4.6m	Exotic	20+	very large tree, historically lopped, large failure on NW side. (Further investigation of extent of decay due to fungal fruiting body is recommended Arb) See Appendix 1 Tree Photos Photo 1
2	<i>Acacia dealbata</i> Silver Wattle	Lost	44cm	18 x 9m	Fair Fair		Tree Removal	Medium	5.28m	2.5m	Vic Native	11-20	Reason for tree removal: Future Melb Water Works See Appendix 1 Tree Photos Photo 2
3	<i>Acacia dealbata</i> Silver Wattle	Retained	60cm	18 x 10m	Fair Fair		No works recommendations have been made	Medium	7.2m	2.7m	Vic Native	11-20	See Appendix 1 Tree Photos Photo 3

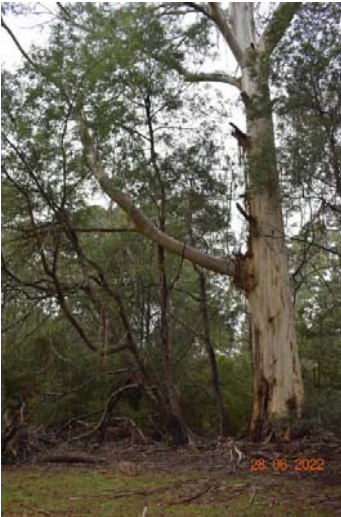
Photo 4: Tree 4 (photo C&R Ryder Consulting P/L)

4	<i>Acacia dealbata</i> Silver Wattle	Retained	28cm	17 x 7m	Good Fair		No works recommendations have been made	Medium	3.36m	2m	Vic Native	11-20	See Appendix 1 Tree Photos Photo 4
5	<i>Eucalyptus viminalis</i> Manna Gum	Retained	204cm	48 x 20m	Good Fair	multiple failures, minimal decay, hanging branch	No works recommendations have been made	High	15m	4.8m	Vic Native	20+	multiple failures, minimal decay, hanging branch See Appendix 1 Tree Photos Photo 5
6	<i>Eucalyptus viminalis</i> Manna Gum	Retained	146cm	48 x 15m	Good Fair		No works recommendations have been made	High	15m	4.2m	Vic Native	20+	See Appendix 1 Tree Photos Photo 6 Note: Encroach Type: Culvert drain
7	<i>Eucalyptus viminalis</i> Manna Gum	Retained	49cm	20 x 8m	Good Good		No works recommendations have been made	Medium	5.88m	2.7m	Vic Native	20+	See Appendix 1 Tree Photos Photo 7
8	<i>Eucalyptus viminalis</i> Manna Gum	Retained	92cm	45 x 16m	Good Good		No works recommendations have been made	High	11.04m	3.6m	Vic Native	20+	See Appendix 1 Tree Photos Photo 8 Note: Encroach Type: Culvert drain (Culvert - 1m wide excavation assumed.

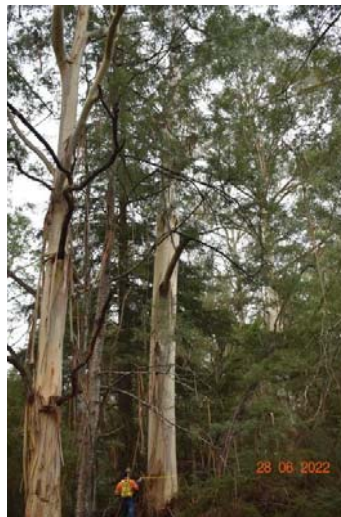
Photo 8: Tree 8 (photo C&R Ryder Consulting P/L)

The trench encroaches within the TPZ areas of trees #8 and 151(see Figure 1 below).

Figure 1 TPZ encroachments from proposed culvert pipe trench to trees #8 and 151 (shaded areas).

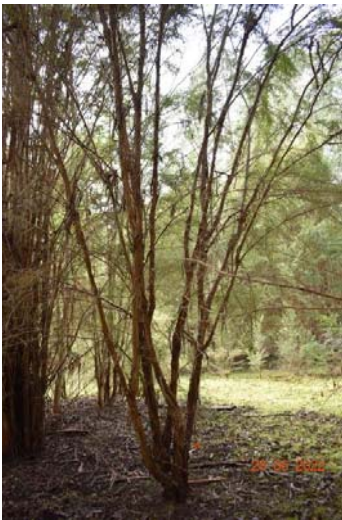
39	<i>Kunzea leptospermoides</i> Yarra Burgan	Retained	20cm	6 x 3m	Good Fair		No works recommendations have been made	Low	2.4m	1.8m	Vic Native	11-20	multistemmed. See Appendix 1 Tree Photos Photo 39
									0%	<input type="checkbox"/> Encroached?			
40	<i>Kunzea leptospermoides</i> Yarra Burgan	Retained	20cm	7 x 3m	Good Fair		No works recommendations have been made	Low	2.4m	1.8m	Vic Native	11-20	multistemmed. See Appendix 1 Tree Photos Photo 40
									0%	<input type="checkbox"/> Encroached?			
41	<i>Kunzea leptospermoides</i> Yarra Burgan	Retained	25cm	7 x 4m	Good Fair		No works recommendations have been made	Low	3m	2m	Vic Native	11-20	multistemmed, 2 specimens See Appendix 1 Tree Photos Photo 41
									0%	<input type="checkbox"/> Encroached?			
42	<i>Kunzea leptospermoides</i> Yarra Burgan	Retained	25cm	7 x 4m	Good Fair		No works recommendations have been made	Low	3m	2m	Vic Native	11-20	multistemmed See Appendix 1 Tree Photos Photo 42

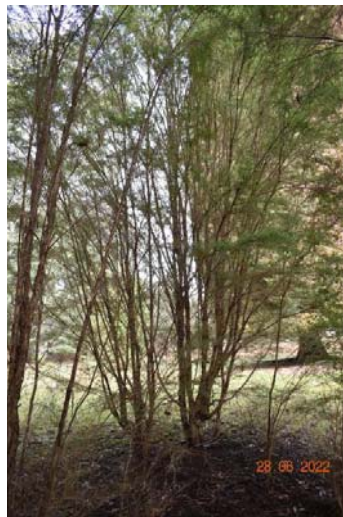
0%	<input type="checkbox"/> Encroached?			
43	<i>Kunzea leptospermoides</i> Yarra Burgan	Retained	30cm	7 x 6m	Good Fair		No works recommendations have been made	Low	3.6m	2.1m	Vic Native	11-20	multistemmed, several specimens. See Appendix 1 Tree Photos Photo 43
									0%	<input type="checkbox"/> Encroached?			
44	<i>Kunzea leptospermoides</i> Yarra Burgan	Retained	25cm	7 x 4m	Good Fair		No works recommendations have been made	Low	3m	2.1m	Vic Native	11-20	multistemmed, 2 specimens See Appendix 1 Tree Photos Photo 44
									0%	<input type="checkbox"/> Encroached?			
45	<i>Kunzea leptospermoides</i> Yarra Burgan	Retained	25cm	7 x 3m	Good Fair		No works recommendations have been made	Low	3m	2m	Vic Native	11-20	multistemmed. See Appendix 1 Tree Photos Photo 45
									0%	<input type="checkbox"/> Encroached?			
46	<i>Eucalyptus viminalis</i> Manna Gum	Lost	26cm	17 x 4m	Good Good		No works recommendations have been made	Low	3.12m	2m	Vic Native	20+	Kunzea at base. In way of trail See Appendix 1 Tree Photos Photo 46

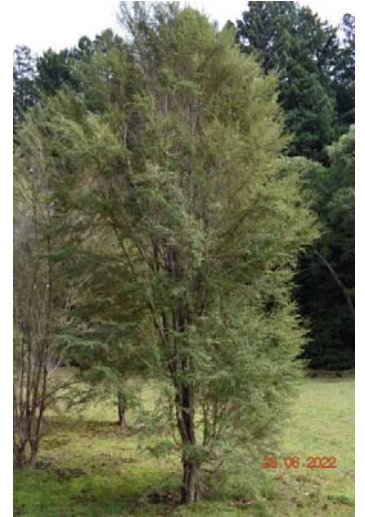
0%	<input type="checkbox"/> Encroached?			
47	<i>Kunzea leptospermoides</i> Yarra Burgan	Retained	30cm	7 x 5m	Good Fair		No works recommendations have been made	Low	3.6m	2.1m	Vic Native	11-20	Multistemmed, several stems in cluster. See Appendix 1 Tree Photos Photo 47
									0%	<input type="checkbox"/> Encroached?

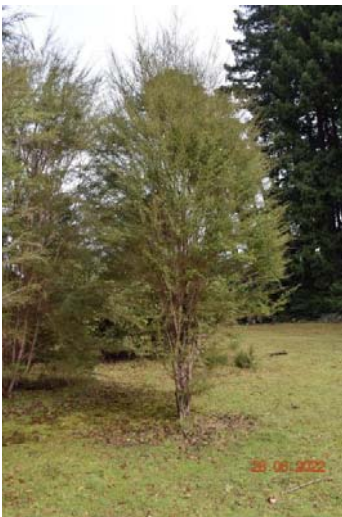
51	<i>Kunzea leptospermoides</i> Yarra Burgan	Retained	25cm	7 x 5m	Good Fair		No works recommendations have been made	Low	3m 0%	2m <input type="checkbox"/> Encroached?	Vic Native	11-20	Multistemmed, several specimens See Appendix 1 Tree Photos Photo 51
52	<i>Kunzea leptospermoides</i> Yarra Burgan	Retained	15cm	5 x 3m	Good Fair		No works recommendations have been made	Low	2m 0%	1.7m <input type="checkbox"/> Encroached?	Vic Native	11-20	Multistemmed See Appendix 1 Tree Photos Photo 52
53	<i>Kunzea leptospermoides</i> Yarra Burgan	Retained	25cm	7 x 3m	Good Fair		No works recommendations have been made	Low	3m 0%	2m <input type="checkbox"/> Encroached?	Vic Native	11-20	Multistemmed See Appendix 1 Tree Photos Photo 53
54	<i>Kunzea leptospermoides</i> Yarra Burgan	Retained	15cm	7 x 2m	Good Fair		No works recommendations have been made	Low	2m 0%	1.7m <input type="checkbox"/> Encroached?	Vic Native	11-20	Multistemmed See Appendix 1 Tree Photos Photo 54

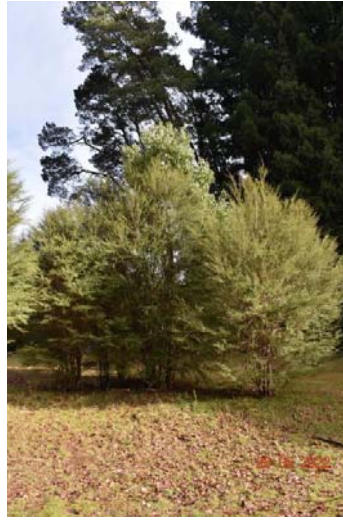
55	<i>Kunzea leptospermoides</i> Yarra Burgan	Retained	25cm	7 x 4m	Good Fair		No works recommendations have been made	Low	3m 0%	2m <input type="checkbox"/> Encroached?	Vic Native	11-20	Multistemmed, small cluster See Appendix 1 Tree Photos Photo 55
56	<i>Kunzea leptospermoides</i> Yarra Burgan	Retained	25cm	6 x 4m	Good Fair		No works recommendations have been made	Low	3m 0%	2m <input type="checkbox"/> Encroached?	Vic Native	11-20	Multistemmed, small cluster See Appendix 1 Tree Photos Photo 56
57	<i>Acacia melanoxylon</i> Blackwood	Retained	14cm	9 x 3m	Good Good		No works recommendations have been made	Low	2m 0%	1.6m <input type="checkbox"/> Encroached?	Vic Native	20+	See Appendix 1 Tree Photos Photo 57
58	<i>Acacia melanoxylon</i> Blackwood	Retained	8cm	6 x 2m	Good Good		No works recommendations have been made	Low	2m 0%	1.5m <input type="checkbox"/> Encroached?	Vic Native	20+	See Appendix 1 Tree Photos Photo 58

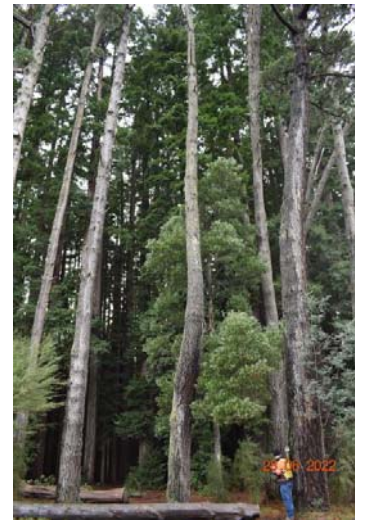
59	<i>Pinus muricata</i> Bishop Pine	Retained	95cm	28 x 10m	Good Fair		No works recommendations have been made	High	11.4m 0%	3.4m <input type="checkbox"/> Encroached?	Exotic	20+	asymmetric, lean over car park. See Appendix 1 Tree Photos Photo 59

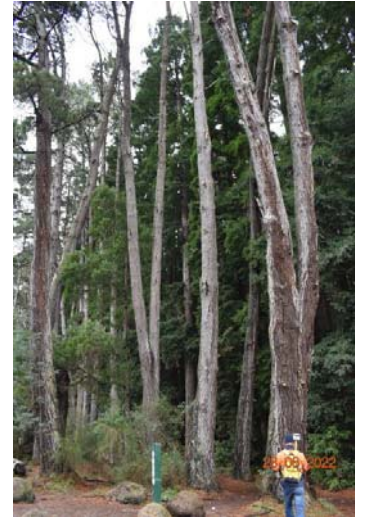
Photo 65 from south-east: Tree 63
recent bifurcation failure

63	<i>Pinus muricata</i> Bishop Pine	Remove	99cm	30+ x 10m	Fair Poor	tree is leaning, recent upper canopy failure, codominant. (poor stem taper of laterals, bifurcation defects Arb)	Tree Removal	Low	11.88m	3.4m	Exotic	6-10	tree is leaning, recent upper canopy failure, codominant. (signs of structural decline large heavy laterals to east southeast have bifurcated unions one has failed recently Arb) Reasons for tree removal: Decline of Structure See Appendix 1 Tree Photos Photos 63, 64 & 65 Note: Encroach Type: P3 Asphalt with line-marking
									4%	<input type="checkbox"/> Encroached?			
64	<i>Pinus muricata</i> Bishop Pine	Retained	79cm	33 x 7m	Fair Poor	possible decay at 2-4m	Further investigation of decay identified by Ryder	Low	9.48m	3.2m	Exotic	11-20	possible decay at 2-4m Reasons for tree removal: Decline of Structure See Appendix 1 Tree Photos Photo 66 Note: Encroach Type: P3 Asphalt with line-marking

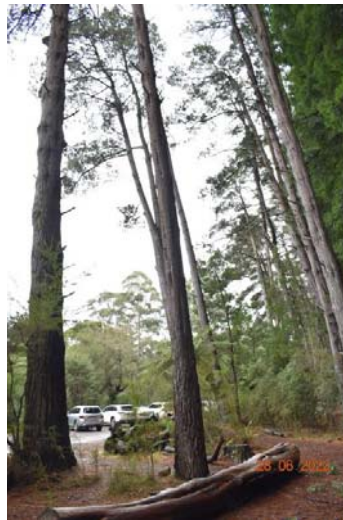
1%	<input type="checkbox"/> Encroached?			
65	<i>Pinus muricata</i> Bishop Pine	Retained	76cm	33 x 7m	Fair Fair	codominant at 4m.	No works recommendations have been made	High	9.12m	3.2m	Exotic	11-20	codominant at 4m. See Appendix 1 Tree Photos Photo 67
									0%	<input type="checkbox"/> Encroached?			
66	<i>Pinus muricata</i> Bishop Pine	Retained	60cm	35 x 5m	Fair Fair		No works recommendations have been made	High	7.2m	2.9m	Exotic	11-20	See Appendix 1 Tree Photos Photo 68
									0%	<input type="checkbox"/> Encroached?			
67	<i>Pinus muricata</i> Bishop Pine	Retained	83cm	32 x 7m	Good Fair	codominant at 9m	No works recommendations have been made	High	9.96m	3.3m	Exotic	11-20	codominant at 9m See Appendix 1 Tree Photos Photo 69
									0%	<input type="checkbox"/> Encroached?			
68	<i>Pinus muricata</i> Bishop Pine	Retained	78cm	37 x 5m	Good Fair		No works recommendations have been made	High	9.36m	3.1m	Exotic	11-20	path at base See Appendix 1 Tree Photos Photo 70

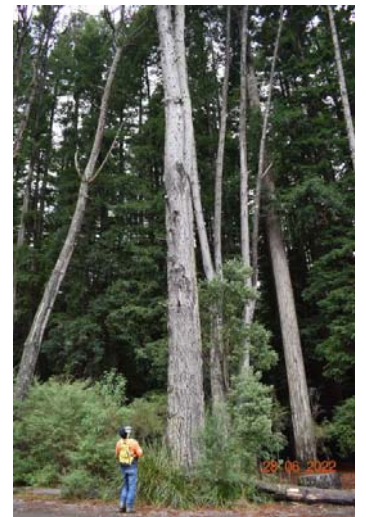
0%	<input type="checkbox"/> Encroached?			
69	<i>Pinus muricata</i> Bishop Pine	Retained	85cm	39 x 6m	Good Fair		No works recommendations have been made	High	10.2m	3.3m	Exotic	11-20	See Appendix 1 Tree Photos Photo 71
									0%	<input type="checkbox"/> Encroached?

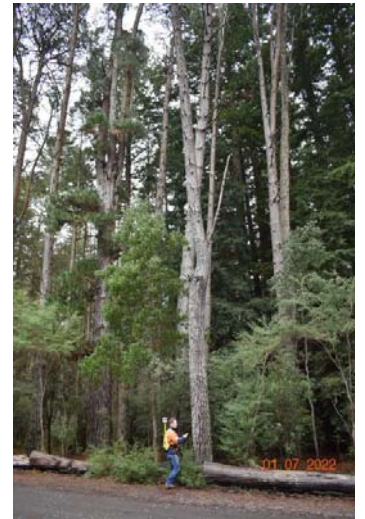
Photo 83: Tree 81 (photo C&R Ryder Consulting P/L)

0%	<input type="checkbox"/> Encroached?			
81	<i>Pinus muricata</i> Bishop Pine	Retained	64cm	37 x 5m	Fair Good	canopy is declining	No works recommendations have been made	High	7.68m	3m	Exotic	11-20	canopy is declining See Appendix 1 Tree Photos Photo 83
									0%	<input type="checkbox"/> Encroached?

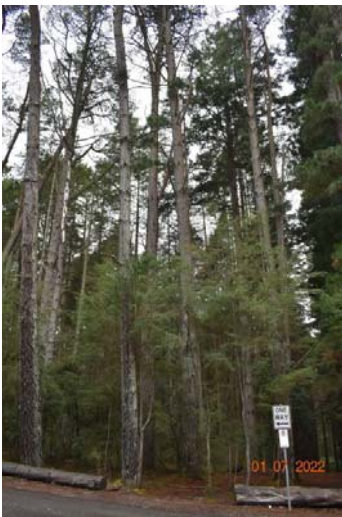
Photo 87: Tree 85 (photo C&R Ryder Consulting P/L)

8%	<input type="checkbox"/> Encroached?			
85	<i>Pinus muricata</i> Bishop Pine	Retained	73cm	39 x 6m	Poor Fair	major canopy decline	No works recommendations have been made	Medium	8.76m	3m	Exotic	1-5	major canopy decline See Appendix 1 Tree Photos Photo 87
									0%	<input type="checkbox"/> Encroached?			
86	<i>Pinus muricata</i> Bishop Pine	Retained	79cm	39 x 8m	Fair Fair	tree is declining	No works recommendations have been made	High	9.48m	3.1m	Exotic	11-20	tree is declining See Appendix 1 Tree Photos Photo 88 Note: Encroach Type: P5 crushed rock (access track)
									0%	<input type="checkbox"/> Encroached?			
87	<i>Pinus muricata</i> Bishop Pine	Remove	51cm	20 x 1m	Dead Poor		Tree Removal	None	6.12m	2.7m	Exotic	0	remove tree Reasons for tree removal: Dead See Appendix 1 Tree Photos Photo 89
									0%	<input type="checkbox"/> Encroached?			
88	<i>Pinus muricata</i> Bishop Pine	Retained	61cm	37 x 8m	Fair Fair		No works recommendations have been made	High	7.32m	2.8m	Exotic	20+	See Appendix 1 Tree Photos Photo 90 Note: Encroach Type: P5 crushed rock (access track)

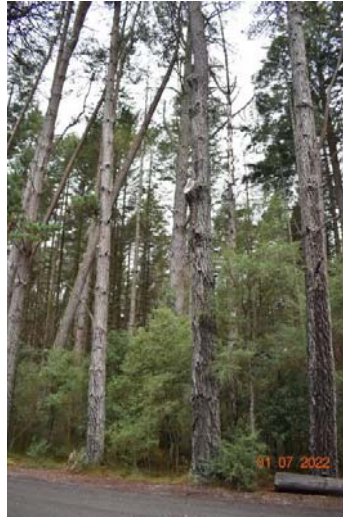
Photo 91: Tree 89 (photo C&R Ryder Consulting P/L)

12%	<input type="checkbox"/> Encroached?			
89	<i>Pinus muricata</i> Bishop Pine	Retained	78cm	37 x 9m	Fair Fair	canopy is declining	No works recommendations have been made	High	9.36m	3.1m	Exotic	11-20	canopy is declining, tree leans over car park See Appendix 1 Tree Photos Photo 91 Note: Encroach Type: P5 crushed rock (access track)
									3%	<input type="checkbox"/> Encroached?			
90	<i>Pinus muricata</i> Bishop Pine	Retained	85cm	37 x 10m	Fair Fair	canopy is declining	No works recommendations have been made	High	10.2m	3.3m	Exotic	11-20	canopy is declining, tree leans over car park See Appendix 1 Tree Photos Photo 92
									0%	<input type="checkbox"/> Encroached?			
91	<i>Pinus muricata</i> Bishop Pine	Retained	59cm	31 x 4m	Poor Fair	canopy is declining	No works recommendations have been made	Medium	7.08m	2.7m	Exotic	6-10	canopy is declining See Appendix 1 Tree Photos Photo 93
									0%	<input type="checkbox"/> Encroached?

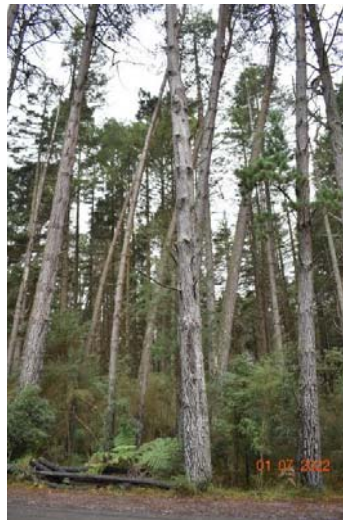
Photo 94: Tree 92 (photo C&R Ryder Consulting P/L)

92	<i>Pinus muricata</i> Bishop Pine	Retained	61cm	39 x 5m	Fair Fair	canopy is declining, on a lean.	No works recommendations have been made	High	7.32m	2.9m	Exotic	11-20	canopy is declining, on a lean. See Appendix 1 Tree Photos Photo 94
									0%	<input type="checkbox"/> Encroached?

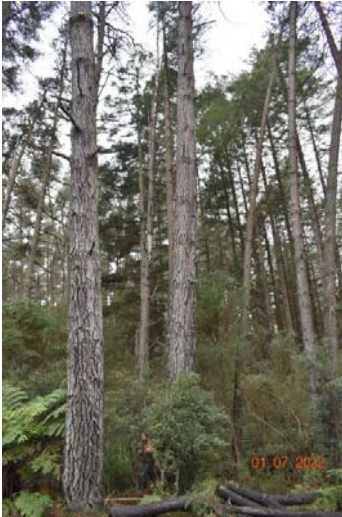
Photo 99: Tree 97 (photo C&R Ryder Consulting P/L)

the planting have been recommended for removal due to defects noticed and declining structural conditions. Some trees including many not included in the inspection display poor stem taper (ratio of stem diameter to tree height). Tree #97 is an extreme example of a tree with poor taper (see Appendix 1, Photo 99). A recent stem failure of tree #238 was probably due to a combination of a bifurcation defect and poor stem taper (see Appendix 1, Photo 211). Poor stem taper usually only becomes a problem for trees in groups when they become exposed often after surrounding trees fail or are removed or, when the tree grows higher than surrounding trees allowing its canopy to be exposed to winds.

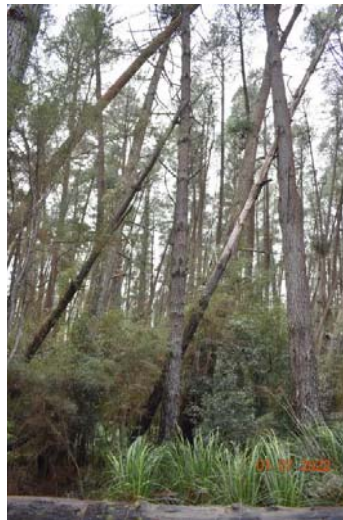
Photo 121: Tree 119 (photo C&R Ryder Consulting P/L)

TREE #	SPECIES / COMMON NAME	IMPACT OUTCOME	DBH ¹	HEIGHT x Width	HEALTH STRUCTURE	DEFECTS/ CONDITIONS ²	ACTIONS ³	RETENTION VALUE	TPZ ⁴ Encroach.	SRZ ⁵ Encroached?	ORIGIN	LIFE Exp. ⁶	COMMENTS
117	<i>Pinus muricata</i> Bishop Pine	Retained	60cm	38 x 8m	Fair Fair		No works recommendations have been made	High	7.2m	2.8m	Exotic	11-20	extensively pruned over car park See Appendix 1 Tree Photos Photo 119
									0%	<input type="checkbox"/> Encroached?			
118	<i>Pinus muricata</i> Bishop Pine	Retained	54cm	38 x 6m	Fair Fair		No works recommendations have been made	High	6.48m	2.7m	Exotic	11-20	extensively pruned over car park See Appendix 1 Tree Photos Photo 120
									0%	<input type="checkbox"/> Encroached?			
119	<i>Pinus muricata</i> Bishop Pine	Retained	72cm	38 x 9m	Fair Fair	codominant at 6m	No works recommendations have been made	High	8.64m	3.1m	Exotic	11-20	codominant at 6m See Appendix 1 Tree Photos Photo 121

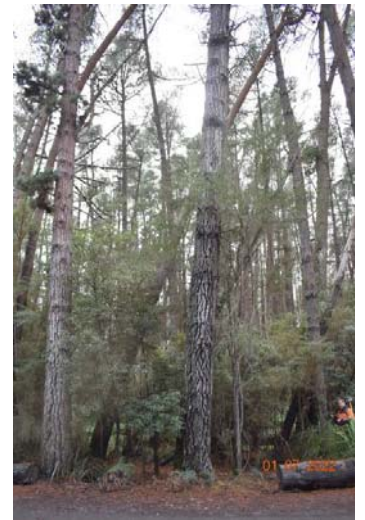
Photo 122: Tree 120 (photo C&R Ryder Consulting P/L)

0%	<input type="checkbox"/> Encroached?			
120	<i>Pinus muricata</i> Bishop Pine	Retained	46cm	35 x 4m	Fair Fair		No works recommendations have been made	High	5.52m	2.5m	Exotic	11-20	See Appendix 1 Tree Photos Photo 122
									0%	<input type="checkbox"/> Encroached?			
121	<i>Pinus muricata</i> Bishop Pine	Retained	74cm	39 x 8m	Good Fair		No works recommendations have been made	High	8.88m	3.1m	Exotic	11-20	pruned up See Appendix 1 Tree Photos Photo 123
									0%	<input type="checkbox"/> Encroached?			
122	<i>Pinus muricata</i> Bishop Pine	Retained	65cm	38 x 6m	Good Fair		No works recommendations have been made	High	7.8m	2.9m	Exotic	11-20	See Appendix 1 Tree Photos Photo 124
									0%	<input type="checkbox"/> Encroached?			
123	<i>Pinus muricata</i> Bishop Pine	Retained	83cm	38 x 10m	Fair Fair	canopy decline	No works recommendations have been made	High	9.96m	3.2m	Exotic	11-20	canopy decline See Appendix 1 Tree Photos Photo 125

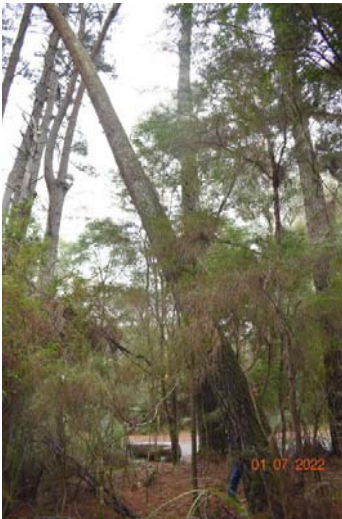
Photo 126: Tree 124 (photo C&R Ryder Consulting P/L)

0%	<input type="checkbox"/> Encroached?			
124	<i>Pinus muricata</i> Bishop Pine	Retained	94cm	38 x 8m	Fair Fair		No works recommendations have been made	High	11.28m	3.2m	Exotic	11-20	lower stem pruned See Appendix 1 Tree Photos Photo 126
									0%	<input type="checkbox"/> Encroached?			
125	<i>Pinus muricata</i> Bishop Pine	Retained	56cm	35 x 12m	Fair Poor	heavy lean	No works recommendations have been made	Medium	6.72m	2.7m	Exotic	6-10	heavy lean See Appendix 1 Tree Photos Photo 127
									0%	<input type="checkbox"/> Encroached?			
126	<i>Pinus muricata</i> Bishop Pine	Retained	46cm	30 x 8m	Fair Fair	heavy lean	No works recommendations have been made	High	5.52m	2.5m	Exotic	11-20	heavy lean See Appendix 1 Tree Photos Photo 128
									0%	<input type="checkbox"/> Encroached?			
127	<i>Pinus muricata</i> Bishop Pine	Retained	89cm	40 x 8m	Fair Fair		No works recommendations have been made	High	10.68m	3.3m	Exotic	11-20	See Appendix 1 Tree Photos Photo 129 Note: Encroach Type: P2b Compacted gravel

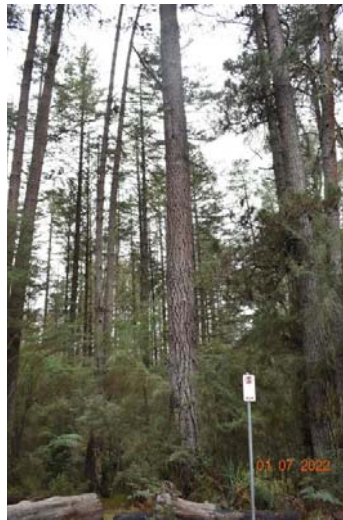
Photo 130: Tree 128 (photo C&R Ryder Consulting P/L)

1%	<input type="checkbox"/> Encroached?			
128	<i>Pinus muricata</i> Bishop Pine	Retained	94cm	40 x 8m	Fair Fair		No works recommendations have been made	High	11.28m	3.3m	Exotic	11-20	See Appendix 1 Tree Photos Photo 130 Note: Encroach Type: P2b Compacted gravel
									2%	<input type="checkbox"/> Encroached?

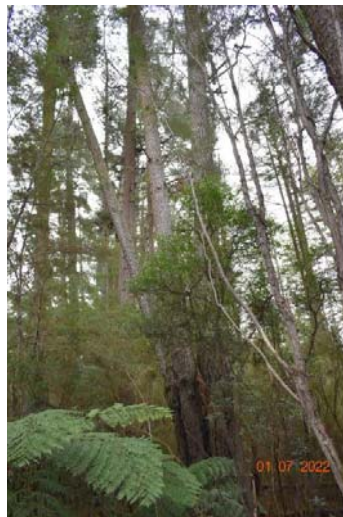
Photo 133: Tree 131 (photo C&R Ryder Consulting P/L)

TREE #	SPECIES / COMMON NAME	IMPACT OUTCOME	DBH ¹	HEIGHT x Width	HEALTH STRUCTURE	DEFECTS/ CONDITIONS ²	ACTIONS ³	RETENTION VALUE	TPZ ⁴ Encroach.	SRZ ⁵ Encroached?	ORIGIN	LIFE Exp. ⁶	COMMENTS
129	<i>Pinus muricata</i> Bishop Pine	Retained	101cm	42 x 10m	Fair Fair		No works recommendations have been made	High	12.12m	3.5m	Exotic	11-20	See Appendix 1 Tree Photos Photo 131 Note: Encroach Type: P2b Compacted gravel
									2%	<input type="checkbox"/> Encroached?			
130	<i>Pinus muricata</i> Bishop Pine	Retained	58cm	32 x 6m	Fair Fair	codominant at 3m	No works recommendations have been made	Medium	6.96m	2.7m	Exotic	11-20	codominant at 3m See Appendix 1 Tree Photos Photo 132
									0%	<input type="checkbox"/> Encroached?			
131	<i>Pinus muricata</i> Bishop Pine	Retained	102cm	40 x 8m	Fair Fair	codominant at 2m	No works recommendations have been made	Medium	12.24m	3.4m	Exotic	6-10	codominant at 2m See Appendix 1 Tree Photos Photo 133 Note: Encroach Type: P2b Compacted gravel

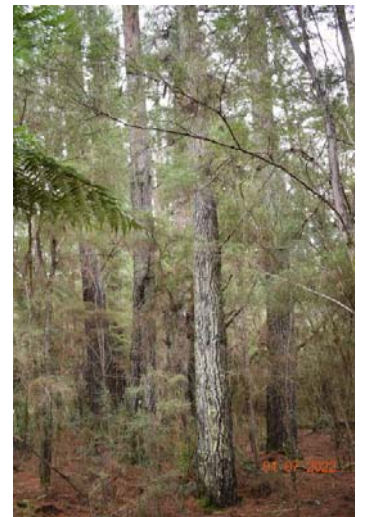
Photo 134: Tree 132 (photo C&R Ryder Consulting P/L)

1%	<input type="checkbox"/> Encroached?			
132	<i>Pinus muricata</i> Bishop Pine	Retained	119cm	42 x 10m	Fair Fair	codominant at 4m	No works recommendations have been made	High	14.28m	3.7m	Exotic	11-20	codominant at 4m See Appendix 1 Tree Photos Photo 134
									0%	<input type="checkbox"/> Encroached?			
133	<i>Pinus muricata</i> Bishop Pine	Retained	53cm	36 x 4m	Fair Fair		No works recommendations have been made	High	6.36m	2.7m	Exotic	11-20	See Appendix 1 Tree Photos Photo 135
									0%	<input type="checkbox"/> Encroached?			
134	<i>Pinus muricata</i> Bishop Pine	Retained	93cm	40 x 10m	Fair Fair	codominant at 7m	No works recommendations have been made	High	11.16m	3.3m	Exotic	11-20	codominant at 7m See Appendix 1 Tree Photos Photo 136 Note: Encroach Type: P2b Compacted gravel
									3%	<input type="checkbox"/> Encroached?			
135	<i>Pinus muricata</i> Bishop Pine	Retained	87cm	38 x 8m	Fair Fair		No works recommendations have been made	High	10.44m	3.2m	Exotic	11-20	See Appendix 1 Tree Photos Photo 137 Note: Encroach Type: P2b Compacted gravel

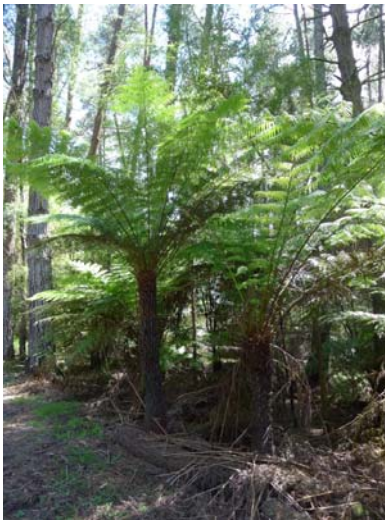
Photo 138: Tree 136 (photo C&R Ryder Consulting P/L)

4%	<input checked="" type="checkbox"/> Encroached?			
136	<i>Cyathea australis</i> Rough Tree-fern	Retained	26cm	4 x 3m	Good Good		No works recommendations have been made	Medium	2.5m	1.9m	Vic Native	20+	See Appendix 1 Tree Photos Photo 138
									0%	<input type="checkbox"/> Encroached?			
137	<i>Cyathea australis</i> Rough Tree-fern	Retained	25cm	2m x 3m	Good Good		No works recommendations have been made	Medium	2.5m	1.9m	Vic Native	20+	See Appendix 1 Tree Photos Photo 139
									0%	<input type="checkbox"/> Encroached?			
138	<i>Cyathea australis</i> Rough Tree-fern	Retained	25cm	3 x 3m	Good Good		No works recommendations have been made	Medium	2.5m	1.9m	Vic Native	20+	See Appendix 1 Tree Photos Photo 140
									0%	<input type="checkbox"/> Encroached?			
139	<i>Cyathea australis</i> Rough Tree-fern	Retained	25cm	3 x 3m	Good Good		No works recommendations have been made	Medium	2.5m	1.9m	Vic Native	20+	See Appendix 1 Tree Photos Photo 141

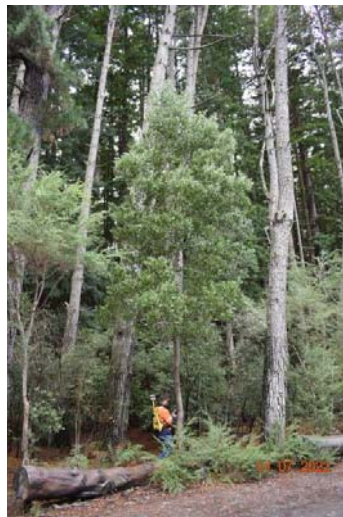
Photo 142: Tree 140 (photo C&R Ryder Consulting P/L)

0%	<input type="checkbox"/> Encroached?			
140	<i>Acacia dealbata</i> Silver Wattle	Retained	27cm	16 x 8m	Good Good		No works recommendations have been made	Medium	3.24m	2.1m	Vic Native	11-20	See Appendix 1 Tree Photos Photo 142
									0%	<input type="checkbox"/> Encroached?

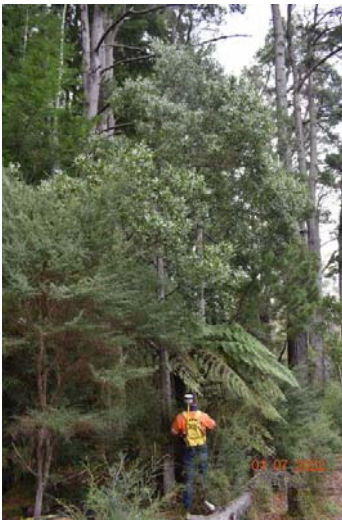
Photo 147: Tree 145 (photo C&R Ryder Consulting P/L)

0%	<input type="checkbox"/> Encroached?			
145	<i>Acacia melanoxylon</i> Blackwood	Retained	10cm	5 x 3m	Good Good		No works recommendations have been made	Low	2m	1.5m	Vic Native	20+	See Appendix 1 Tree Photos Photo 147
									0%	<input type="checkbox"/> Encroached?			
146	<i>Acacia melanoxylon</i> Blackwood	Retained	20cm	8 x 4m	Good Good		No works recommendations have been made	Low	2.4m	1.8m	Vic Native	20+	See Appendix 1 Tree Photos Photo 148
									0%	<input type="checkbox"/> Encroached?			
147	<i>Sequoia sempervirens</i> Coast Redwood	Retained	21cm	10 x 4m	Good Good		No works recommendations have been made	Medium	2.52m	1.9m	Exotic	20+	See Appendix 1 Tree Photos Photo 149
									0%	<input type="checkbox"/> Encroached?			
148	<i>Sequoia sempervirens</i> Coast Redwood	Retained	22cm	10 x 4m	Good Good		No works recommendations have been made	Low	2.64m	1.8m	Exotic	20+	Check species identification of this tree. Photo appears to be of a Blackwood See Appendix 1 Tree Photos Photo 150

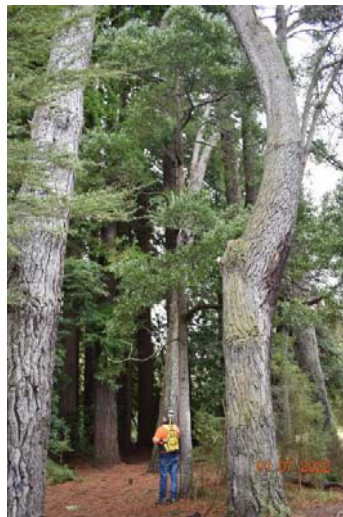
Photo 151: Tree 149 (photo C&R Ryder Consulting P/L)

0%	<input type="checkbox"/> Encroached?			
149	<i>Cyathea australis</i> Rough Tree-fern	Retained	27cm	4 x 3m	Good Good		No works recommendations have been made	Medium	2.5m	2m	Vic Native	20+	See Appendix 1 Tree Photos Photo 151
									0%	<input type="checkbox"/> Encroached?			
150	<i>Acacia melanoxylon</i> Blackwood	Retained	25cm	10 x 4m	Good Good		No works recommendations have been made	Medium	3m	2m	Vic Native	20+	See Appendix 1 Tree Photos Photo 152
									0%	<input type="checkbox"/> Encroached?			
151	<i>Acacia melanoxylon</i> Blackwood	Retained	58cm	20 x 8m	Good Fair		No works recommendations have been made	High	6.96m	2.9m	Vic Native	20+	See Appendix 1 Tree Photos Photo 153 Note: Encroach Type: Culvert drain
									1%	<input type="checkbox"/> Encroached?			
152	<i>Eucalyptus viminalis</i> Manna Gum	Retained	117cm	38 x 16m	Good Fair		No works recommendations have been made	Very High	14.04m	3.8m	Vic Native	20+	close to road edge. See Appendix 1 Tree Photos Photo 154 Note: Encroach Type: Culvert drain

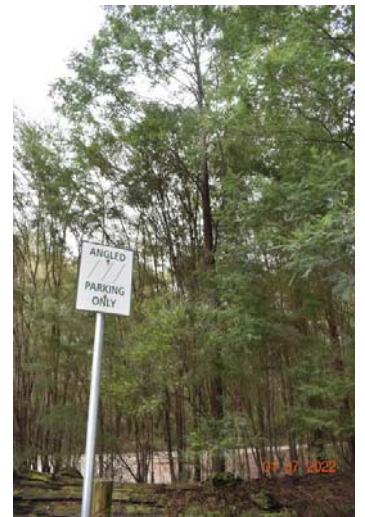
Photo 161: Tree 159 (photo C&R Ryder Consulting P/L)

159	<i>Acacia dealbata</i> Silver Wattle	Lost	60cm	17 x 12m	Fair Fair	codominant at 5m	No works recommendations have been made	Medium	7.2m	2.8m	Vic Native	11-20	codominant at 5m See Appendix 1 Tree Photos Photo 161 Note: Encroach Type: P2b Compacted gravel
									100%	<input checked="" type="checkbox"/> Encroached?			
160	<i>Acacia dealbata</i> Silver Wattle	Lost	19cm	10-14m x 4m	Good Good		No works recommendations have been made	Low	2.28m	1.8m	Vic Native	11-20	See Appendix 1 Tree Photos Photo 162 Note: Encroach Type: P4 Concrete
									100%	<input checked="" type="checkbox"/> Encroached?			
161	<i>Acacia dealbata</i> Silver Wattle	Lost	27cm	12 x 5m	Good Good		No works recommendations have been made	Medium	3.24m	2m	Vic Native	11-20	See Appendix 1 Tree Photos Photo 163 Note: Encroach Type: P4 Concrete
									100%	<input checked="" type="checkbox"/> Encroached?			
162	<i>Acacia dealbata</i> Silver Wattle	Retained	32cm	16 x 8m	Good Fair		No works recommendations have been made	Medium	3.84m	2.2m	Vic Native	11-20	See Appendix 1 Tree Photos Photo 164

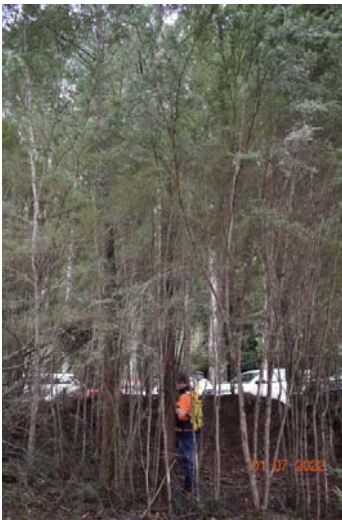
Photo 165: Tree 163 (photo C&R Ryder Consulting P/L)

0%	<input type="checkbox"/> Encroached?			
163	<i>Acacia dealbata</i> Silver Wattle	Retained	19cm	15 x 3m	Good Good		No works recommendations have been made	Low	2.28m	1.8m	Vic Native	11-20	See Appendix 1 Tree Photos Photo 165
									0%	<input type="checkbox"/> Encroached?

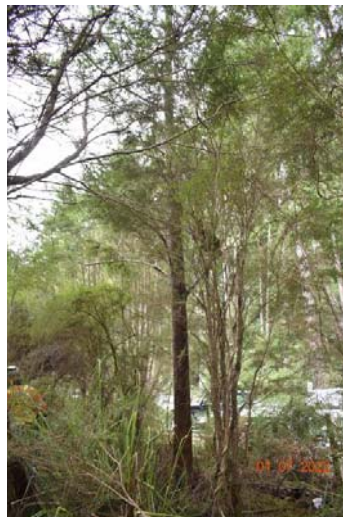
Photo 169: Tree 167 (photo C&R Ryder Consulting P/L)

167	<i>Acacia dealbata</i> Silver Wattle	Retained	30cm	17 x 6m	Good Good		No works recommendations have been made	Medium	3.6m 0%	2.2m <input type="checkbox"/> Encroached?	Vic Native	20+	See Appendix 1 Tree Photos Photo 169
168	<i>Acacia dealbata</i> Silver Wattle	Lost	26cm	16 x 7m	Good Good		No works recommendations have been made	Medium	3.12m 40%	2m <input checked="" type="checkbox"/> Encroached?	Vic Native	11-20	See Appendix 1 Tree Photos Photo 170 Note: Encroach Type: P2b Compacted gravel (Significant SRZ encroachment)
169	<i>Cyathea australis</i> Rough Tree-fern	Retained	25cm	4 x 3m	Good Good		No works recommendations have been made	Medium	2.5m 0%	1.9m <input type="checkbox"/> Encroached?	Vic Native	20+	patch of several specimens. See Appendix 1 Tree Photos Photo 171
170	<i>Acacia melanoxylon</i> Blackwood	Lost (Remove)	78cm	14 x 8m	Dead Poor	tree is likely to fail	Tree Removal	Low	9.36m 24%	3.1m <input checked="" type="checkbox"/> Encroached?	Vic Native	0	tree is likely to fail Reasons for tree removal: Decline of Structure See Appendix 1 Tree Photos Photo 172 Note: Encroach Type: P2b Compacted gravel (Dead tree stem could be reduced to <=6m and retained for habitat if desired)

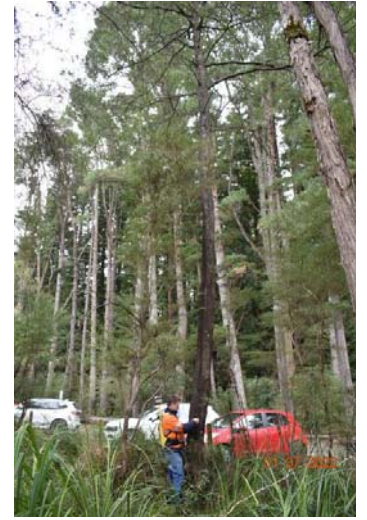
Photo 173: Tree 171 (photo C&R Ryder Consulting P/L)

171	<i>Acacia melanoxylon</i> Blackwood	Lost	32cm	17 x 8m	Good Good		No works recommendations have been made	Medium	3.84m 100%	2.2m <input checked="" type="checkbox"/> Encroached?	Vic Native	11-20	See Appendix 1 Tree Photos Photo 173 Note: Encroach Type: P2b Compacted gravel
172	<i>Pomaderris aspera</i> Hazel Pomaderris	Retained	22cm	9 x 6m	Fair Fair		No works recommendations have been made	Medium	2.64m 0%	1.9m <input type="checkbox"/> Encroached?	Vic Native	11-20	See Appendix 1 Tree Photos Photo 174
173	<i>Pomaderris aspera</i> Hazel Pomaderris	Lost	18cm	9 x 4m	Fair Poor		No works recommendations have been made	Medium	2.16m 100%	1.7m <input checked="" type="checkbox"/> Encroached?	Vic Native	6-10	See Appendix 1 Tree Photos Photo 175 Note: Encroach Type: P2b Compacted gravel

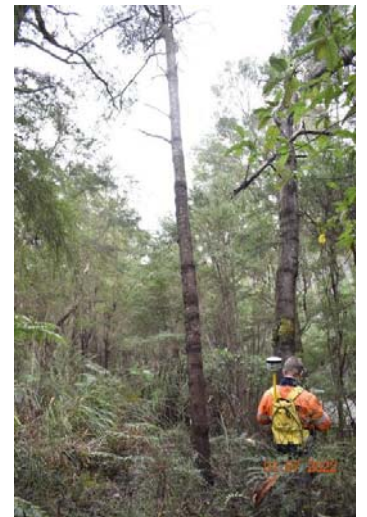
Photo 179: Tree 177 (photo C&R Ryder Consulting P/L)

100%	<input checked="" type="checkbox"/> Encroached?			
177	<i>Acacia dealbata</i> Silver Wattle	Remove	26cm	13 x 7m	Poor Poor		Tree Removal	Low	3.12m	2.1m	Vic Native	0	leaning towards car park Reasons for tree removal: Poor health and structure See Appendix 1 Tree Photos Photo 179 Note: Encroach Type: P2b Compacted gravel
									10%	<input checked="" type="checkbox"/> Encroached?			
178	<i>Acacia dealbata</i> Silver Wattle	Remove	21cm	11 x 5m	Dead Poor		Tree Removal	Low	2.52m	1.9m	Vic Native	0	remove tree Reasons for tree removal: Poor health and structure See Appendix 1 Tree Photos Photo 180
									0%	<input type="checkbox"/> Encroached?			
179	<i>Eucalyptus obliqua</i> Messmate	Retained	108cm	35 x 18m	Good Good		No works recommendations have been made	High	12.96m	3.7m	Vic Native	20+	See Appendix 1 Tree Photos Photo 181 Note: Encroach Type: P2b Compacted gravel (Arborist to be present during excavation)

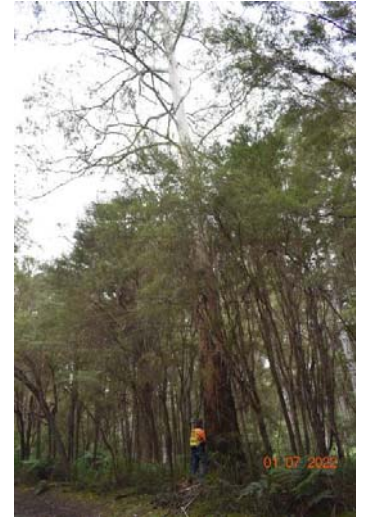
Photo 182: Tree 180 (photo C&R Ryder Consulting P/L)

13%	<input type="checkbox"/> Encroached?			
180	<i>Pinus muricata</i> Bishop Pine	Retained	46cm	18 x 7m	Good Good		No works recommendations have been made	High	5.52m	2.5m	Exotic	20+	See Appendix 1 Tree Photos Photo 182
									0%	<input type="checkbox"/> Encroached?			
181	<i>Eucalyptus viminalis</i> Manna Gum	Retained	92cm	35 x 18m	Good Good		No works recommendations have been made	High	11.04m	3.4m	Vic Native	20+	See Appendix 1 Tree Photos Photo 183 Note: Encroach Type: P2b Compacted gravel
									3%	<input type="checkbox"/> Encroached?			
182	<i>Eucalyptus viminalis</i> Manna Gum	Retained	69cm	40 x 12m	Good Good		No works recommendations have been made	High	8.28m	3m	Vic Native	20+	See Appendix 1 Tree Photos Photo 184
									0%	<input type="checkbox"/> Encroached?			
183	<i>Acacia dealbata</i> Silver Wattle	Remove	35cm	25 x 8m	Dead Poor		Tree Removal	None	4.2m	2.2m	Vic Native	0	remove tree Reasons for tree removal: Decline of Structure See Appendix 1 Tree Photos Photo 185 Note: Encroach Type: P2b Compacted gravel

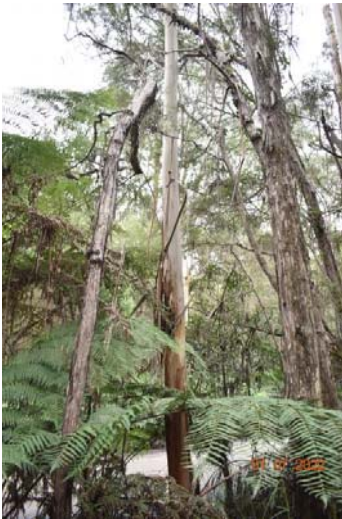
Photo 189: Tree 187 (photo C&R Ryder Consulting P/L)

187	<i>Acacia dealbata</i> Silver Wattle	Retained	35cm	19 x 8m	Fair Fair		No works recommendations have been made	Medium	4.2m	2.3m	Vic Native	11-20	See Appendix 1 Tree Photos Photo 189 Note: Encroach Type: P2b Compacted gravel
									13%	<input type="checkbox"/> Encroached?			
188	<i>Eucalyptus viminalis</i> Manna Gum	Retained	25cm	25 x 8m	Good Fair		No works recommendations have been made	Medium	3m	2m	Vic Native	20+	See Appendix 1 Tree Photos Photo 190
									0%	<input type="checkbox"/> Encroached?			
189	<i>Eucalyptus viminalis</i> Manna Gum	Retained	52cm	35 x 10m	Good Good		No works recommendations have been made	High	6.24m	2.7m	Vic Native	20+	See Appendix 1 Tree Photos Photo 191
									0%	<input type="checkbox"/> Encroached?			
190	<i>Eucalyptus viminalis</i> Manna Gum	Retained	41cm	22 x 6m	Fair Fair	borers in trunk	No works recommendations have been made	Medium	4.92m	2.5m	Vic Native	11-20	borers in trunk See Appendix 1 Tree Photos Photo 192

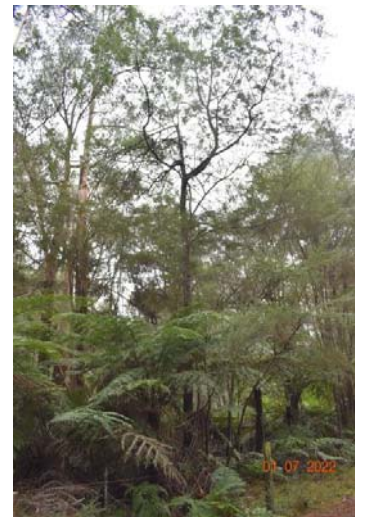
Photo 197: Tree 195 (photo C&R Ryder Consulting P/L)

0%	<input type="checkbox"/> Encroached?			
195	<i>Acacia dealbata</i> Silver Wattle	Retained	26cm	18 x 8m	Good Fair		No works recommendations have been made	Medium	3.12m	2m	Vic Native	11-20	See Appendix 1 Tree Photos Photo 197 Note: Encroach Type: P2b Compacted gravel
									15%	<input checked="" type="checkbox"/> Encroached?
