**ATTACHMENT D:
PILE CAP EXPOSURES,
REPORT**

20144725-003-L-Rev0

28 CLARENDON STREET, SOUTHBANK – PILE CAP EXPOSURES

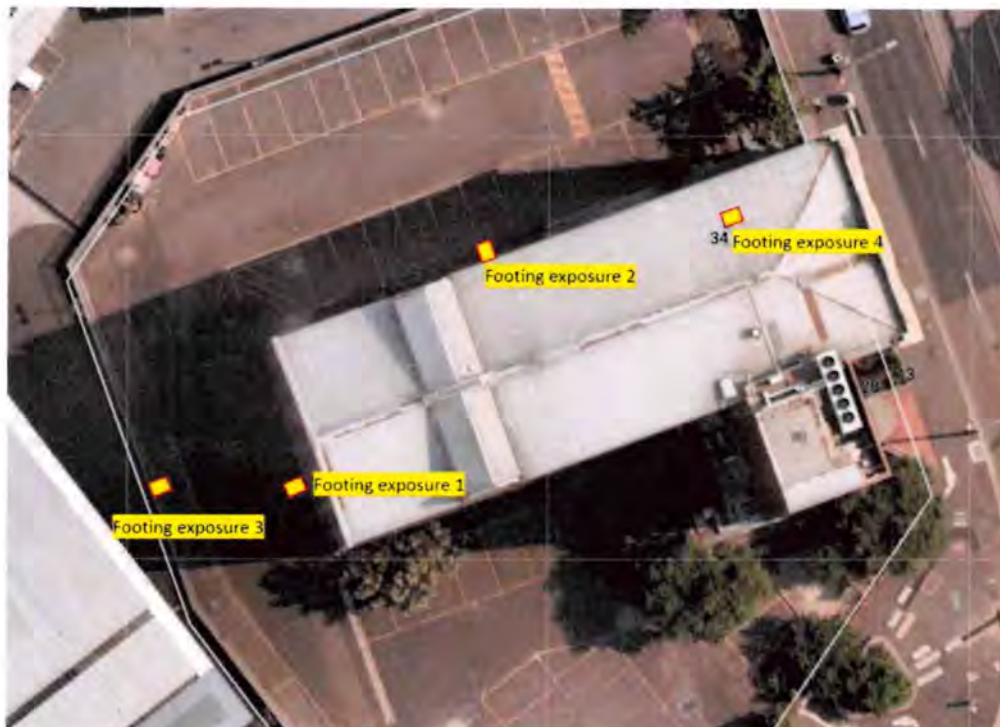
Figure 1: Investigation location plan

A geotechnical engineer from Golder attended the site on 7, 16 and 18 December 2020 to undertake three footing exposures of pile caps and one footing exposure underneath the western perimeter wall of the site as directed by CostaFox with input from RBG. The location of pile cap/footing exposures are shown on Figure 1. Prior to undertaking excavation works a service locator was engaged to undertaken service clearance on 7 and 16 December 2020 to identify the location of underground services. The following information is relevant to the footing exposures:
