# Tree Audit and Risk Assessment Report

Ormond College  
49 College Cres, Parkville

Report prepared by  
Matthew P James  
*MUrbanHort* (studying)  
*GradCertArb*  
*Dip.Arb*

Submitted  
27/02/2025

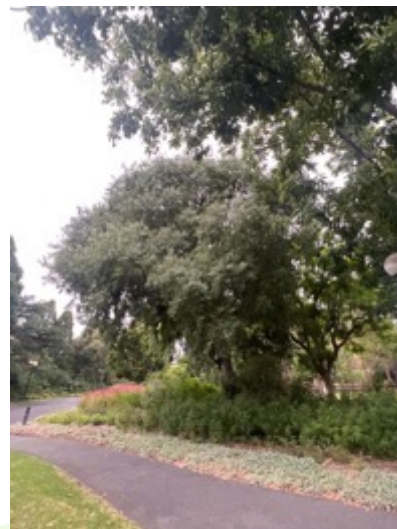
**Tree Id:** 116

**Observations:** Decay. Hollows. Included codominant stems. Previously lopped. Previous failures. Cable brace installed.

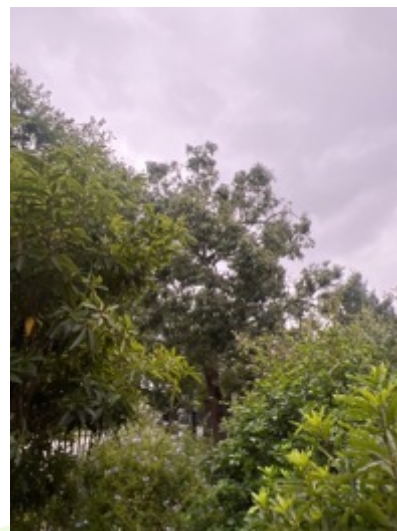
**Tree Id:** 119 **Location:** Onsite  
**Botanical Name:** *Syzygium sp.* **Origin:** Aus. Native  
**Common Name:** Lilly Pilly **Age:** Mature  
**Tree Height (m):** 12 **Canopy Spread (m):** 12 **DBH (cm):** 70  
**Health:** Good **Structure:** Fair **ULE:** Medium  
**Observations:** ?australe. Encroaching structures.  
**Works:** Asset clearance  
**Priority:** Asset Management **RoH:** <1/1,000,000 **TPZ (m):** 8.4

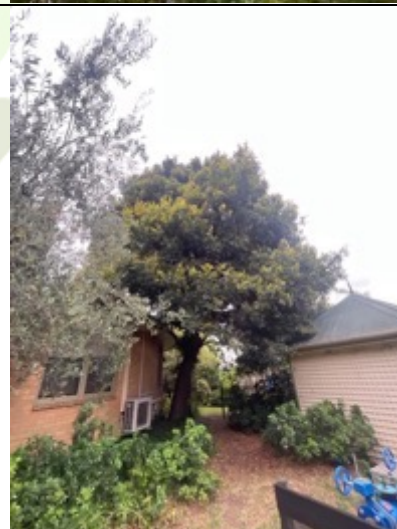
**Tree Id:** 120 **Location:** Onsite  
**Botanical Name:** *Pittosporum undulatum* **Origin:** Vic. Native  
**Common Name:** Sweet Pittosporum **Age:** Semi mature  
**Tree Height (m):** 6 **Canopy Spread (m):** 6 **DBH (cm):** 26  
**Health:** Poor **Structure:** Fair **ULE:** Short  
**Observations:** Weed species. Acute codominant stems. In decline.  
**Works:** Removal  
**Priority:** Medium **RoH:** <1/1,000,000 **TPZ (m):** 3.12
