**APPENDIX C:
ROBERT BIRD GROUP,
HERITAGE BUILDING
STRUCTURAL WORKS FOR
TEA HOUSE**

Heritage Building Structural Works for **Tea House**

Issue: F – For Authority Approval

26 May 2022

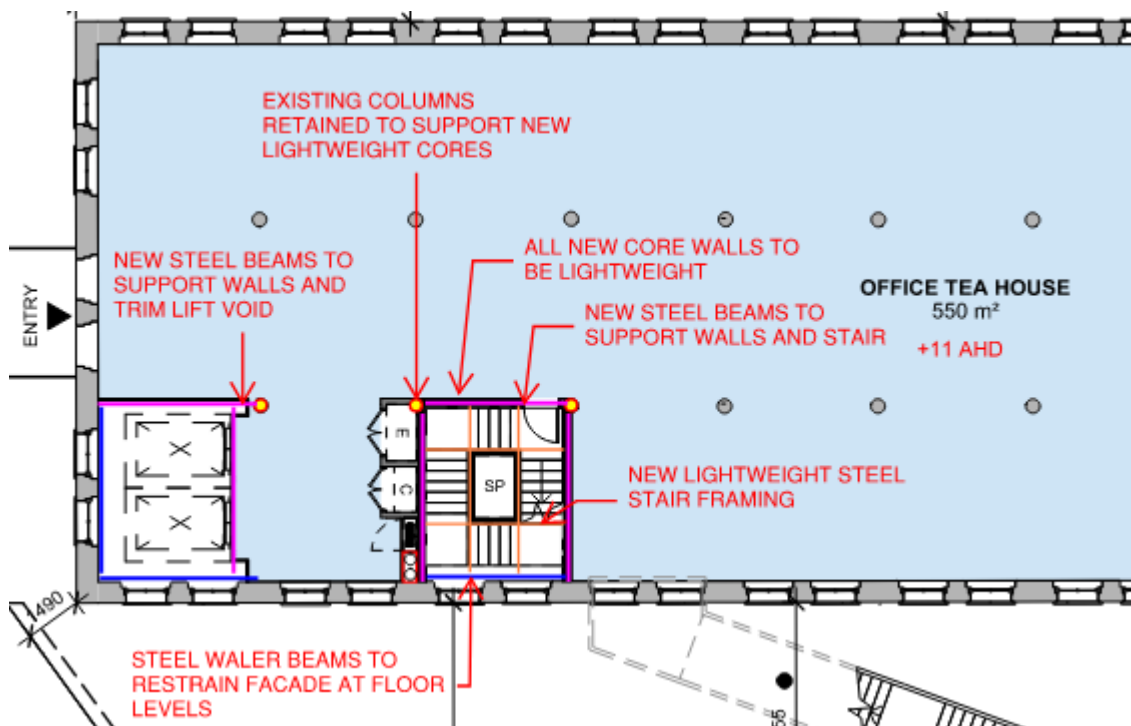
Figure 1: Lift and Stair Core Framing

In order to minimise impact on the existing floor members, the new stair core will utilise only the footings of the existing structure and be otherwise self-supporting. The proposed framing will consist of steel columns and floor beams, shown indicatively in Figure 1.

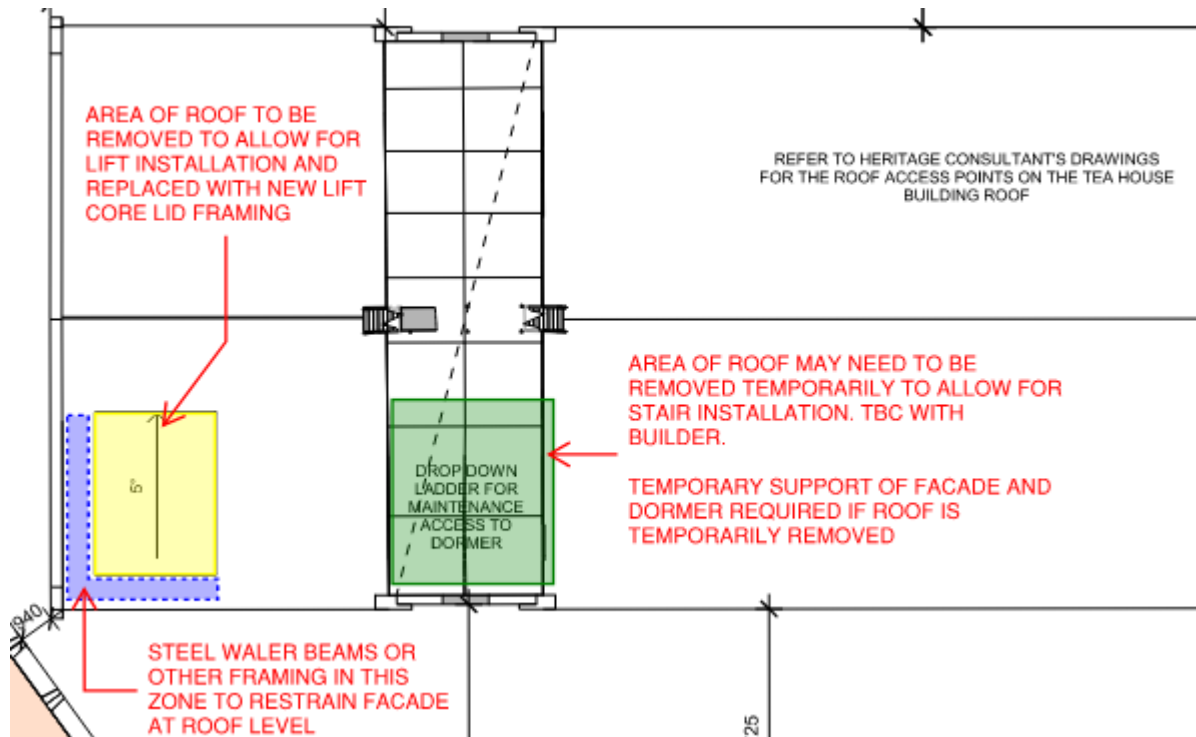
Figure 2: Lift and stair roof modifications

Installation of the proposed lifts and stairs will require partial demolition of existing framing. The anticipated extent is shown in yellow and green shading in the above figure, which shall be confirmed with the builder, once appointed.

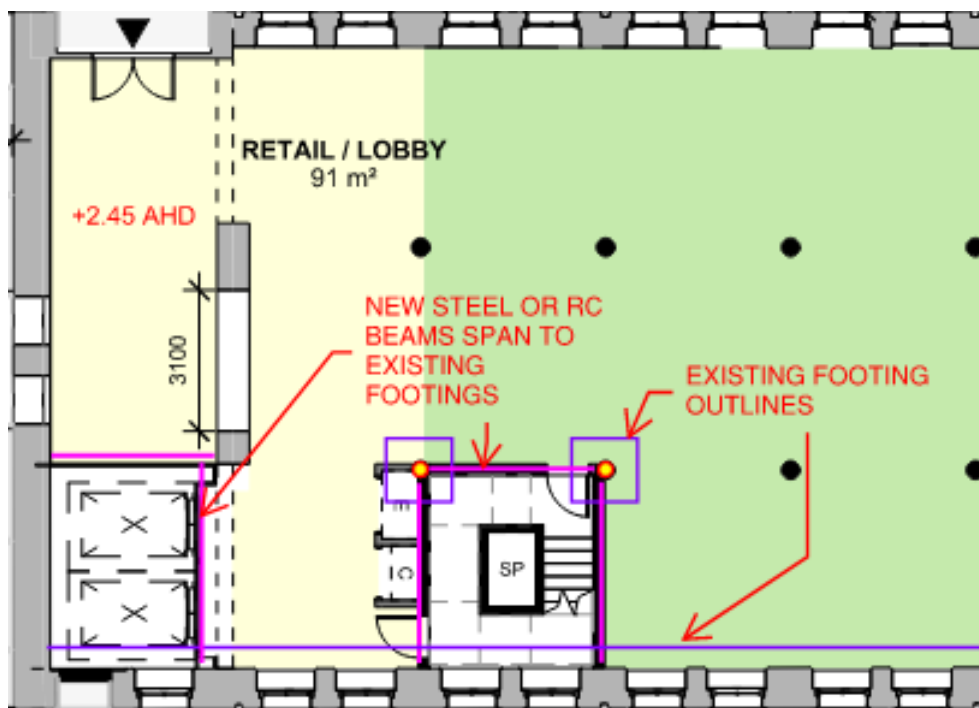
Figure 3: Lift and Stair Core Footing Concepts

Further modifications will be required within the crawl-space – and to a minor extent on ground floor – to connect the new framing to the existing footings. It is proposed that the framing, which may be steel or reinforced concrete beams, span between the existing footings as shown in Figure 3.

For both the steel and RC beam options, the beams can simply rest on top of the bluestone load-spreader, with drill and epoxy reinforcing bars from the beam into the existing footing.

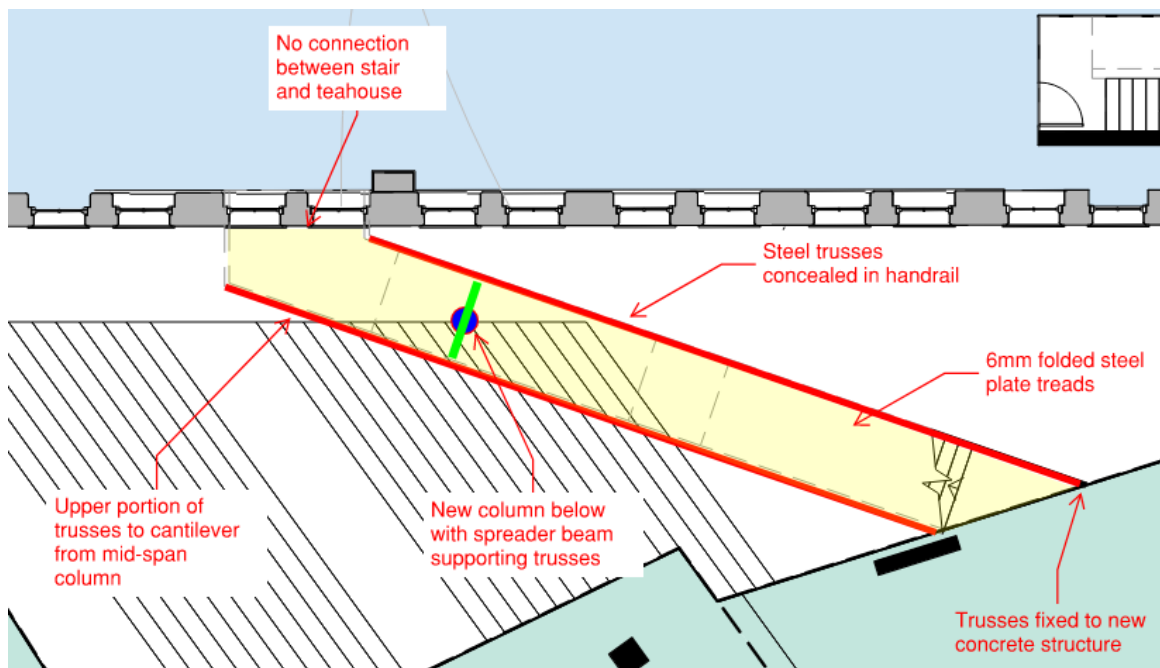
Proposed Southern Link Bridge Structural Arrangement

The new bridge connection to the southern side of the Tea House is proposed to be supported by the new concrete retail structure at its eastern end and by a single new column near to its western end. This structural arrangement does not rely on support from the Tea House itself and thus fixings to the heritage masonry will be kept to a minimum. The proposed arrangement is shown in the image below.

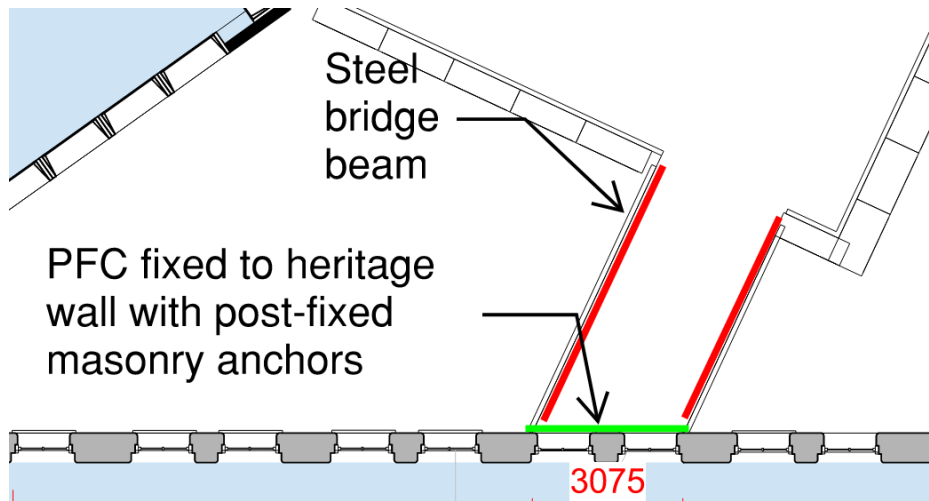
Proposed Northern Link Bridge Structural Arrangement

The bridge proposed to link to the northern face of the Tea House is intended to be constructed from two primary UB stringers fixing to a PFC positioned flush against the heritage wall. The PFC will be fixed to the façade via post-fixed masonry anchors through its web. The proposed arrangement is indicatively shown in the image below.

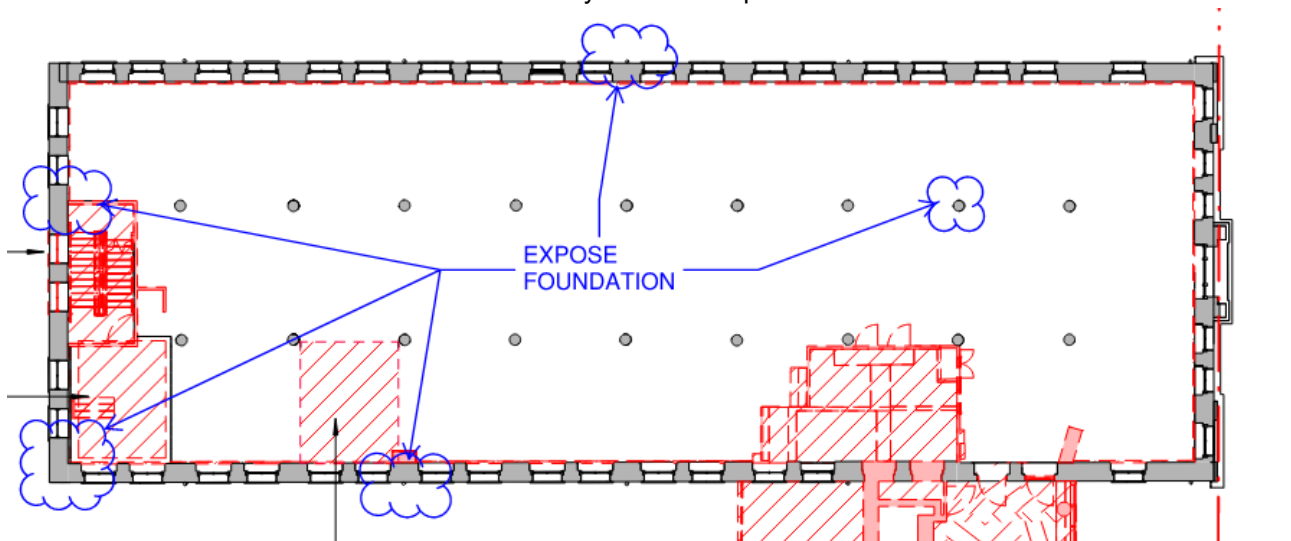
Figure 1: Locations where the tops of the existing piles are to be exposed.

The existing foundations, which are understood to be timber piles, shall be investigated to determine if there is any damage or deterioration. The following scope is proposed for their investigation:

- Excavate locally to expose the tops of the timber piles under a pile cap. The pile cap shall not be undermined, both RBG and Golders shall be on site during excavation works. A timber specialist shall also be in attendance when the tops of the timber piles are exposed.
- Measure the dimensions of the existing pile cap including height, length and depth
- Determine the construction of the existing pile cap: construction material and dimensions. Determine the condition and map any deterioration observed
- Do integrity testing on the pile to determine its approximate length
- Determine the timber grade and species of the pile, and drill a core sample of the pile to determine any deterioration across its section – to be done by the timber specialist

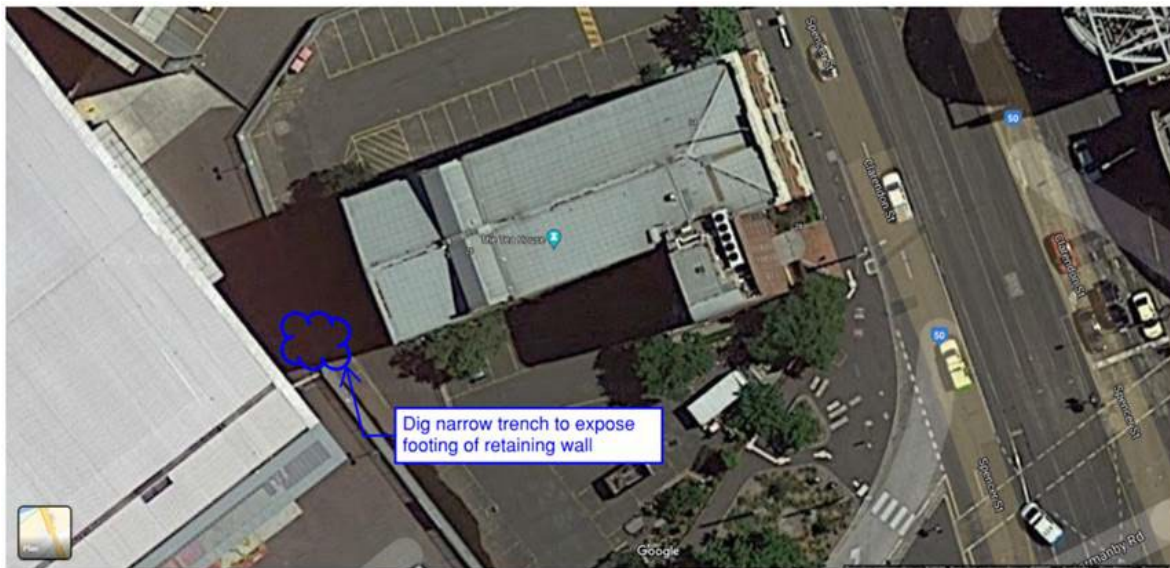
Figure 2: Location of narrow test pit along site boundary to investigate the footing of the retaining wall on the neighbouring site

The retaining wall on the neighbouring site along the site boundary to the west and north may result in surcharge loading on the proposed site retention. The drawings for this retaining wall shall be provided to RBG for consideration in the structural design. In addition, a test is proposed within the boundary of the Tea House site to determine if the footing from the neighbouring retaining wall is protruding into the site. The trench shall

be narrow and localised, and dug under the supervision of RBG and a geotechnical engineer. The location is proposed in the following figure:

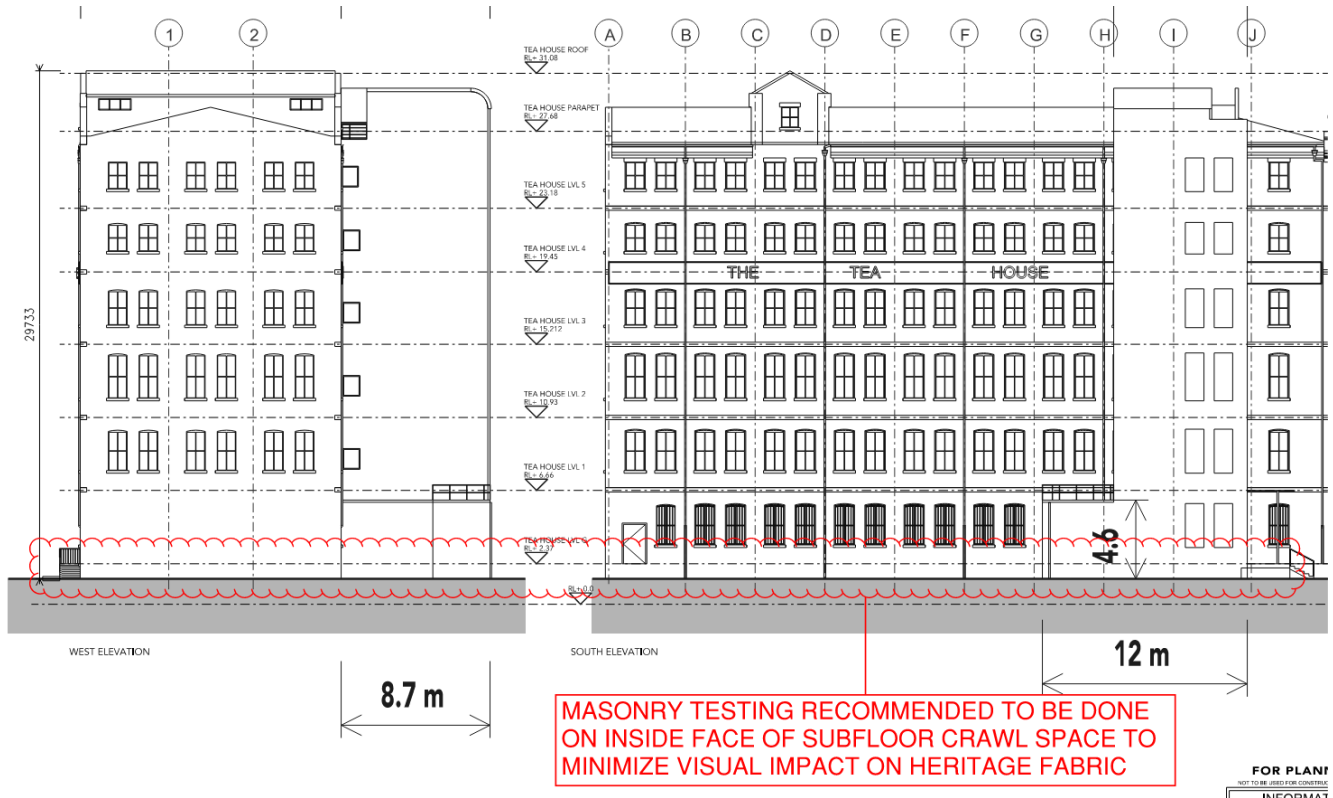
Figure 3: General location proposed for masonry sampling

RBG recommend the masonry tests be done in the crawl space beneath the ground floor slab to minimize their visual impact. The condition and type of the masonry in this location is assumed to be representative of all masonry in the building.

RBG therefore recommend that this test be undertaken, as the damage to the heritage fabric by this test will be relatively minor in comparison with the strengthening works likely required should the test not be performed.

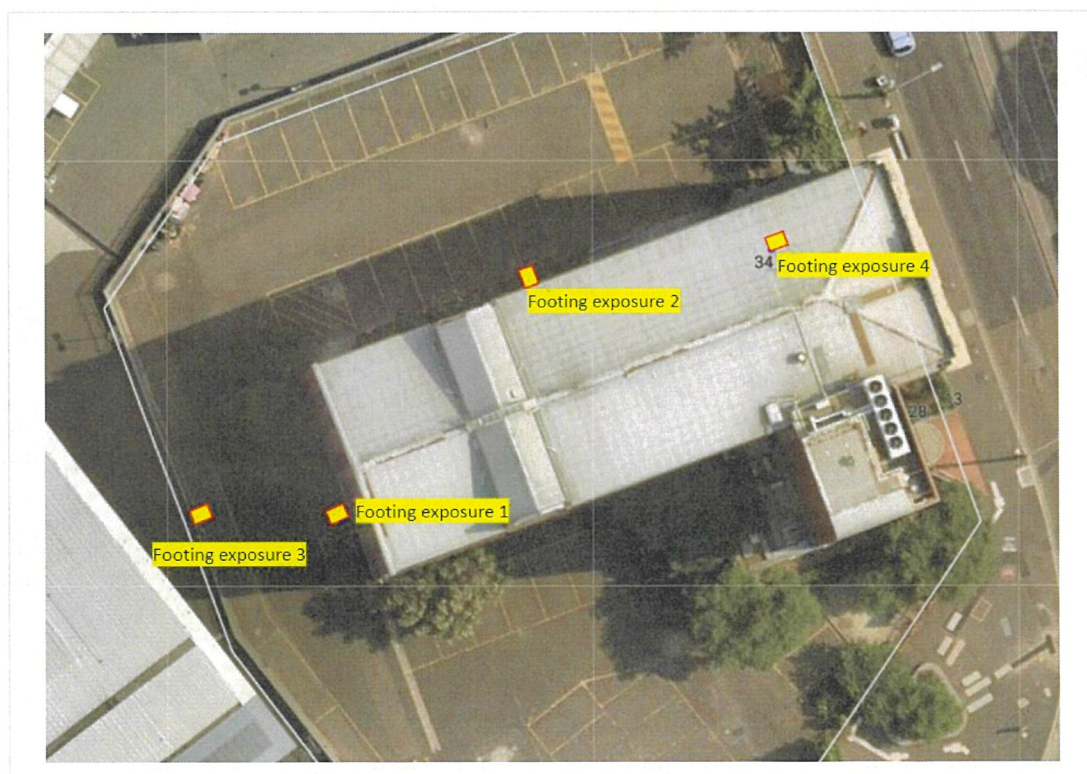
Figure 1: Investigation location plan

A geotechnical engineer from Golder attended the site on 7, 16 and 18 December 2020 to undertake three footing exposures of pile caps and one footing exposure underneath the western perimeter wall of the site as directed by CostaFox with input from RBG. The location of pile cap/footing exposures are shown on Figure 1. Prior to undertaking excavation works a service locator was engaged to undertaken service clearance on 7 and 16 December 2020 to identify the location of underground services. The following information is relevant to the footing exposures:
