# All Saints' Anglican Church

2 Chapel Street, East St Kilda.

March 1999

## EXISTING CONDITION SURVEY

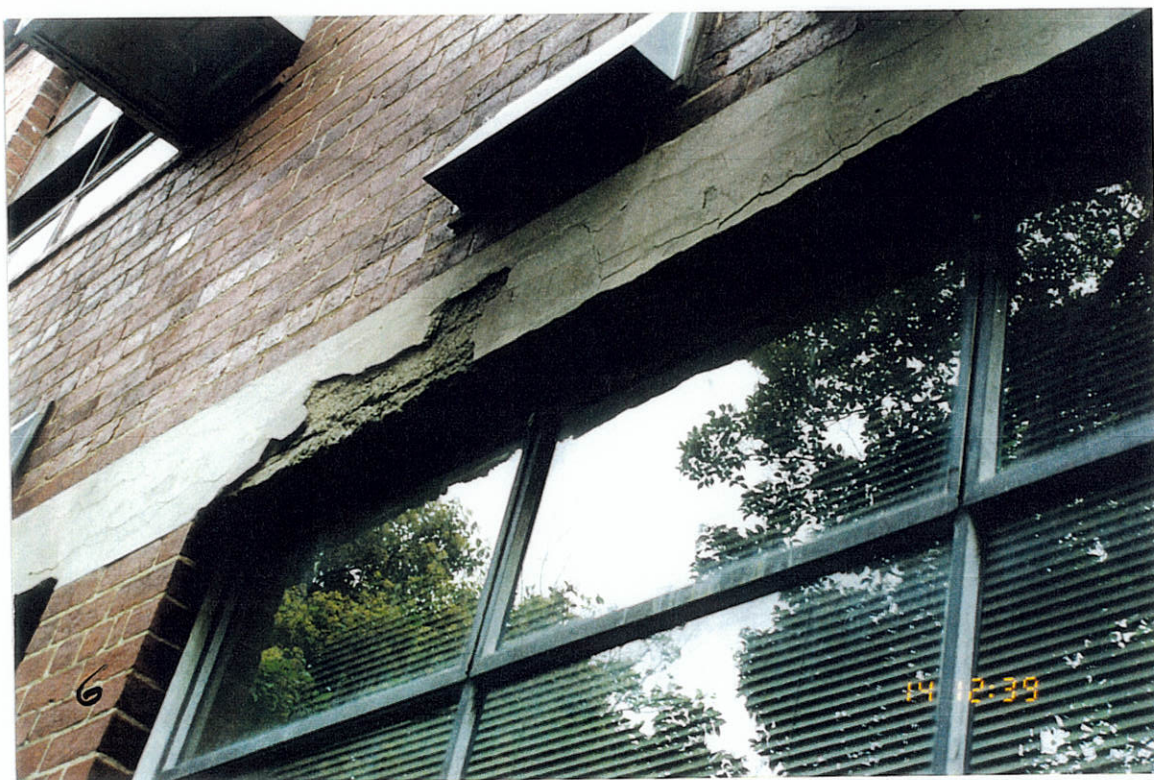
The lintels over the windows to the hall are in a poor state of repair. The concrete lintels to The single storey section of the hall on the south-east side of the building have all cracked because of rusting of the reinforcing steel in the lintels, photo 1. The steel arch bars over many of the windows on the south, west and north side of the hall are rusting, this has caused the render above the lintels to spall and has caused cracking at the ends of the lintel where the bars are embedded in the brickwork. Photos 2-5 show typical examples of the problem. The render to the concrete lintels over the large windows on the north side of the hall is spalling and there are cracks in the lintels, photo 6.

The cracking to the concrete lintels on the north and south sides of the hall is due to the rusting of the reinforcing bars in the lintels, as these rust the volume of rust produced causes an expansion that cracks the concrete. Normally the reinforcing bars are protected from rusting by the alkaline nature of the concrete that surrounds them, but as the concrete ages carbon dioxide in the air converts the alkaline calcium hydroxide in the concrete into non-alkaline calcium carbonate. When the alkalinity of the concrete drops below a pH of 11.5 rusting of the reinforcing bars can occur if water and oxygen is present. Because the rust occupies three times the volume of the steel splitting of the concrete occurs.

Similarly the expansion of the rust to the arch bar lintels has caused the render to spall and the brickwork at each end of the arch bars to crack.

The small concrete lintels to the hall, that have spalled, should be replaced. This will involve needling and tomming the brickwork above the window openings to support it while the old lintels are removed and new concrete lintels are installed. An alternative to the concrete lintels would be to install galvanised steel angle lintels with four courses of new brickwork above the steel lintels to fill the space occupied by the concrete lintels. If the external face of the new brickwork was set back 20 mm it could then be rendered to replicate the appearance of the rendered concrete lintels. The cost of replacing the concrete lintels would be approximately \$1500.00 per lintel. There are 11 lintels that need to be replaced.
