Heritage Impact Statement

Heritage Impact Statement for: Beehive Company Gold Mine

Victorian Heritage Register Number: H1361

Address and location description: Main Street, Maldon (Chimney feature)

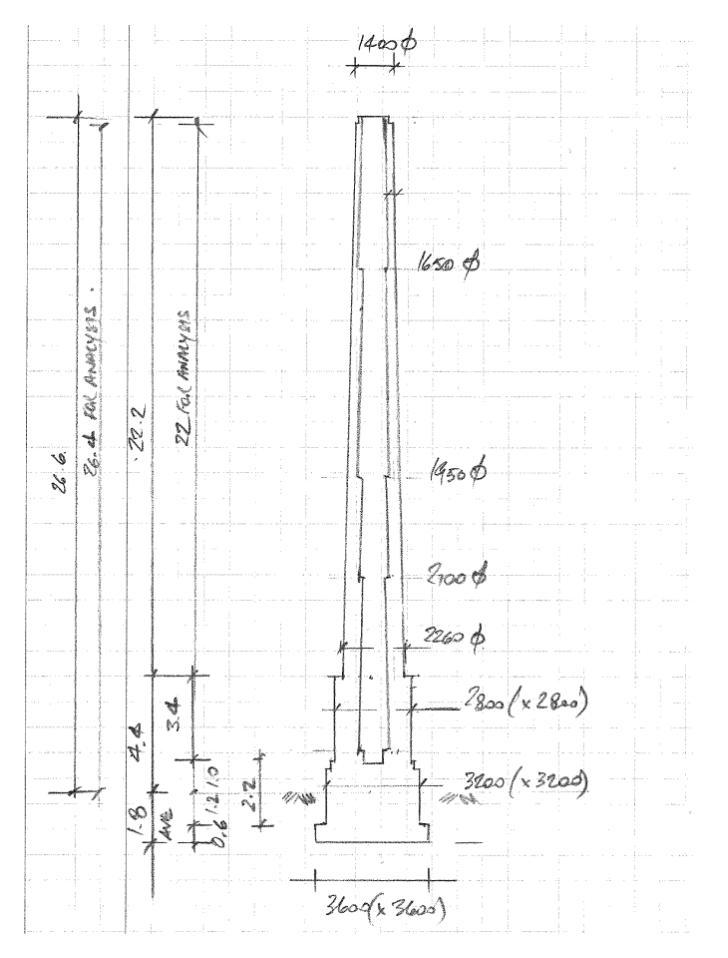
Approximately two metres of the chimney were removed following damage from a lightning strike in 1923. The chimney currently stands at 26.6 metres above the ground – and therefore is estimated to originally have been approximately 29 metres tall. The Chimney consists of tapered circular shaft of varying wall thickness (thickness decreases with increase in height)

seated on a rendered square pedestal (assumed to be rendered brickwork) seated on a stone & brick base / footing (appears predominantly stone). See *Figure 1*.

Figure 1: Structural engineer's sketch of the Chimney, showing the stepped shaft wall thickness
