Heritage Impact Statement

Forum Theatre H0438 – Urgent Makesafe Works

150-162 Flinders Street, Melbourne

RE: PRELIMINARY STRUCTURAL PRIORITY ADVICE

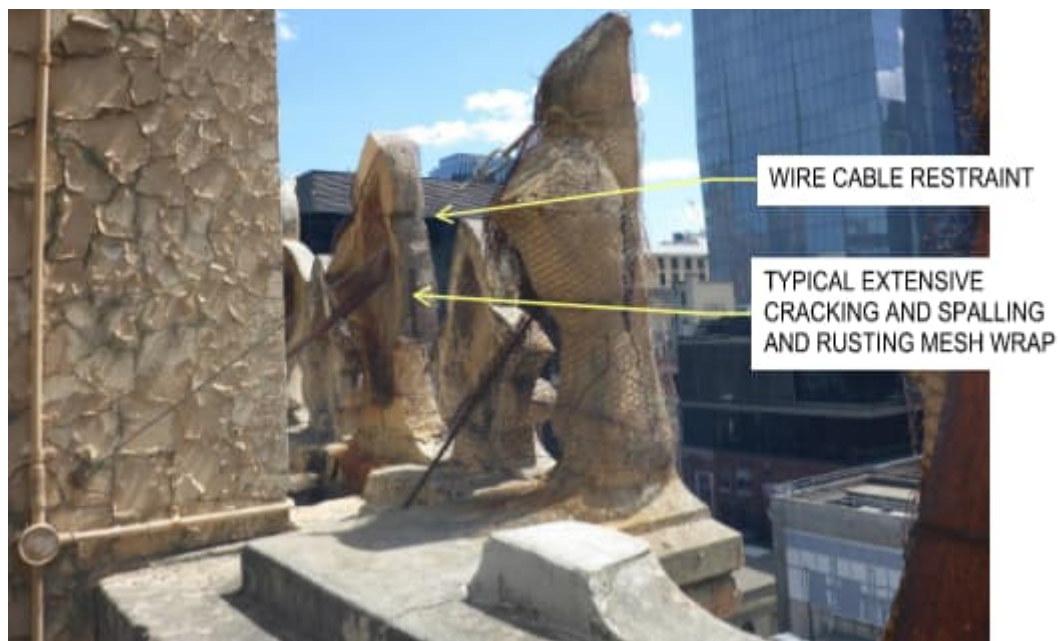
Photos 06 to 11 show various typical views of a pressed cement crenelations along the tower upper balustrade. Many, or most of these have been provided with supplementary metal support and wrapped in a light wire mesh. One or two have been tied back with a short cable as shown in Figure 03 below. The temporary support and mesh is past end of life and the units have continued to deteriorate since it was installed. The stability of these units is parlous both in terms of local spalling and overall stability and they are considered dangerous. I support the Conservation Studio recommendation to remove and store for replication and reinstatement as an urgent priority matter.

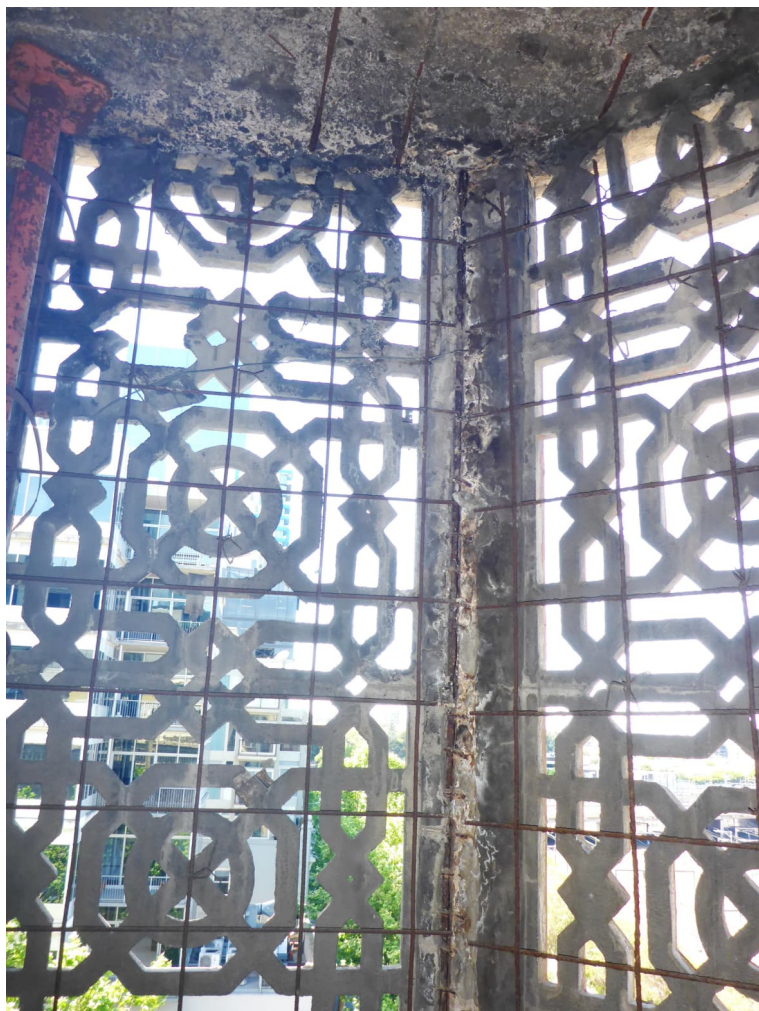
Photo 02

At the top of the bay window screen, the soffit of a slab is visible that appears to cantilever from the brickwork wall below the upper floor slab and beam level. (Refer Photos 02 & 04). This also supports the upper corbels and copper dome.

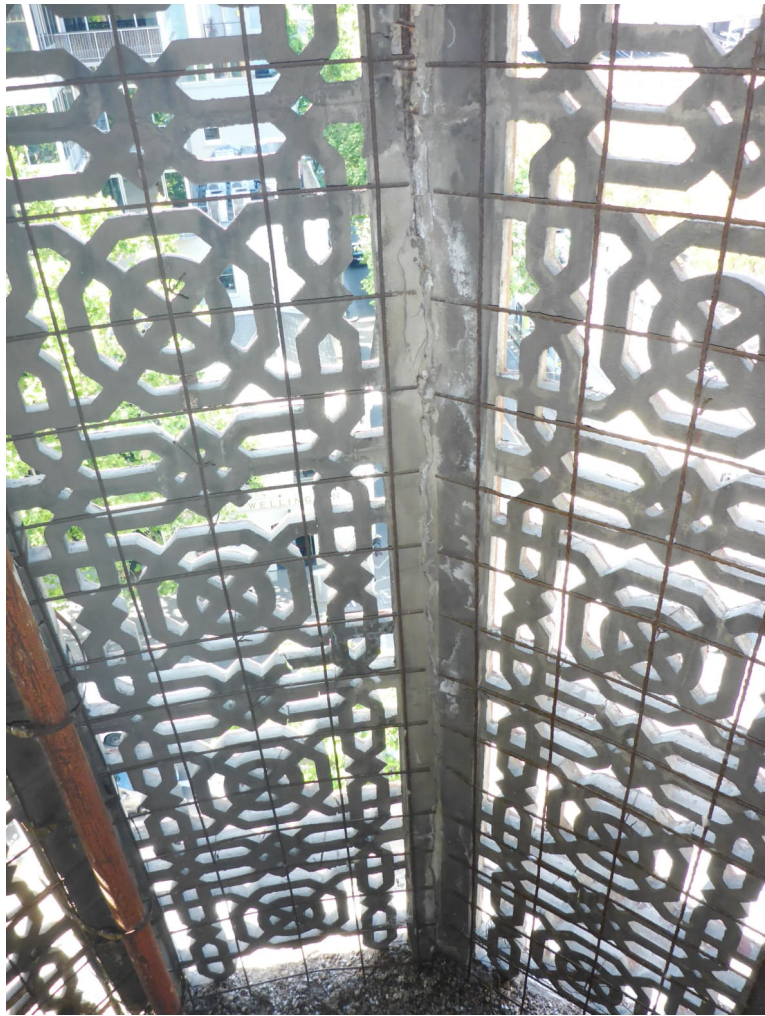
Photo 03

At the base of the screen, a structural beam zone aligns with likely parapet and roof support to the north. From this a slab appears to cantilever out, perhaps from floor level but this has not been confirmed. This supports the base of the mullions and screen as visible in Photo 03. Within the tower, immediately below the balcony, a large cast in concrete block is built within the masonry, likely to support the precast concrete corbels. Whether these corbels are load bearing or decorative is unclear at present.
