7th December 2022

C+S Consult Group Reference N^o: CS22136

**ENGINEER'S REPORT ON DAMAGE TO WHITE HOUSE BUILDING, ST KILLIAN'S PARISH
161 MCCRAE ST STREET, BENDIGO, VIC, 3550**

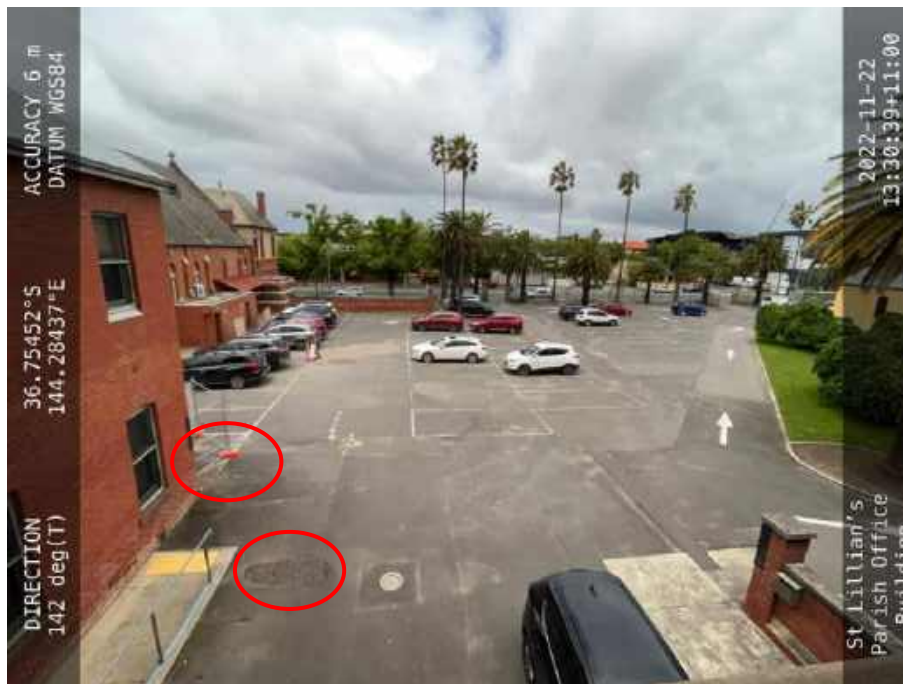
These sink holes were located adjacent to the Southernmost corner of the White House Building (**subject building**). Refer Figure 1 below for photo showing the location of the backfilled sink holes.

Figure 1 – NearMap aerial photograph of the property and garage (dated 22nd July 2022).

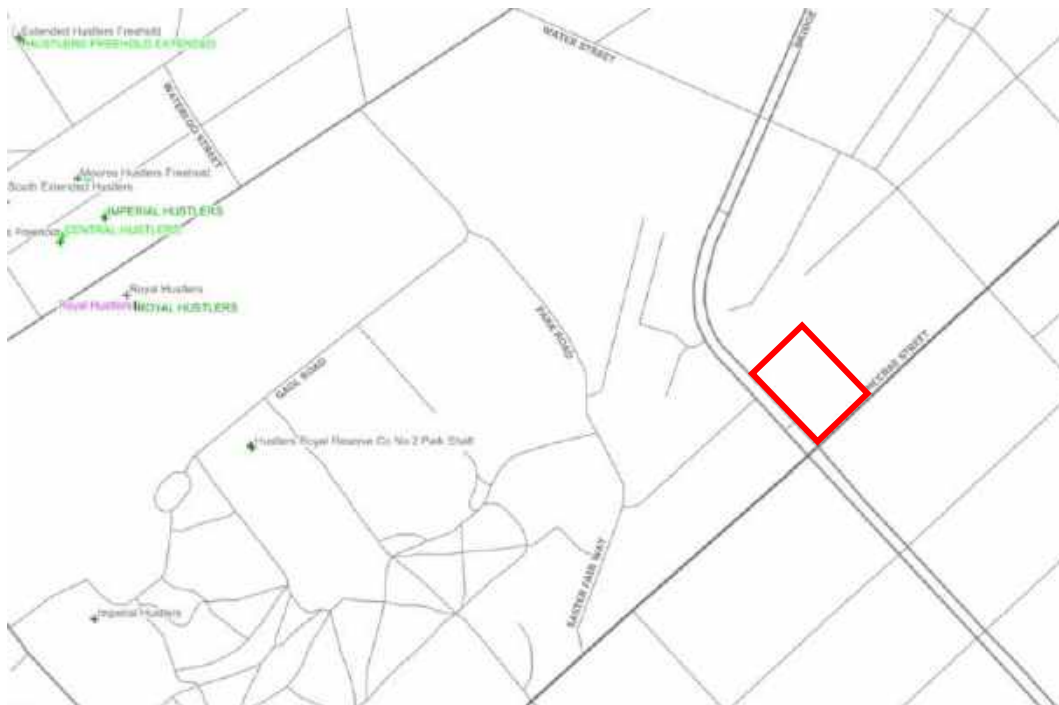
However, this does not mean that there are no unmapped shafts present on this site.

Major shafts and mining operations were known to exist nearby namely Hustlers Royal Reserve and Royal Hustlers.

**Figure 2 – Historical mine mapping data for the subject site shown by area enclosed by red rectangle. No known historical mines to this site.
(Earth Resources – Geovic Explore Victoria Online mapping data).**

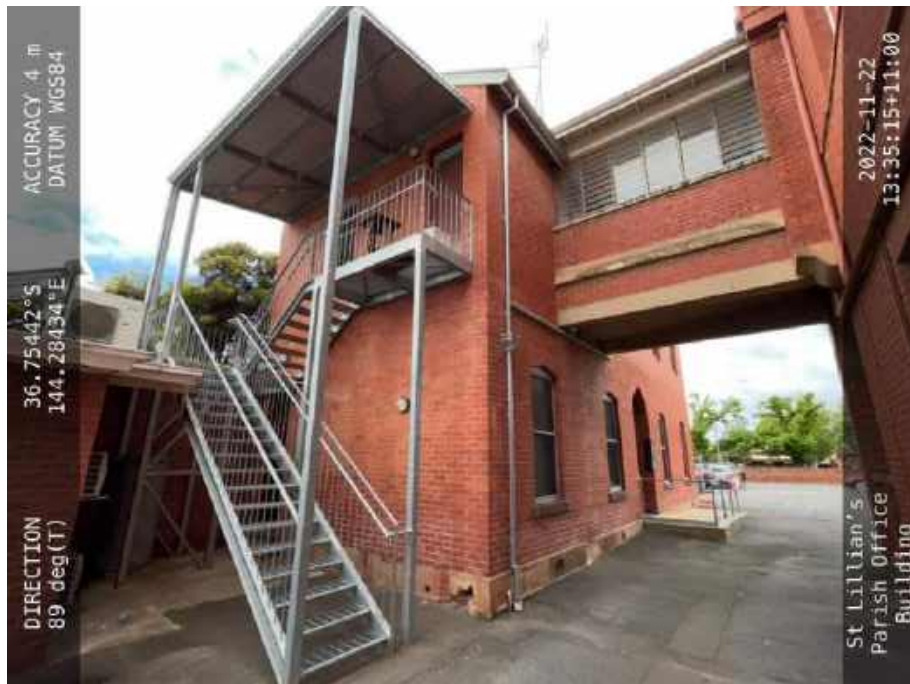
Photo 19 – Existing link bridge between original presbytery building and White House.

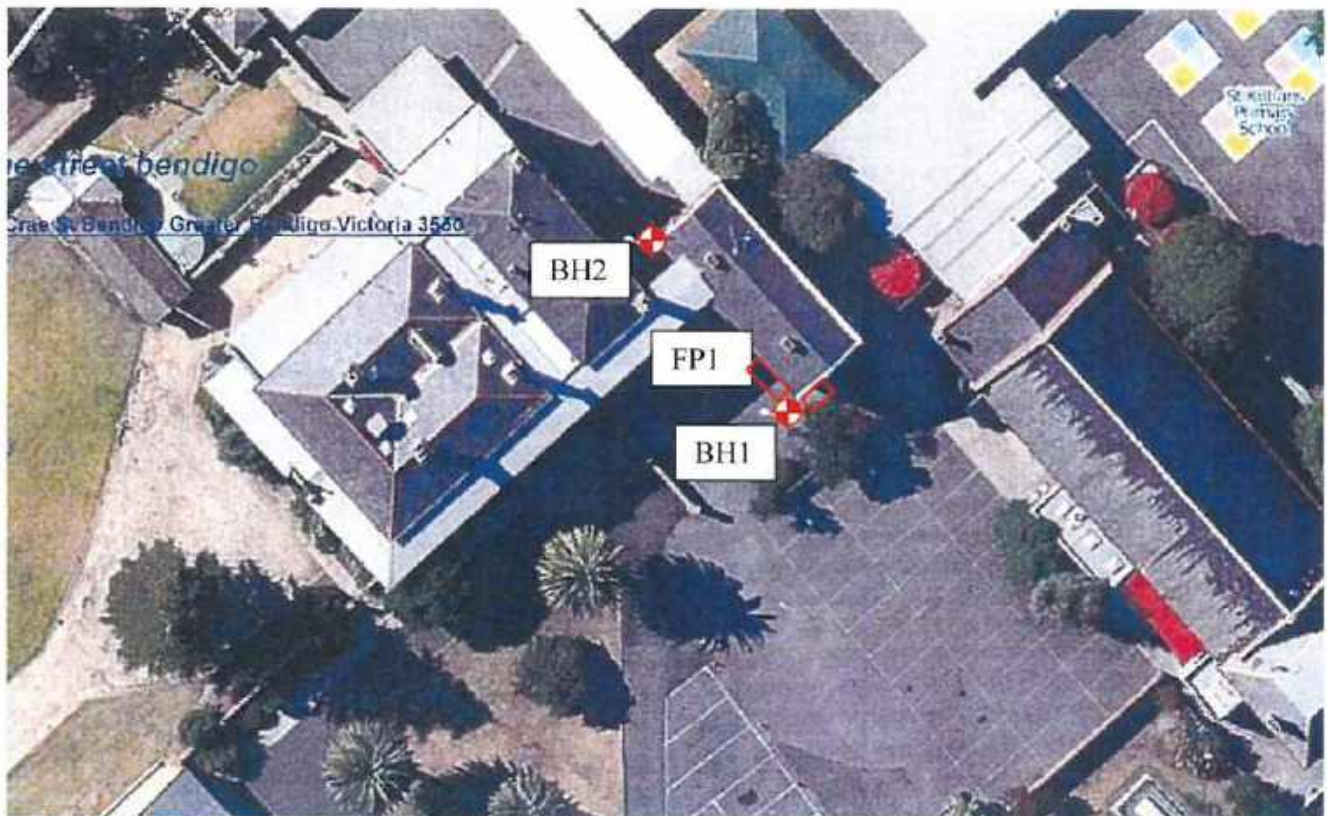
Figure 3

Denotes Approximate Footing Probe Location

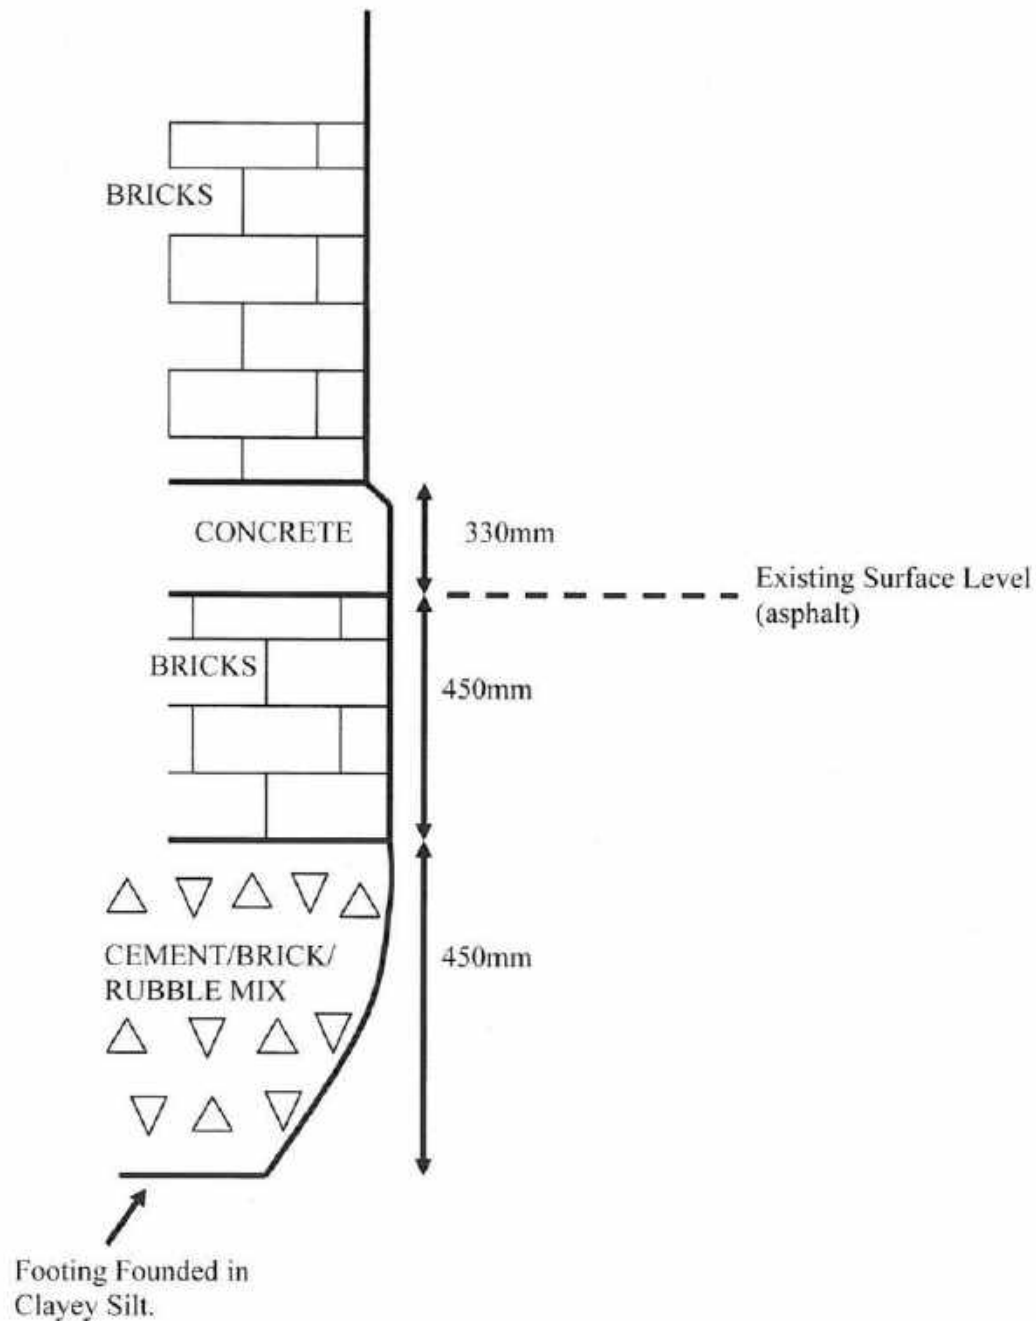
FOOTING PROBE DETAIL – FP 1

- 3.01 Cause of Foundation Movement:** On the basis of the geotechnical investigation work completed to date, together with our inspection, it is apparent that the cause of the movement may be a combination of factors:
1. The actual footing of the "White House" structure consists of a continuation of the brickwork which terminates at 0.45m & 0.26m below the existing surface level. At the base of the brickwork is a cemented combination of broken bricks, rubble and cement. This rough "blinding" footing is founded in clayey silt at a depth of 0.9m & 0.59m below the existing

surface level and has become weakened and easily broken. The clayey silt at the base of the footing in the vicinity of Footing Probe 2 was saturated and a further investigation into nearby sewer and stormwater pipes should be initiated.
