History, Significance & Condition

Kardinia House VHR H0337 1 Riverview Terrace, Belmont 3216

AuthorTrethowan ArchitectureDate24 March 2025

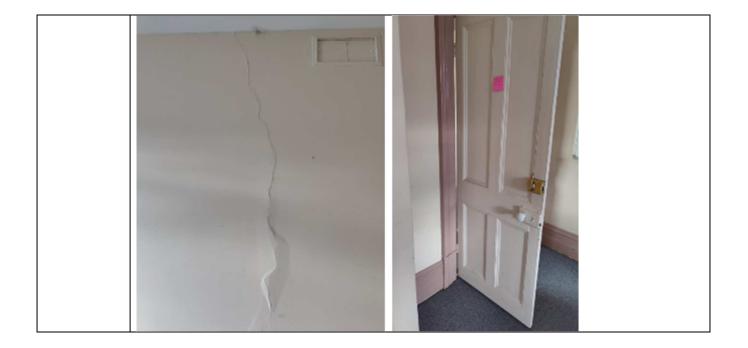
1 Riverview T	ion Survey errace. Belmont	(Kardinia House)		Date Surveyed	14 May 2024
Room No.	12A & 12B	Room Name	N/A	Surveyed by	JY
Use				the red brick rear addition	
Ceiling		ntains the original c	eiling with cornice	es, an access hatch show	vs timber slats above
	the ceiling 12B has a drop	ped ceiling with light	t tubes and smoke	e detectors	
Walls	Cream painted				
	Skirtings in dee				
	Arched doorway	top part of the west	wall		
		ar doorway to red b	rick building A		
Floor	Dark grey carpe	t, floor level higher	than that of 10		
Doors				tted with a non-original g	
				am, with deep dusty pin with plain door frame, le	
	stairs	uoor to south wall (p	bainteu în creani),		
Windows		unched window wit	h aluminium fram	e	
Significant	Original ceiling				
Items	Architrave and o				
Intrusive Items	Non-original dro South door to e	xternal fire stairs			
	Punched windo				
	Doorway to red	brick building			
Other	Carpet N/A

Features	IN/A				
Notes	N/A				
Significance		Space Secondary (L	ow integrity)		
Integrity Photos	Low
