**RE:     Assessment of trees and vegetation, 48 Howe Crescent, South Melbourne**

I inspected the above site on 20 March 2026. The property is occupied by a single Victorian Terrace dwelling and is located on the west side of Howe Crescent at the southern end of *Hazelwood Terrace*. *Hazelwood Terrace* is included on the Victorian Heritage Register as VHR H0223 and includes 46, 47 and 48 Howe Crescent.

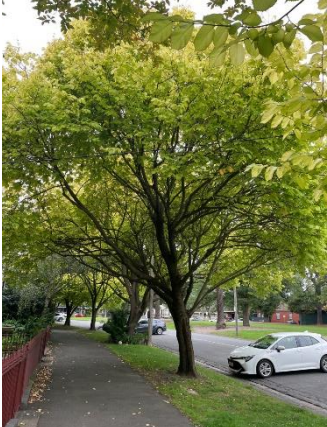
| | <b>TREE: 4</b> | <i>Ulmus glabra 'Lutescens'</i> , Golden Wych Elm | | | |

| | <b>ORIGIN:</b><br>Exotic | <b>HEALTH:</b><br>Fair-good | <b>STRUCTURE:</b><br>Fair-good | <b>FORM:</b><br>Symmetrical | <b>ULE:</b><br>20+years |
| | <b>AGE:</b><br>Mature | <b>HEIGHT (m):</b><br>12 | <b>WIDTH (m):</b><br>14 | <b>DSH (cm):</b><br>51<br><b>DAB (cm):</b><br>65 | <b>NRZ (m):</b><br>6.2<br><b>SRZ (m):</b><br>2.8 |
| | <b>NOTES</b> | | | <b>ARBORICULTURAL RATING:</b><br>Moderate | |
